CVFPB Meeting March 22, 2013

USACE INSPECTION RESULTS

Meegan G Nagy, PE
Levee Safety Program Manager

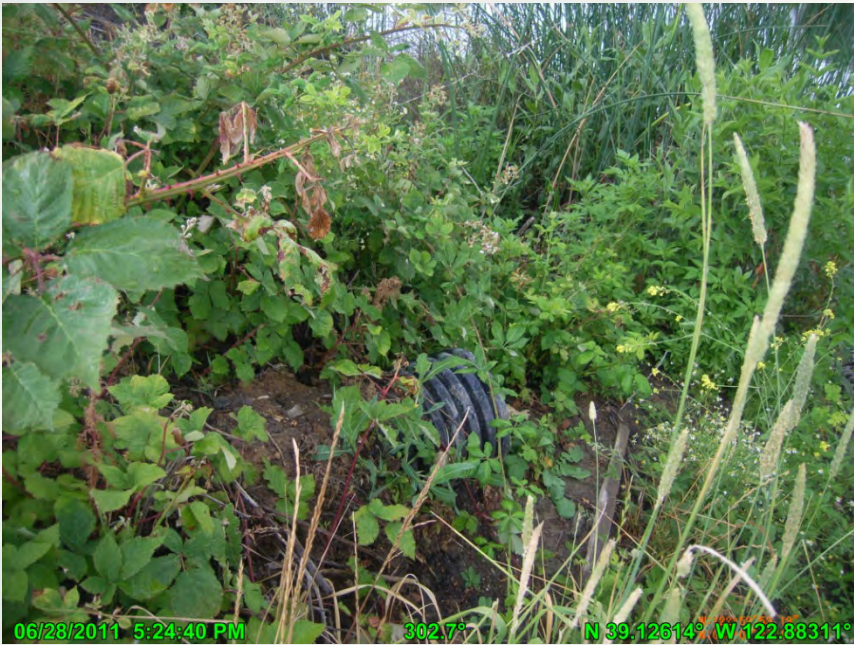
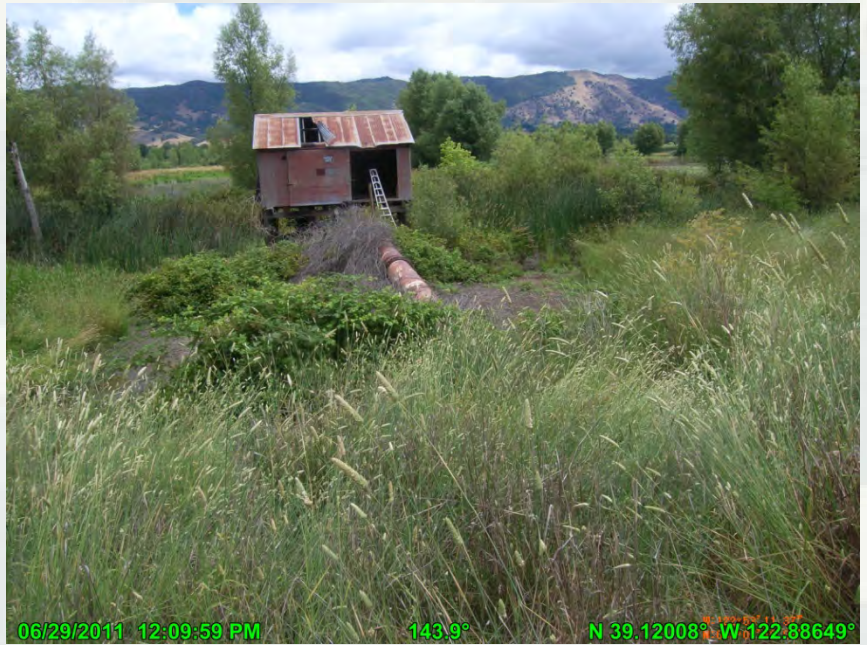
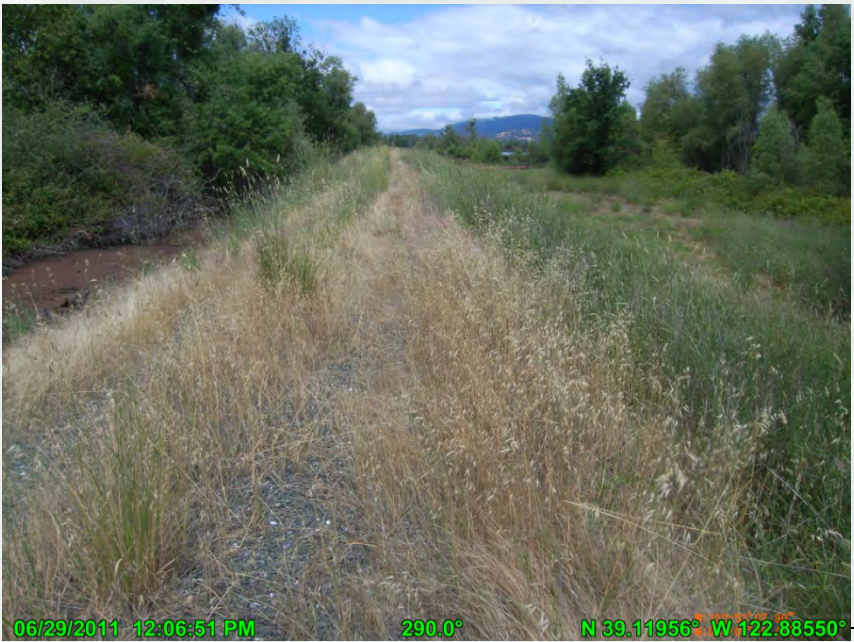
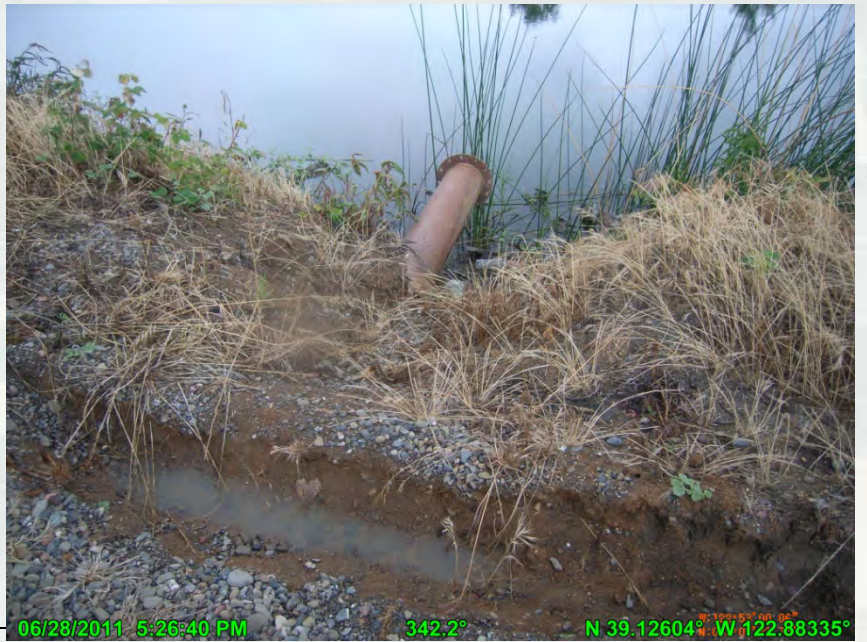
Middle Creek – Unit 1 at Clear Lake

System
Middle Creek Left Bank - Unit 1 at
Clear Lake
Unacceptable - Inactive

General	Operations and Maintenance Manuals	A								
	Emergency Supplies and Equipment	A								
	Flood Preparedness and Training	A								
Levee Embankments	Unwanted Vegetation Growth	U								
	Sod Cover	NA								
	Encroachments	U								
	Closure Structures	NA								
	Slope Stability	A								
	Erosion/Bank Caving	A								
	Settlement	U								
	Depressions/Rutting	M								
	Cracking	A								
	Animal Control	A								
	Culverts/Discharge Pipes	NA								
	Riprap Revetments & Bank Protection	NA								
	Revetments other than Riprap	NA								
	Underseepage Relief Wells/Toe Drainage Systems	NA								
	Seepage	A

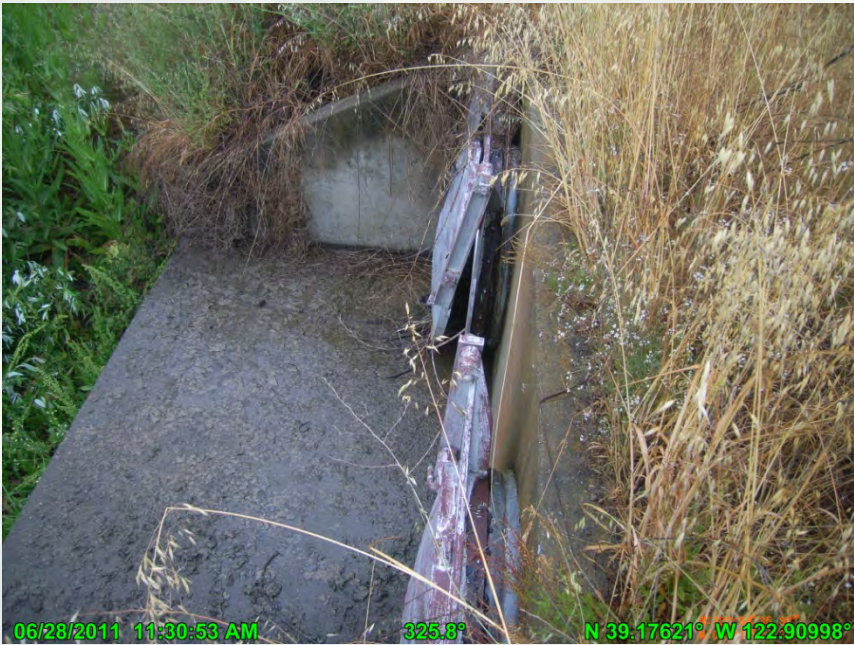
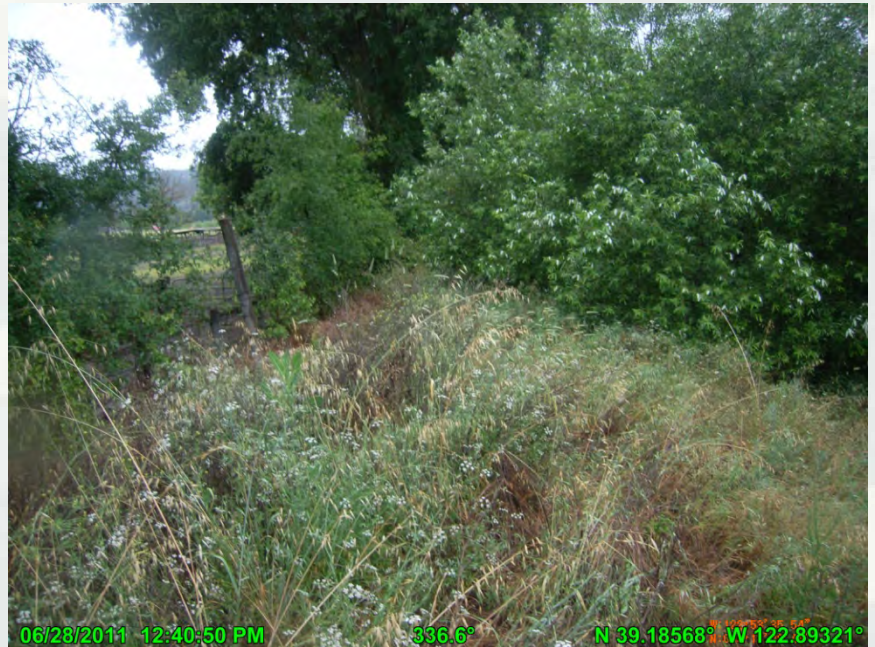
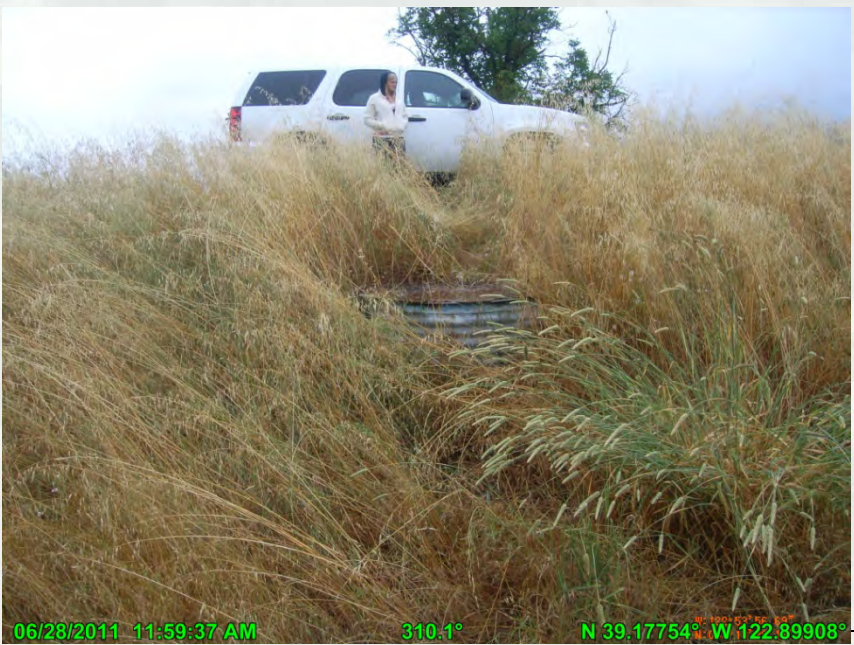
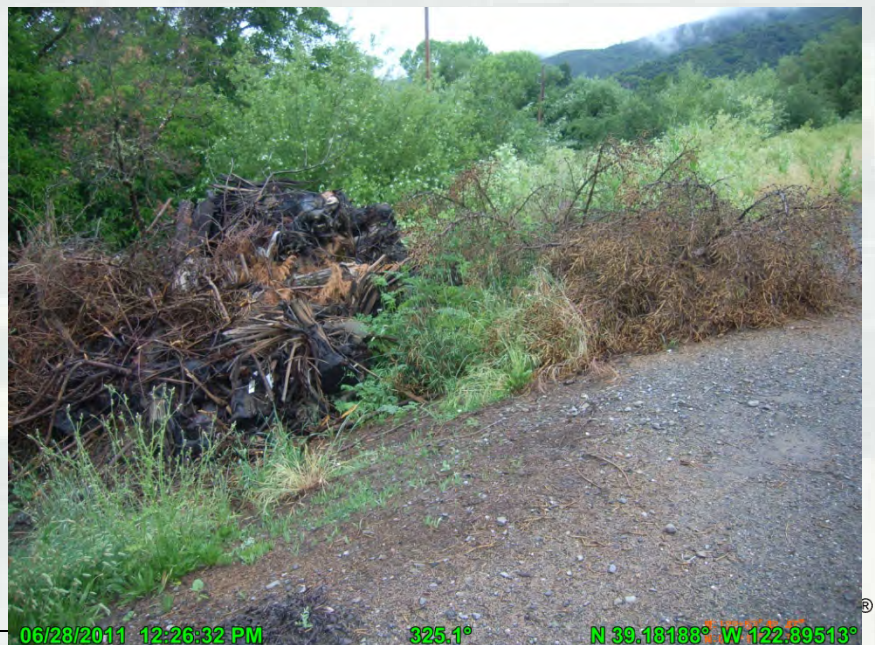
Middle Creek – Unit 1 North

System Middle Creek Left Bank – Unit 1 North Unacceptable - Inactive										
		Middle Creek- Lake Co- U 1 north left bank (MC1A)	Middle Creek – Lake Co - U 4 Alley Creek right bank (MC04)									
General	Operations and Maintenance Manuals	A	A									
	Emergency Supplies and Equipment	A	A									
	Flood Preparedness and Training	A	A									
Levee Embankments	Unwanted Vegetation Growth	U	U									
	Sod Cover	NA	NA									
	Encroachments	U	U									
	Closure Structures	NA	NA									
	Slope Stability	A	A									
	Erosion/Bank Caving	A	A									
	Settlement	A	A									
	Depressions/Rutting	M	M									
	Cracking	A	A									
	Animal Control	A	A									
	Culverts/Discharge Pipes	NA	NA									
	Riprap Revetments & Bank Protection	NA	NA									
	Revetments other than Riprap	NA	NA									
	Underseepage Relief Wells/Toe Drainage Systems	NA	NA									
Seepage	A	A

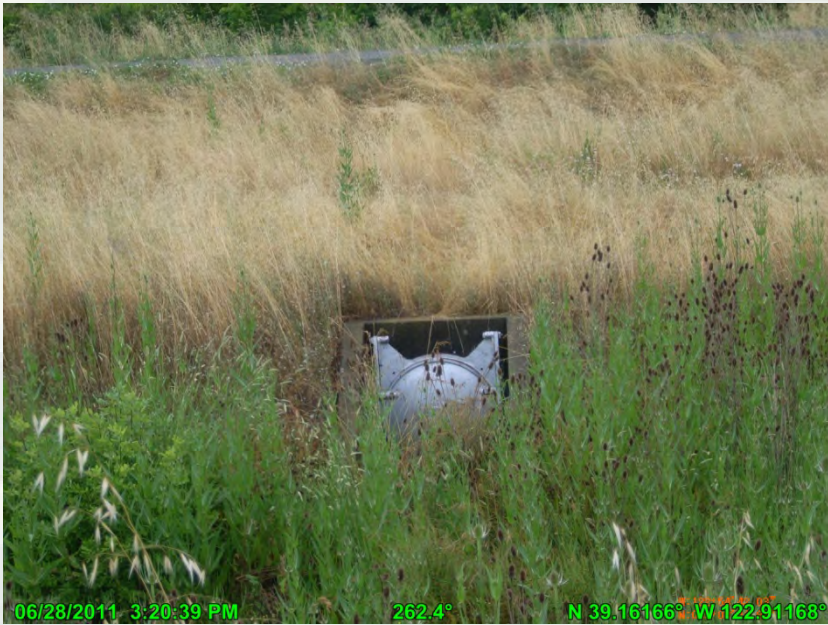
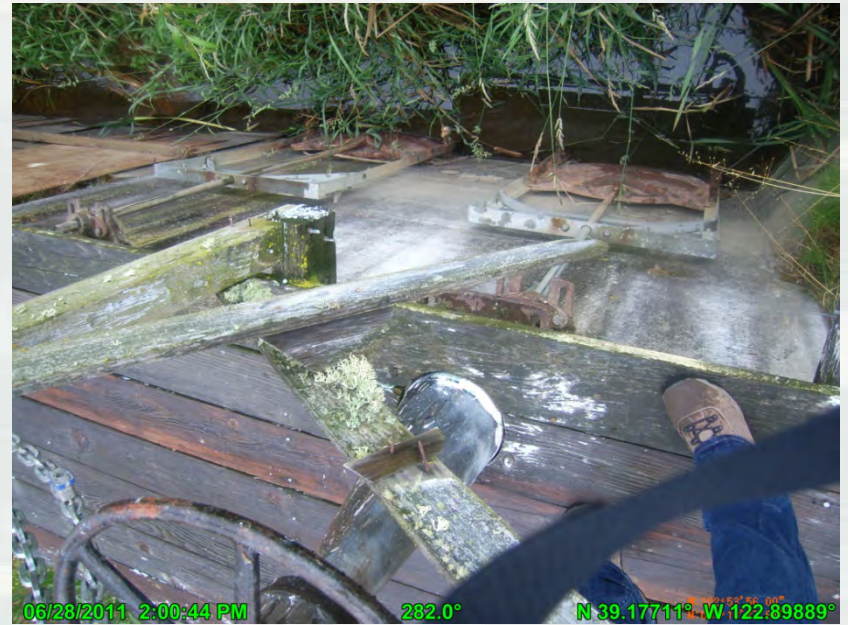
Middle Creek – Unit 5 and part of 1

System Middle Creek Left Bank - Unit 5 and part of 1 Unacceptable - Inactive		Middle Creek- Lake Co- U 1 left brk above Clover C (MC1B) Middle Creek - Lake Co - U 5 Alley Creek left bank (MC05)								
General	Operations and Maintenance Manuals	A	A							
	Emergency Supplies and Equipment	A	A							
	Flood Preparedness and Training	A	A							
Levee Embankments	Unwanted Vegetation Growth	U	U							
	Sod Cover	NA	NA							
	Encroachments	U	U							
	Closure Structures	NA	NA							
	Slope Stability	A	A							
	Erosion/Bank Caving	A	A							
	Settlement	A	M							
	Depressions/Rutting	M	M							
	Cracking	A	A							
	Animal Control	A	M							
	Culverts/Discharge Pipes	NA	NA							
	Riprap Revetments & Bank Protection	NA	NA							
	Revetments other than Riprap	NA	NA							
	Underseepage Relief Wells/Toe Drainage Systems	NA	NA							
Seepage	A	A

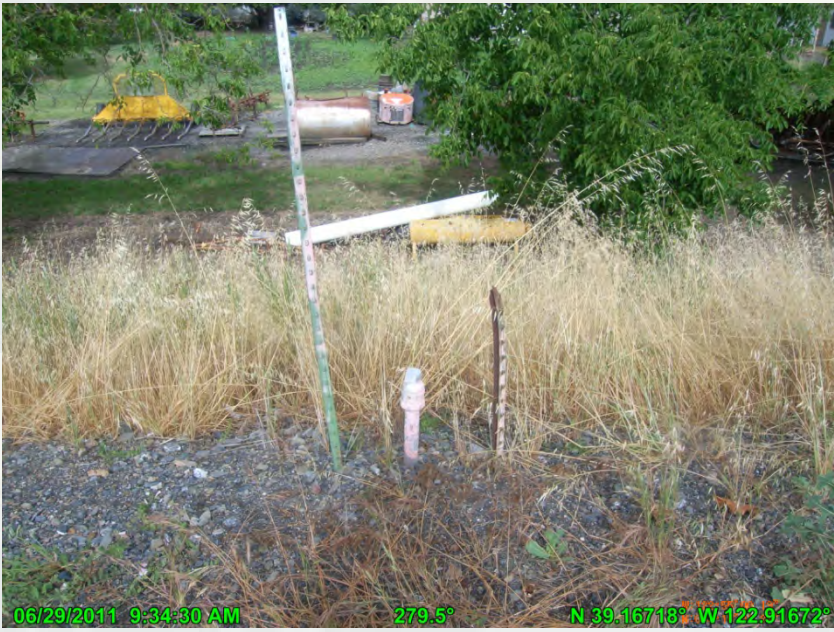
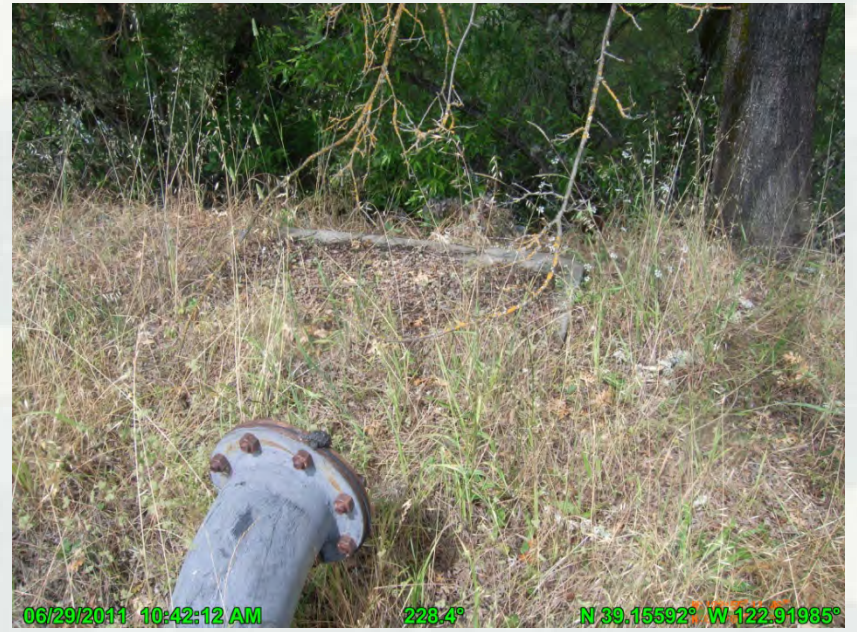
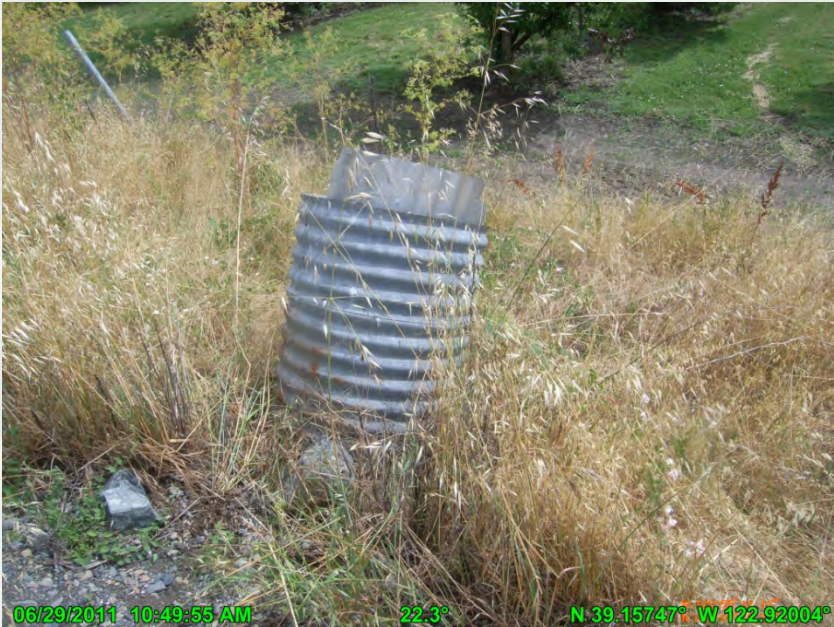
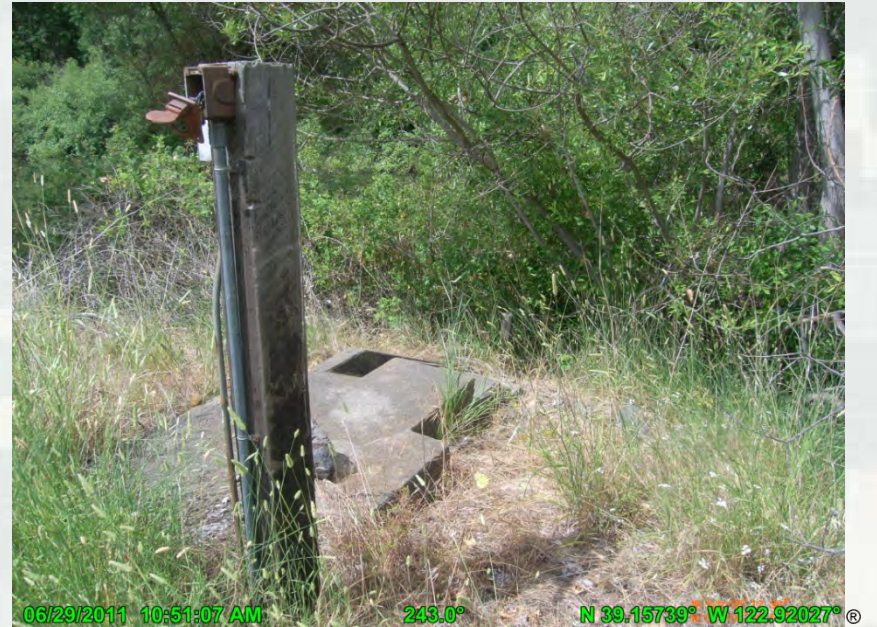
Middle Creek – Unit 2

System Middle Creek Right Bank - Unit 2 Unacceptable - Inactive		Middle Creek- Lake Co- U2 right bank abv Scotts C (MC2B) Middle Creek - Lake Co - U 3 Scotts Creek left bank (MC03)								
General	Operations and Maintenance Manuals	A	A							
	Emergency Supplies and Equipment	A	A							
	Flood Preparedness and Training	A	A							
Levee Embankments	Unwanted Vegetation Growth	U	U							
	Sod Cover	NA	NA							
	Encroachments	U	U							
	Closure Structures	NA	NA							
	Slope Stability	A	A							
	Erosion/Bank Caving	A	A							
	Settlement	A	A							
	Depressions/Rutting	A	A							
	Cracking	A	A							
	Animal Control	A	A							
	Culverts/Discharge Pipes	NA	NA							
	Riprap Revetments & Bank Protection	NA	NA							
	Revetments other than Riprap	NA	NA							
	Underseepage Relief Wells/Toe Drainage Systems	NA	NA							
Seepage	A	A

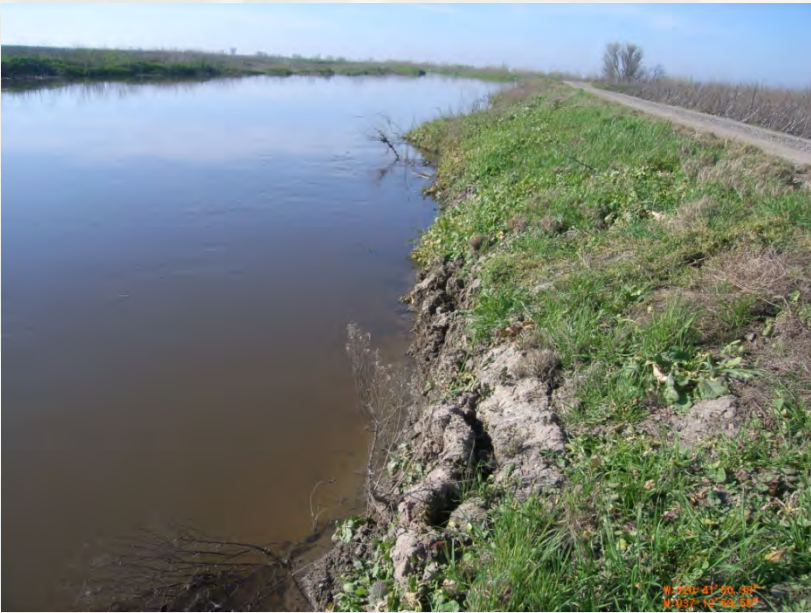
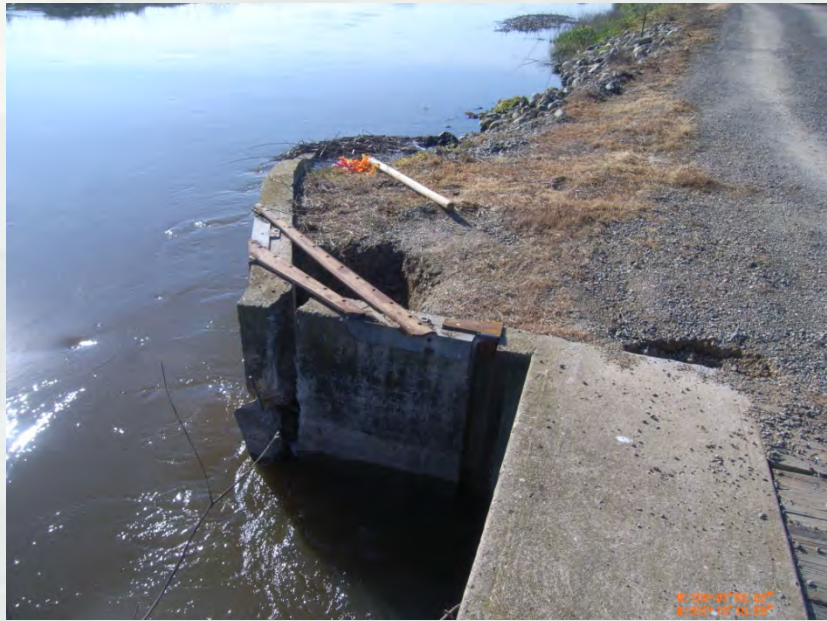
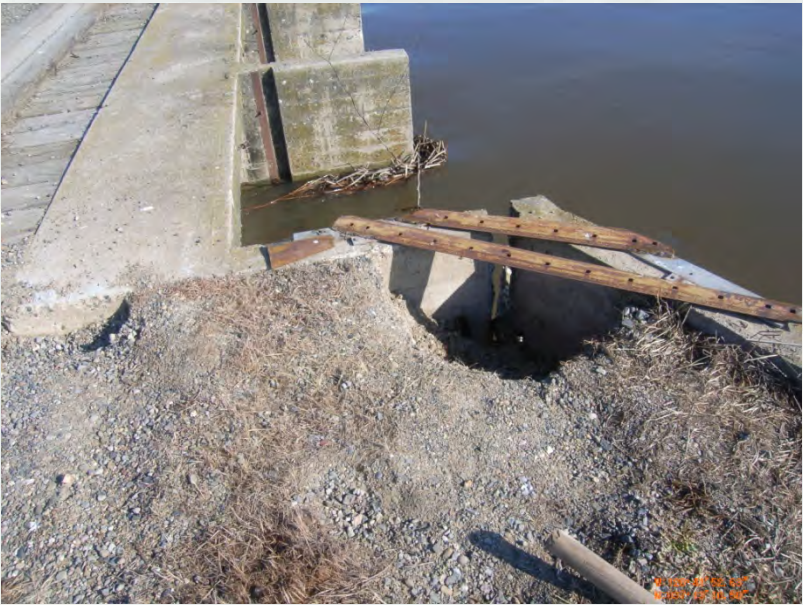
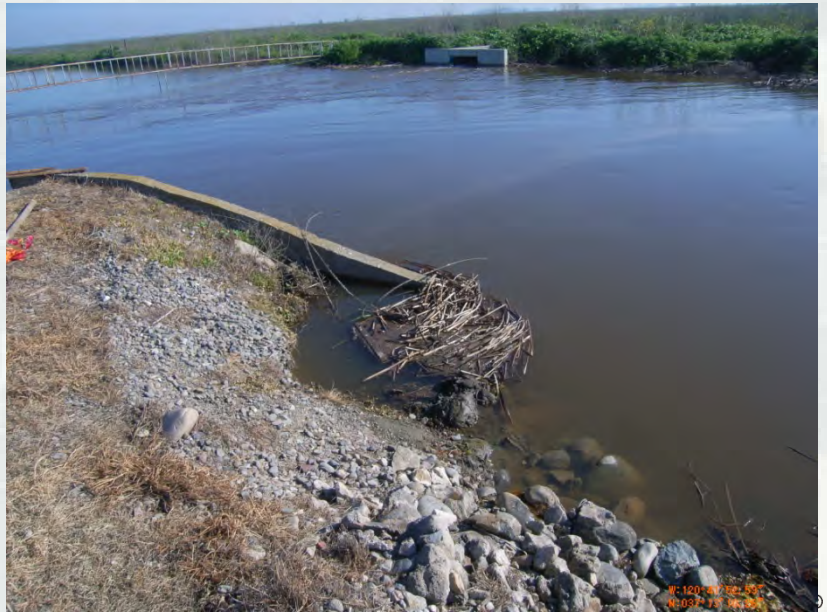
LSJLD – Units 5, 10, & 22

System LSJLD-Units 5, 10, and 22 Unacceptable - Inactive		LSJLD- U 5 Deep Slough right bank above Owens Creek (L05C)	LSJLD- U 10 Owens Creek left bank (L010)	LSJLD- U 22 East Side Canal left bank above Owens Creek (L22C)						
General	Operations and Maintenance Manuals	A	A	A						
	Emergency Supplies and Equipment	A	A	A						
	Flood Preparedness and Training	A	A	A						
Levee Embankments	Unwanted Vegetation Growth	U	U	U						
	Sod Cover	NA	NA	NA						
	Encroachments	U	U	U						
	Closure Structures	NA	NA	NA						
	Slope Stability	A	A	A						
	Erosion/Bank Caving	A	A	U						
	Settlement	A	A	A						
	Depressions/Rutting	A	A	U						
	Cracking	A	A	A						
	Animal Control	U	U	U						
	Culverts/Discharge Pipes	NA	NA	NA						
	Riprap Revetments & Bank Protection	NA	NA	NA						
	Revetments other than Riprap	NA	NA	NA						
	Underseepage Relief Wells/Toe Drainage Systems	NA	NA	NA						
	Seepage	A	A	A						
Flood Damage Reduction Channels	Vegetation and Obstructions	A	A	A

Shoaling	A	A	A						
	Encroachments	M	A	A						
	Erosion	A	A	U						
	Concrete Surfaces	NA	NA	A						
	Tilting, Sliding, or Settlement of Concrete	NA	NA	U						
	Foundation of Concrete Structures	NA	NA	U						
	Slab and Monolith Joints	NA	NA	NA						
	Flap Gates/Flap Valves/Pinch Valves	NA	NA	NA						
	Riprap Revetments & Banks	NA	NA	NA						
	Revetments other than Riprap	NA	NA	NA						
Likely to Prevent Performance in Next Flood Event/Inactive					Legend A Acceptable M Minimally Acceptable U Unacceptable N/A Not Applicable					
Serious Deficiency noted in past inspections has not been corrected within the established timeframe										
Not Likely to Prevent Performance in Next Flood Event/Active										
The lowest rating is used to determine the overall segment & system ratings and PL 84-99 Eligibility

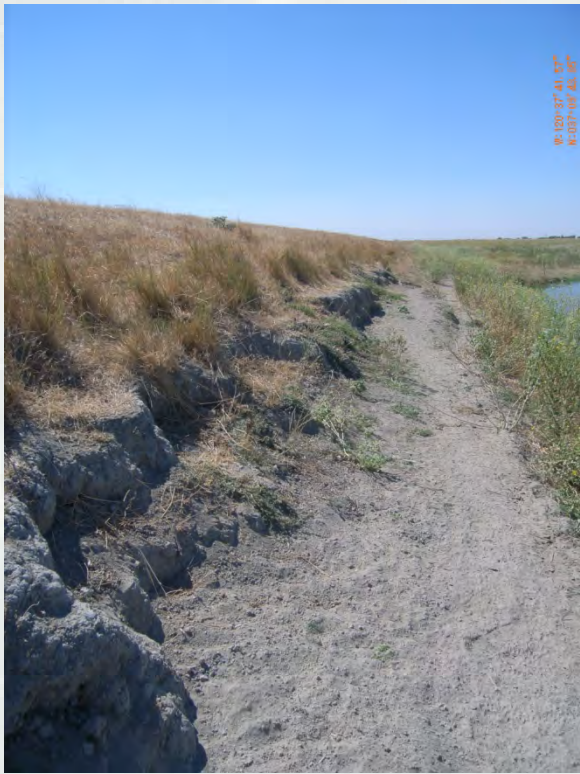
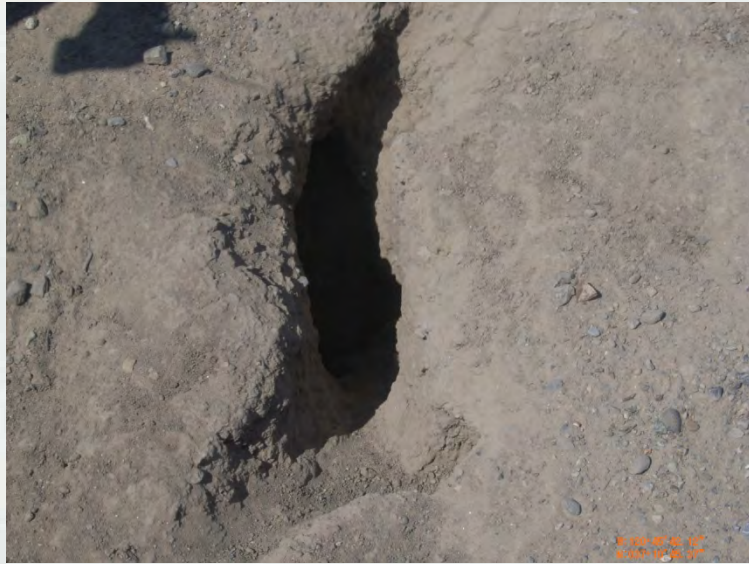
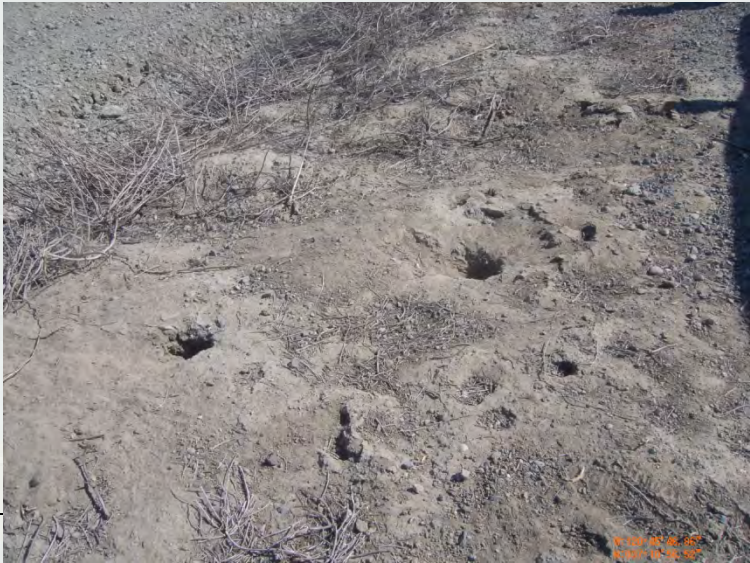
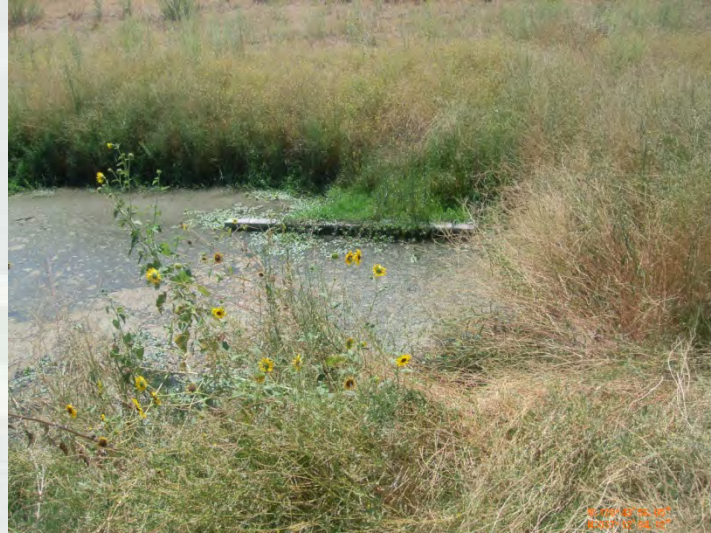
LSJLD – Units 1, 4, 6, & 12

System LSJLD-Units 1, 4, 6, and 12 Unacceptable - Inactive		LSJLD- U 1 South, San Joaquin River right bank above Mariposa Bypass (L01C)				LSJLD- U 4, San Joaquin River left bank above Mariposa Slough-Eastside Bypass (L004)				LSJLD- U 6, Eastside Bypass left bank above Mariposa Bypass (L06B)				LSJLD- U 12, Mariposa Bypass south levee (L012)			
General	Operations and Maintenance Manuals	A	A	A	A												
	Emergency Supplies and Equipment	A	A	A	A												
	Flood Preparedness and Training	A	A	A	A												
Levee Embankments	Unwanted Vegetation Growth	U	U	U	U												
	Sod Cover	NA	U	U	NA												
	Encroachments	U	U	U	U												
	Closure Structures	NA	NA	NA	NA												
	Slope Stability	A	M	A	A												
	Erosion/Bank Caving	A	A	U	A												
	Settlement	A	A	A	A												
	Depressions/Rutting	A	M	U	U												
	Cracking	A	A	U	A												
	Animal Control	U	U	U	U												
	Culverts/Discharge Pipes	NA	NA	NA	NA

Riprap Revetments & Bank Protection	NA	NA	NA	NA												
	Revetments other than Riprap	NA	NA	NA	NA												
	Underseepage Relief Wells/Toe Drainage Systems	NA	NA	NA	NA												
Seepage	A	A	A	A													
Flood Damage Reduction Channels	Vegetation and Obstructions	U	A	A	A												
	Shoaling	A	A	A	A												
	Encroachments	U	A	U	U												
	Erosion	M	A	A	M												
	Concrete Surfaces	NA	NA	A	A												
	Tilting, Sliding, or Settlement of Concrete	NA	NA	NA	NA												
	Foundation of Concrete Structures	NA	NA	NA	NA												
	Slab and Monolith Joints	U	NA	NA	NA												
	Flap Gates/Flap Valves/Pinch Valves	NA	NA	NA	NA												
	Riprap Revetments & Banks	NA	NA	NA	NA												
Revetments other than Riprap	NA	NA	A	NA													
<p>Unlikely to Prevent Performance in Next Flood Event/Inactive</p> <p>Serious deficiency noted in past inspections has not been corrected within the established timeframe</p> <p>Not Likely to Prevent Performance in Next Flood Event/Active</p>											<p>Legend</p> <p>A Acceptable</p> <p>M Minimally Acceptable</p> <p>U Unacceptable</p> <p>N/A Not Applicable</p>

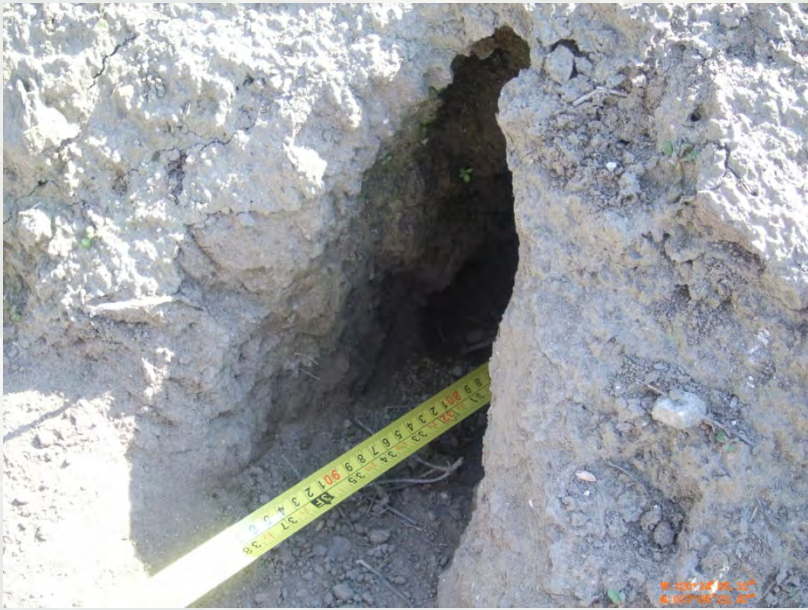
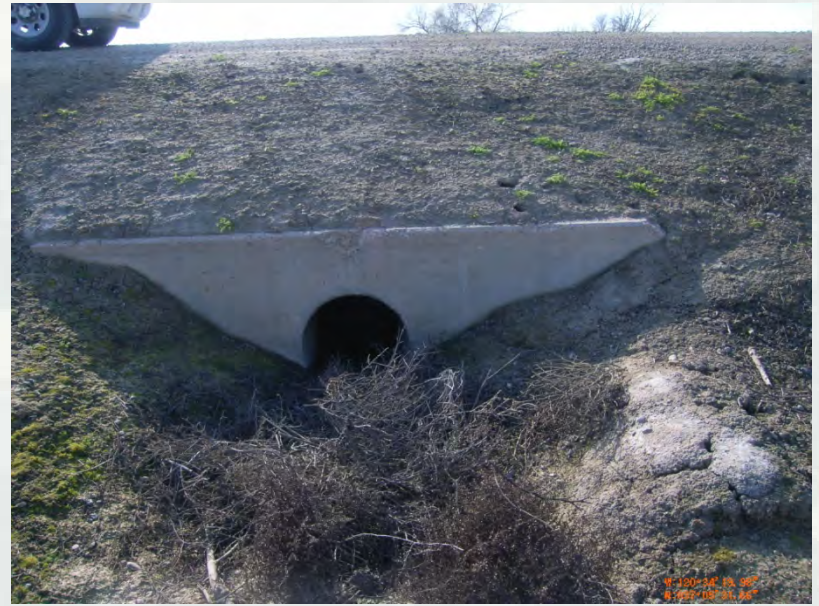
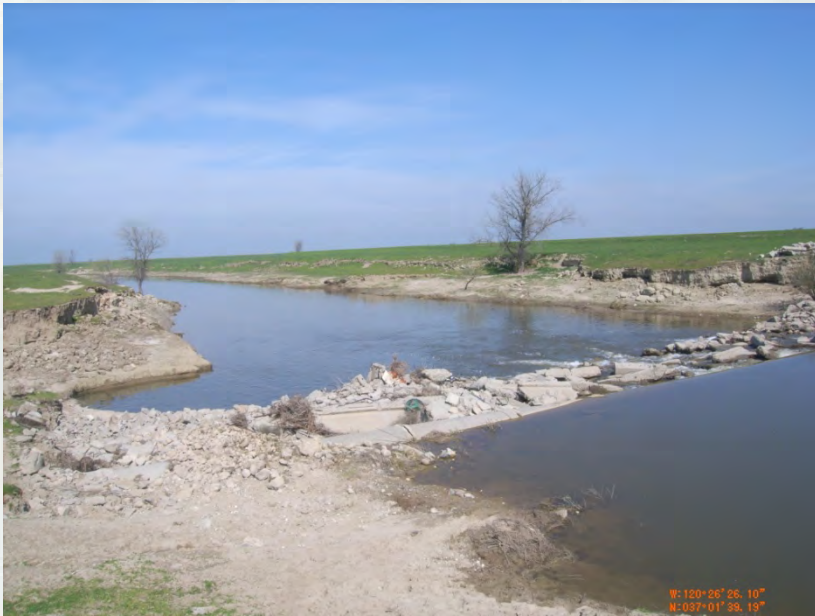
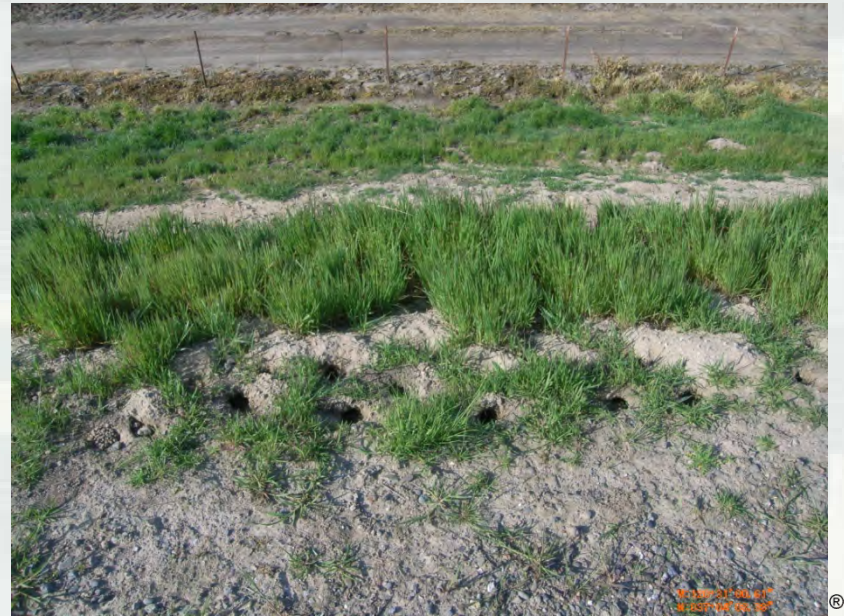
LSJLD Units 3, 6, & 18

LSJLD-Units 3, 6, 18 – Eastside-Chowchilla Bypass Unacceptable - Inactive								
		LSJLD- U 3 San Joaquin R right bank abv Mariposa S	LSJLD- U 6 Eastside Byp left bank below Fresno R	LSJLD- U 18 Eastside Bypass left bnk abov Fresno R						
General	Operations and Maintenance Manuals	A	A	A						
	Emergency Supplies and Equipment	A	A	A						
	Flood Preparedness and Training	A	A	A						
Levee Embankments	Unwanted Vegetation Growth	A	M	U						
	Sod Cover	M	NA	NA						
	Encroachments	U	U	U						
	Closure Structures	NA	NA	NA						
	Slope Stability	A	A	A						
	Erosion/Bank Caving	A	U	A						
	Settlement	A	A	A						
	Depressions/Rutting	M	U	M						
	Cracking	A	A	A						
	Animal Control	U	U	U						
	Culverts/Discharge Pipes	NA	NA	NA						
	Riprap Revetments & Bank Protection	NA	NA	NA						
	Revetments other than Riprap	NA	NA	NA						
	Underseepage Relief Wells/Toe Drainage Systems	NA	NA	NA						
Seepage	A	A	M

Flood Damage Reduction Channels	Vegetation and Obstructions	A	M	U						
	Shoaling	A	M	A						
	Encroachments	A	U	A						
	Erosion	A	A	A						
	Concrete Surfaces	NA	M	M						
	Tilting, Sliding, or Settlement of Concrete	NA	M	NA						
	Foundation of Concrete Structures	NA	A	NA						
	Slab and Monolith Joints	NA	NA	NA						
	Flap Gates/Flap Valves/Pinch Valves	NA	NA	NA						
	Riprap Revetments & Banks	NA	NA	NA						
Revetments other than Riprap	NA	NA	NA							
		<p>Legend</p> <p>A Acceptable</p> <p>M Minimally Acceptable</p> <p>U Unacceptable</p> <p>N/A Not Applicable</p>								
		<p>The worst rating is used to determine the overall segment & system ratings and PL 84-99 Eligibility</p>

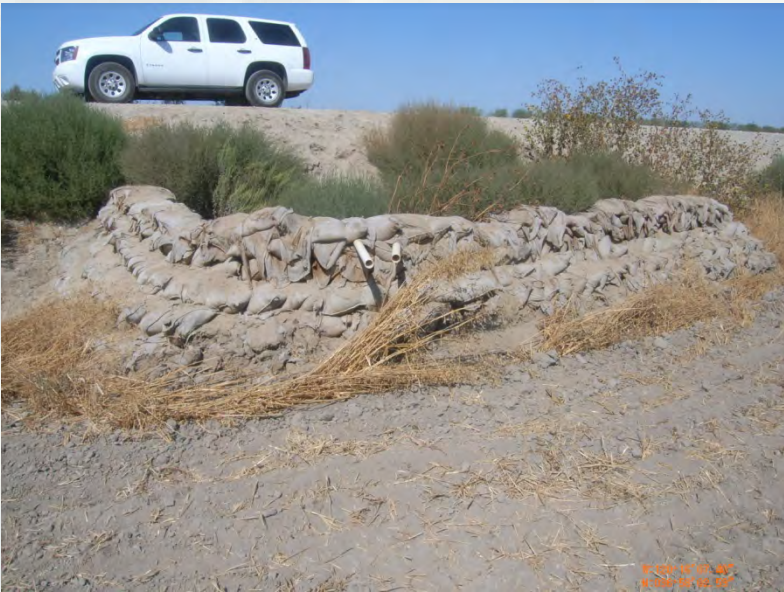
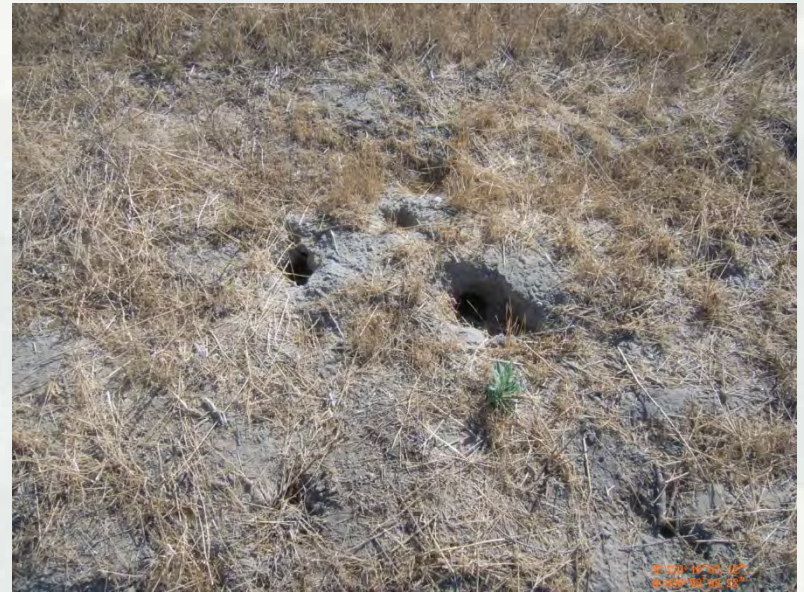
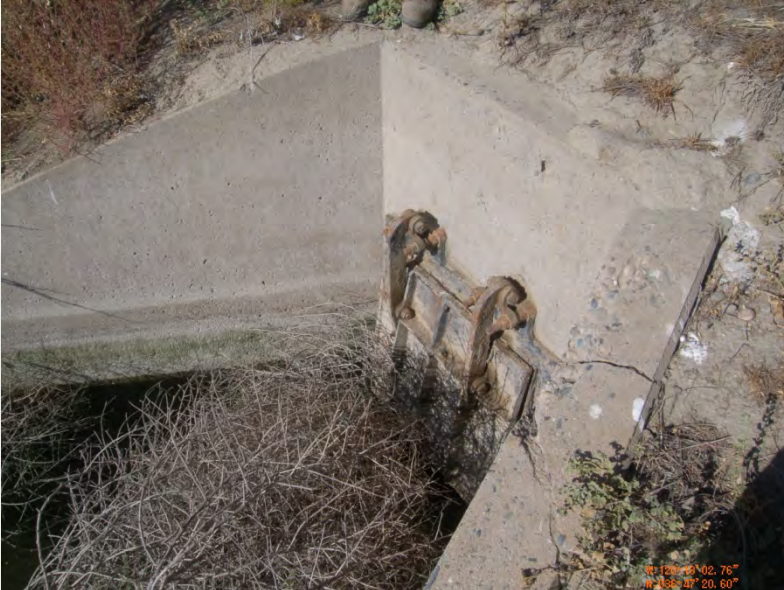
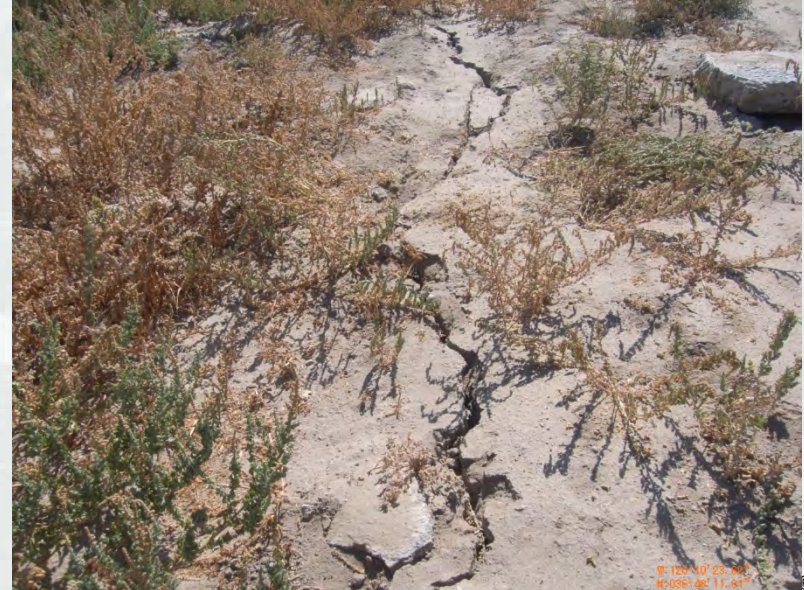
LSJLD Units 17, 23, Fresno River, Chowchilla Bypass

System LSJLD-Units 17, 23, Fresno River, Chowchilla Bypass Unacceptable - Inactive		Fresno River - left bank (FRN2)			LSJLD-Unit 17, Chowchilla Bypass right bank above Fresno River (L017)			LSJLD- Unit 23, San Joaquin River right bank above Chowchilla Bypass (L023)		
General	Operations and Maintenance Manuals	A	A	A						
	Emergency Supplies and Equipment	A	A	A						
	Flood Preparedness and Training	A	A	A						
Levee Embankments	Unwanted Vegetation Growth	U	U	U						
	Sod Cover	NA	NA	NA						
	Encroachments	U	U	U						
	Closure Structures	NA	NA	NA						
	Slope Stability	U	A	U						
	Erosion/Bank Caving	M	A	U						
	Settlement	A	A	A						
	Depressions/Rutting	U	U	U						
	Cracking	A	A	A						
	Animal Control	U	U	U						
	Culverts/Discharge Pipes	NA	NA	NA						
	Riprap Revetments & Bank Protection	NA	NA	M						
	Revetments other than Riprap	NA	NA	NA						
	Underseepage Relief Wells/Toe Drainage Systems	NA	NA	NA

Seepage	U	A	A							
Flood Damage Reduction Channels	Vegetation and Obstructions	A	A	M						
	Shoaling	A	M	M						
	Encroachments	U	U	U						
	Erosion	A	A	A						
	Concrete Surfaces	A	M	NA						
	Tilting, Sliding, or Settlement of Concrete	A	M	NA						
	Foundation of Concrete Structures	A	A	NA						
	Slab and Monolith Joints	A	M	NA						
	Flap Gates/Flap Valves/Pinch Valves	NA	NA	NA						
	Riprap Revetments & Banks	NA	NA	NA						
	Revetments other than Riprap	NA	NA	NA						
<p>U Not Likely to Prevent Performance in Next Flood Event/Inactive</p> <p>M Serious deficiency noted in past inspections has not been corrected within the established timeframe.</p> <p>U Not Likely to Prevent Performance in Next Flood Event/Active</p>		<p>Legend</p> <p>A Acceptable</p> <p>M Minimally Acceptable</p> <p>U Unacceptable</p> <p>N/A Not Applicable</p>								
The worst rating is used to determine the overall segment & system ratings and PL 84-99 Eligibility

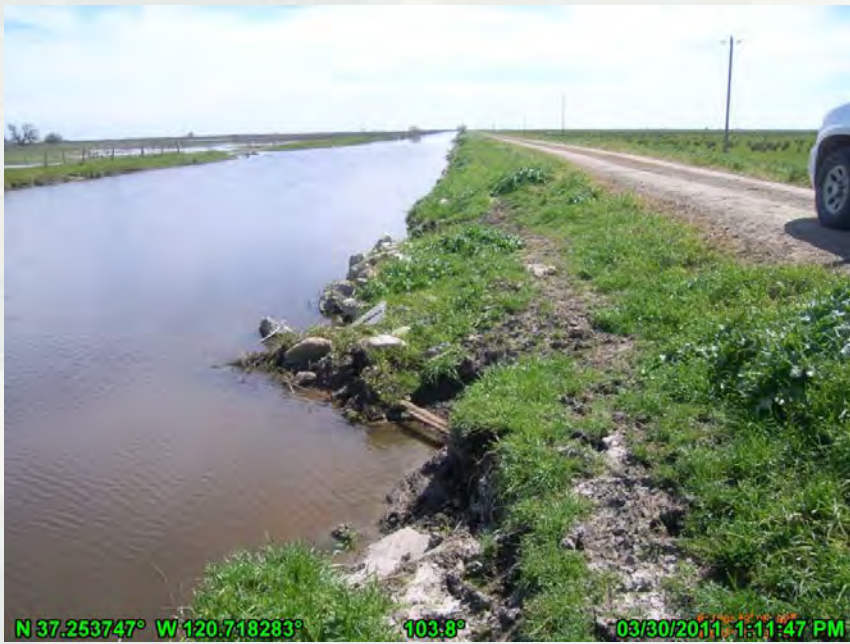
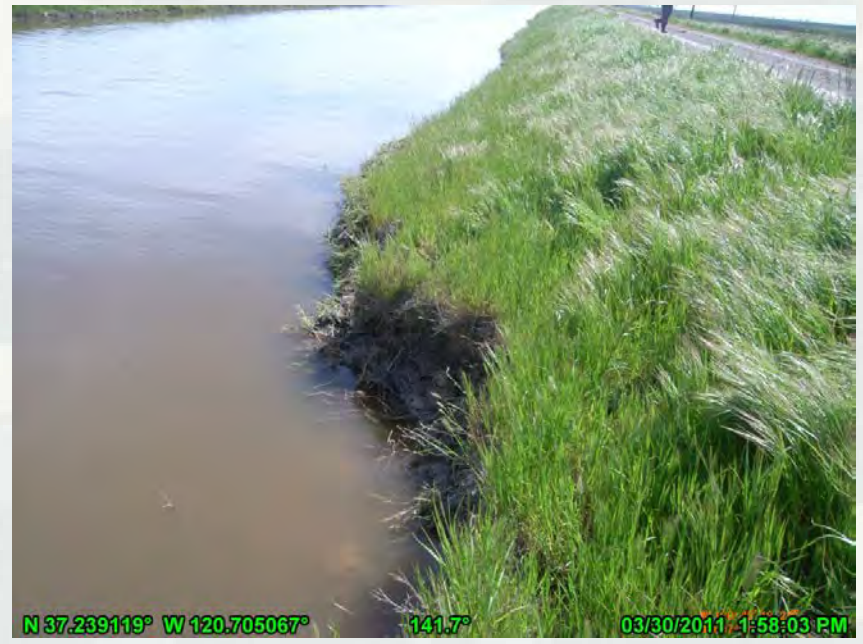
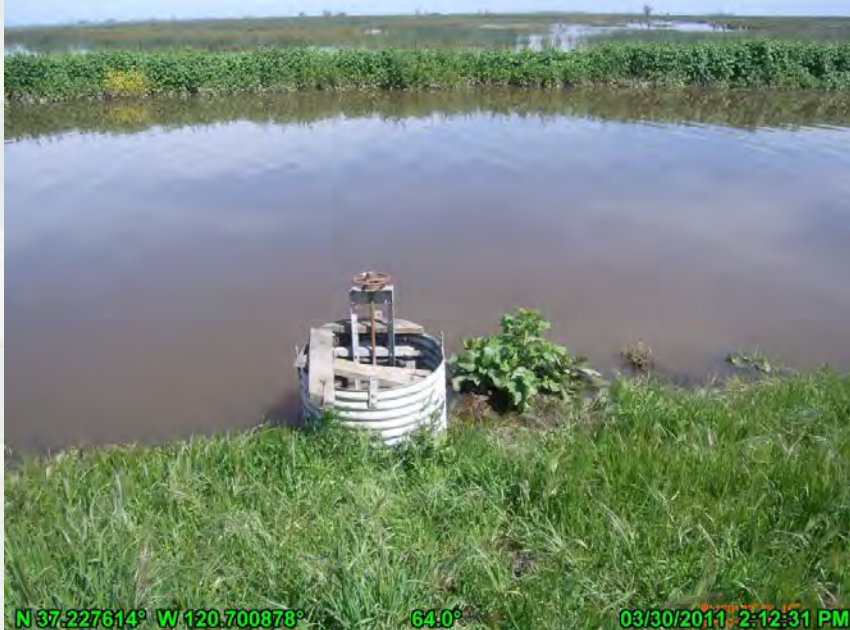
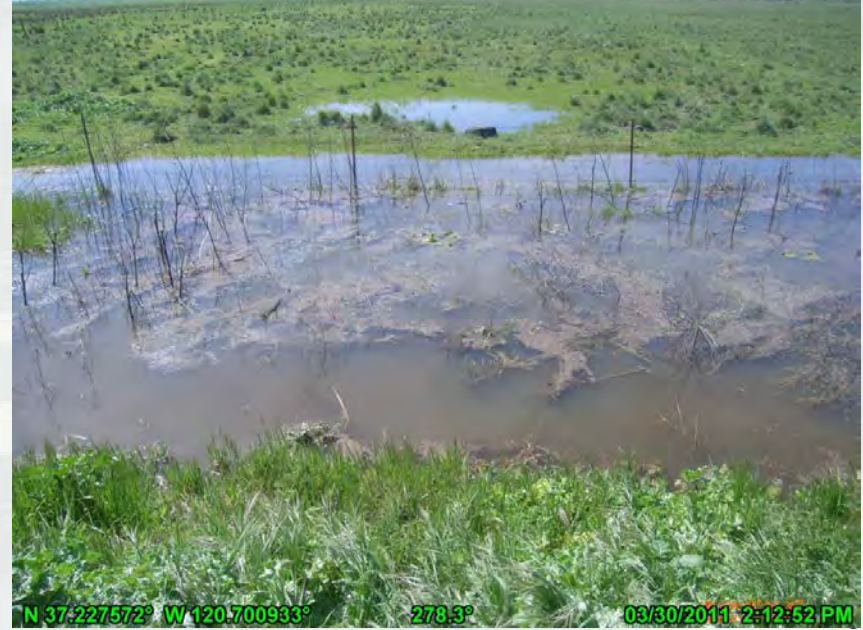
LSJLD Units 5, 8, 9, & 22

System LSJLD-Units 5, 8, 9, and 22 Unacceptable - Inactive										
		LSJLD- U 5 Deep Slough right bank above Bear Creek (L09B)	LSJLD- U 8 Bear Creek left bank (L008)	LSJLD- U 9 Owens Creek right bank (L009)	LSJLD- U 22 East Side Canal left bank abv Bear Cr (L22B)							
General	Operations and Maintenance Manuals	A	A	A	A							
	Emergency Supplies and Equipment	A	A	A	A							
	Flood Preparedness and Training	A	A	A	A							
Levee Embankments	Unwanted Vegetation Growth	A	U	U	U							
	Sod Cover	NA	NA	NA	NA							
	Encroachments	U	U	U	U							
	Closure Structures	NA	NA	NA	NA							
	Slope Stability	A	A	A	U							
	Erosion/Bank Caving	A	A	M	U							
	Settlement	A	A	A	A							
	Depressions/Rutting	M	A	A	U							
	Cracking	A	A	A	A							
	Animal Control	U	U	U	U							
	Culverts/Discharge Pipes	NA	NA	NA	NA							
	Riprap Revetments & Bank Protection	NA	NA	NA	NA							
	Revetments other than Riprap	NA	NA	NA	NA

Underseepage Relief Wells/Toe Drainage Systems	NA	NA	NA	NA							
Seepage	A	A	A	A								
Flood Damage Reduction Channels	Vegetation and Obstructions	M	A	M	A							
	Shoaling	A	A	A	A							
	Encroachments	A	A	M	U							
	Erosion	A	A	A	A							
	Concrete Surfaces	NA	NA	NA	NA							
	Tilting, Sliding, or Settlement of Concrete	NA	NA	NA	NA							
	Foundation of Concrete Structures	NA	NA	NA	NA							
	Slab and Monolith Joints	NA	NA	NA	NA							
	Flap Gates/Flap Valves/Pinch Valves	NA	NA	NA	NA							
	Riprap Revetments & Banks	NA	NA	NA	NA							
	Revetments other than Riprap	NA	NA	NA	NA							
										Legend A Acceptable M Minimally Acceptable U Unacceptable N/A Not Applicable		
Daily Inspections Performance in Past Flood Event inactive												
Serious deficiency noted in past inspections has not been corrected within the established timeframe												
Not Likely to Prevent Performance in Next Flood Event/Active
