CVFPB Meeting March 22, 2013

USACE INSPECTION RESULTS

Meegan G Nagy, PE
Levee Safety Program Manager

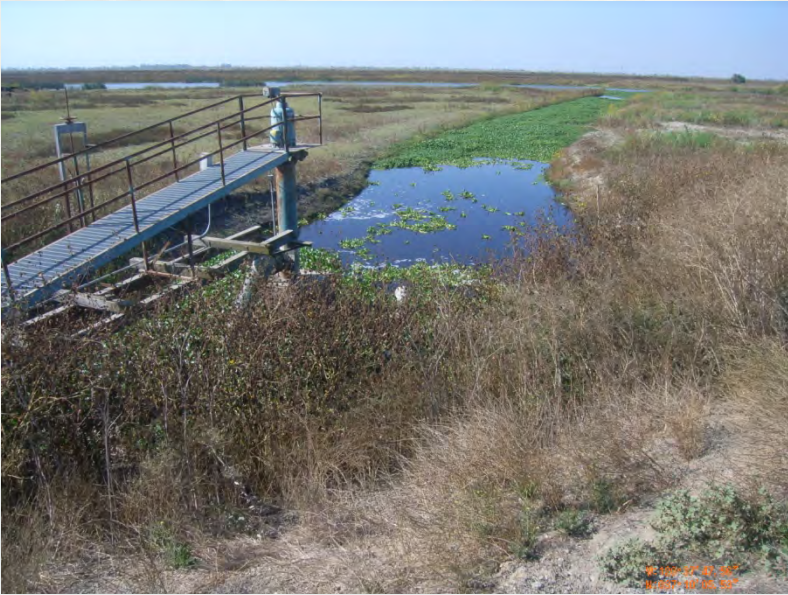
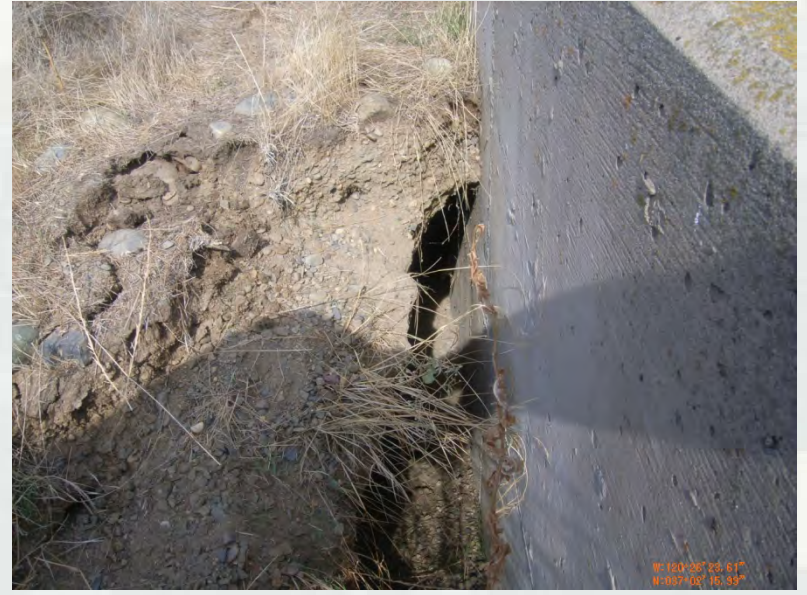
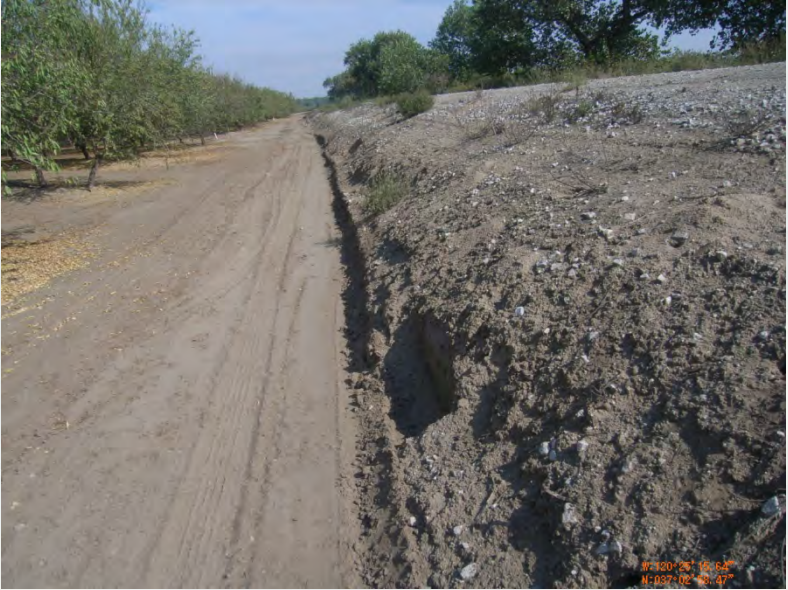
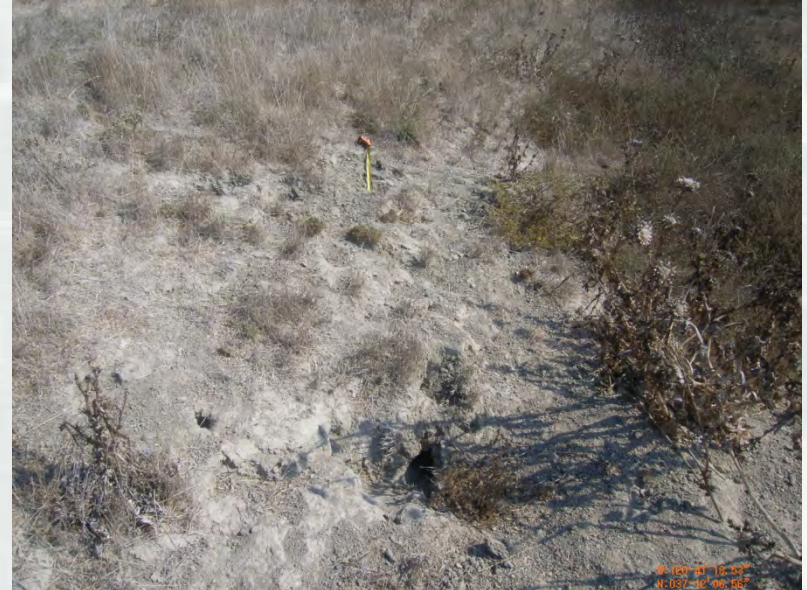
LSJLD – Units 5,13, Ash Slough

System LSJLD-Units 5 and 13 Unacceptable - Inactive		Chowchilla River - Ash Slough Right Bank (CHW1)			Lower San Joaquin LD - Unit 5, Eastside Bypass Right Bank Below Ash Slough (L05D)			Lower San Joaquin LD - Unit 13, Ash Slough right bank (L013)		
General	Operations and Maintenance Manuals	A	A	A						
	Emergency Supplies and Equipment	A	A	A						
	Flood Preparedness and Training	A	A	A						
Levee Embankments	Unwanted Vegetation Growth	U	U	U						
	Sod Cover	NA	NA	NA						
	Encroachments	U	U	U						
	Closure Structures	NA	NA	NA						
	Slope Stability	A	A	A						
	Erosion/Bank Caving	A	U	A						
	Settlement	A	A	A						
	Depressions/Rutting	U	A	A						
	Cracking	A	A	A						
	Animal Control	U	U	U						
	Culverts/Discharge Pipes	NA	NA	NA						
	Riprap Revetments & Bank Protection	NA	NA	NA						
	Revetments other than Riprap	NA	NA	NA						
	Underseepage Relief Wells/Toe Drainage Systems	NA	NA	NA						
Seepage	A	A	A

Flood Damage Reduction Channels	Vegetation and Obstructions	A	A	A						
	Shoaling	A	A	A						
	Encroachments	A	M	A						
	Erosion	A	A	U						
	Concrete Surfaces	NA	NA	A						
	Tilting, Sliding, or Settlement of Concrete	NA	NA	NA						
	Foundation of Concrete Structures	NA	NA	U						
	Slab and Monolith Joints	NA	NA	NA						
	Flap Gates/Flap Valves/Pinch Valves	NA	NA	NA						
	Riprap Revetments & Banks	NA	NA	NA						
	Revetments other than Riprap	NA	NA	NA						
<p>Highly Presents Performance in Next Flood Event/Inactive</p> <p>Serious deficiency noted in past inspections that has not been corrected within the established timeframe</p> <p>Not Likely to Prevent Performance in Next Flood Event/Active</p> <p>The lowest rating is used to determine the overall segment & system ratings and PL 84-99 Eligibility</p>		<p>Legend</p> <p>A Acceptable</p> <p>M Minimally Acceptable</p> <p>U Unacceptable</p> <p>N/A Not Applicable</p>

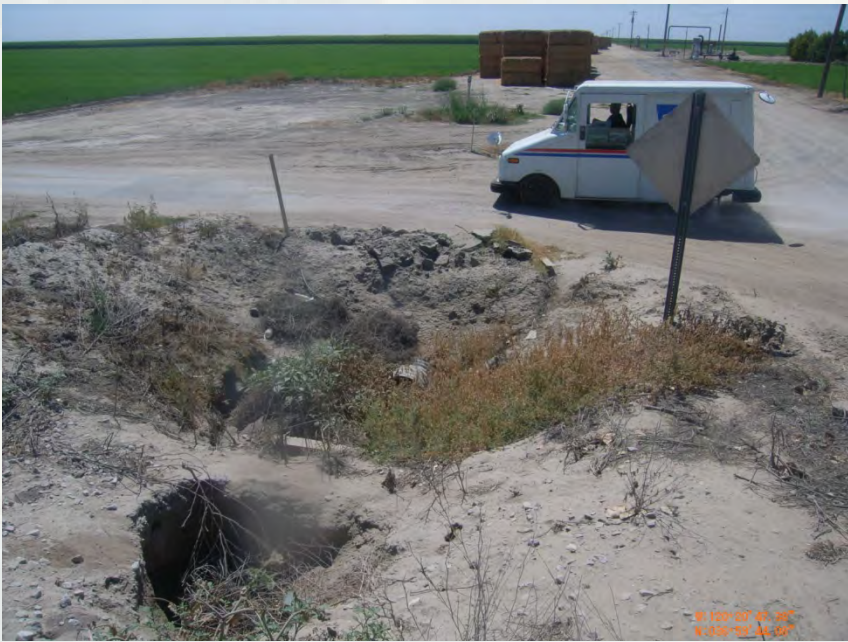
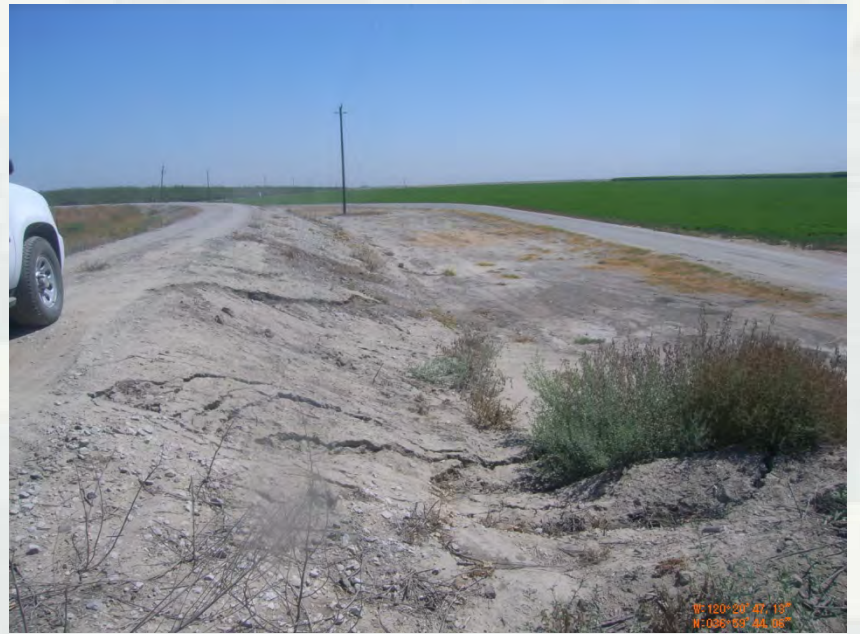
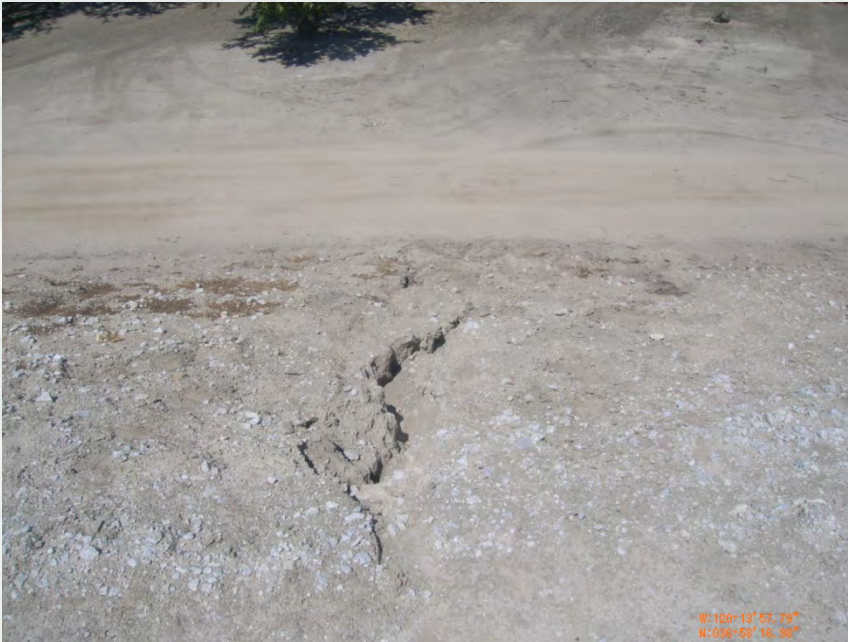
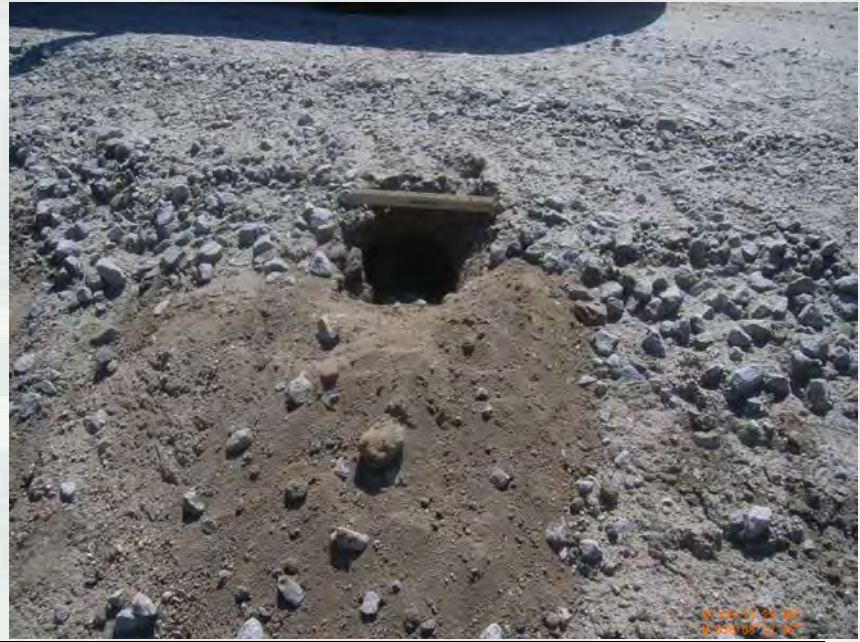
LSJLD – Units 5,16, Brenda Slough and Fresno River

System LSJLD-Units 5, 16 Brenda Fresno Unacceptable - Active		Chowchilla River - Berenda Slough Left Bank (CHW4)				Fresno River - Right Bank (FRN1)				LSJLD - Unit 5 South, Eastside Bypass Right Bank above Berenda Slough (L05F)				LSJLD - Berenda Slough Left Bank (L016)			
		A		A		A		A		A		A		A			
General	Operations and Maintenance Manuals	A	A	A	A												
	Emergency Supplies and Equipment	A	A	A	A												
	Flood Preparedness and Training	A	A	A	A												
Levee Embankments	Unwanted Vegetation Growth	U	U	U	U												
	Sod Cover	NA	U	NA	NA												
	Encroachments	U	U	U	U												
	Closure Structures	NA	NA	NA	NA												
	Slope Stability	U	U	A	A												
	Erosion/Bank Caving	A	A	A	A												
	Settlement	A	A	A	A												
	Depressions/Rutting	U	U	A	U												
	Cracking	A	A	A	A												
	Animal Control	U	U	U	U												
	Culverts/Discharge Pipes	NA	NA	NA	NA												
	Riprap Revetments & Bank Protection	NA	NA	NA	NA

Revetments other than Riprap	NA	NA	NA	NA												
	Underseepage Relief Wells/Toe Drainage Systems	NA	NA	NA	NA												
	Seepage	A	A	A	A												
Flood Damage Reduction Channels	Vegetation and Obstructions	A	U	A	A												
	Shoaling	A	M	A	A												
	Encroachments	A	A	A	A												
	Erosion	A	U	A	A												
	Concrete Surfaces	NA	NA	A	NA												
	Tilting, Sliding, or Settlement of Concrete	NA	NA	A	NA												
	Foundation of Concrete Structures	NA	NA	M	NA												
	Slab and Monolith Joints	NA	NA	NA	NA												
	Flap Gates/Flap Valves/Pinch Valves	NA	NA	NA	NA												
	Riprap Revetments & Banks	NA	NA	NA	NA												
	Revetments other than Riprap	NA	NA	NA	NA												
<p>Very Poor/Not Performant In Next Flood Event/Active</p> <p>Serious deficiency noted in past inspections has not been corrected within the established timeframes</p> <p>Not Likely to Prevent Performance In Next Flood Event/Active</p> <p>The lowest rating is used to determine the overall segment & system ratings and PL 84-99 Eligibility</p>														<p>Legend</p> <p>A Acceptable</p> <p>M Minimally Acceptable</p> <p>U Unacceptable</p> <p>N/A Not Applicable</p>
