CVFPB Meeting August 22, 2014

USACE INSPECTION RESULTS

Merced County Streams Group

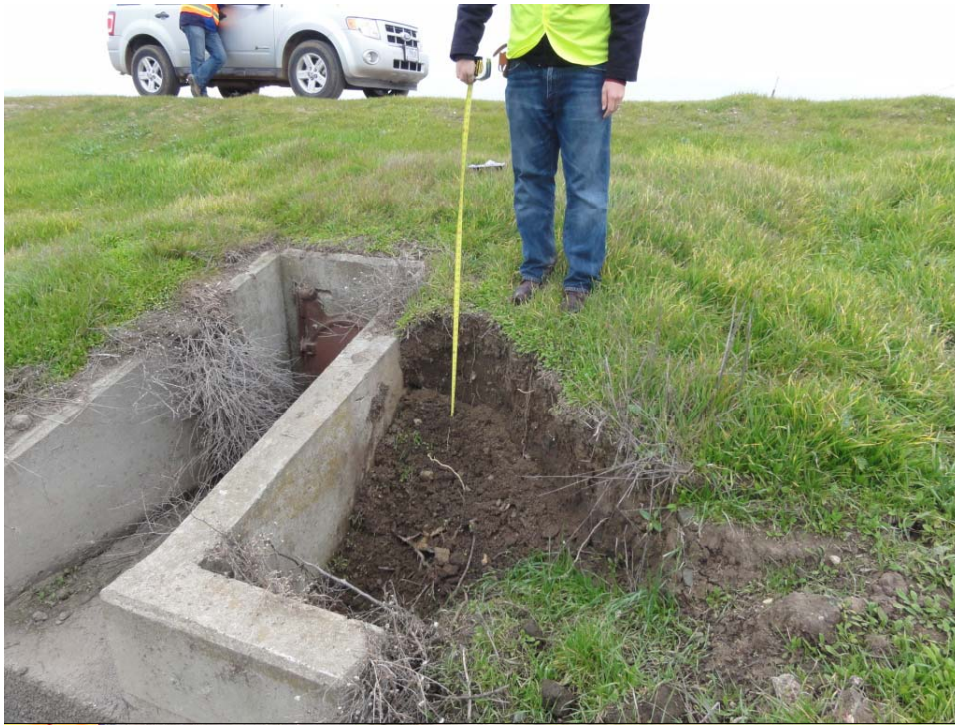
System: Merced Stream Group - Black Rascal - Unit 1 Levee System System Rating: Unacceptable Approved SWIF / LOI: No PL 84-99 RP Eligibility: Inactive		Merced County Stream Group - Black Rascal Diverting Canal right bank, Unit 1 (MGBU)	
General	Operations and Maintenance Manuals	A		
	Emergency Supplies and Equipment	A		
	Flood Preparedness and Training	M		
Levee - Items Affecting PL 84-99 RP Eligibility	Encroachments	M		
	Closure Structures	N/A		
	Slope Stability	M		
	Erosion/Bank Caving	A		
	Animal Control	U		
	Culverts/Discharge Pipes	N/A		
	Underseepage Relief Wells/Toe Drainage Systems	N/A		
Levee Embankments - Other Items	Vegetation Growth	M		
	Sod Cover	A		
	Settlement	A		
	Depressions/Rutting	M		
	Cracking	A		
	Riprap Revetments & Bank Protection	N/A		
	Revetments other than Riprap	N/A		
	Seepage	A		
Legend A Acceptable M Minimally Acceptable U Unacceptable N/A Not Applicable RP Rehabilitation Program (Note: flood fight assistance available regardless of eligibility status)		M U U	Includes Unacceptable observations not likely to prevent performance in next flood event Serious deficiency noted in past inspection report has not been corrected within the established timeframe Likely prevents performance in next flood event

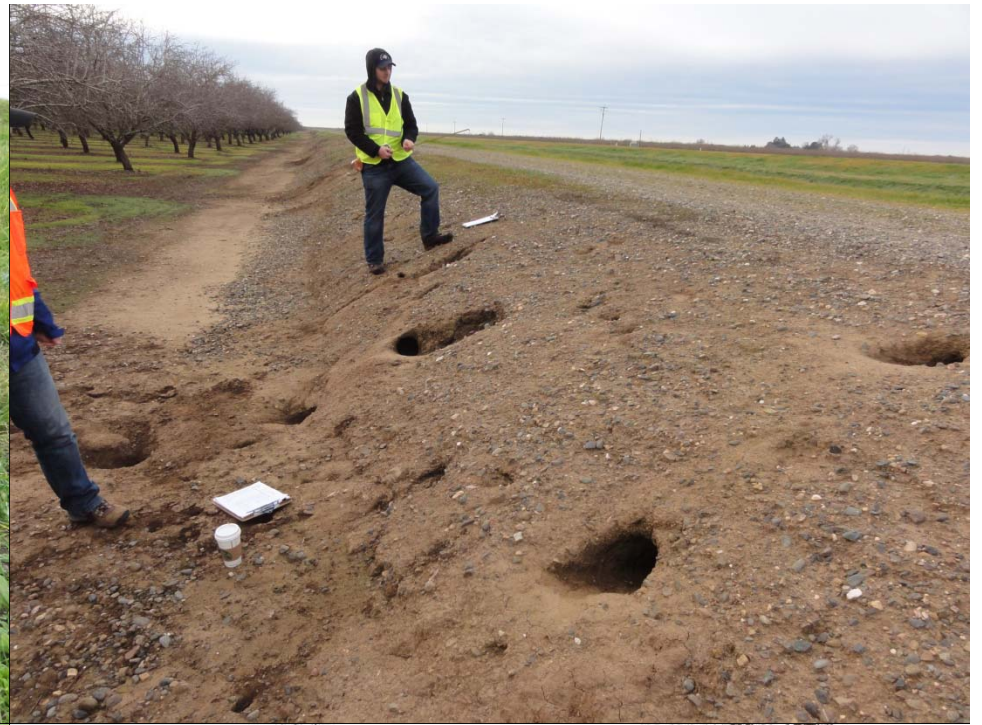
System: Merced Stream Group - Black Rascal - Unit 2 Levee System System Rating: Unacceptable Approved SWIF / LOI: No PL 84-99 RP Eligibility: Inactive		<div>Merced County Stream Group - Black Rascal Diverting Canal left bank, Unit 2 (MGB2)</div>
General	Operations and Maintenance Manuals	A	
	Emergency Supplies and Equipment	A	
	Flood Preparedness and Training	M	
Levee - Items Affecting PL 84-99 RP Eligibility	Encroachments	U	
	Closure Structures	N/A	
	Slope Stability	M	
	Erosion/Bank Caving	M	
	Animal Control	U	
	Culverts/Discharge Pipes	N/A	
	Underseepage Relief Wells/Toe Drainage Systems	N/A	
Levee Embankments - Other Items	Vegetation Growth	M	
	Sod Cover	M	
	Settlement	M	
	Depressions/Rutting	M	
	Cracking	A	
	Riprap Revetments & Bank Protection	N/A	
	Revetments other than Riprap	N/A	
	Seepage	A	
	Legend A Acceptable M Minimally Acceptable U Unacceptable N/A Not Applicable RP Rehabilitation Program (Note: flood fight assistance available regardless of eligibility status)		<div>M</div> Includes Unacceptable observations not likely to prevent performance in next flood event <div>U</div> Serious deficiency noted in past inspection report has not been corrected within the established timeframe <div>U</div> Likely prevents performance in next flood event

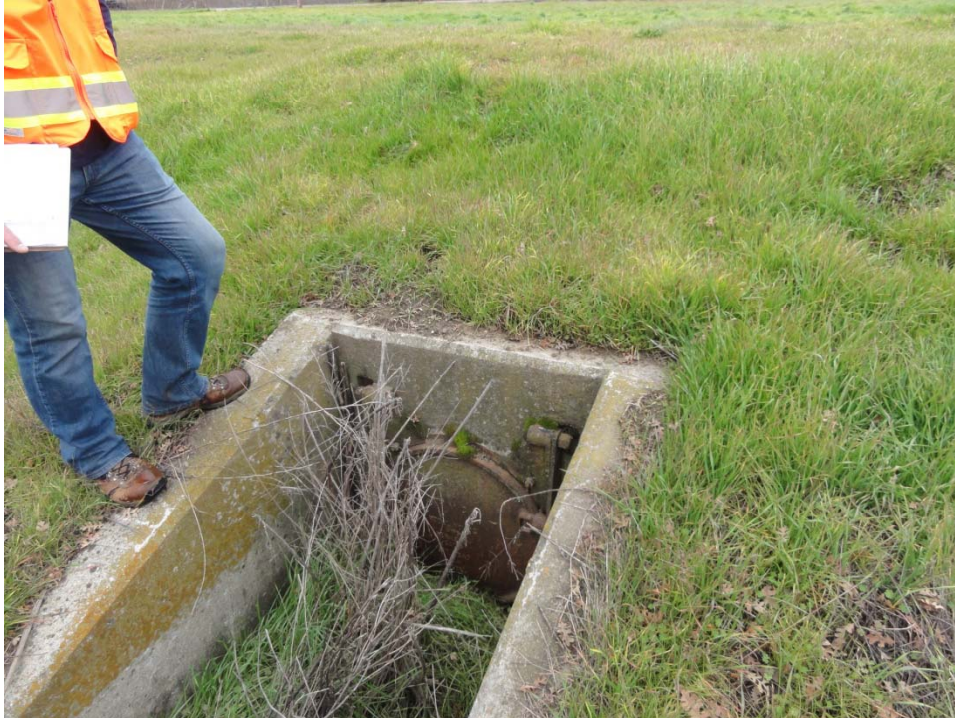
System: Merced Stream Group - Owens Creek - Unit 1 Levee System System Rating: Unacceptable Approved SWIF / LOI: No PL 84-99 RP Eligibility: Inactive		Merced County Stream Group - Owens Creek Diverging Canal right bank, Unit 1 (MG01)	
General	Operations and Maintenance Manuals	A		
	Emergency Supplies and Equipment	A		
	Flood Preparedness and Training	M		
Levee - Items Affecting PL 84-99 RP Eligibility	Encroachments	U		
	Closure Structures	N/A		
	Slope Stability	A		
	Erosion/Bank Caving	M		
	Animal Control	U		
	Culverts/Discharge Pipes	N/A		
	Underseepage Relief Wells/Toe Drainage Systems	N/A		
Levee Embankments - Other Items	Vegetation Growth	M		
	Sod Cover	A		
	Settlement	A		
	Depressions/Rutting	M		
	Cracking	A		
	Riprap Revetments & Bank Protection	N/A		
	Revetments other than Riprap	N/A		
	Seepage	A		
	Legend <div> <div>A</div> <div>Acceptable</div> </div> <div> <div>M</div> <div>Minimally Acceptable</div> </div> <div> <div>U</div> <div>Unacceptable</div> </div> <div> <div>N/A</div> <div>Not Applicable</div> </div> <div> <div>RP</div> <div>Rehabilitation Program (Note: flood fight assistance available regardless of eligibility status)</div> </div> <div> <div>M</div> <div>Includes Unacceptable observations not likely to prevent performance in next flood event</div> </div> <div> <div>U</div> <div>Serious deficiency noted in past inspection report has not been corrected within the established timeframe</div> </div> <div> <div>U</div> <div>Likely prevents performance in next flood event</div> </div>

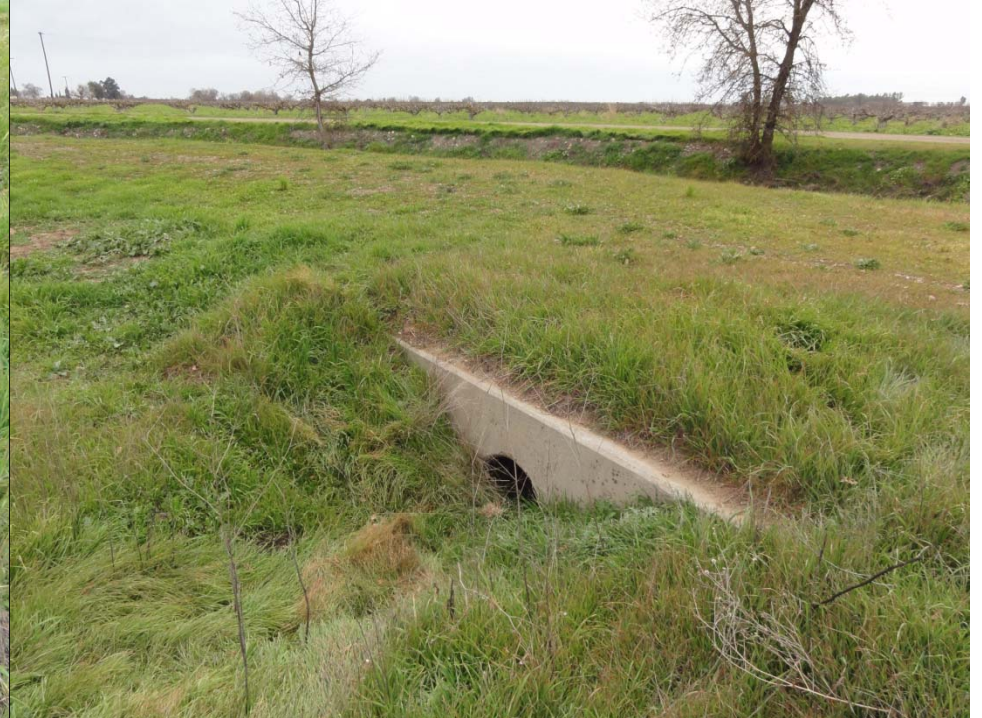
System: Merced Stream Group - Owens Creek - Unit 2 Levee System System Rating: Unacceptable Approved SWIF / LOI: No PL 84-99 RP Eligibility: Inactive		Merced County Stream Group - Owens Creek Diverting Canal left bank, Unit 2 (MG02)	
General	Operations and Maintenance Manuals	A		
	Emergency Supplies and Equipment	A		
	Flood Preparedness and Training	M		
Levee - Items Affecting PL 84-99 RP Eligibility	Encroachments	U		
	Closure Structures	N/A		
	Slope Stability	M		
	Erosion/Bank Caving	U		
	Animal Control	U		
	Culverts/Discharge Pipes	N/A		
	Underseepage Relief Wells/Toe Drainage Systems	N/A		
Levee Embankments - Other Items	Vegetation Growth	M		
	Sod Cover	M		
	Settlement	M		
	Depressions/Rutting	M		
	Cracking	A		
	Riprap Revetments & Bank Protection	N/A		
	Revetments other than Riprap	N/A		
	Seepage	A		
Legend A Acceptable M Minimally Acceptable U Unacceptable N/A Not Applicable RP Rehabilitation Program (Note: flood fight assistance available regardless of eligibility status)		M Includes Unacceptable observations not likely to prevent performance in next flood event U Serious deficiency noted in past inspection report has not been corrected within the established timeframe U Likely prevents performance in next flood event
