**Meeting of the Central Valley Flood Protection Board
March 22, 2013**

Staff Report – Transmittal of Reclamation District 1001’s Letter of Intent for a System-Wide Improvement Framework to the U.S. Army Corps of Engineers

Sacramento and Sutter Counties

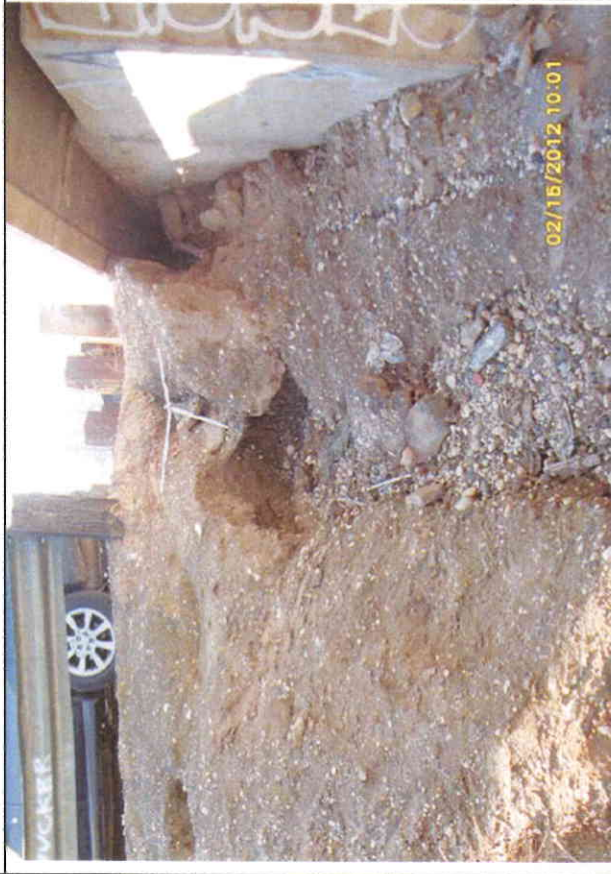
**Inspect ID: NICU_2012_p_0351 Title: USACE_CESPK_NICU_2012_p_0351_1.jpg
Rated Item: 2. Sod Cover Caption: Surface runoff erosion at bridge abutment on upper half of waterside slope. 24 inches wide and 12 to 24 inches deep. (U)**

**September 2012: Surface runoff erosion repaired
Levee Mile: 6.51**

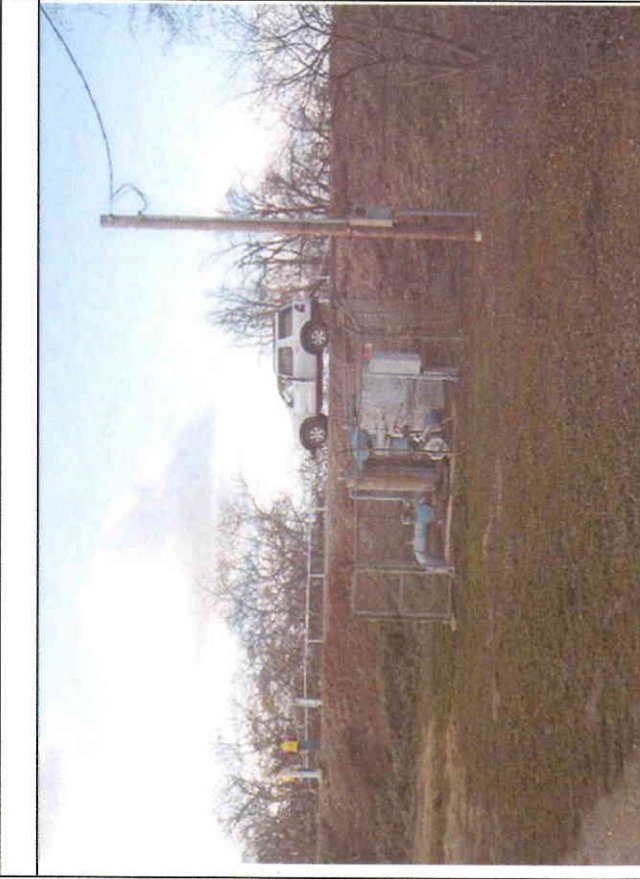
<p>Inspect ID: NICU_2012_p_0108 Title: USACE_CESPK_NICU_2012_p_0108_5.jpg Rated Item: 3. Encroachments Caption: 30 inch metal pipe through levee with well at waterside toe. Metal walkway from crown, and slide gate on waterside. Fenced pumping structure with service pole at landside toe (Permit No. 4505). Inspection records not available. (U)</p>

<p>Date Unknown: Currently pump is permitted and active. Pump, pipes and adjacent structures are maintained by the property owner. Levee Mile: 1.86</p>

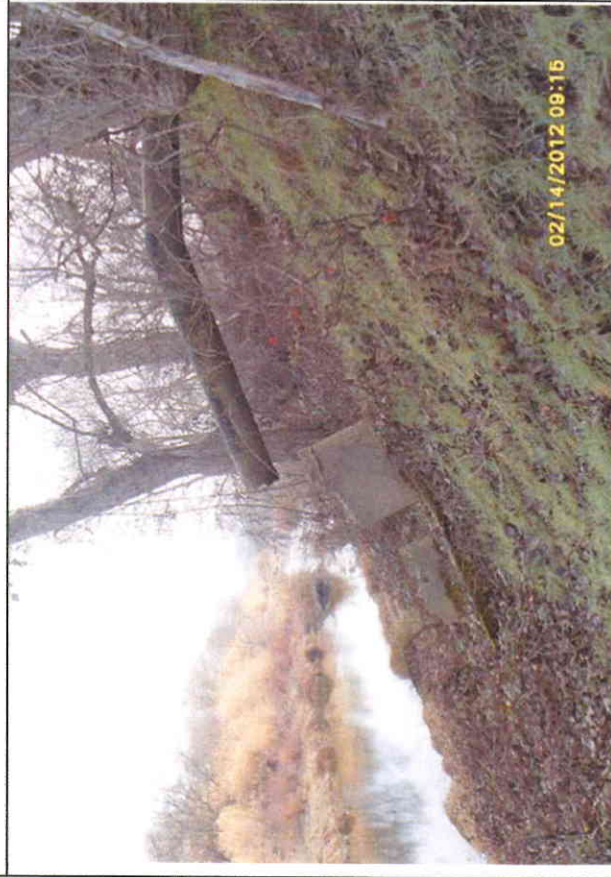
Inspect ID: NICU_2012_p_0147 **Title:** USACE_CESPK_NICU_2012_p_0147_1.jpg
Rated Item: 3. Encroachments **Caption:** 18 inch pipe through levee. Discharge pipe on waterside, no closure device. Concrete riser structure with tree growing out of it on landside. Inspection records not available. (U)

September 28, 2012: Currently negotiating with property owner for removal and repair of pipe.
Levee Mile: 2.61

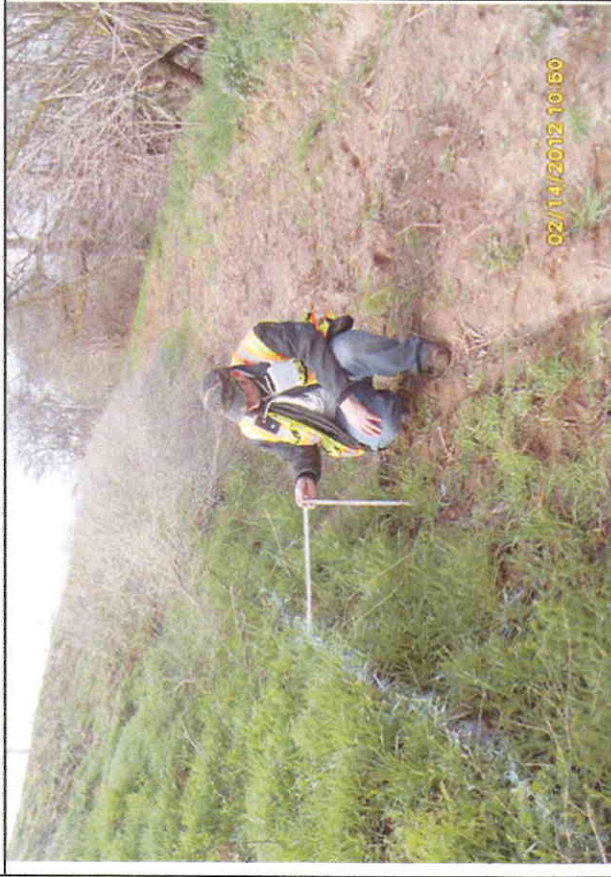
Inspect ID: NICU_2012_p_0188 **Title:** USACE_CESPK_NICU_2012_p_0188_1.jpg
Rated Item: 3. Encroachments **Caption:** Waterside toe cut, 24 inches deep, 150 feet long. Likely due to maintenance vehicles. (U)

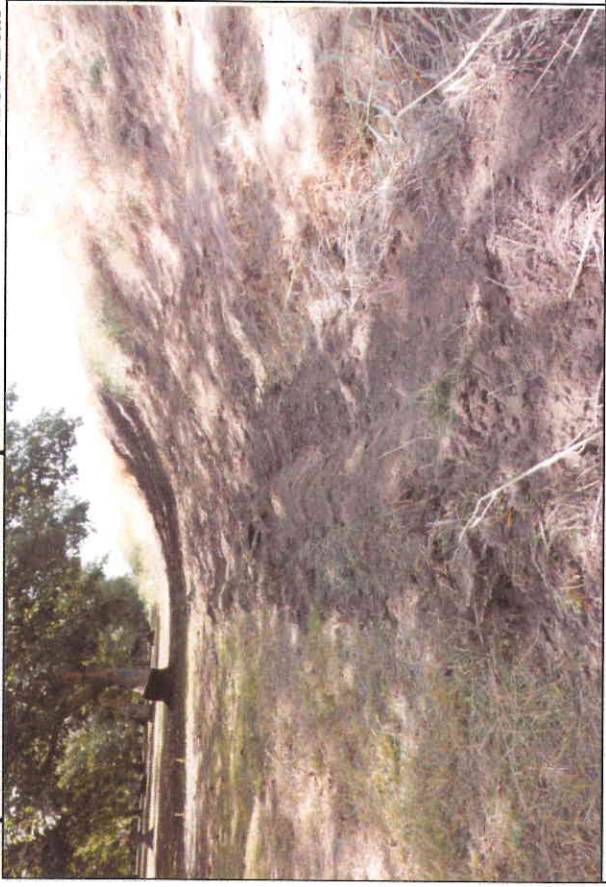
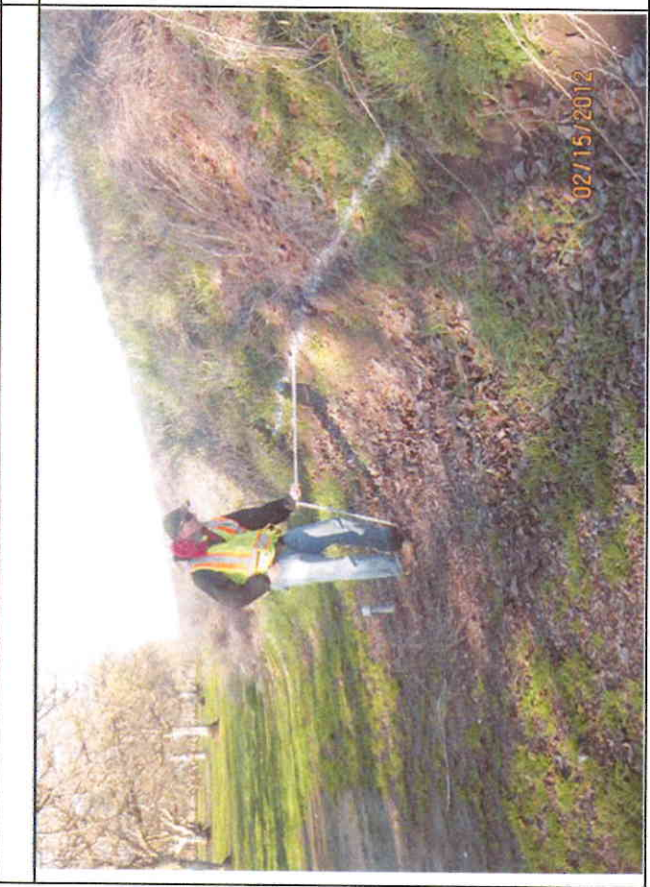
<p>September 2012: Landside toe cut removed Levee Mile: 5.88</p> <p>Inspect ID: NICU_2012_p_0310 Title: USACE_CESPK_NICU_2012_p_0310_1.jpg Rated Item: 3. Encroachments Caption: Landside toe cut, up to 30 inches deep, 75 feet long. (U)</p>

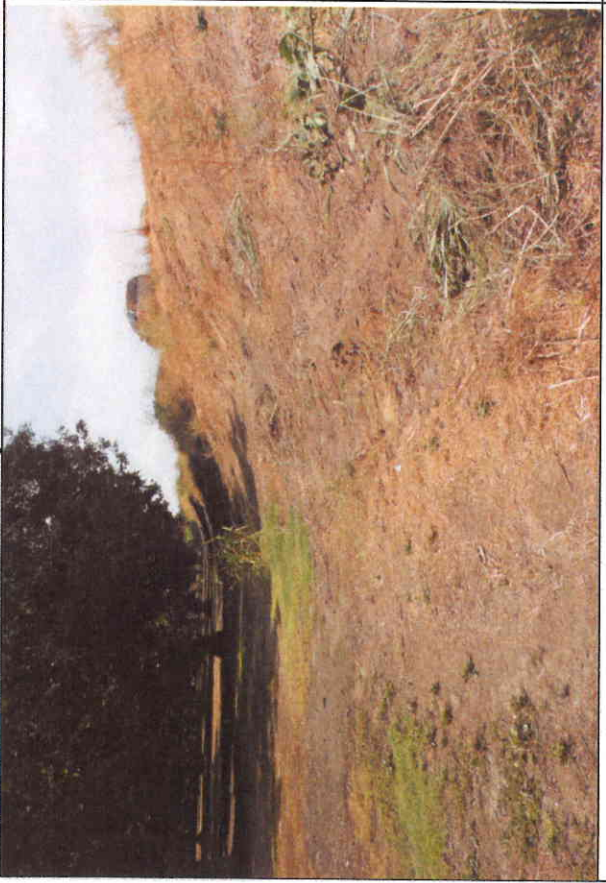
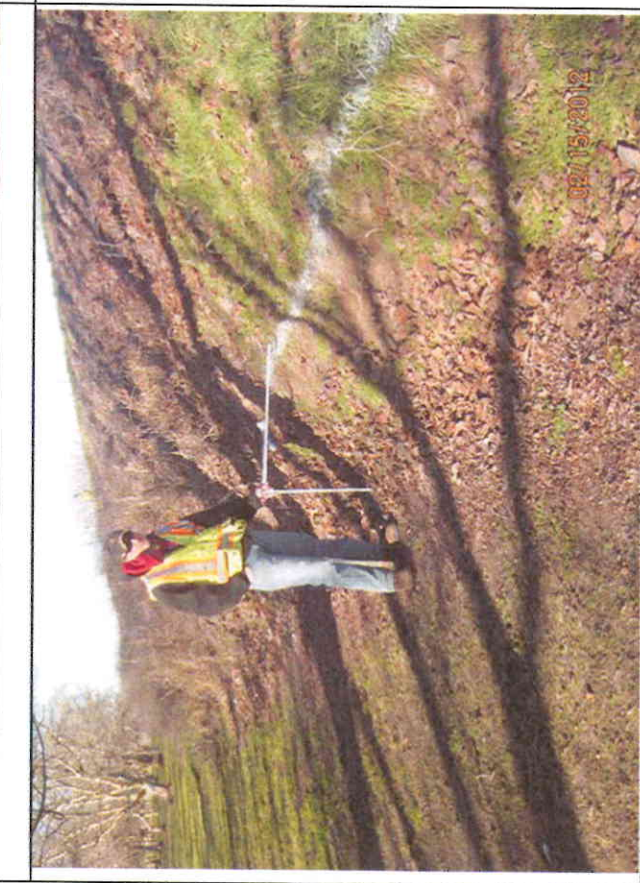
<p>September 2012: Landside toe cut removed Levee Mile: 5.98</p> <p>Inspect ID: NICU_2012_p_0318 Title: USACE_CESPK_NICU_2012_p_0318_1.jpg Rated Item: 3. Encroachments Caption: Start point. Landside toe cut, 36 inches deep, about 25 feet long. End point is 327. (U)</p>

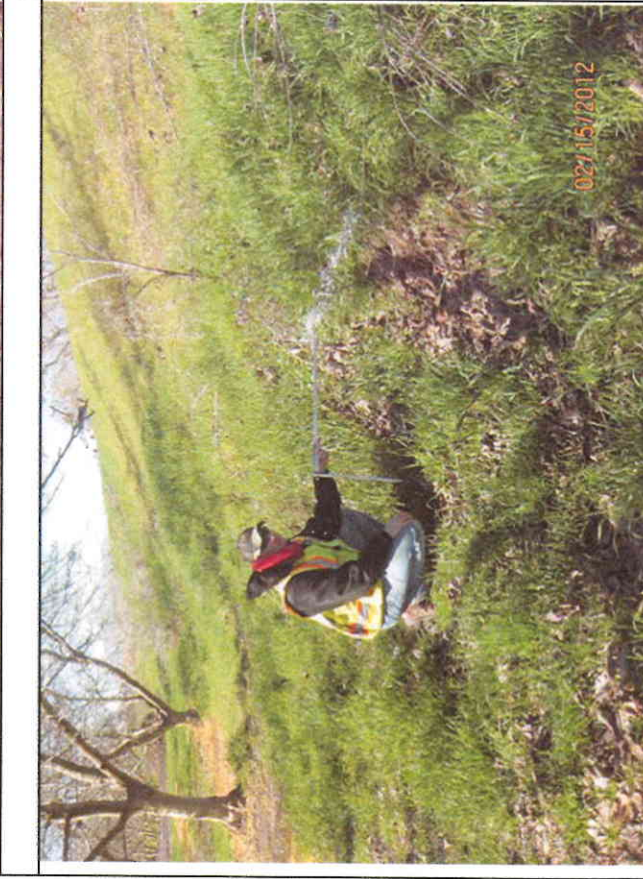
<p>Inspect ID: NICU_2012_p_0388 Title: USACE_CESPK_NICU_2012_p_0388_1.jpg Rated Item: 3. Encroachments Caption: Landside toe cut, up to 24 inches deep, 100 feet long. (U)</p>

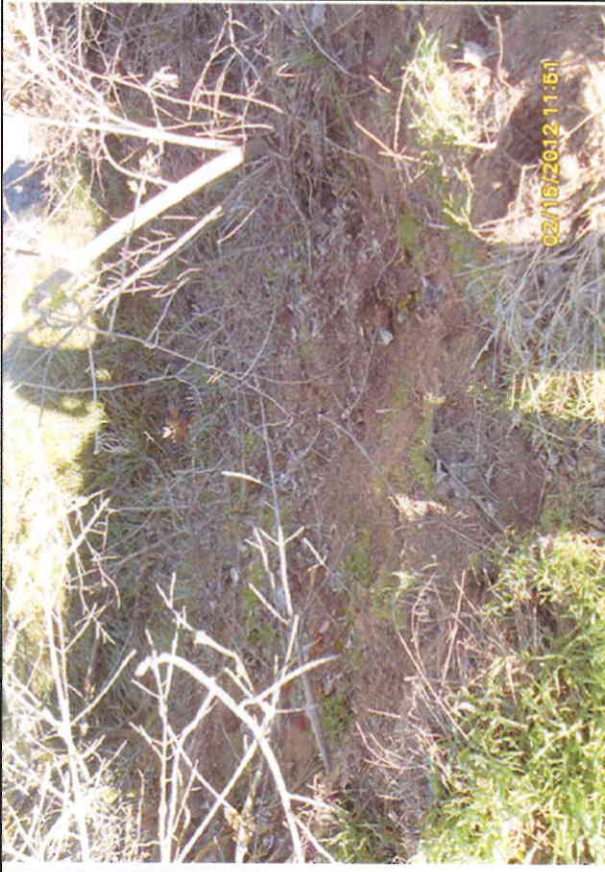
Inspect ID: NICU_2012_p_0385 Title: USACE_CESPK_NICU_2012_p_0385_2.jpg Rated Item: 6. Erosion/ Bank Caving Caption: Line of erosion/bank caving 20 feet from waterside toe. Erosion up to 25 feet deep with near vertical face, appears to cut into projected prism. (U)

September 28, 2012: Currently management and staff are determining the most effective way to repair erosion/bank caving. Levee Mile: 7.42

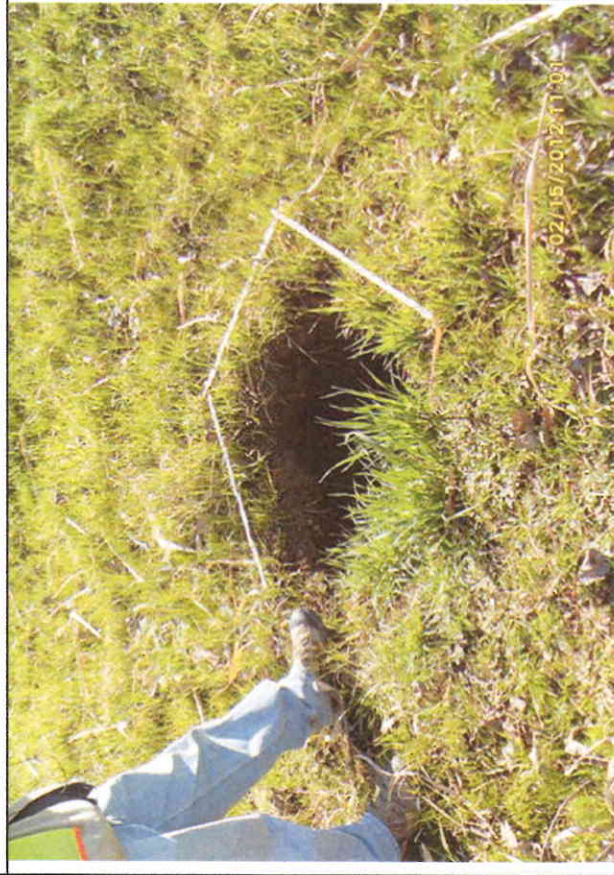
Inspect ID: NICU_2012_p_0375 Title: USACE_CESPK_NICU_2012_p_0375_1.jpg
Rated Item: 8. Depressions/ Rutting Caption: Hole at waterside toe, 3 feet diameter, 3 feet deep. (U)

August 2012: Hole at waterside toe repaired
Levee Mile: 7.12

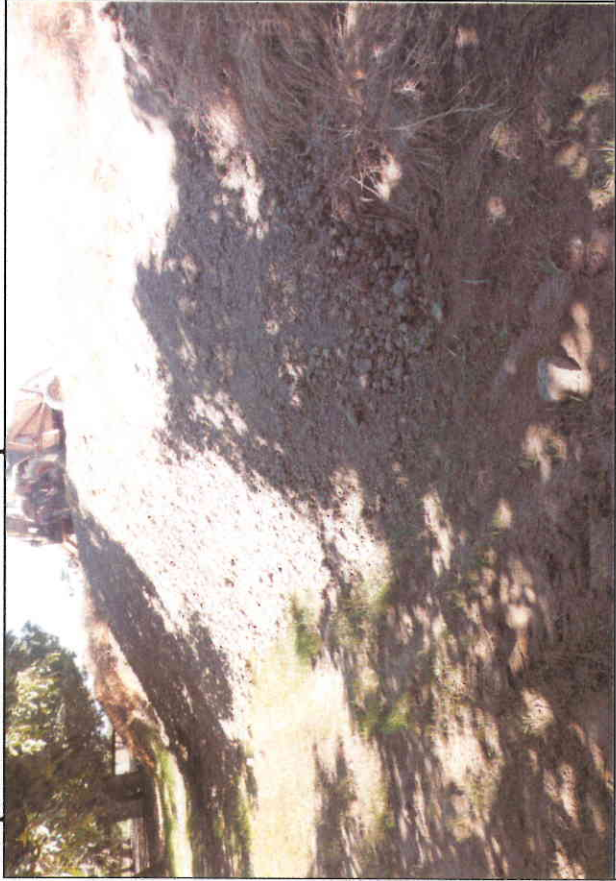
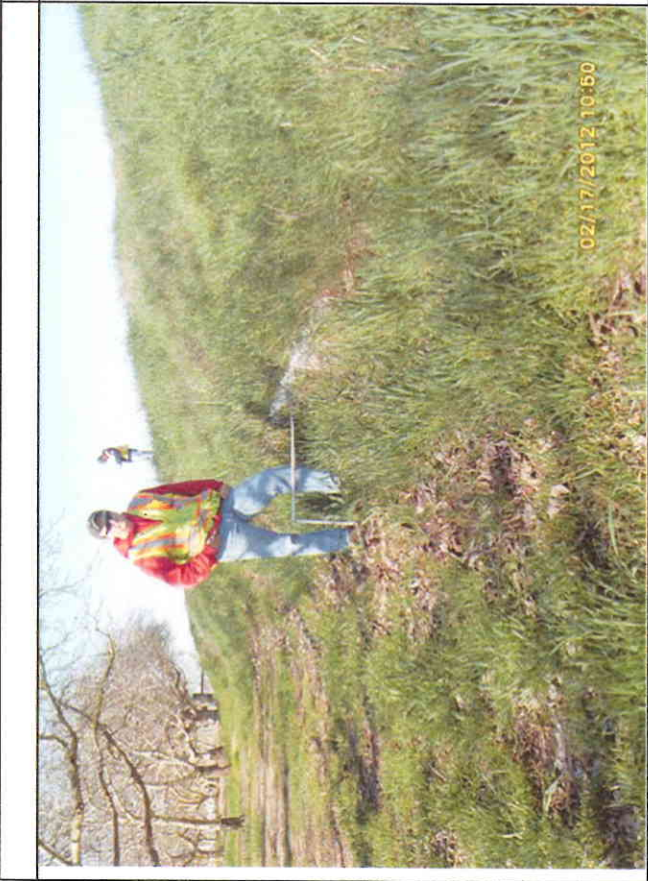
<p>September 2012: Landside toe cut removed. 10 cubic yards of dirt added to levee. Levee Mile: .45</p> <p>Inspect ID: NIC2_2012_p_0034 Title: USACE_CESPK_NIC2_2012_p_0034_1.jpg Rated Item: 3. Encroachments Caption: Landside toe cut, up to 12 to 24 inches tall, 70 feet long. (U)</p>

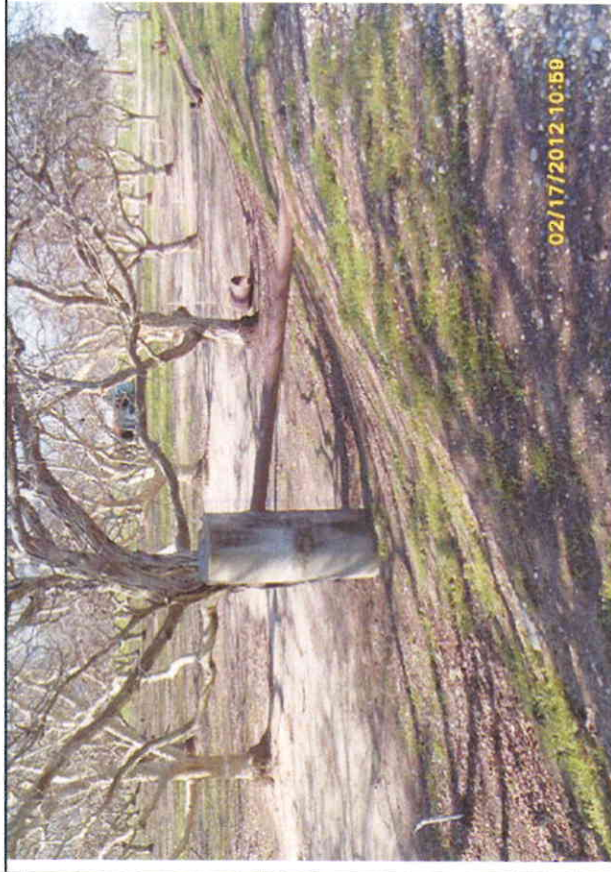
Inspect ID: NIC2_2012_p_0035 **Title:** USACE_CESPK_NIC2_2012_p_0035_1.jpg
Rated Item: 3. Encroachments **Caption:** 7 inch Pipe through the levee. Open on the waterside (broken), concrete standpipe at landside toe. (Permit No. 2281). Inspection records not available. (U)

RD 1001 Response: Currently negotiating with property owner for removal and repair of the concrete standpipe and pipe through the levee. Pipe is permitted (Permit No. 2281) and may be considered operable.

September 28, 2012: Currently negotiating with property owner for removal and repair of the concrete standpipe and pipe through the levee.
Levee Mile: .48

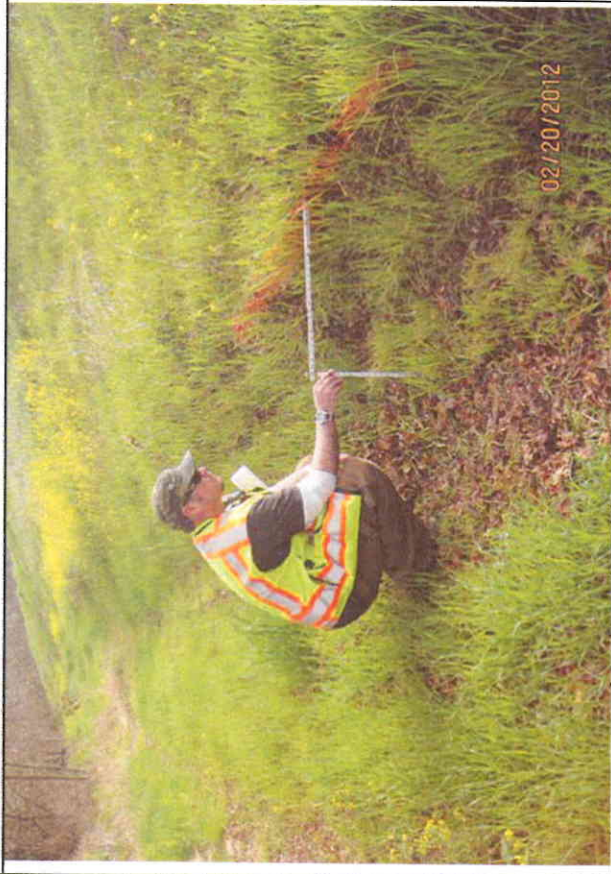
**Inspect ID: NIC2_2012_p_0194 Title: USACE_CESPK_NIC2_2012_p_0194_1.jpg
Rated Item: 3. Encroachments Caption: Start point. Waterside toe cut, up to 24 inches
tall. Likely due to maintenance vehicles. End point is 196. (U)**

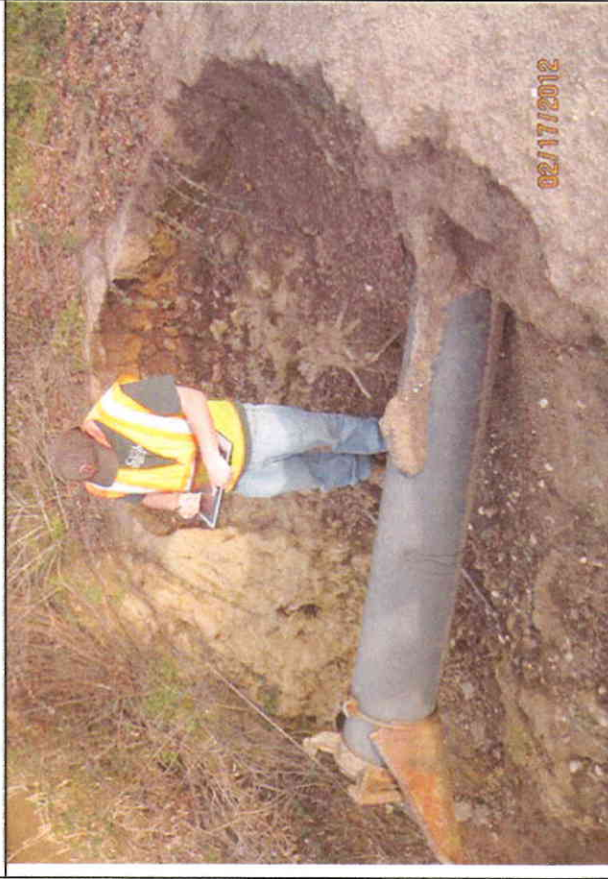
Inspect ID: NIC2_2012_p_0155 Title: USACE_CESPK_NIC2_2012_p_0155_2.jpg
Rated Item: 6. Erosion/Bank Caving Caption: Scour around outlet pipe at waterside
bank, 15 feet wide and 4 feet deep. Scour appears to cut into projected levee prism. (U)

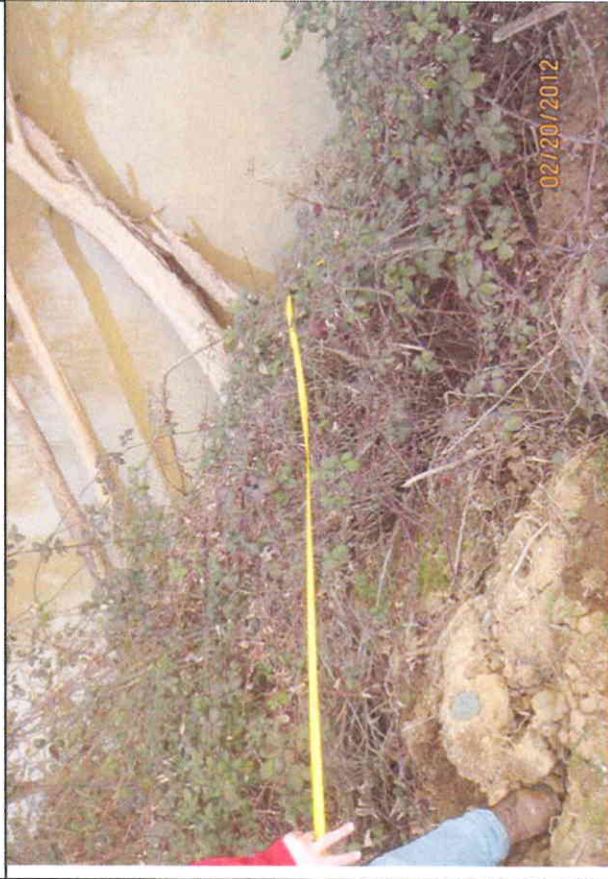
Inspect ID: NIC2_2012_p_0218 **Title:** USACE_CESPK_NIC2_2012_p_0218_3.jpg
Rated Item: 6. Erosion/ Bank Caving **Caption:** 100 foot long erosion site at waterside toe. Erosion has up to 11 foot face with 1H:1V slope. Vegetation impairs erosion inspection. (U)

September 28, 2012: Currently management and staff are determining the most effective way to repair erosion/bank caving.
Levee Mile: 3.65

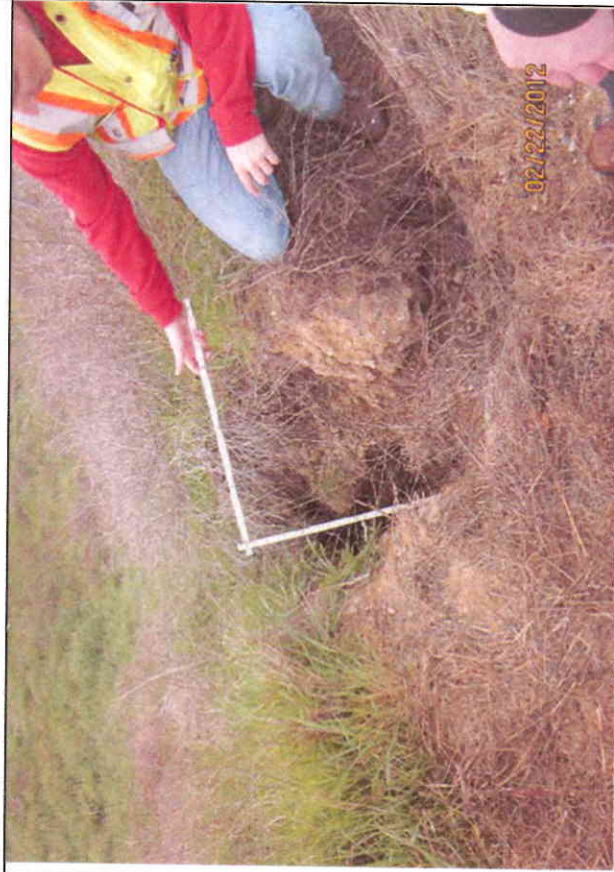
**Inspect ID: NIC3_2012_p_0029 Title: USACE_CESPK_NIC3_2012_p_0029_1.jpg
Rated Item: 2. Sod Cover Caption: Erosion rill on landside embankment from hinge to midslope. 24 inches wide and 30 inches deep. (U)**

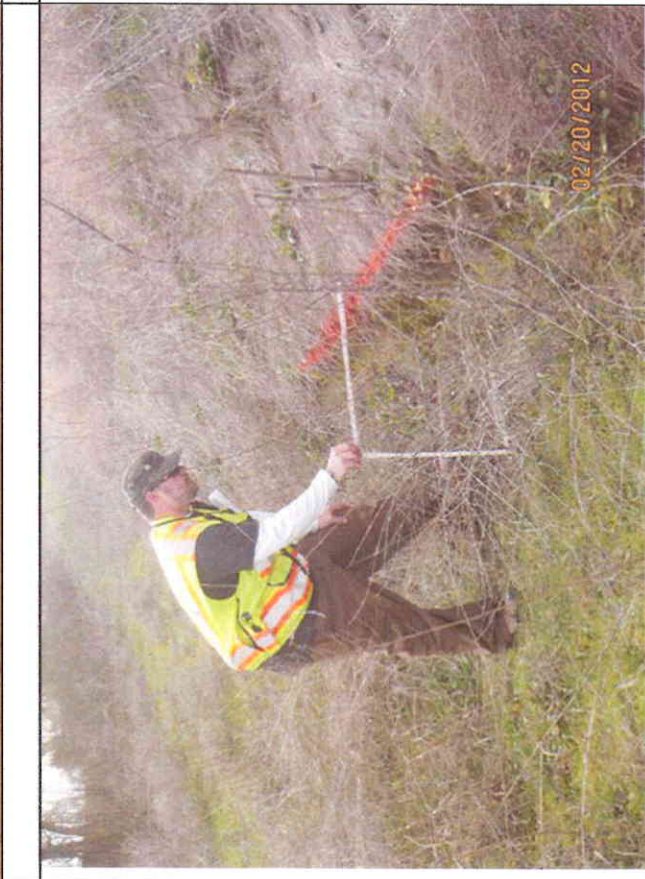
<p>Inspect ID: NIC3_2012_p_0012 Title: USACE_CESPK_NIC3_2012_p_0012_1.jpg Rated Item: 3. Encroachments Caption: Start point. Waterside toe cut, 12 to 24 inches tall. Likely due to maintenance vehicles. End point is 38. (U)</p>

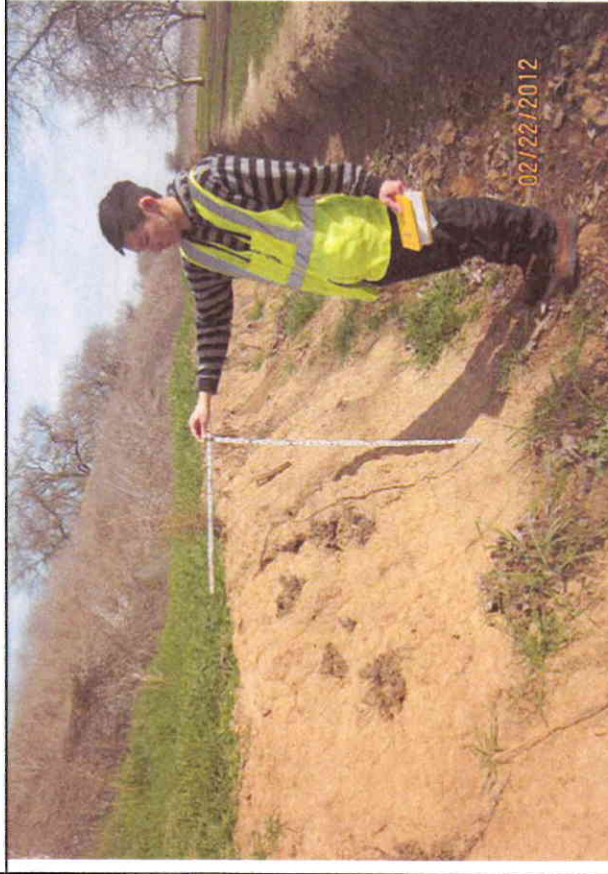
Inspect ID: NIC3_2012_p_0108 **Title:** USACE_CESPK_NIC3_2012_p_0108_1.jpg
Rated Item: 3. Encroachments **Caption:** Landside toe cut, up to 3.5 foot tall. Likely due to ditch construction near toe. (U)

September 28, 2012: Currently negotiating with property owner for repair of the landside toe cut.
Levee Mile: 11.29

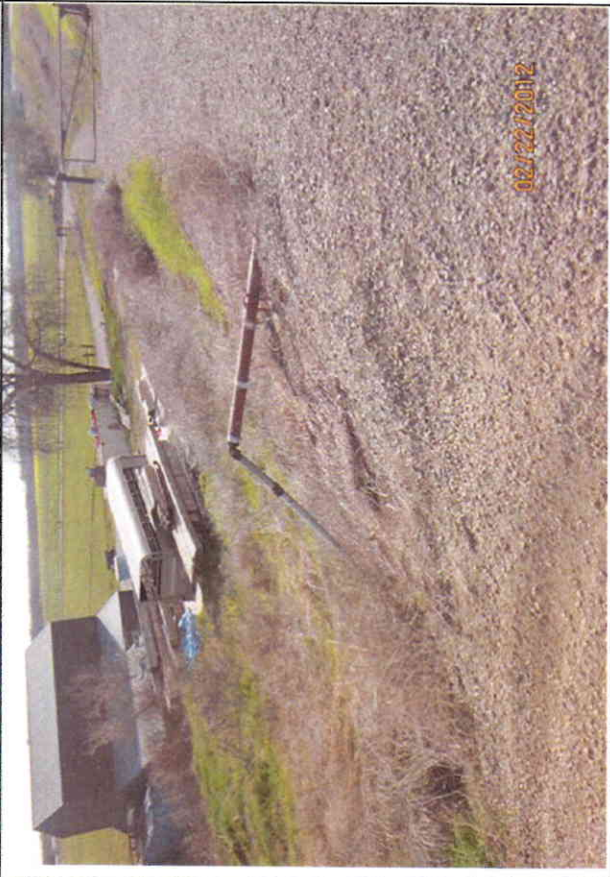
<p>Inspect ID: NIC3_2012_p_0136 Title: USACE_CESPK_NIC3_2012_p_0136_1.jpg Rated Item: 3. Encroachments Caption: 3 inch pipe through levee, part of pipe is PVC slip lined. No positive closure observed. Located less than a foot below crown. (U)</p>

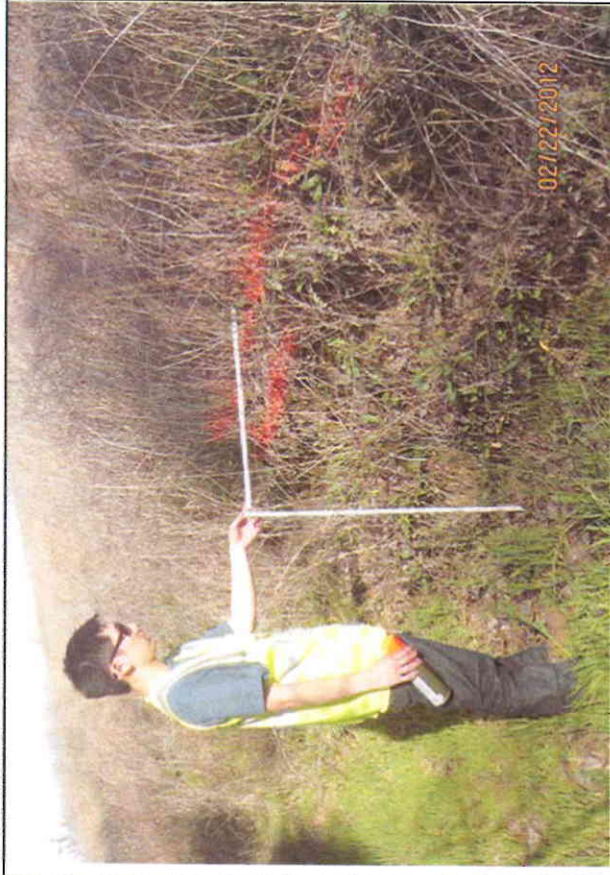
Inspect ID: NIC3_2012_p_0160 **Title:** USACE_CESPK_NIC3_2012_p_0160_1.jpg
Rated Item: 3. Encroachments **Caption:** Waterside toe cut, up to 3 feet tall, 350 feet long. Likely due to maintenance vehicles. (U)

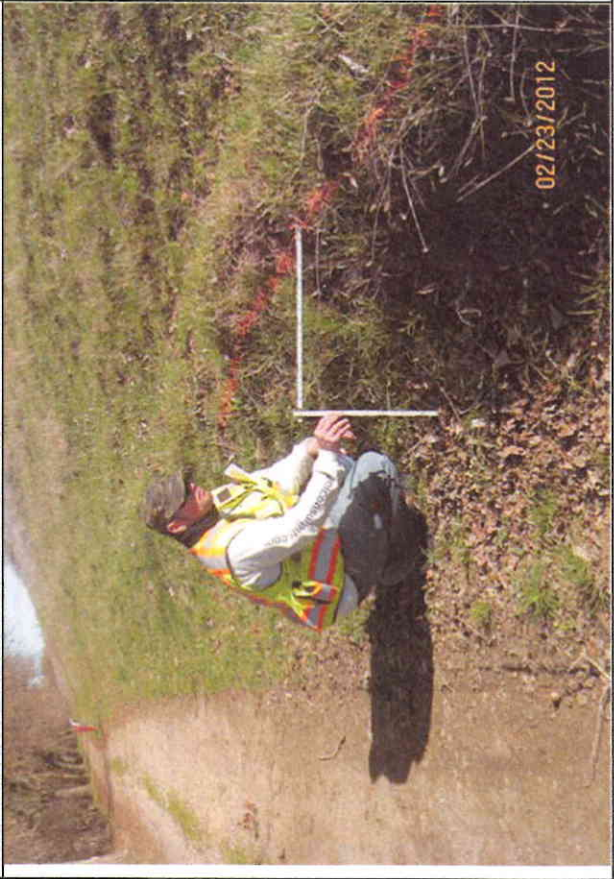
Inspect ID: NIC4_2012_p_0100 Title: USACE_CESPK_NIC4_2012_p_0100_1.jpg Rated Item: 3. Encroachments Caption: Vertical waterside toe cut up to 24 inches tall for a 50 foot stretch. Likely due to maintenance vehicles. (U)

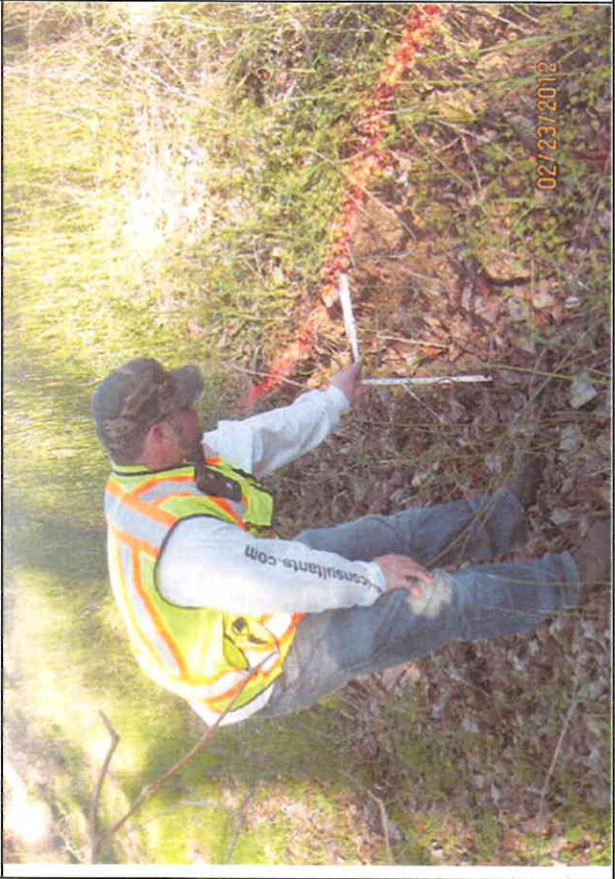
Inspect ID: NIC4_2012_p_0208 Title: USACE_CESPK_NIC4_2012_p_0208_1.jpg Rated Item: 3. Encroachments Caption: Start point. Vertical waterside toe cut 12 to 24 inches tall. Likely due to maintenance vehicles. End point is 212. (U)

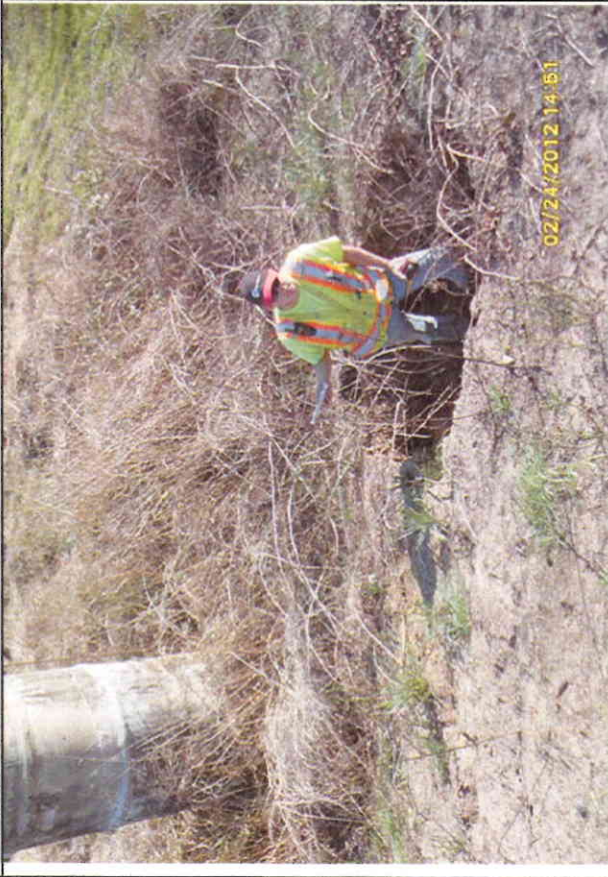
Inspect ID: NIC4_2012_p_0390 Title: USACE_CESPK_NIC4_2012_p_0390_3.jpg Rated Item: 3. Encroachments Caption: Two 14 inch pipes through levee. Pump on riverbank to 36 inch standpipe at landside toe. Shutoff valves located on waterside embankment. Hole in slope above exposed pipe (point 392). No inspection records available. (Permit No. 2062) (U)

September 28, 2012: Currently working with property owner to repair hole in slope above exposed pipe. To be completed before onset of flood season. Levee Mile: 6.87

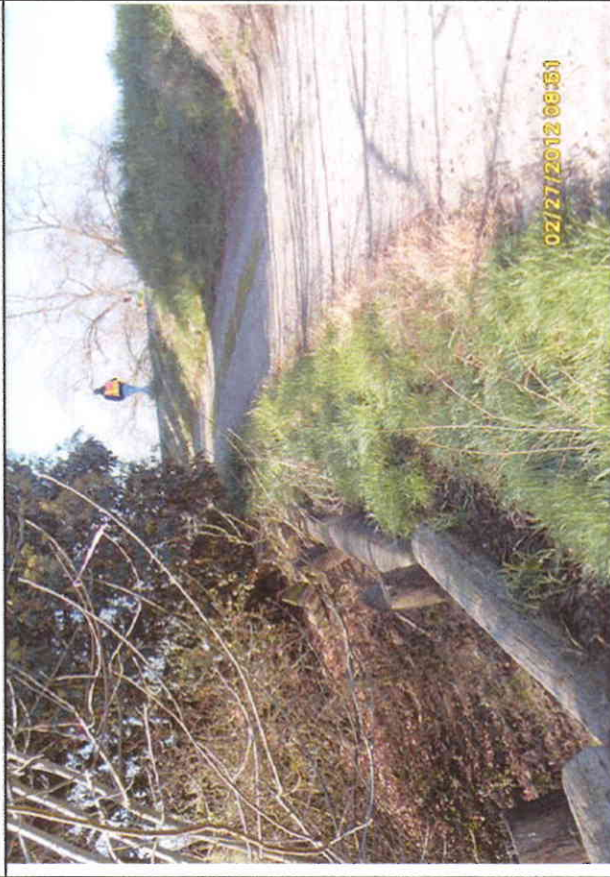
<p>Inspect ID: NIC4_2012_p_0443 Title: USACE_CESPK_NIC4_2012_p_0443_1.jpg</p> <p>Rated Item: 3. Encroachments Caption: Wooden retaining wall cut into landside embankment. Retaining wall is approximately 2 to 4 feet high and 100 feet long. (U)</p>

<p>September 28, 2012: Currently negotiating with property owner as to best possible method to resolve wooden retaining wall.</p> <p>Levee Mile: 7.76</p>

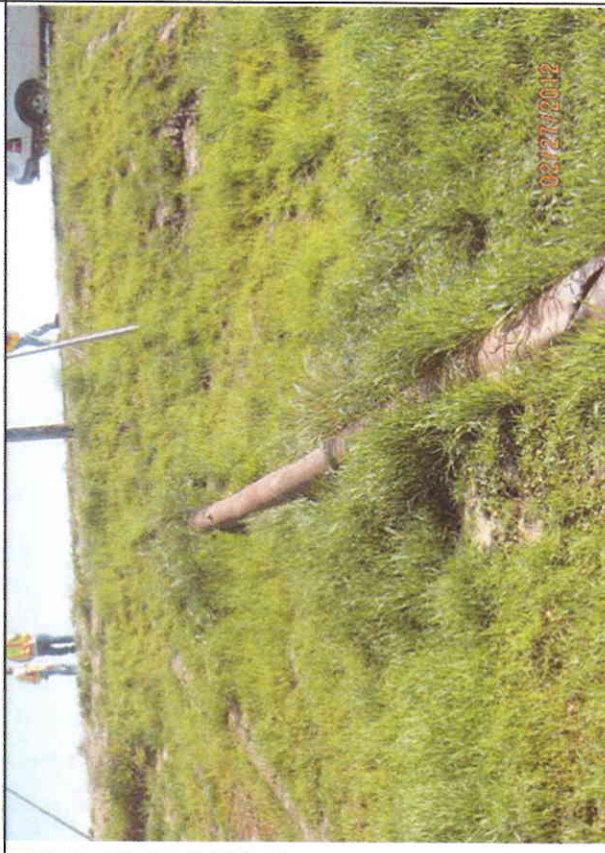
<p>Inspect ID: NIC4_2012_p_0512 Title: USACE_CESPK_NIC4_2012_p_0512_2.jpg Rated Item: 3. Encroachments Caption: 12 inch pipe through levee. Pipe exposed on waterside and landside with no positive closure device. Pipe on waterside is breached with holes and sand is visible within. Animals were exiting pipe at time of inspection. No inspection records available. (U)</p>

<p>September 28, 2012: Currently negotiating with property owner for removal and repair of pipe. Levee Mile: 9.55</p>

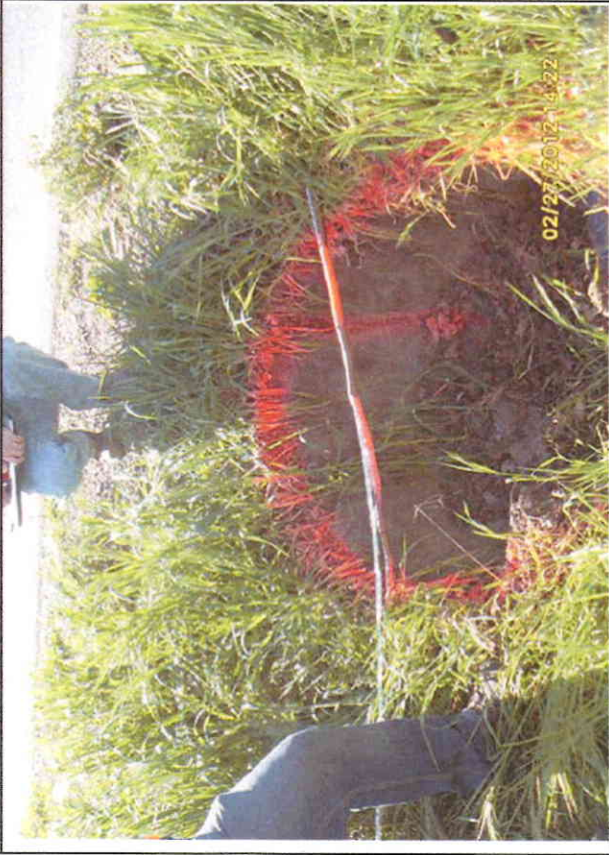
Inspect ID: NIC4_2012_p_0534 Title: USACE_CESPK_NIC4_2012_p_0534_2.jpg Rated Item: 3. Encroachments Caption: 2.5 foot deep, 3.5 foot wide hole at landside hinge likely due to excavation. Possibly a removed gate foundation. (U)

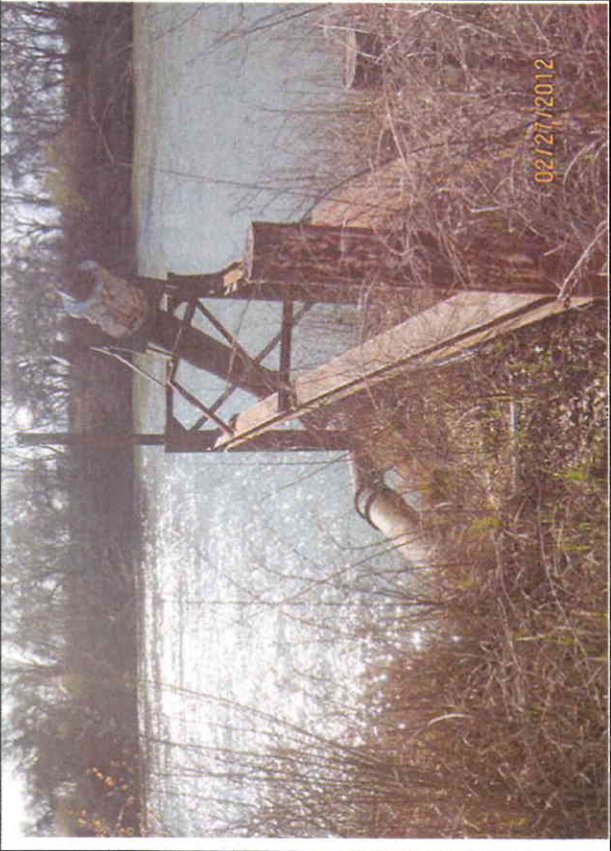
Inspect ID: NIC4_2012_p_0549 **Title:** USACE_CESPK_NIC4_2012_p_0549_3.jpg
Rated Item: 3. Encroachments **Caption:** 12 inch pipe through levee. Slant pump on waterside bank to 24 inch standpipe at landside toe. No positive closure on waterside shoulder. Pipe broken near siphon breaker on landside embankment. No inspection records available. (Permit No. 3297) (U)

September 28, 2012: Currently negotiating with property owner for removal and repair of pipe.
Levee Mile: 10.02

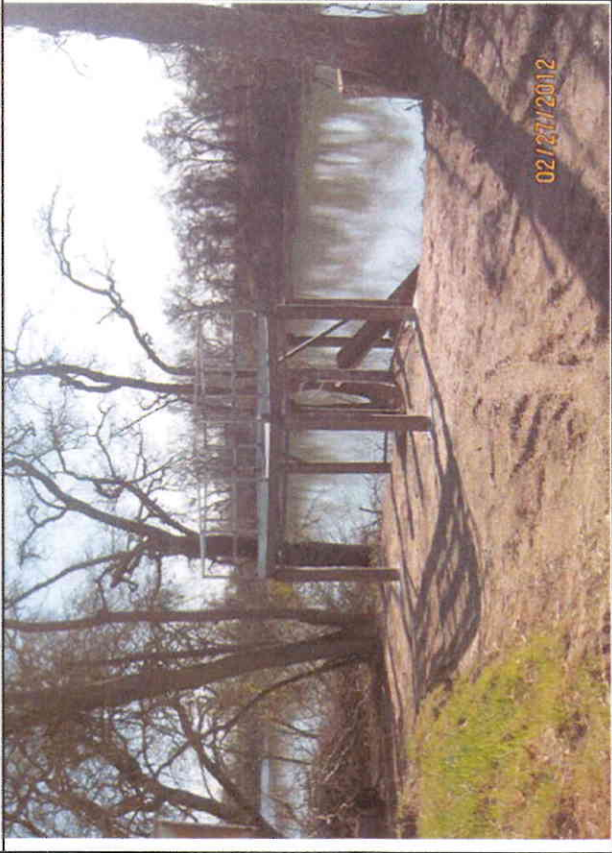
<p>Inspect ID: NIC4_2012_p_0560 Title: USACE_CESPK_NIC4_2012_p_0560_1.jpg Rated Item: 3. Encroachments Caption: 18 inch pipe through levee. Waterside slant pump removed and being reconstructed. No positive closure device observed. Siphon break on landside hinge. Utility poles on landside slope and near waterside toe. No inspection record available (Permit 1881) (U)</p>

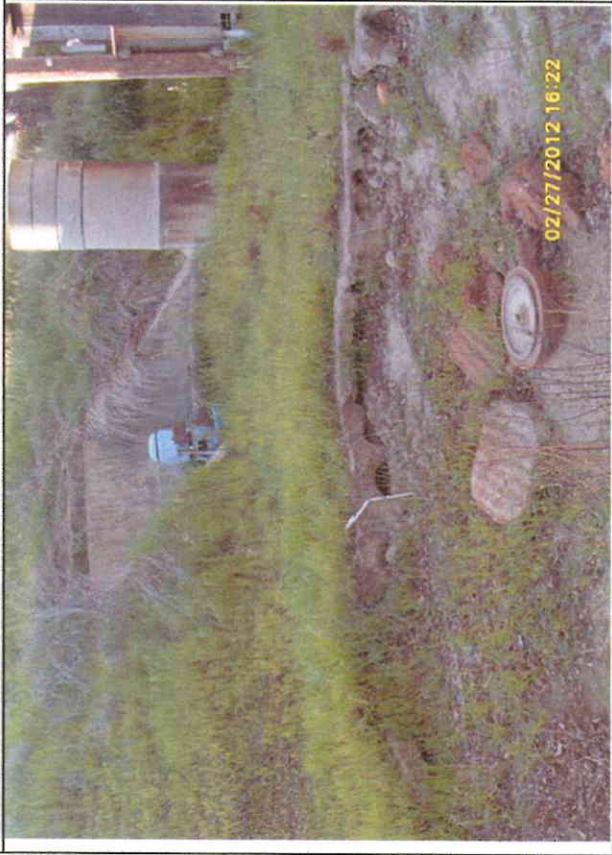
<p>Inspect ID: NIC4_2012_p_0582 Title: USACE_CESPK_NIC4_2012_p_0582_5.jpg Rated Item: 3. Encroachments Caption: Groundwater pump cut into landside embankment. 7 foot tall concrete headwall surrounds pump. Pump feeds 36 inch standpipe within 15 feet of landside toe. Approximately 1 foot of scour located 8 feet from toe. (U)</p>

<p>September 28, 2012: Currently negotiating with property owner for repair of scour on landside toe. Levee Mile: 10.71</p>

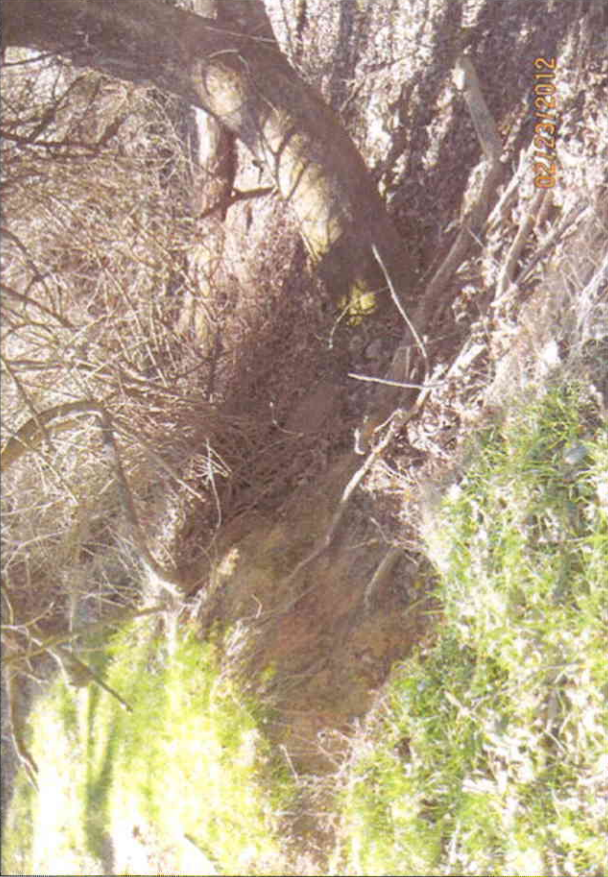
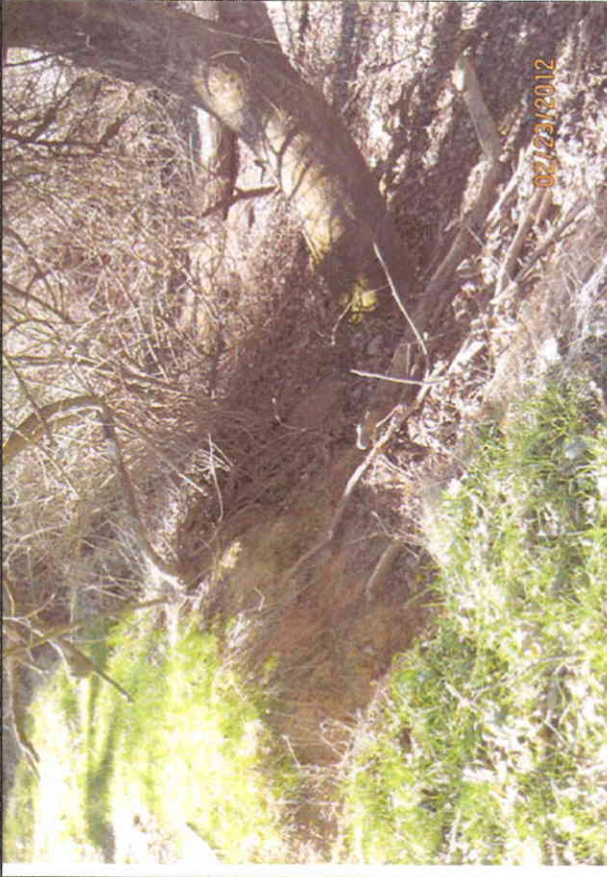
<p>September 28, 2012: Currently management and staff are determining the most effective way to repair erosion/bank caving. Levee Mile: 1.79</p>	
		<p>Inspect ID: NIC4_2012_p_0122 Title: USACE_CESPK_NIC4_2012_p_0122_2.jpg Rated Item: 6. Erosion/ Bank Caving Caption: Start point. Erosion site at waterside toe. Erosion area is within the levee prism. Erosion face is 10 feet at a 1H:1V slope, with tree roots exposed. End point is 134. (U)</p>

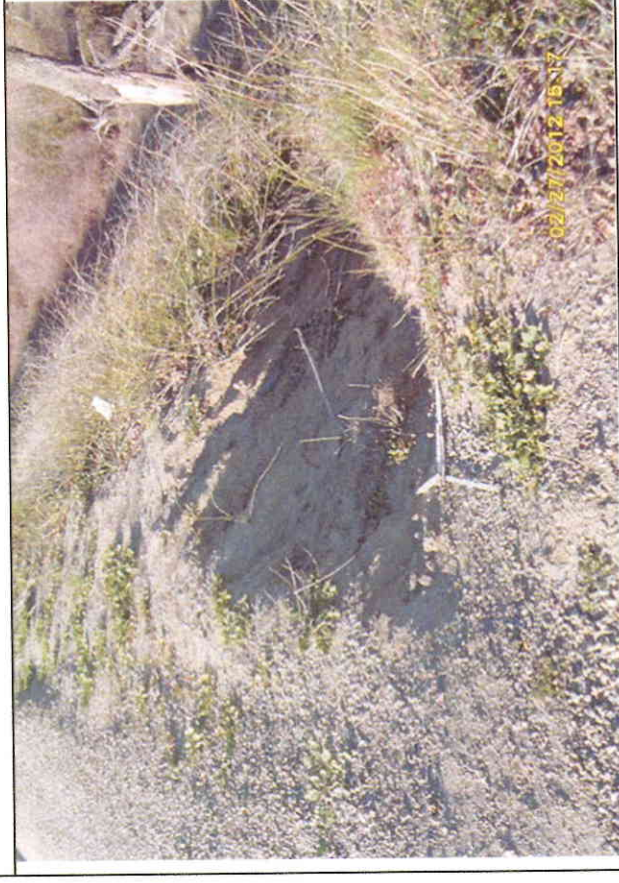
Inspect ID: NIC4_2012_p_0559 Title: USACE_CESPK_NIC4_2012_p_0559_2.jpg
Rated Item: 8. Depressions/ Rutting Caption: Rutting full height of landside embankment up to 24 inches deep and 18 inches wide. (U)

September 2012: Rutting full height of landside embankment up to 24 inches deep and 18 inches wide, filled. 10 cubic yards of shale rock added to levee.
Levee Mile: 10.20

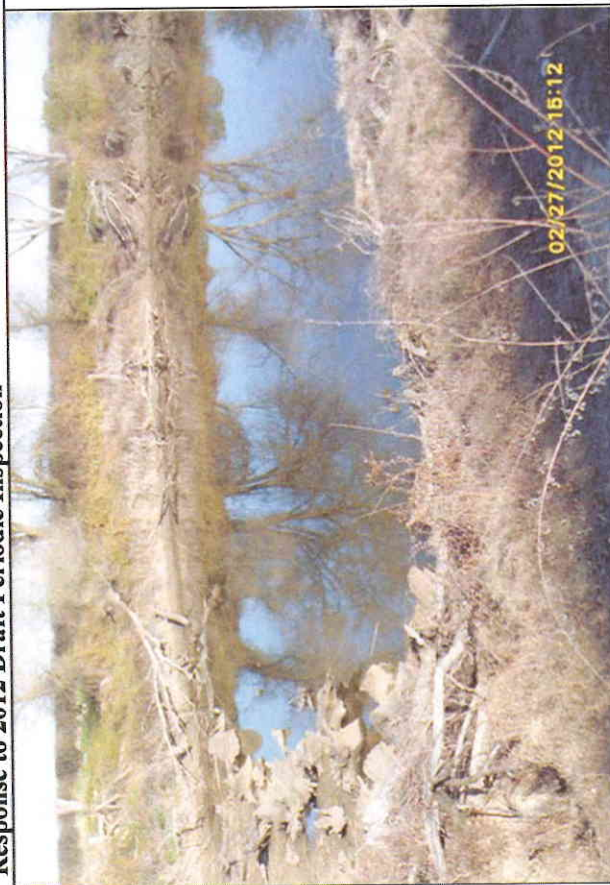
<p>December 1955: Scour hole created by the historical levee breach on December 24, 1955. Scour hole remained after levee was repaired and prior to the Memo of Understanding (MOU) of 1957 design profile. Therefore scour hole existed at the time the levee system was turned over to district. Levee Mile: 10.18</p>

<p>Inspect ID: NIC4_2012_p_0557 Title: USACE_CESPK_NIC4_2012_p_0557_3.jpg Rated Item: 15. Seepage Caption: Scour hole 12 to 15 feet from LS toe, likely from historical levee breach. Continuous saturated area remains at historic breach/seepage location. Water appears to be the same elevation as the water level of the waterside channel. (U)</p>

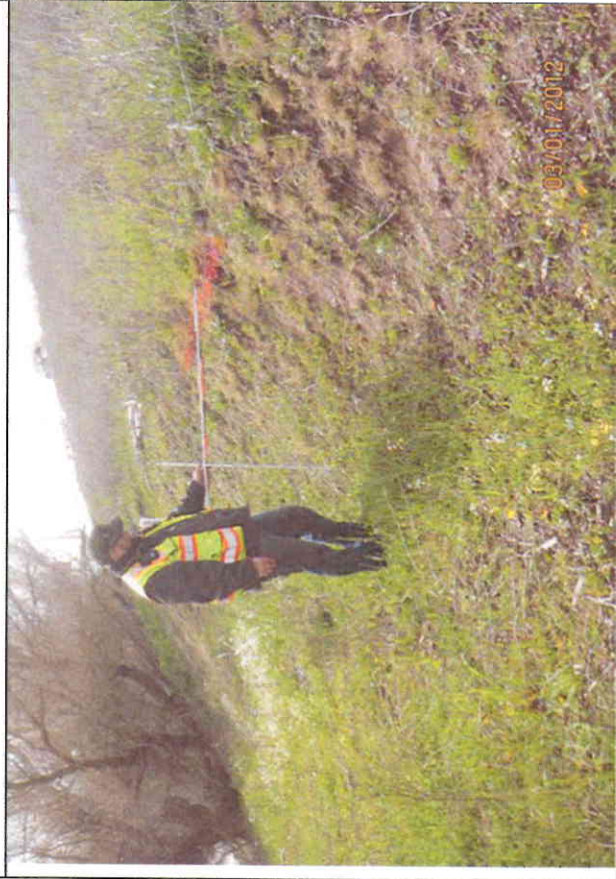
Inspect ID: NIC5_2012_p_0128 **Title:** USACE_CESPK_NIC5_2012_p_0128_3.jpg
Rated Item: 3. Encroachments **Caption:** 3 foot tall waterside toe cut for 100 feet. Likely due to maintenance vehicles. (U)

August 2012: Waterside toe cut removed
Levee Mile: 3.77
