**Meeting of the Central Valley Flood Protection Board
March 22, 2013**

Staff Report – Transmittal of Reclamation District 1001’s Letter of Intent for a System-Wide Improvement Framework to the U.S. Army Corps of Engineers

Sacramento and Sutter Counties

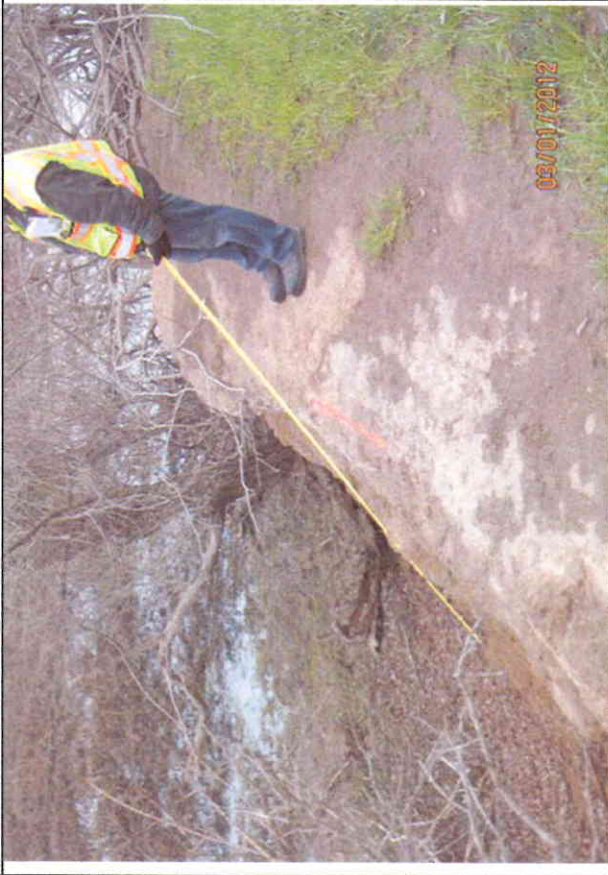
<p>Inspect ID: NIC5_2012_p_0048 Title: USACE_CESPK_NIC5_2012_p_0048_2.jpg Rated Item: 6. Erosion/ Bank Caving Caption: Start point. Erosion at waterside toe with near vertical to 1H:1V face ranging from 6 to 10 feet along face. End point is 61. (U)</p>

<p>September 28, 2012: Currently management and staff are determining the most effective way to repair erosion/bank caving. Levee Mile: 1.07</p>

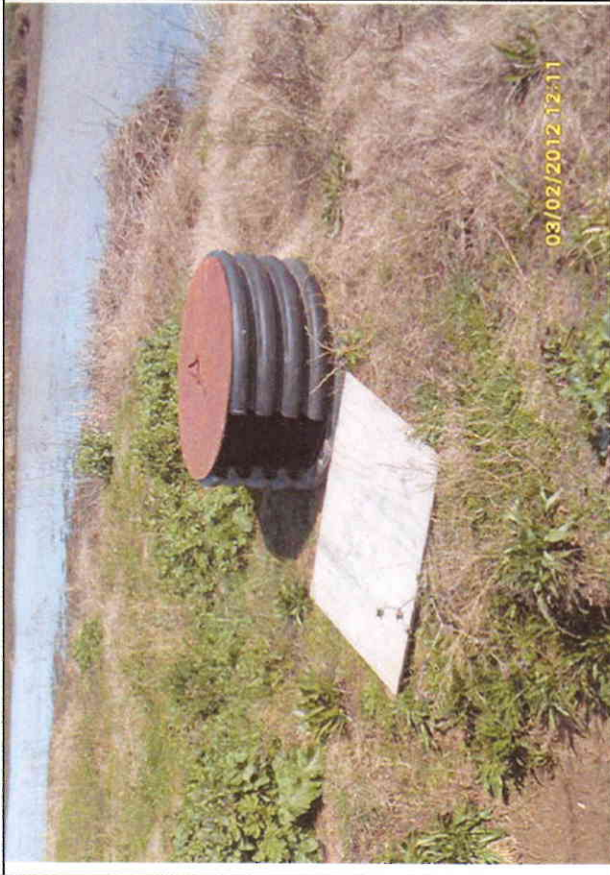
<p>Inspect ID: NIC6_2012_p_0069 Title: USACE_CESPK_NIC6_2012_p_0069_3.jpg Rated Item: 3. Encroachments Caption: 16 inch pipe through the levee. No waterside closure. Air break on landside hinge. Landside outlet is on the other side of the road. No inspection records available. (Permit 12208) (U)</p>

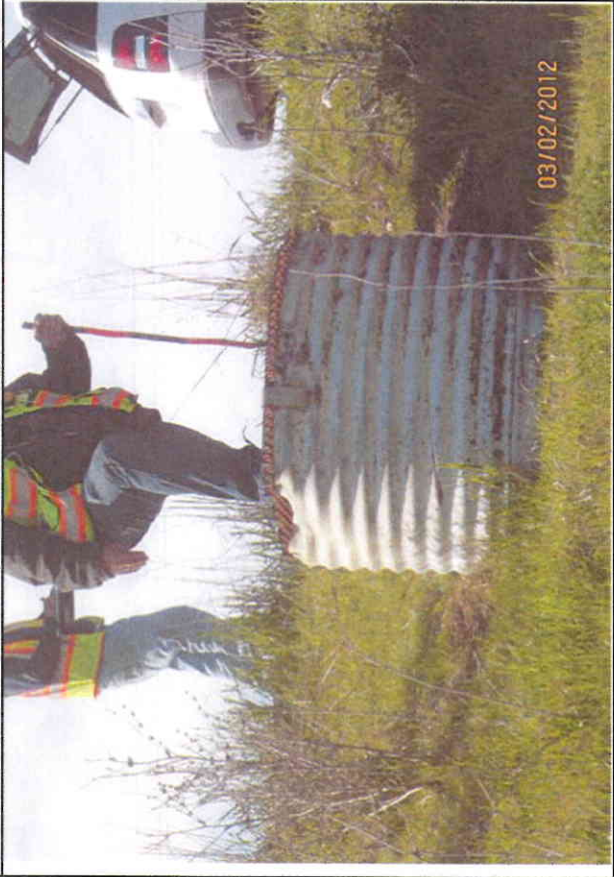
<p>Inspect ID: NIC6_2012_p_0084 Title: USACE_CESPK_NIC6_2012_p_0084_1.jpg Rated Item: 3. Encroachments Caption: 24 inch pipe through levee. Slide gate in CMP riser at waterside hinge. Slide gate appears to be inoperable. Cannot determine if gate is open or closed. No inlet or outlet observed for the pipe. No inspection records available. (U)</p>

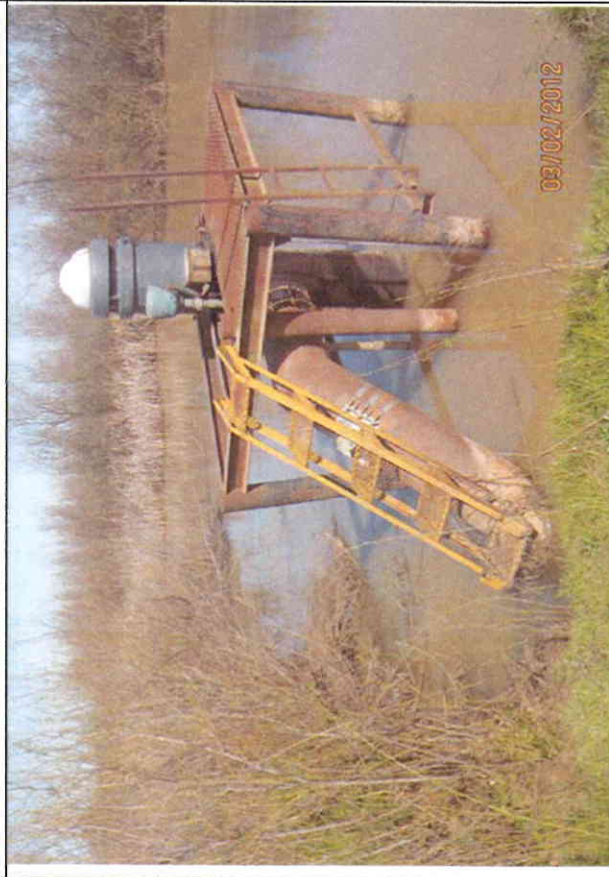
Inspect ID: NIC6_2012_p_0087 Title: USACE_CESPK_NIC6_2012_p_0087_1.jpg
Rated Item: 3. Encroachments Caption: 16 inch pipe through the levee. No positive closure device observed. Air break on landside hinge. Landside outlet is on the other side of the road. (Permit 13153) (U)
