CVFPB Meeting June 27, 2014

## USACE INSPECTION RESULTS

# Cache Creek Unit 1 – Yolo Bypass Unit 2 – Knights Landing Unit 1

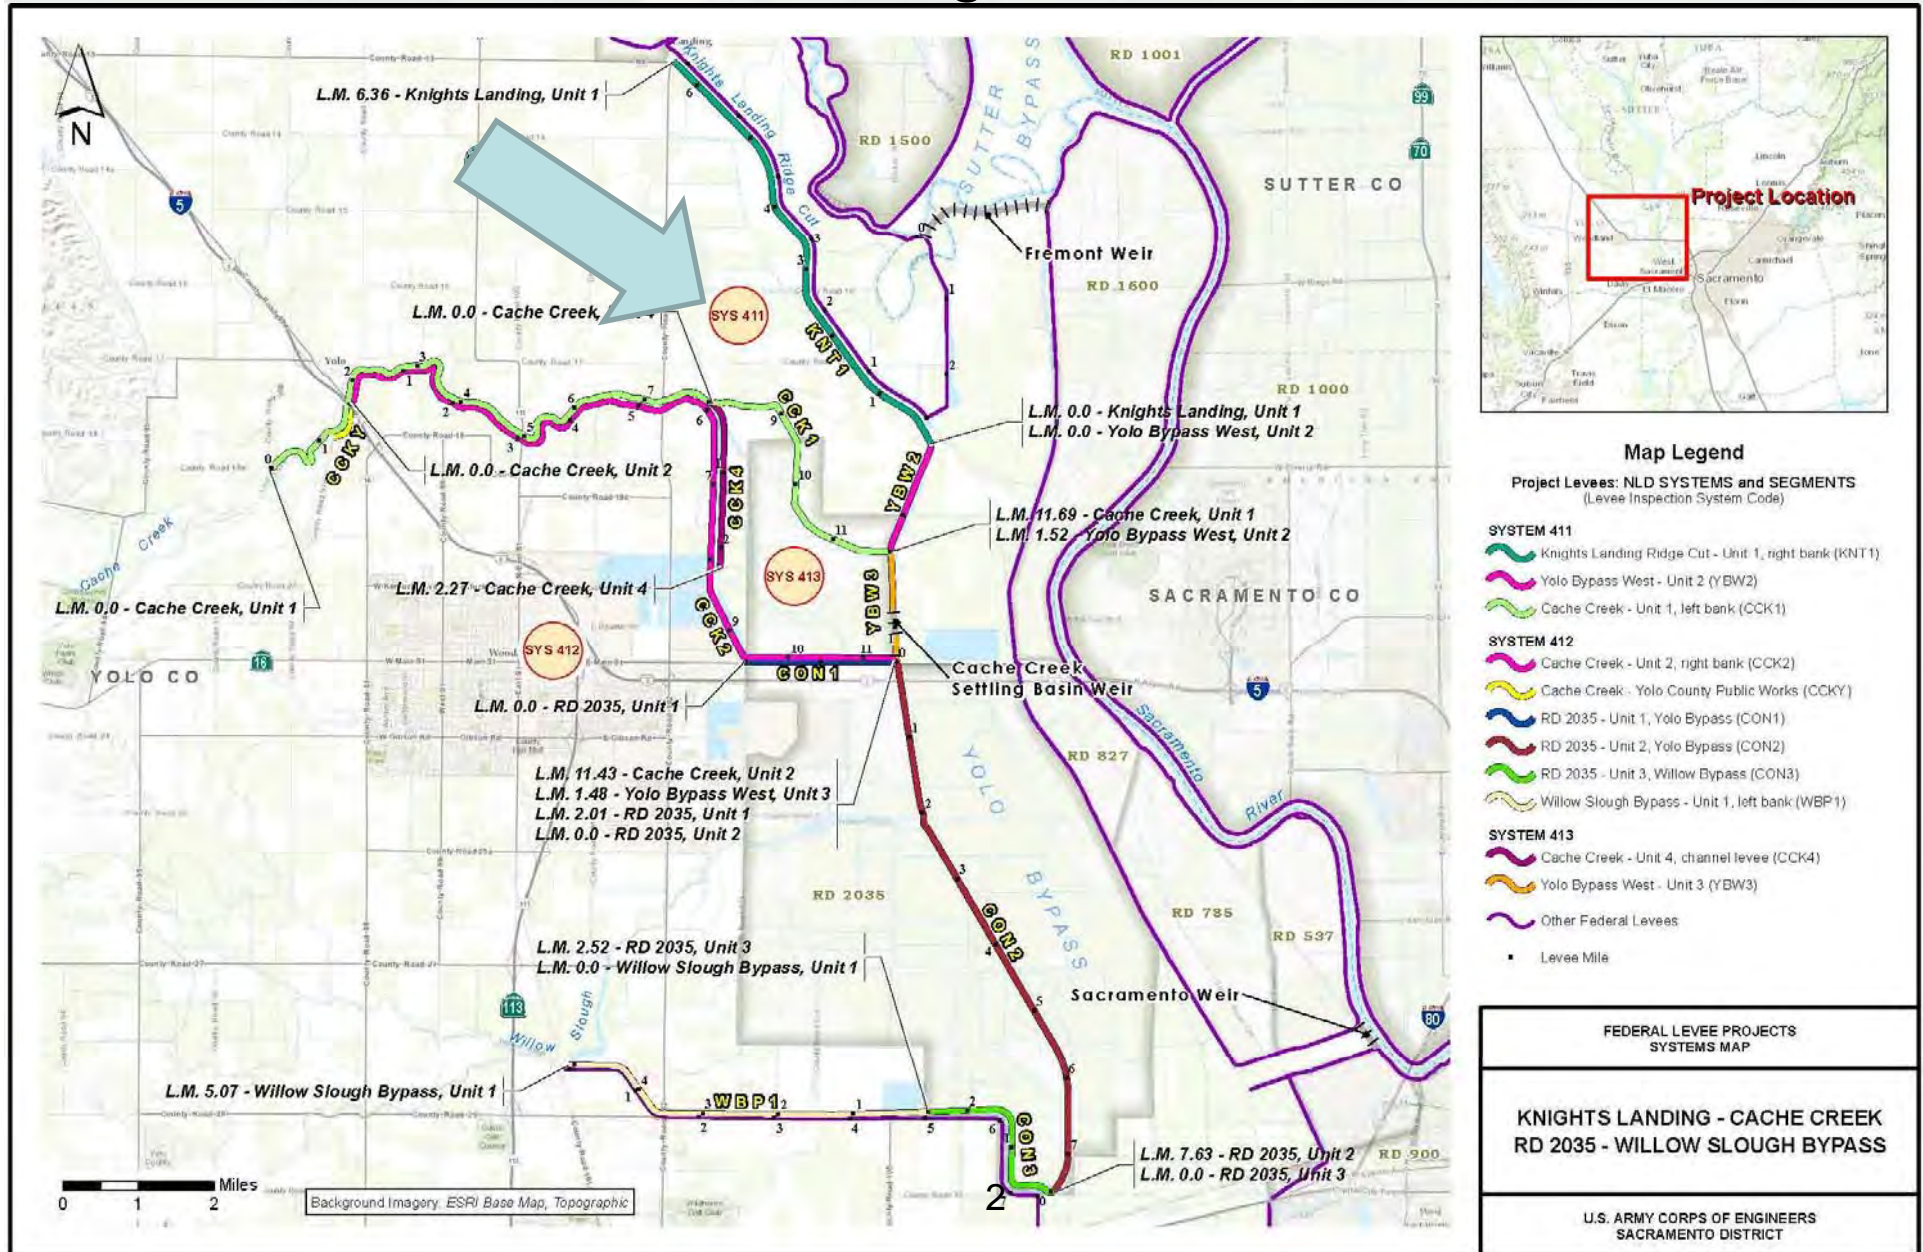
System: Cache Creek U1 - Yolo Bypass U2 - Knights Landing U1 System Rating: Unacceptable Approved SWIF / LOI: No PL 84-99 RP Eligibility: Inactive		Knights Landing Ridge Cut - Unit 1, Right Bank (KNT1)	Yolo Bypass - West Levee - Unit 2 (YBW2)	Cache Creek - Unit 1, Left Bank (CCK1)					
General	Operations and Maintenance Manuals	A	M	M					
	Emergency Supplies and Equipment	A	A	A					
	Flood Preparedness and Training	M	M	M					
Levee - Items Affecting PL 84-99 RP Eligibility	Encroachments	U	U	U					
	Closure Structures	NA	NA	NA					
	Slope Stability	U	A	M					
	Erosion/Bank Caving	U	M	U					
	Animal Control	U	M	M					
	Culverts/Discharge Pipes	NA	NA	NA					
	Underseepage Relief Wells/Toe Drainage Systems	NA	NA	NA					
Levee Embankments - Other Items	Vegetation Growth	M	M	M					
	Sod Cover	M	M	M					
	Settlement	M	M	M					
	Depressions/Rutting	U	A	M					
	Cracking	U	M	M					
	Riprap Revetments & Bank Protection	A	M	A

Revetments other than Riprap	NA	NA	A					
	Seepage	M	M	M					
<b>Legend</b> A    Acceptable M    Minimally Acceptable U    Unacceptable N/A    Not Applicable RP    Rehabilitation Program (Note: flood fight assistance available regardless of eligibility status)		<div>M</div>	<div>U</div>	<div>U</div>	Includes Unacceptable observations not likely to prevent performance in next flood event Serious deficiency noted in past inspection report has not been corrected Likely prevents performance in next flood event

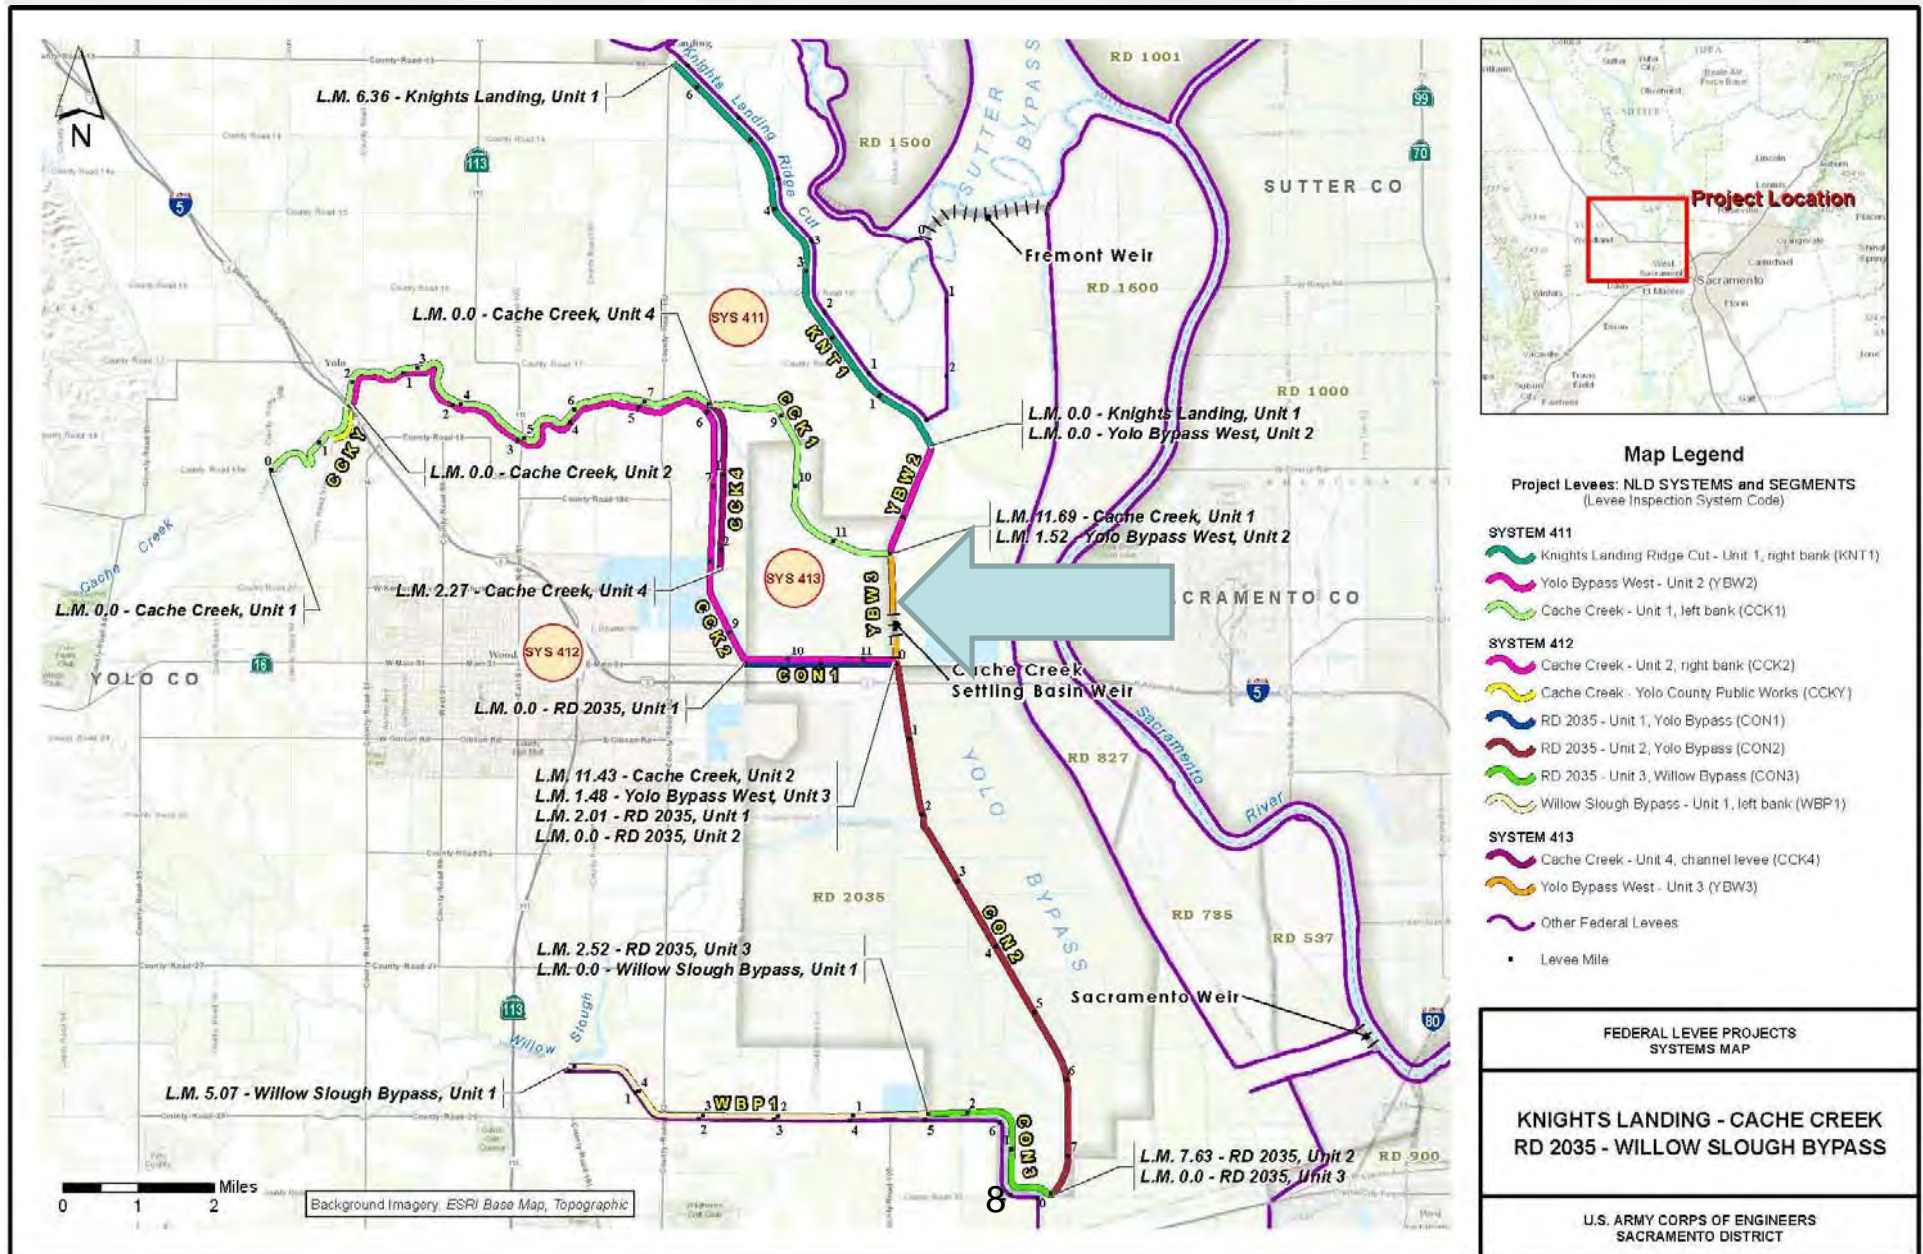
System: Yolo Bypass West Levee - Cache Creek Unit 4 Levee System Rating: Unacceptable Approved SWIF / LOI: No PL 84-99 RP Eligibility: Inactive		Cache Creek - Unit 4, Channel Levee Left Bank (CCK4)	Yolo Bypass - West Levee - Unit 3 (YBW3)						
General	Operations and Maintenance Manuals	M	M						
	Emergency Supplies and Equipment	A	A						
	Flood Preparedness and Training	M	M						
Levee - Items Affecting PL 84-99 RP Eligibility	Encroachments	M	U						
	Closure Structures	N/A	N/A						
	Slope Stability	A	A						
	Erosion/Bank Caving	M	M						
	Animal Control	U	M						
	Culverts/Discharge Pipes	N/A	N/A						
	Underseepage Relief Wells/Toe Drainage Systems	N/A	N/A						
Levee Embankments - Other Items	Vegetation Growth	A	A						
	Sod Cover	A	A						
	Settlement	A	A						
	Depressions/Rutting	M	A						
	Cracking	A	M						
	Riprap Revetments & Bank Protection	N/A	M						
	Revetments other than Riprap	N/A	N/A

Seepage	A	A						
<b>Legend</b> <div> <div>A</div> <div>Acceptable</div> </div> <div> <div>M</div> <div>Minimally Acceptable</div> </div> <div> <div>U</div> <div>Unacceptable</div> </div> <div> <div>N/A</div> <div>Not Applicable</div> </div> <div> <div>RP</div> <div>Rehabilitation Program (Note: flood fight assistance available regardless of eligibility status)</div> </div> <div> <div>M</div> <div>Includes Unacceptable observations not likely to prevent performance in next flood event</div> </div> <div> <div>U</div> <div>Serious deficiency noted in past inspection report has not been corrected within the established timeframe</div> </div> <div> <div>U</div> <div>Likely prevents performance in next flood event</div> </div>

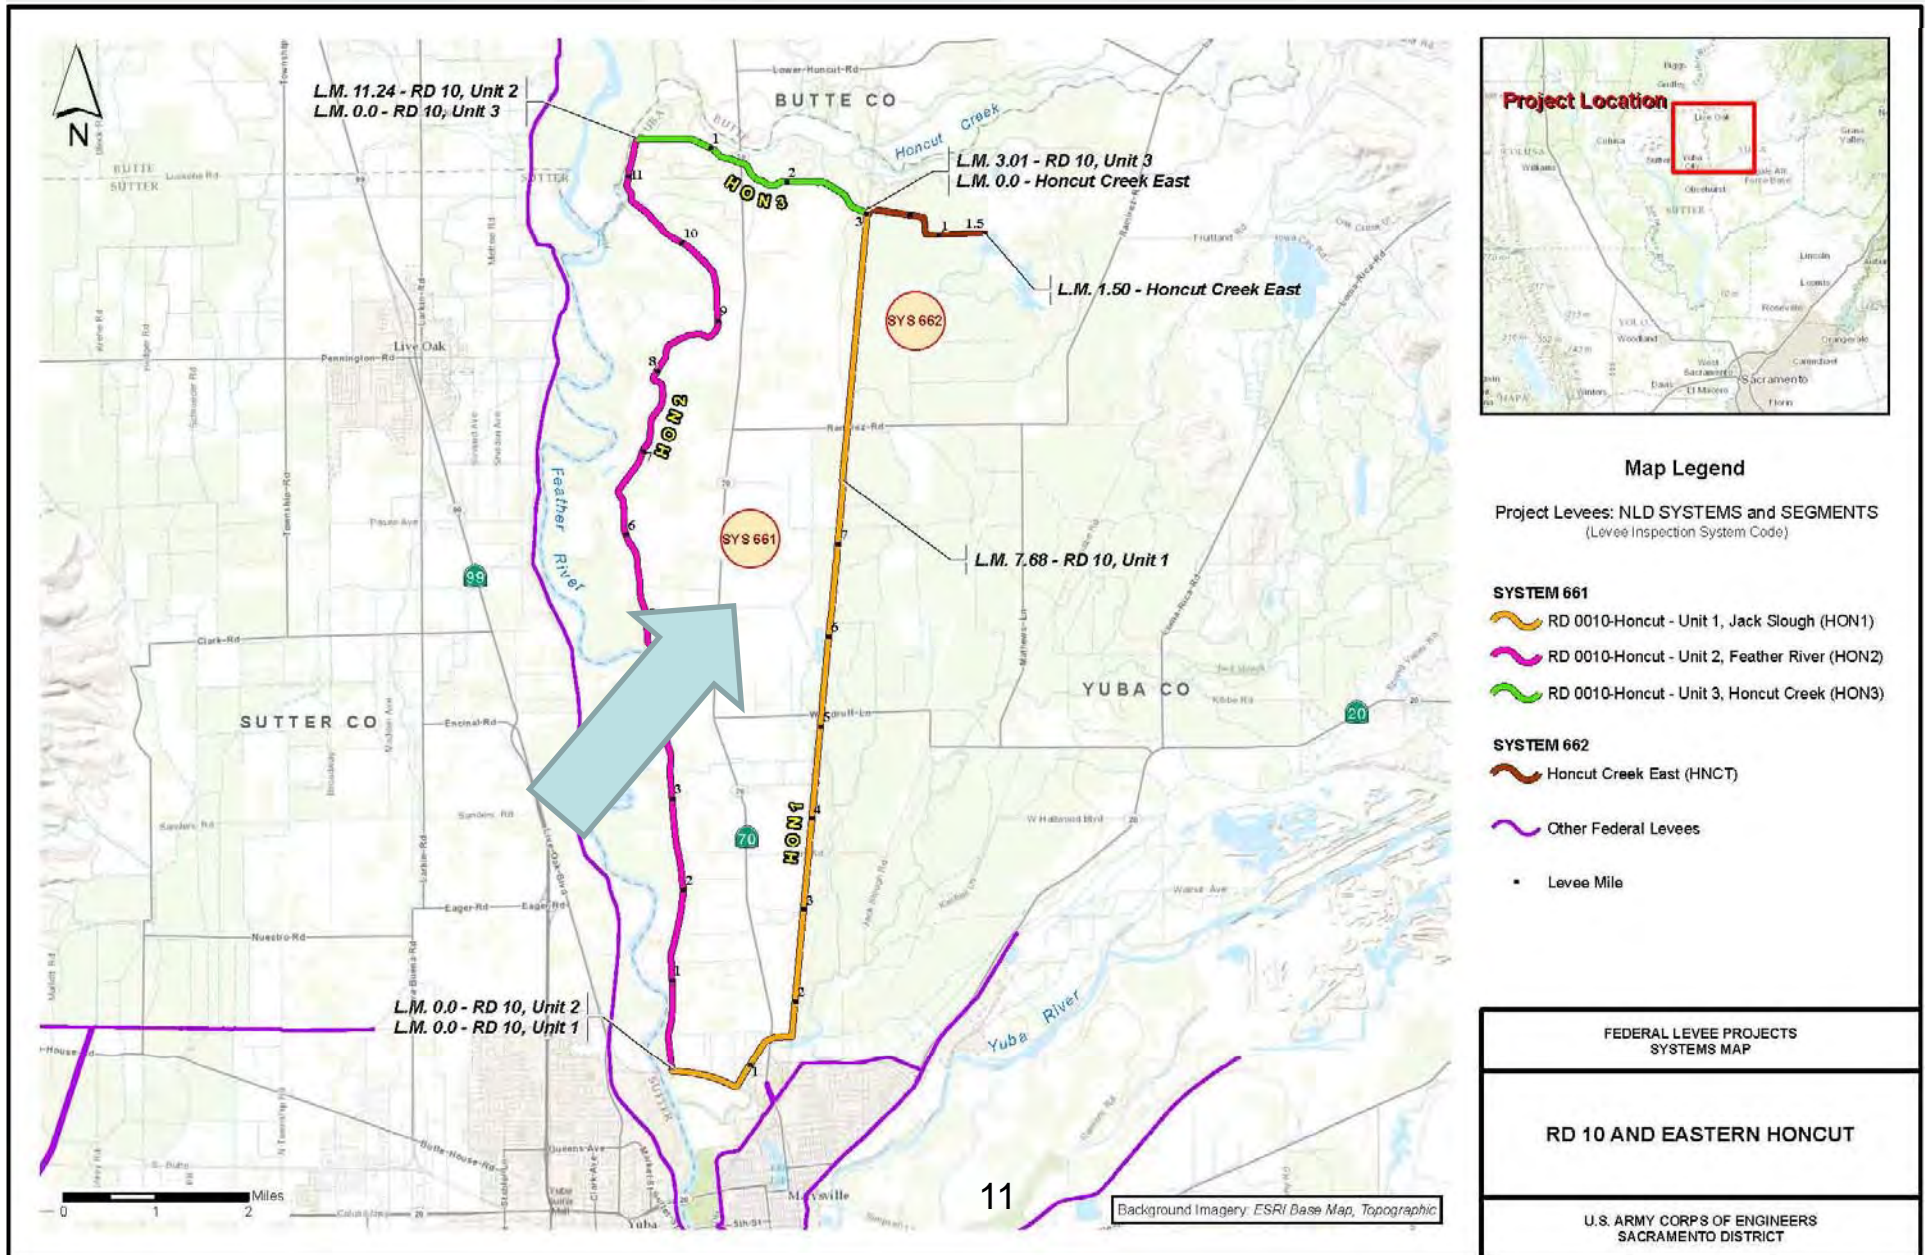
<p><b>System: RD 10 - Honcut</b>  <b>Drainage Basin Levee System</b>  <b>System Rating: Unacceptable</b>  <b>Approved SWIF / LOI: No</b>  <b>PL 84-99 RP Eligibility: Inactive</b></p>				
		RD 10 - Honcut - Unit 1, Jack Slough (HON1)	RD 10 - Honcut - Unit 2, Feather River (HON2)	RD 10 - Honcut - Unit 3, Honcut Creek (HON3)	
General	Operations and Maintenance Manuals	M	M	M	
	Emergency Supplies and Equipment	M	M	M	
	Flood Preparedness and Training	M	M	M	
Levee - Items Affecting PL 84-99 RP Eligibility	Encroachments	U	U	U	
	Closure Structures	N/A	N/A	N/A	
	Slope Stability	M	M	M	
	Erosion/Bank Caving	U	A	A	
	Animal Control	U	U	U	
	Culverts/Discharge Pipes	N/A	N/A	N/A	
	Underseepage Relief Wells/Toe Drainage Systems	N/A	N/A	N/A	
Levee Embankments - Other Items	Vegetation Growth	M	M	M	
	Sod Cover	M	M	M	
	Settlement	A	M	A	
	Depressions/Rutting	M	M	M	
	Cracking	M	A	A	
	Riprap Revetments & Bank Protection	A	M	M	
	Revetments other than Riprap	N/A	N/A	N/A

Seepage	M	U	M	
	<p><b>Legend</b></p> <p>A Acceptable</p> <p>M Minimally Acceptable</p> <p>U Unacceptable</p> <p>N/A Not Applicable</p> <p>RP Rehabilitation Program (Note: flood fight assistance available regardless of eligibility status)</p>

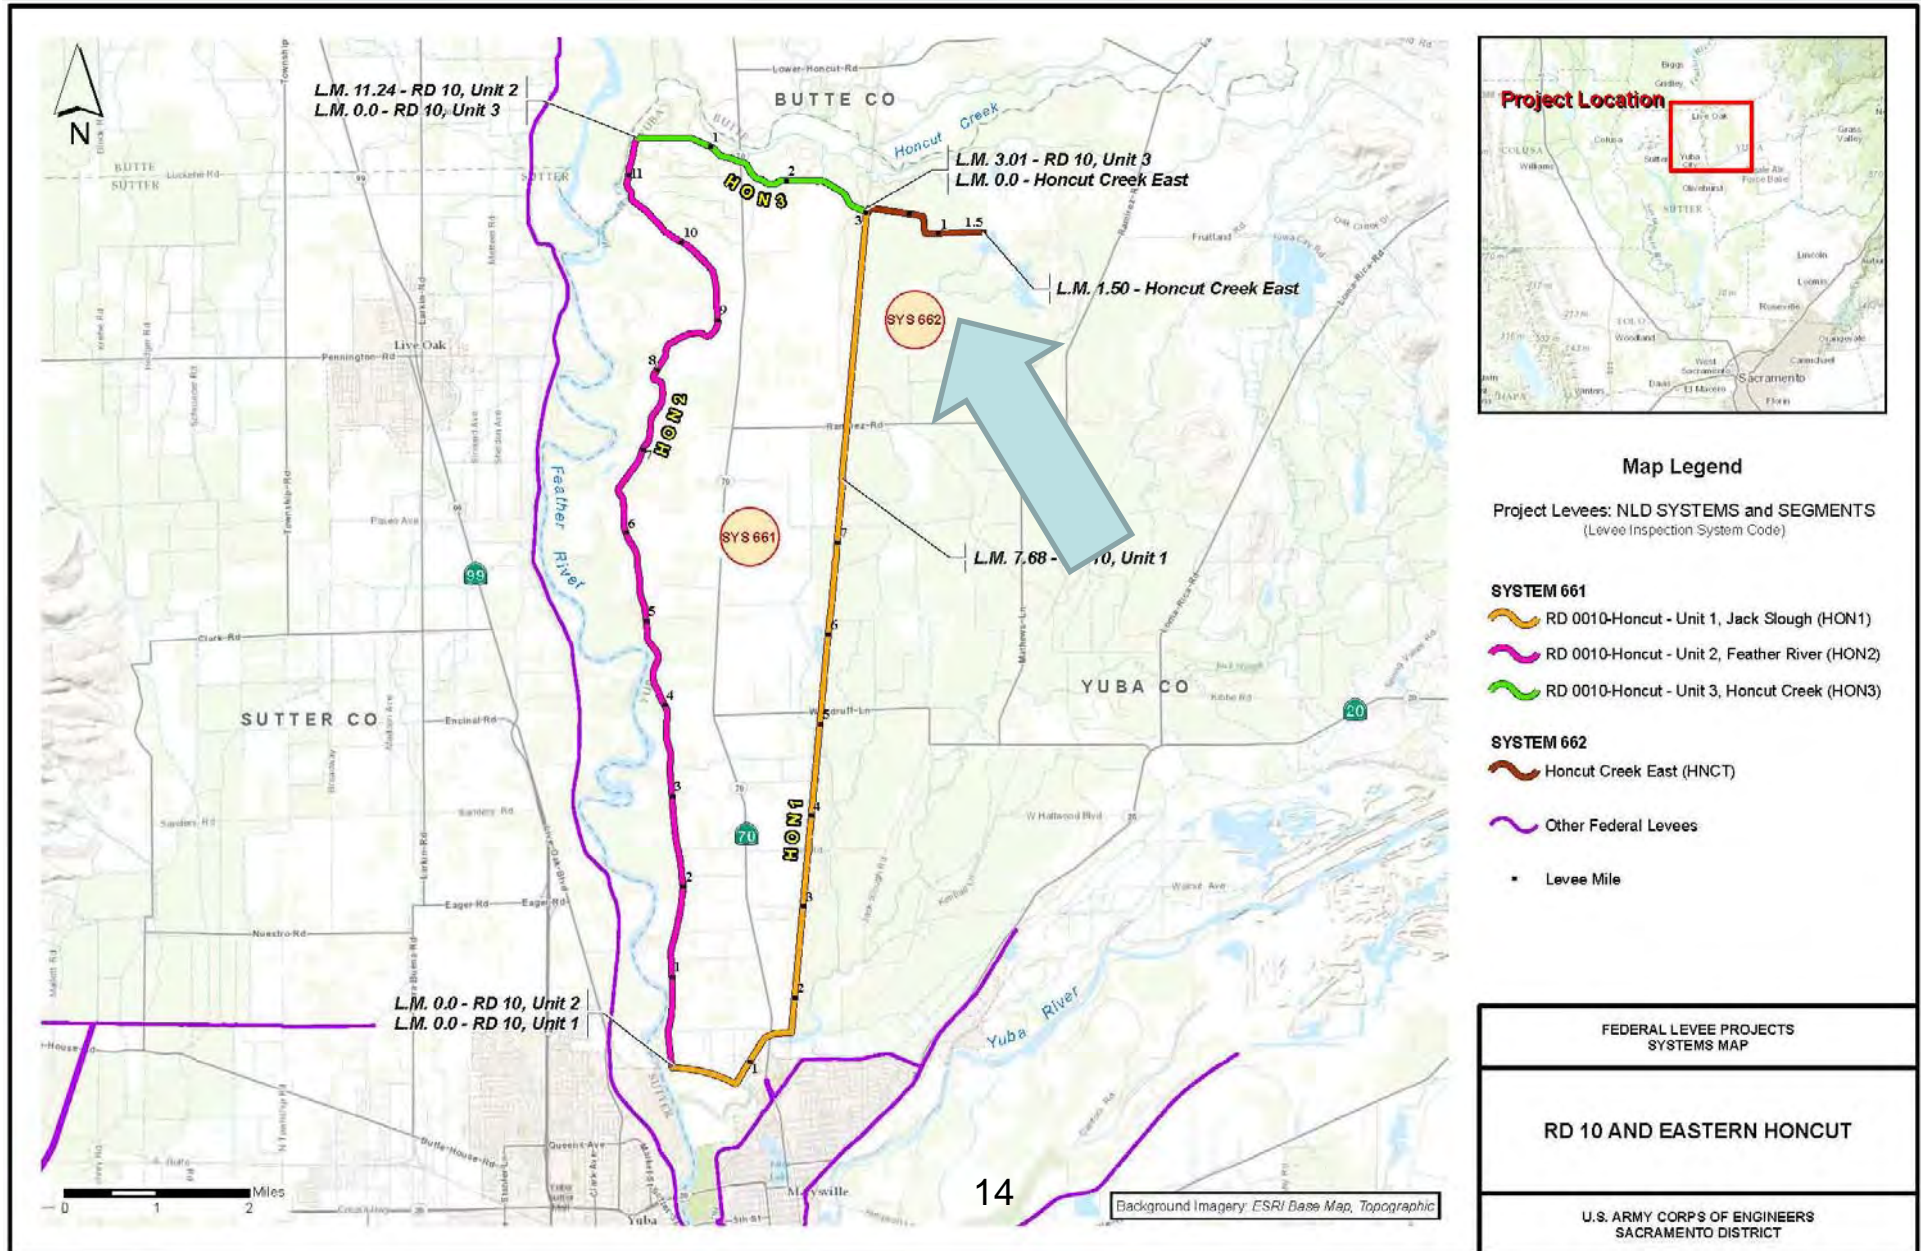
System: Honcut Creek Area - Eastern Levee System System Rating: Unacceptable Approved SWIF / LOI: No PL 84-99 RP Eligibility: Inactive		Honcut Creek Area - Eastern (HNCT)
General	Operations and Maintenance Manuals	M	
	Emergency Supplies and Equipment	M	
	Flood Preparedness and Training	M	
Levee - Items Affecting PL 84-99 RP Eligibility	Encroachments	U	
	Closure Structures	N/A	
	Slope Stability	M	
	Erosion/Bank Caving	U	
	Animal Control	U	
	Culverts/Discharge Pipes	N/A	
	Underseepage Relief Wells/Toe Drainage Systems	N/A	
	Levee Embankments - Other Items	Vegetation Growth	
Sod Cover		M	
Settlement		U	
Depressions/Rutting		M	
Cracking		A	
Riprap Revetments & Bank Protection		N/A	
Revetments other than Riprap		N/A	
Seepage		M	
<div><div><div><b>Legend</b></div><div>A    Acceptable</div><div>M    Minimally Acceptable</div><div>U    Unacceptable</div><div>N/A    Not Applicable</div><div>RP    Rehabilitation Program (Note: flood fight assistance available regardless of eligibility status)</div></div><div><div><div>M</div><div>U</div><div>U</div></div><div><div>Includes Unacceptable observations not likely to prevent performance in next flood event</div><div>Serious deficiency noted in past inspection report has not been corrected within the established timeframe</div><div>Likely prevents performance in next flood event</div></div></div></div>
