USACE Inspection Results

Flood Protection and Navigation Section

Sacramento District

August 28, 2015

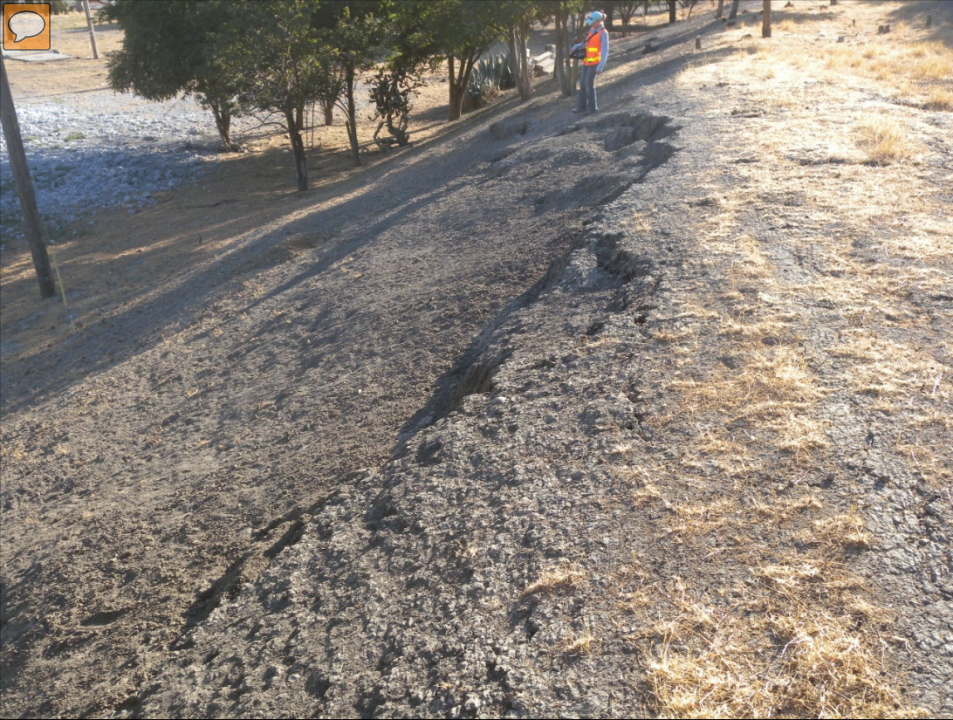
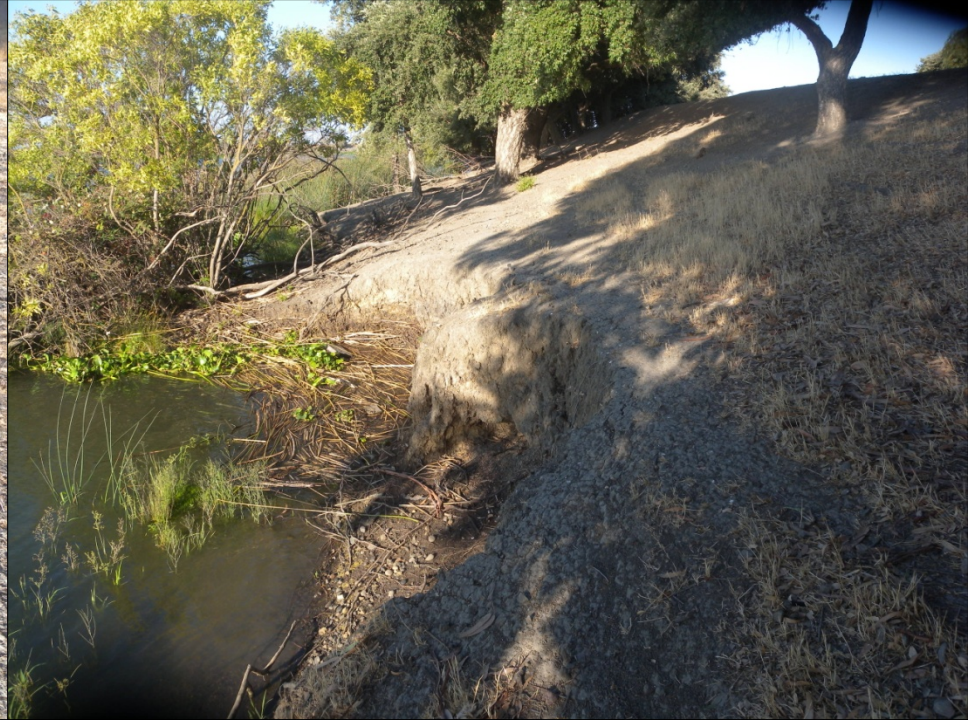
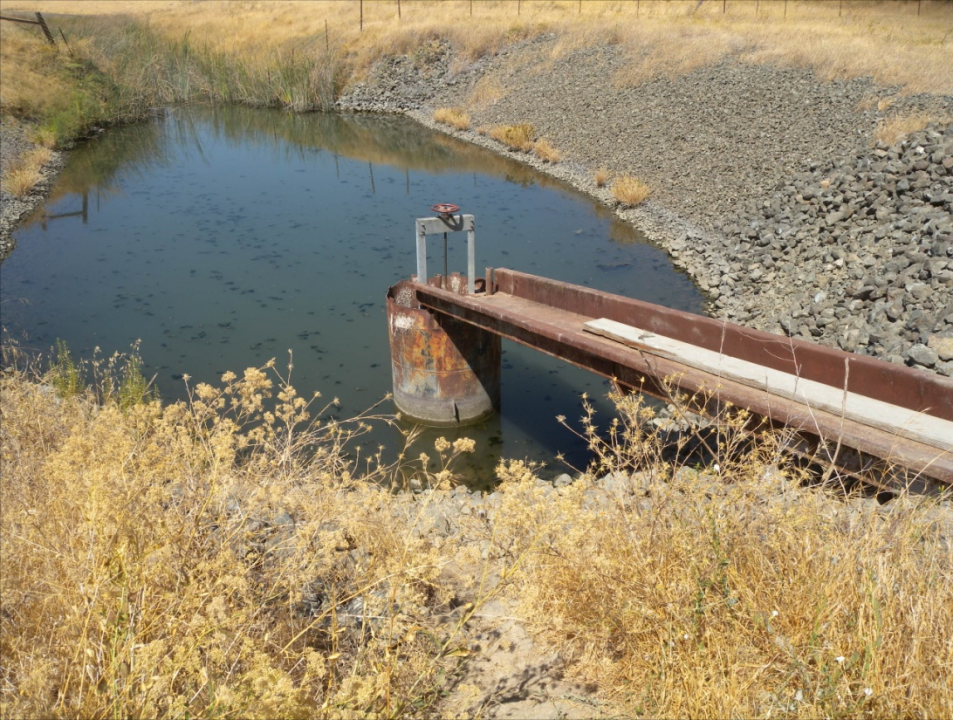
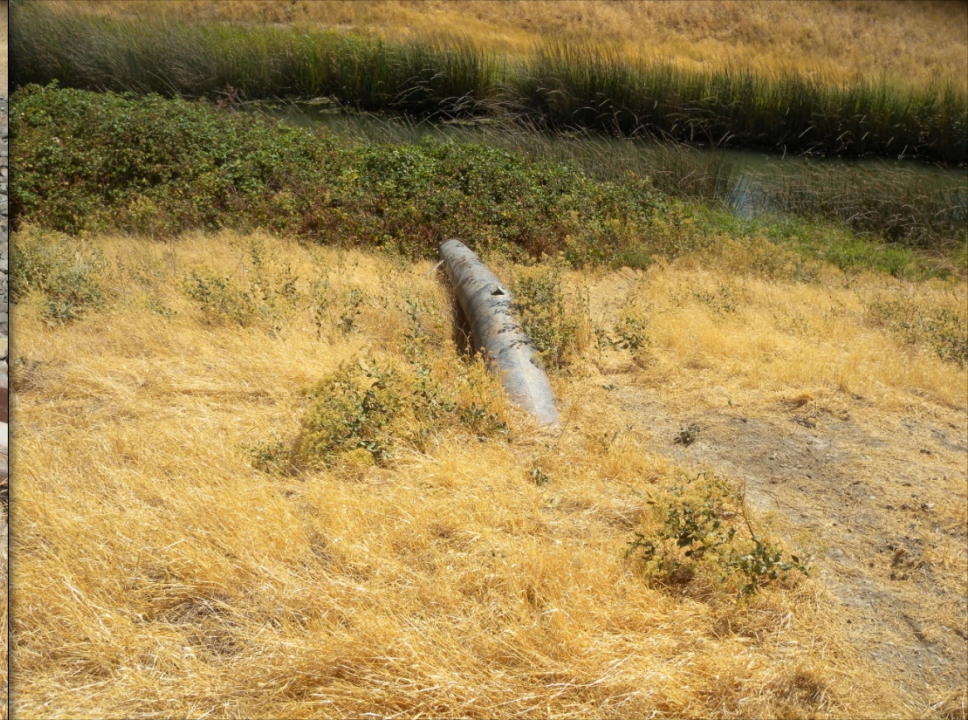
System: RD 0536 - Egbert tract System Rating: Unacceptable Approved SWIF/LOI: No PL 84-99 RP Eligibility: Inactive	RD 0536 - Egbert - Unit 1, Lindsey Slough (EGB1)	RD 0536 - Egbert - Unit 2, south levee (EGB2)						
General	Operations and Maintenance Manuals	M	M						
	Emergency Supplies and Equipment	M	M						
	Flood Preparedness and Training	M	M						
Levee - Items Affecting PL 84-99 RP Eligibility	Encroachments	U	U						
	Closure Structures	NA	NA						
	Slope Stability	U	A						
	Erosion/Bank Caving	U	A						
	Animal Control	U	U						
	Culverts/Discharge Pipes	NA	NA						
	Underseepage Relief Wells/Toe Drainage Systems	NA	NA						
Levee Embankments - Other Items	Vegetation Growth	M	M						
	Sod Cover	M	A						
	Settlement	M	M						
	Depressions/Rutting	M	M						
	Cracking	M	M						
	Riprap Revetments & Bank Protection	M	A						
	Revetments other than Riprap	NA	NA						
	Seepage	M	M						
	Legend A Acceptable M Minimally Acceptable U Unacceptable N/A Not Applicable RP Rehabilitation Program (Note: flood fight assistance available regardless of eligibility status) <div> <div>M</div> Includes Unacceptable observations not likely to prevent performance in next flood event <div>U</div> Serious deficiency noted in past inspection report has not been corrected within the established timeframe <div>U</div> Likely prevents performance in next flood event </div>

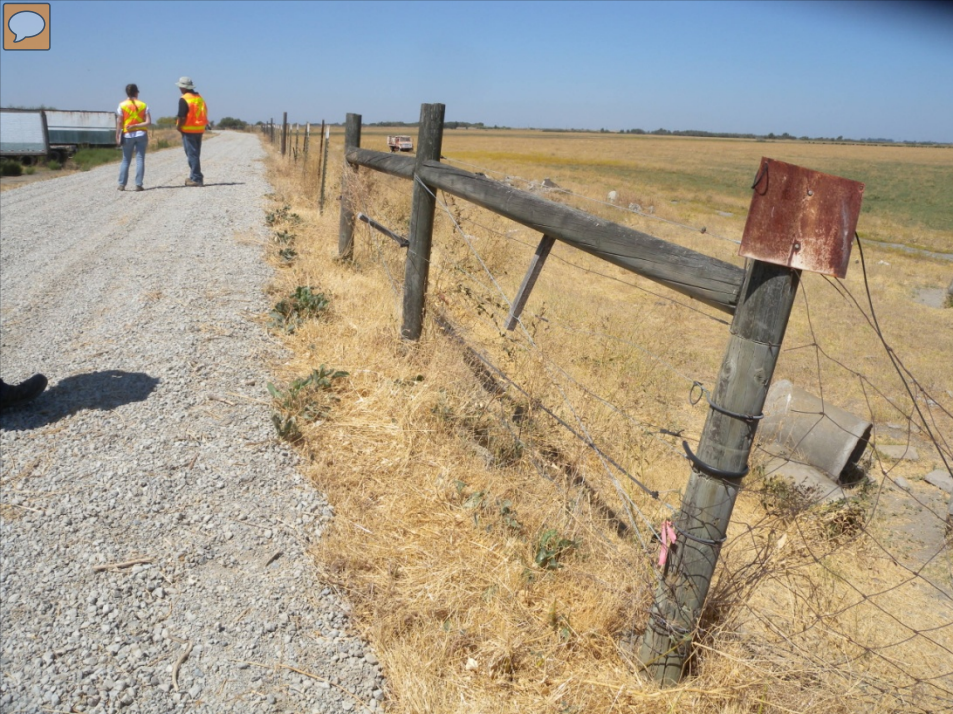
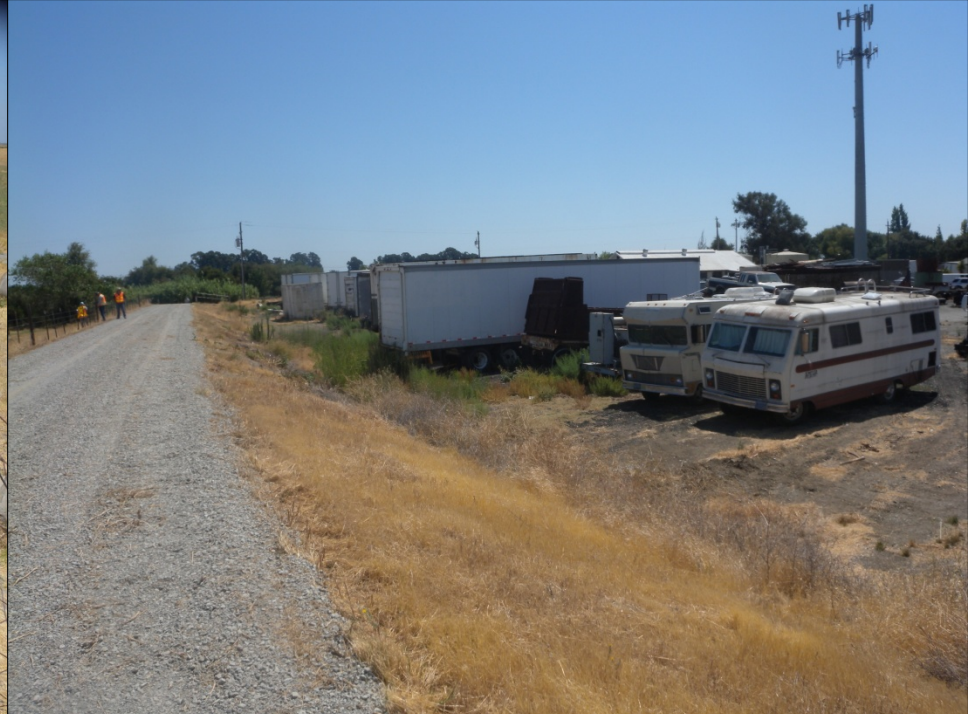
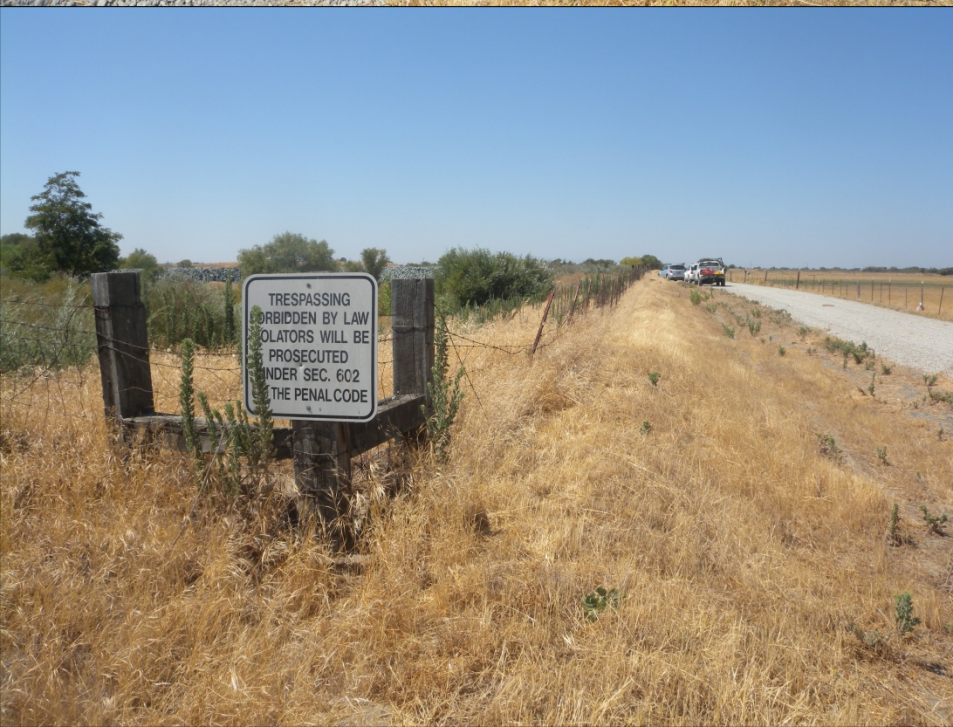
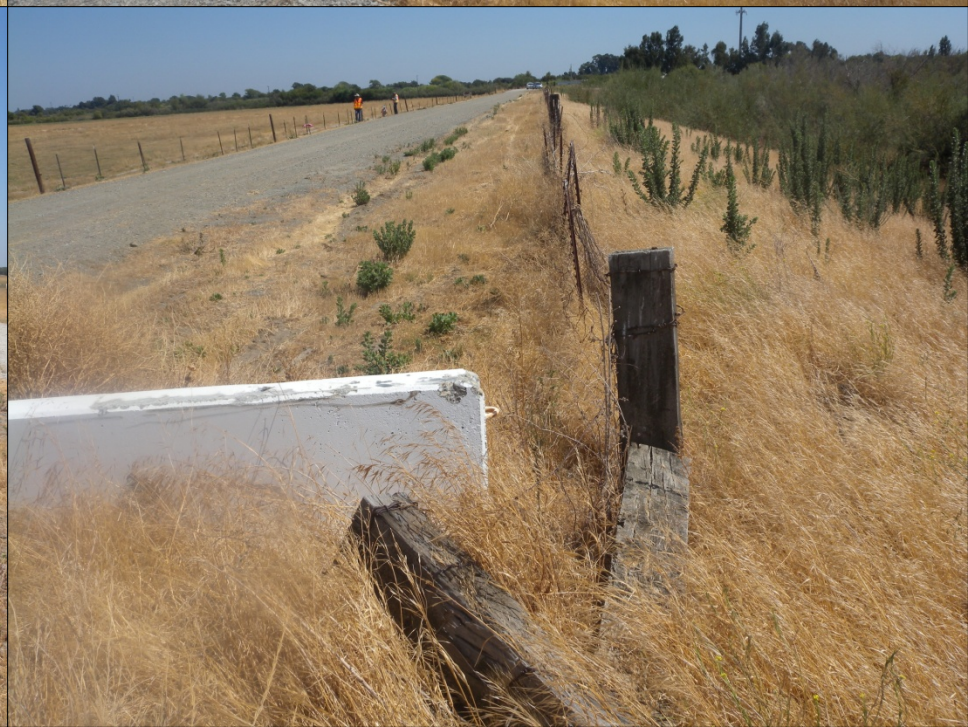
System: Mellin Levee - Rio Vista System Rating: Unacceptable Approved SWIF/LOI: No PL 84-99 RP Eligibility: Inactive	Mellin Levee (MELN)							
General	Operations and Maintenance Manuals	A							
	Emergency Supplies and Equipment	M							
	Flood Preparedness and Training	M							
Levee - Items Affecting PL 84-99 RP Eligibility	Encroachments	U							
	Closure Structures	NA							
	Slope Stability	A							
	Erosion/Bank Caving	A							
	Animal Control	A							
	Culverts/Discharge Pipes	NA							
	Underseepage Relief Wells/Toe Drainage Systems	NA							
Levee Embankments - Other Items	Vegetation Growth	M							
	Sod Cover	A							
	Settlement	M							
	Depressions/Rutting	A							
	Cracking	A							
	Riprap Revetments & Bank Protection	NA							
	Revetments other than Riprap	NA							
	Seepage	A							
	Legend	M	Includes Unacceptable observations not likely to prevent performance in next flood event						
	A Acceptable	U	Serious deficiency noted in past inspection report has not been corrected within the established timeframe

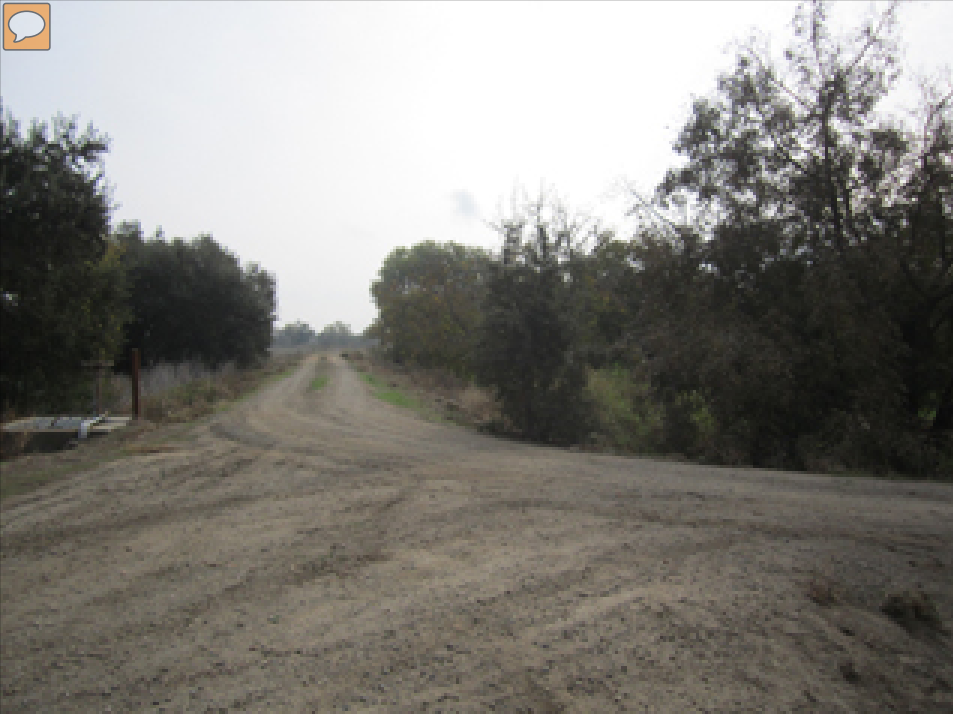
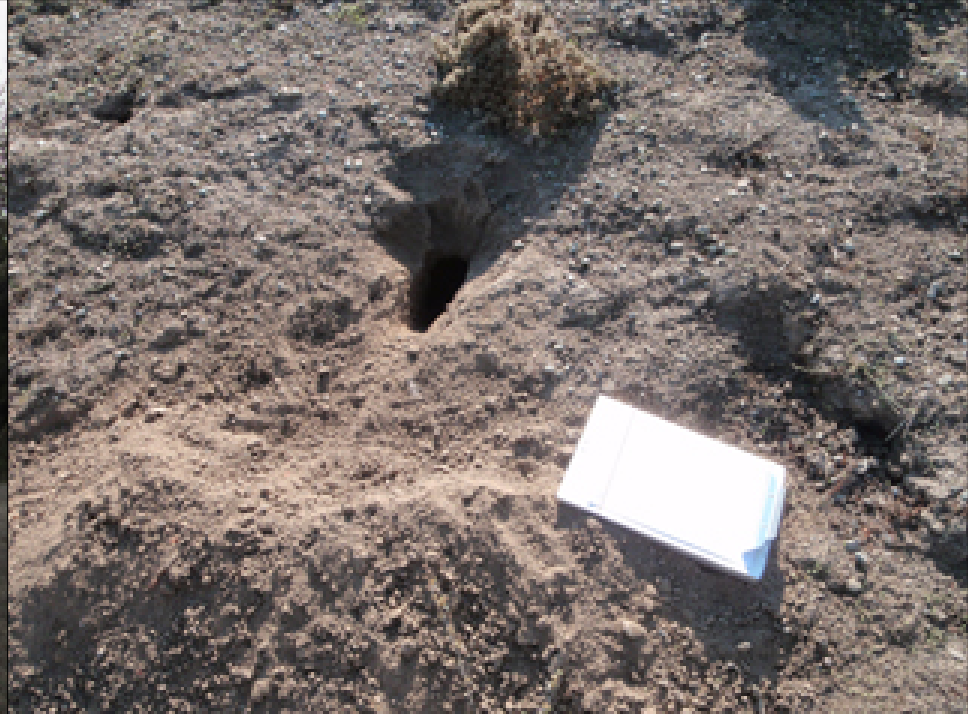
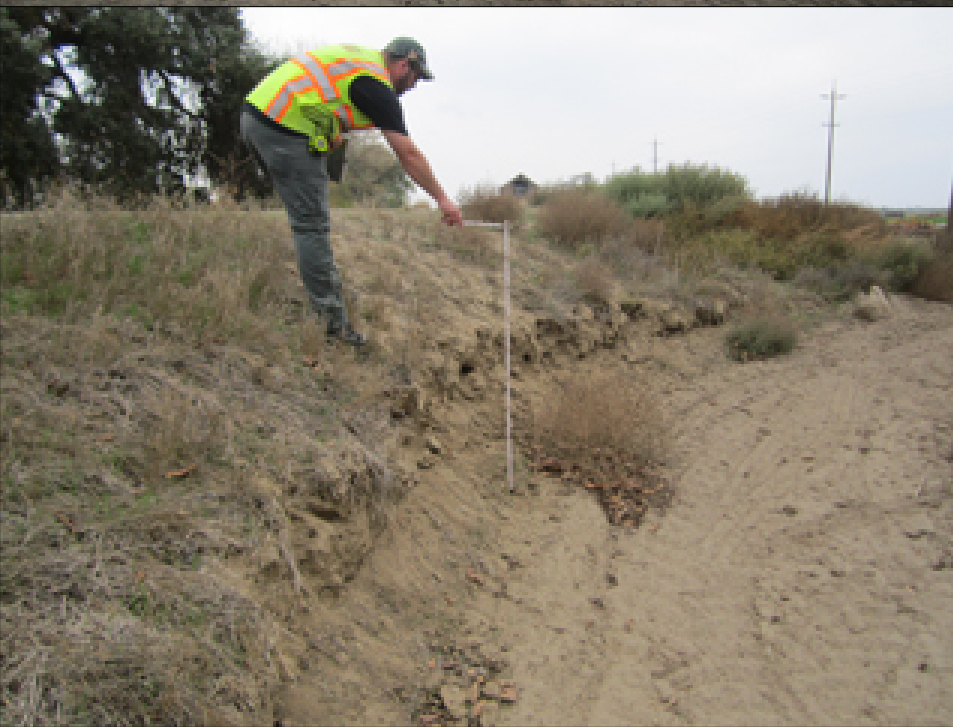
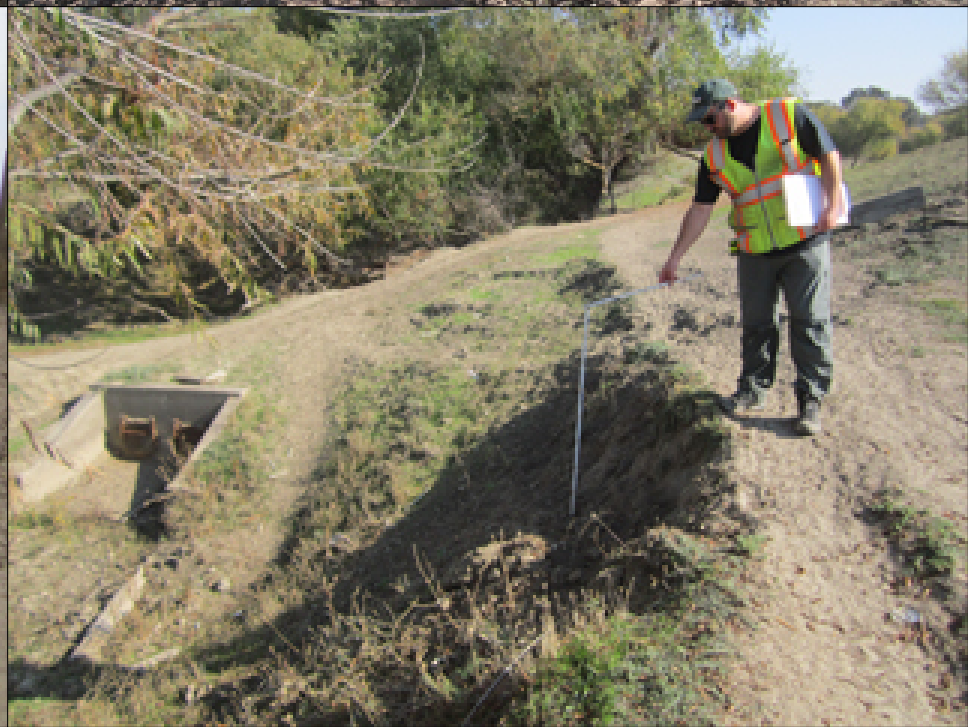
System: RD 1602 - Del Puerto System Rating: Unacceptable Approved SWIF/LOI: No PI 84-99 RP Eligibility: Inactive	RD 1602 - Del Puerto (DELP)						
General	Operations and Maintenance Manuals	A						
	Emergency Supplies and Equipment	M						
	Flood Preparedness and Training	M						
Levee - Items Affecting PL 84-99 RP Eligibility	Encroachments	U						
	Closure Structures	NA						
	Slope Stability	M						
	Erosion/Bank Caving	U						
	Animal Control	U						
	Culverts/Discharge Pipes	NA						
	Underseepage Relief Wells/Toe Drainage Systems	NA						
Levee Embankments - Other Items	Vegetation Growth	U						
	Sod Cover	M						
	Settlement	A						
	Depressions/Rutting	M						
	Cracking	A						
	Riprap Revetments & Bank Protection	NA						
	Revetments other than Riprap	NA						
	Seepage	A						
Legend A Acceptable M Minimally Acceptable U Unacceptable N/A Not Applicable RP Rehabilitation Program (Note: flood fight assistance available regardless of eligibility status)		M U U	Includes Unacceptable observations not likely to prevent performance in next flood event Serious deficiency noted in past inspection report has not been corrected within the established timeframe Likely prevents performance in next flood event

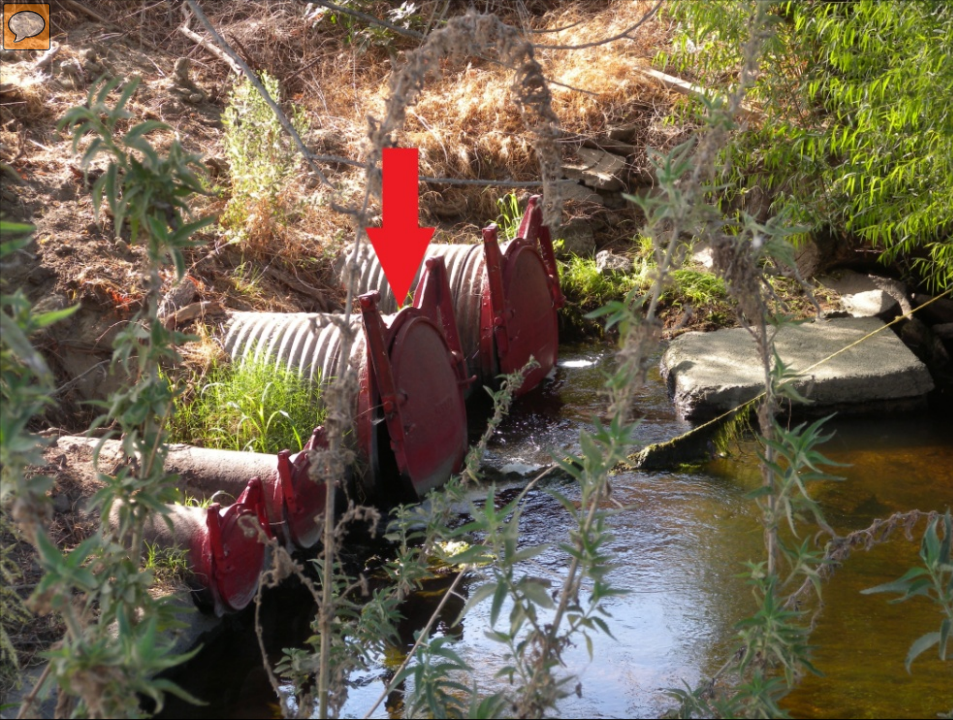
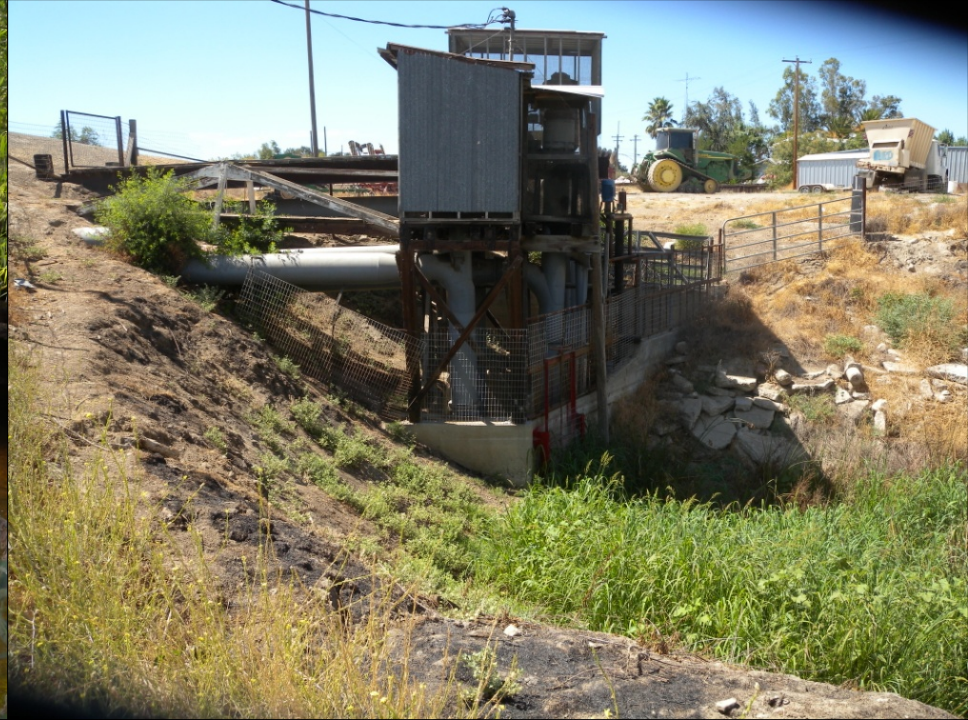
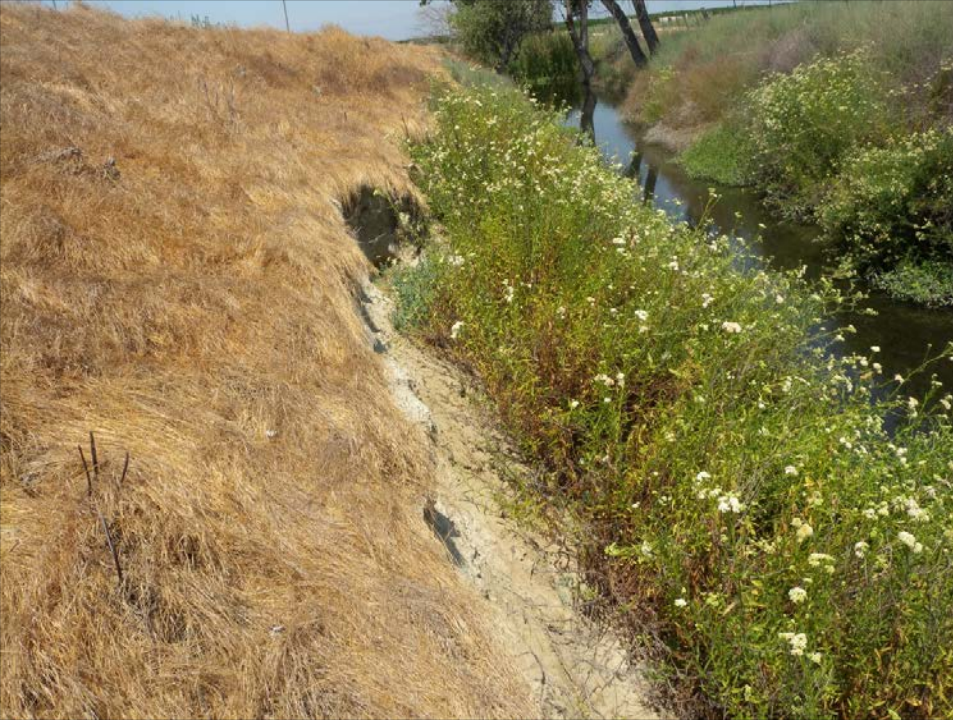
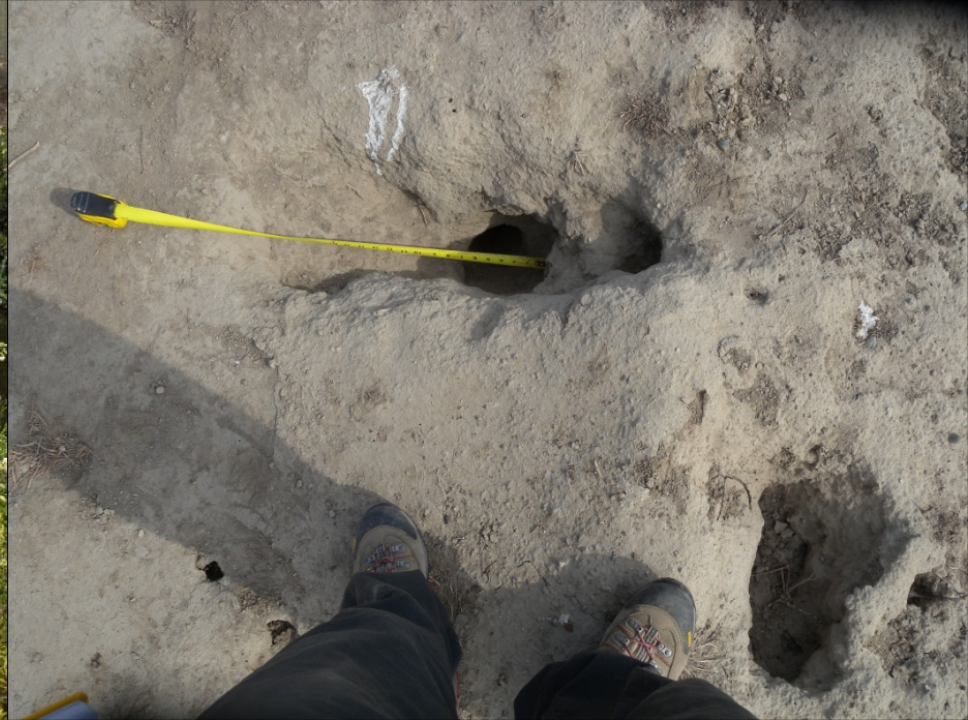
System: RD 2091 and RD 2063 - Chase and Crows Landing System Rating: Unacceptable Approved SWIF/LOI: No PL 84-99 RP Eligibility: Inactive	RD 2091 - Chase - Unit 1, San Joaquin River right bank (CHS1)	RD 2091 - Chase - Unit 2, spur levee (CHS2)	RD 2063 - Crows Landing (CROW)					
Interior Drainage	Vegetation and Obstructions			M					
	Encroachments			M					
	Ponding Areas			NA					
	Fencing and Gates			M					
	Concrete Surfaces (Such as gate wells, outfalls, intakes, Tilting, Sliding or Settlement of Concrete and Sheet Pile			A					
	Foundation of Concrete Structures (Such as culverts, Monolith Joints			A					
	Culverts/ Discharge Pipes			M					
	Sluice/ Slide Gates			M					
	Flap Gates/ Flap Valves/ Pinch Valves			U					
	Trash Racks (non-mechanical)			NA					
	Other Metallic Items			NA					
	Riprap Revetments of Inlet/ Discharge Areas			NA					
	Revetments other than Riprap			NA					
	Legend								
	A Acceptable	M	Includes Unacceptable observations not likely to prevent performance in next flood event

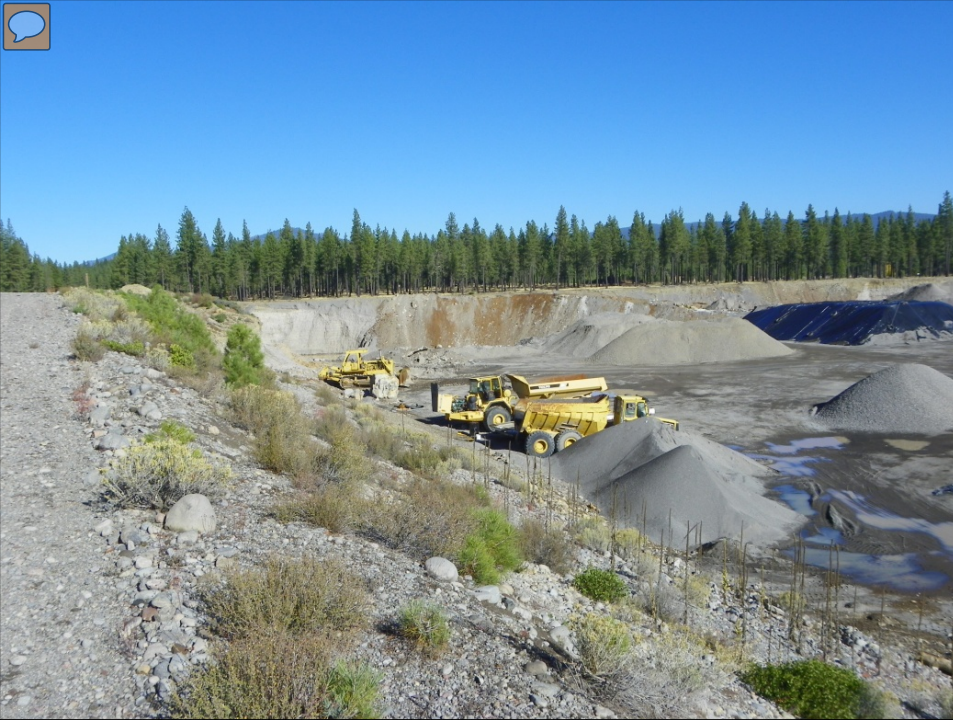
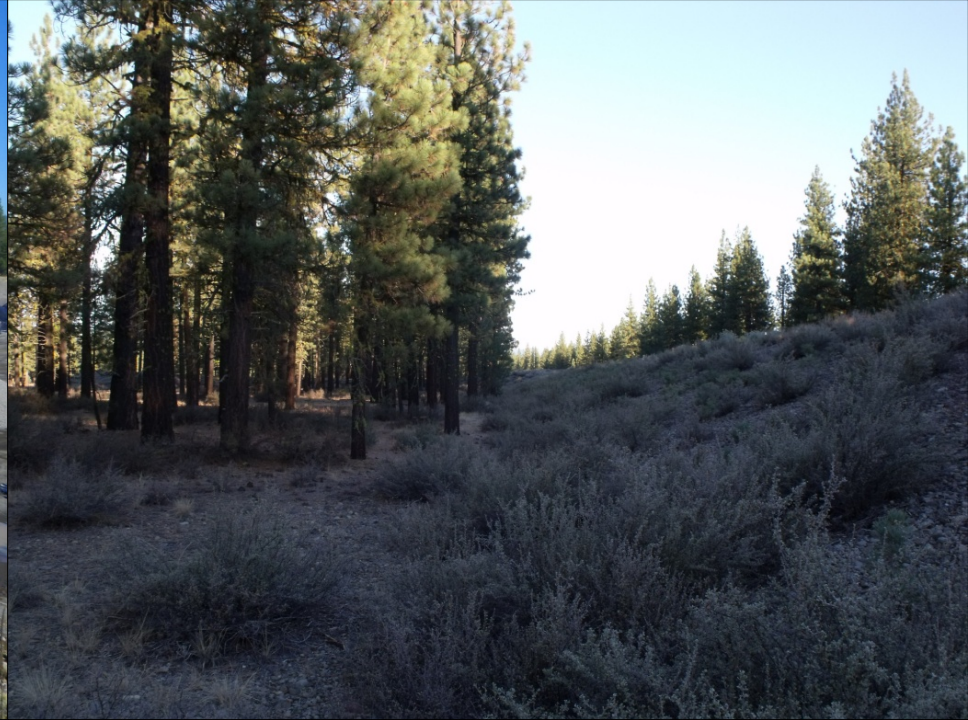
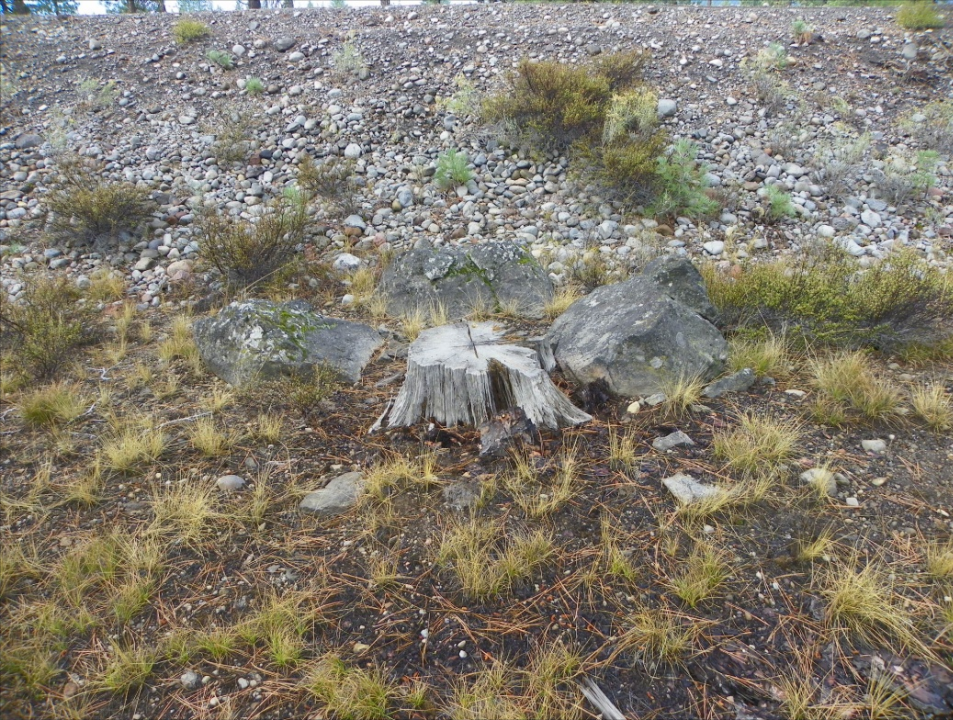
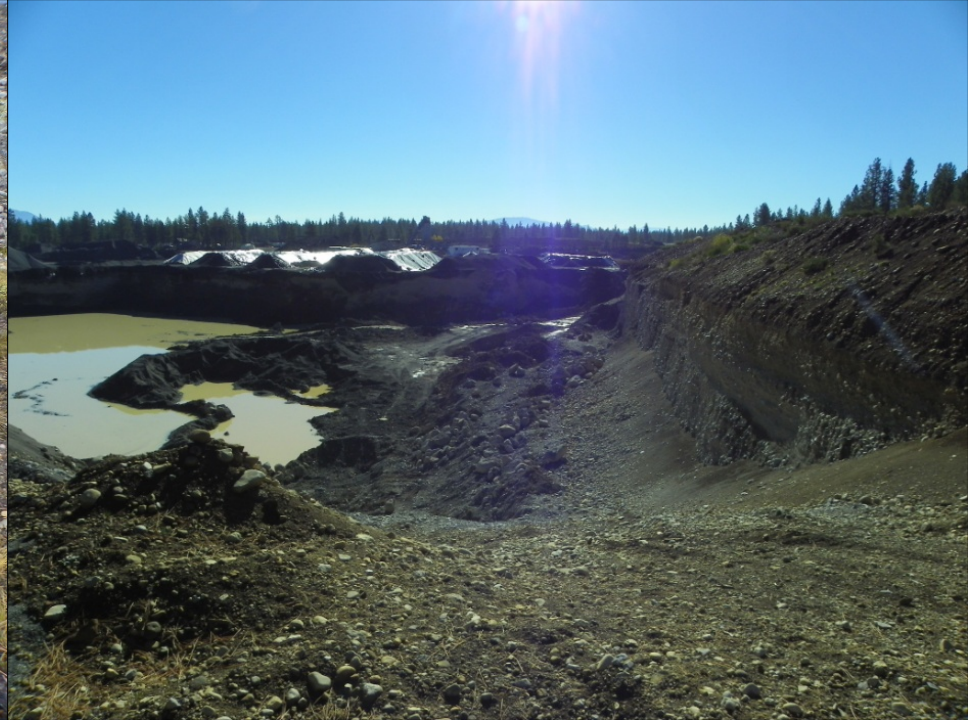
System: North Fork Feather River at Chester - east levee System Rating: Unacceptable Approved SWIF/LOI: No PL 84-99 RP Eligibility: Inactive	North Fork Feather River at Chester - east levee (FRC2)							
General	Operations and Maintenance Manuals	A							
	Emergency Supplies and Equipment	A							
	Flood Preparedness and Training	M							
Levee - Items Affecting PL 84-99 RP Eligibility	Encroachments	U							
	Closure Structures	NA							
	Slope Stability	U							
	Erosion/Bank Caving	A							
	Animal Control	A							
	Culverts/Discharge Pipes	NA							
	Underseepage Relief Wells/Toe Drainage Systems	NA							
Levee Embankments - Other Items	Vegetation Growth	U							
	Sod Cover	M							
	Settlement	A							
	Depressions/Rutting	M							
	Cracking	A							
	Riprap Revetments & Bank Protection	A							
	Revetments other than Riprap	NA							
	Seepage	M							
Flood Damage Reduction Channels	Vegetation and Obstructions	A

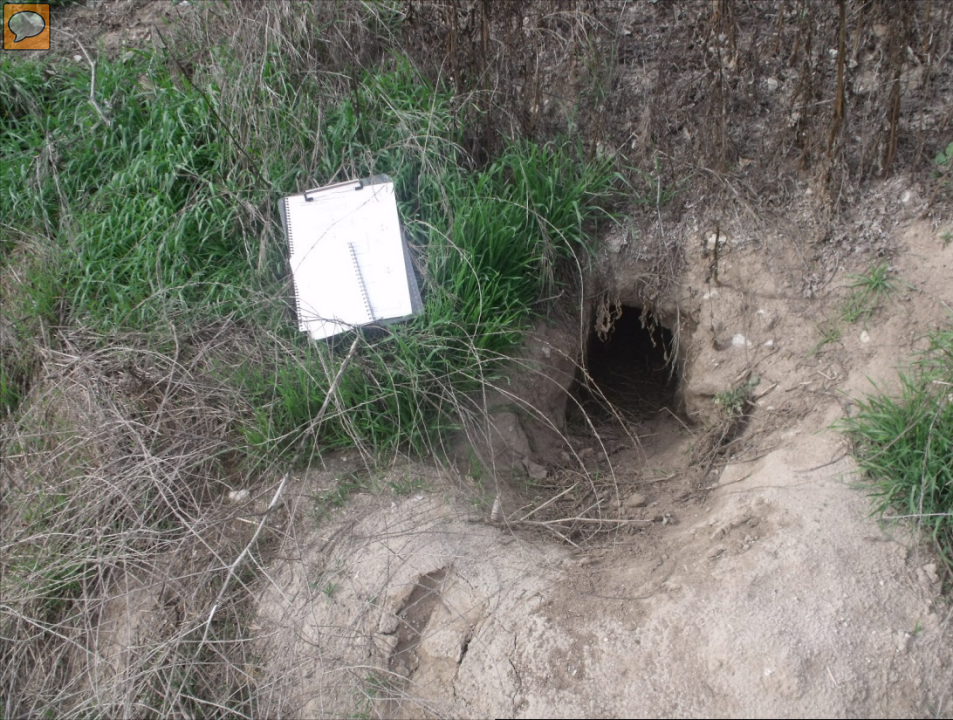
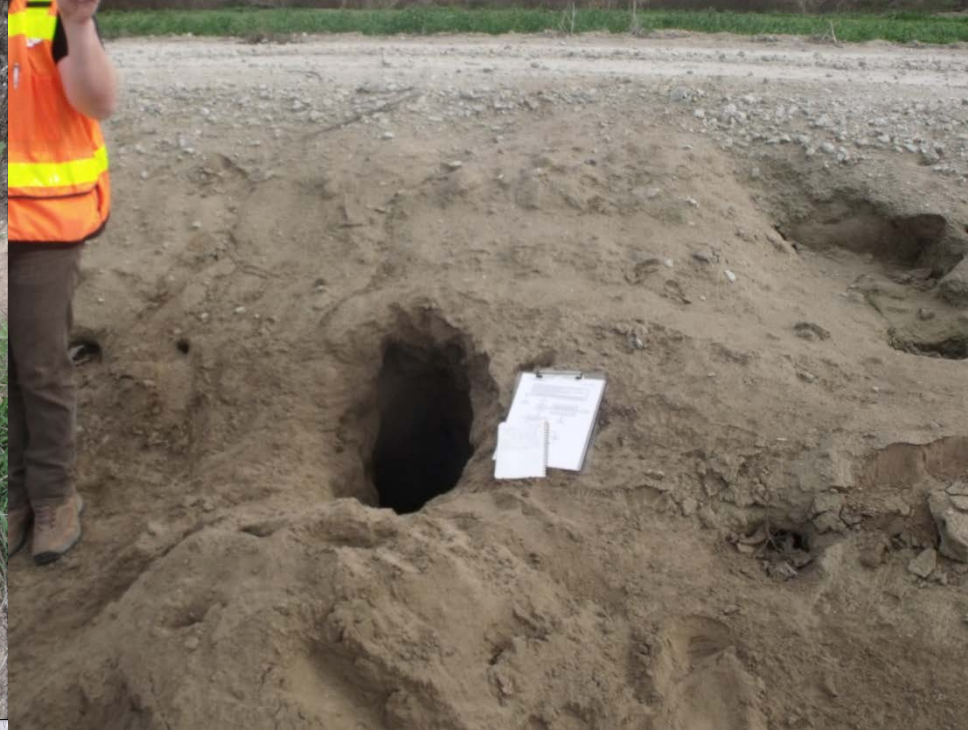
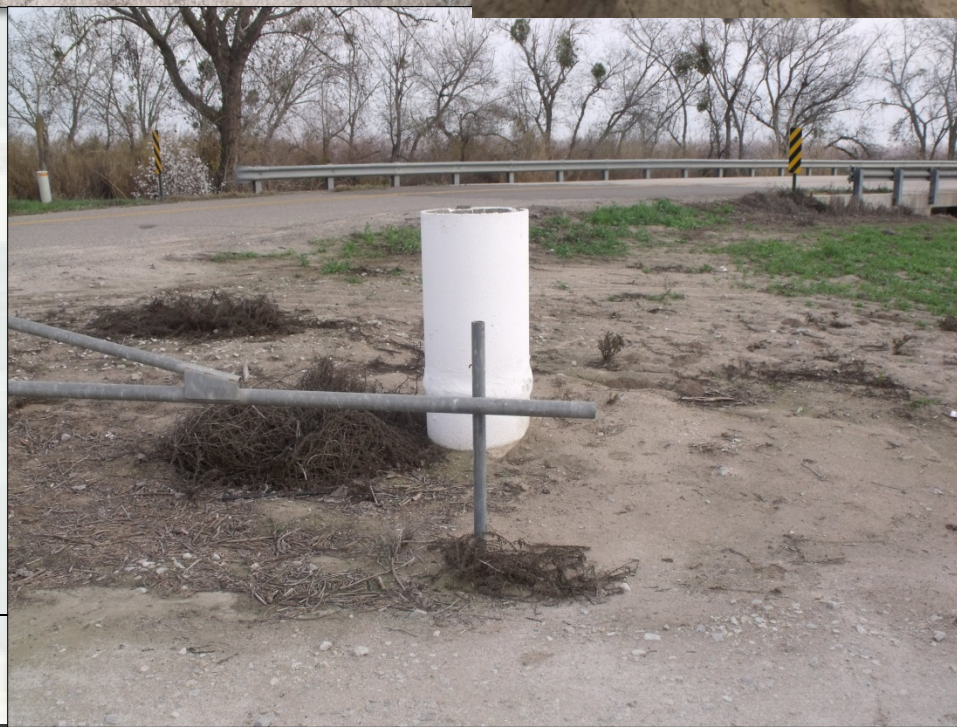
System: Ash Slough right bank System Rating: Unacceptable Approved SWIF/LOI: No PL 84-99 RP Eligibility: Inactive	Chowchilla River - Ash Slough right bank (CHW1)							
General	Operations and Maintenance Manuals	A							
	Emergency Supplies and Equipment	M							
	Flood Preparedness and Training	M							
Levee - Items Affecting PL 84-99 RP Eligibility	Encroachments	U							
	Closure Structures	NA							
	Slope Stability	M							
	Erosion/Bank Caving	U							
	Animal Control	U							
	Culverts/Discharge Pipes	NA							
	Underseepage Relief Wells/Toe Drainage Systems	NA							
Levee Embankment - Other Items	Vegetation Growth	U							
	Sod Cover	M							
	Settlement	M							
	Depressions/Rutting	U							
	Cracking	A							
	Riprap Revetments & Bank Protection	M							
	Revetments other than Riprap	NA							
	Seepage	A							
Legend A Acceptable M Minimally Acceptable U Unacceptable N/A Not Applicable		M U U	Not likely to prevent performance in next flood event / Active Serious deficiency noted in past inspection report has not been corrected within the established timeframe / Inactive Likely prevents performance in next flood event / Inactive

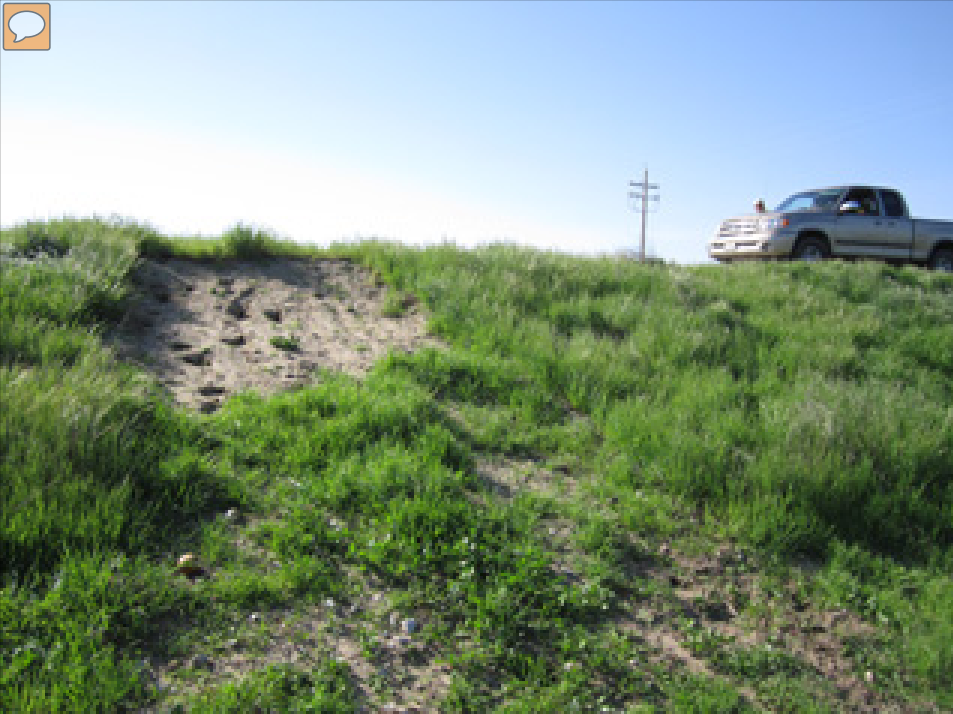
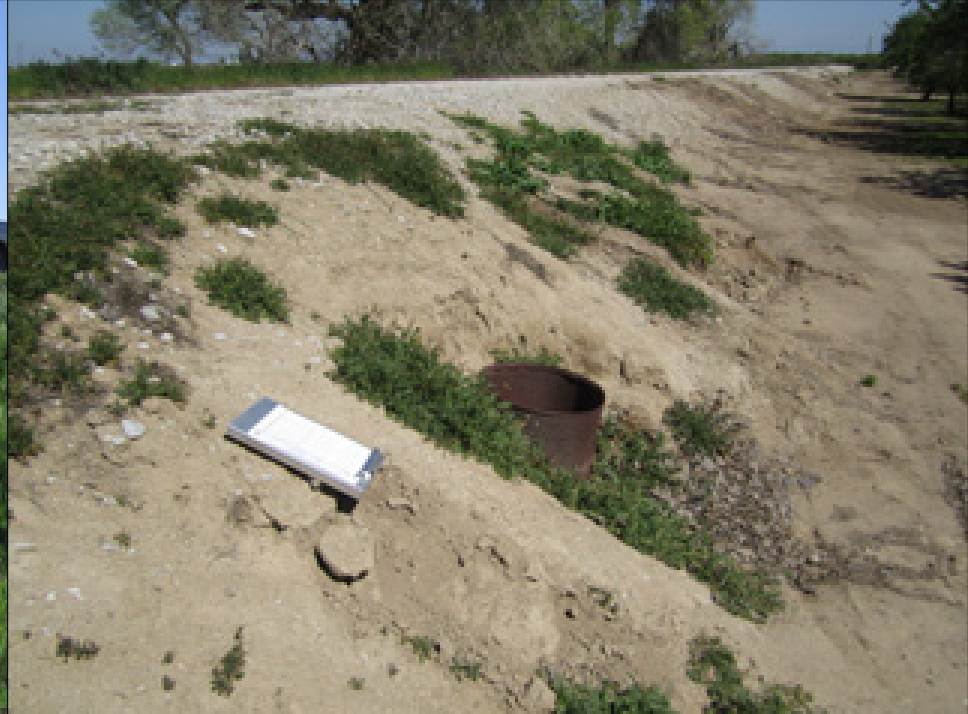
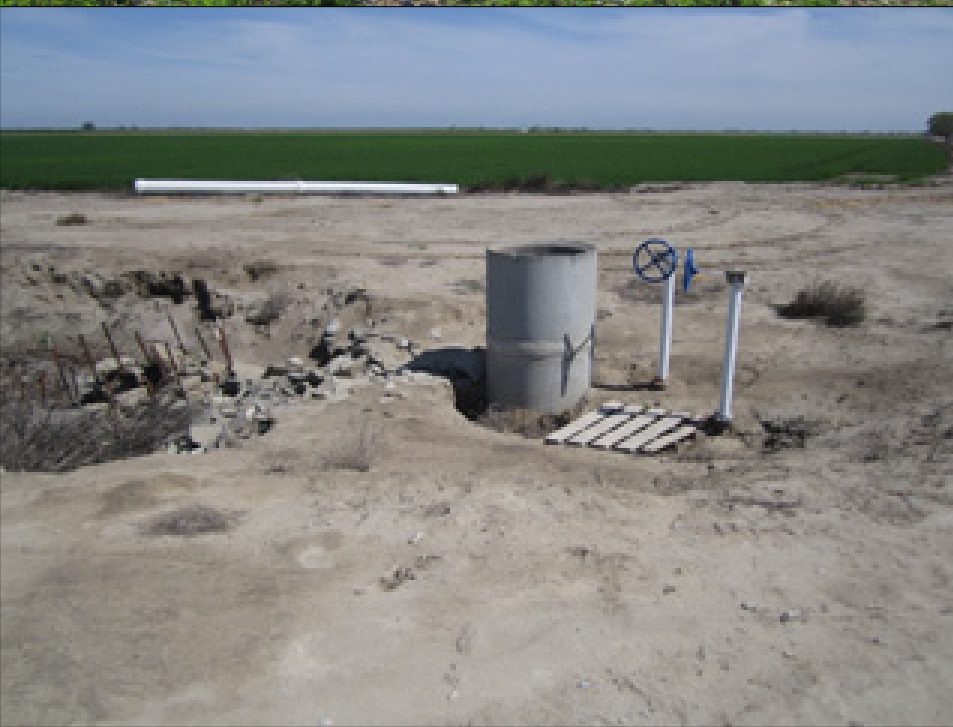
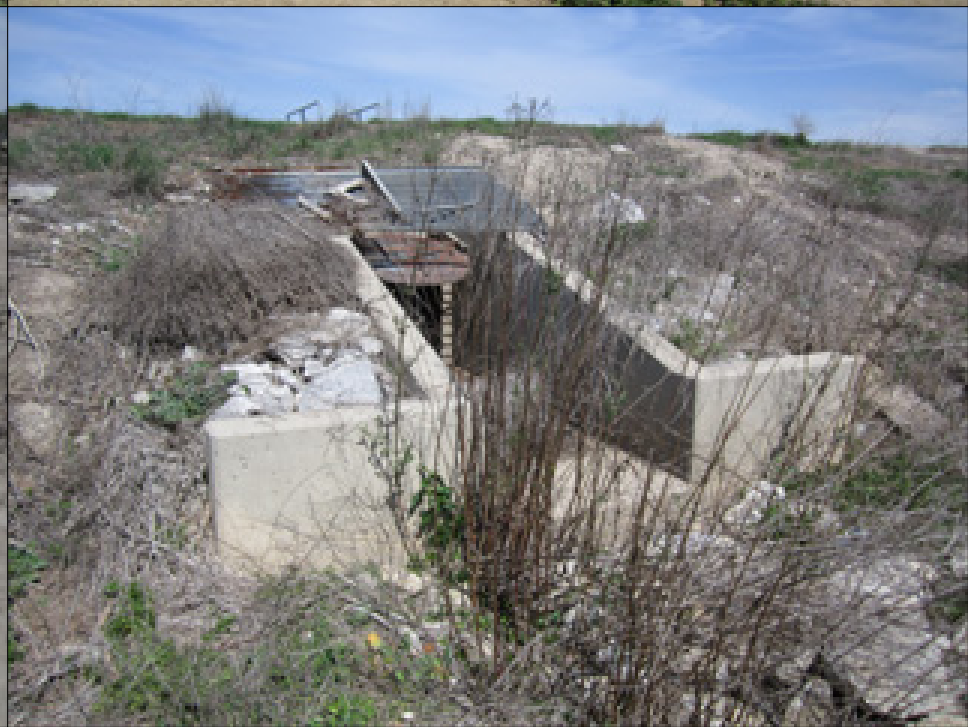
System: Ash Slough left bank - Berenda Slough right bank System Rating: Unacceptable Approved SWIF/LOI: No PL 84-99 RP Eligibility: Inactive		<div>Chowchilla River - Ash Slough left bank (CHW2)</div> <div>Chowchilla River - Berenda Slough right bank (CHW3)</div> <div></div> <div></div> <div></div> <div></div> <div></div> <div></div>							
General	Operations and Maintenance Manuals	M	M						
	Emergency Supplies and Equipment	M	M						
	Flood Preparedness and Training	M	M						
Levee - Items Affecting PL 84-99 RP Eligibility	Encroachments	U	U						
	Closure Structures	NA	NA						
	Slope Stability	A	A						
	Erosion/Bank Caving	U	U						
	Animal Control	U	U						
	Culverts/Discharge Pipes	NA	NA						
	Underseepage Relief Wells/Toe Drainage Systems	NA	NA						
Levee Embankments - Other Items	Vegetation Growth	U	U						
	Sod Cover	U	U						
	Settlement	U	U						
	Depressions/Rutting	U	U						
	Cracking	A	A
