USACE Inspection Results

Flood Protection and Navigation Section

Sacramento District

August 28, 2015

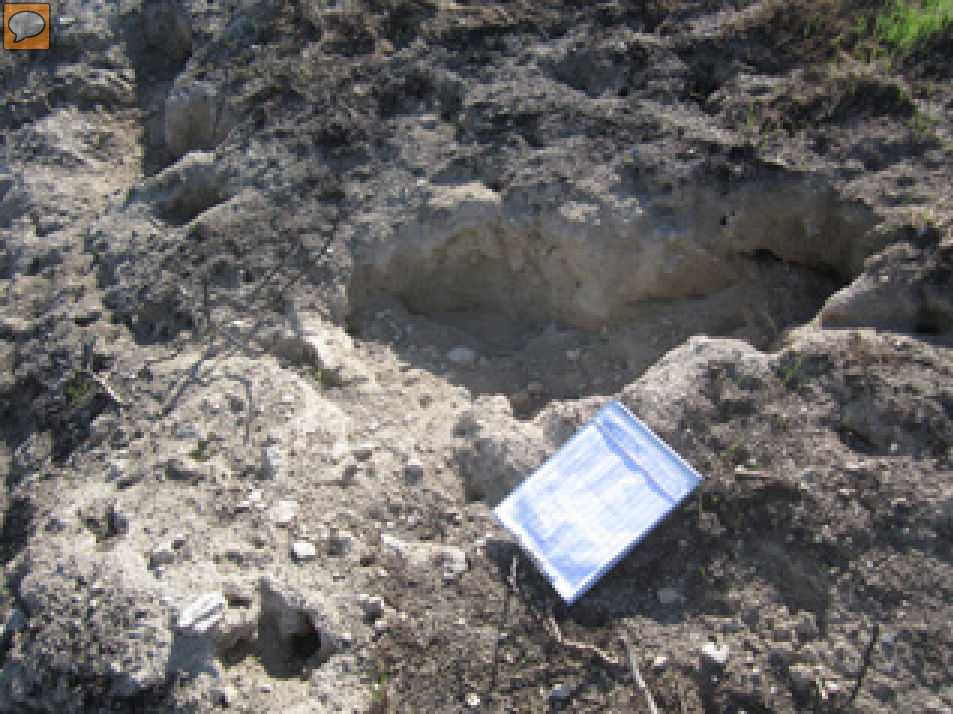
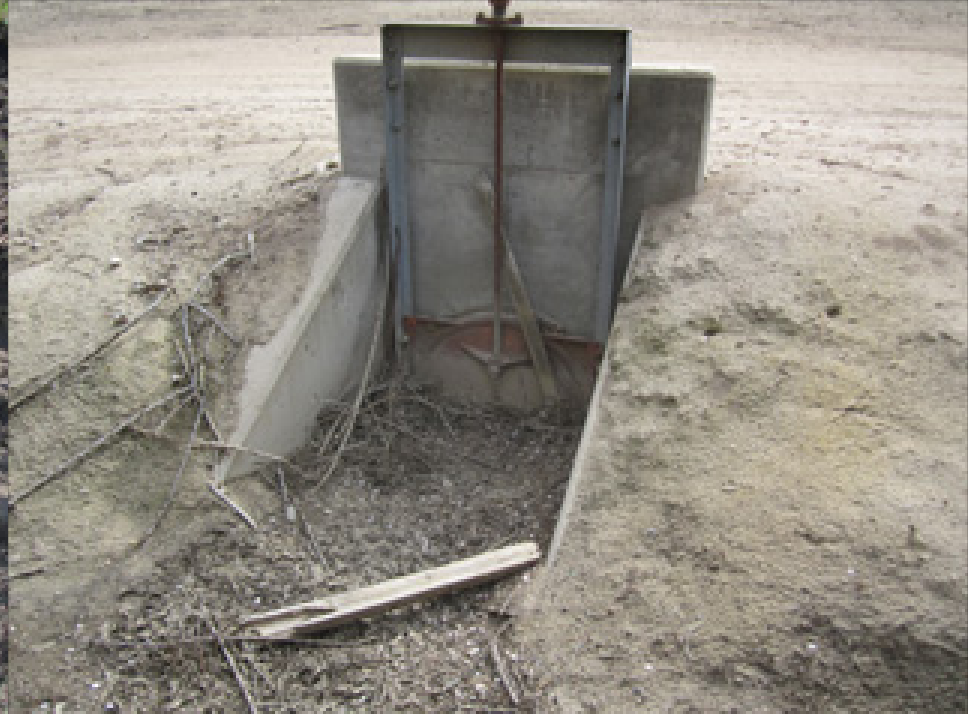
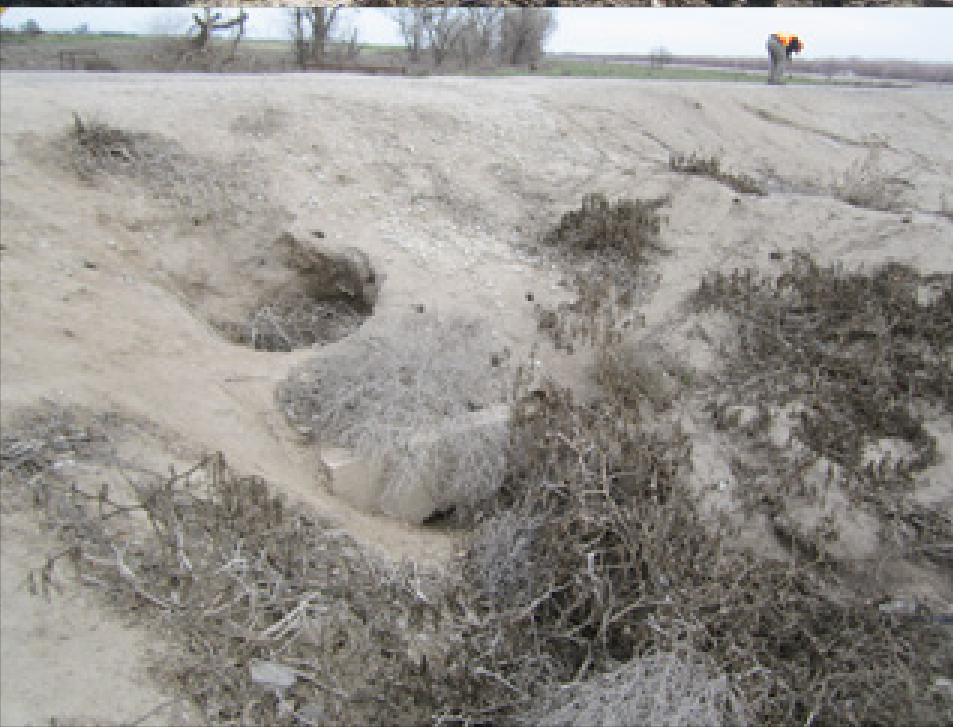
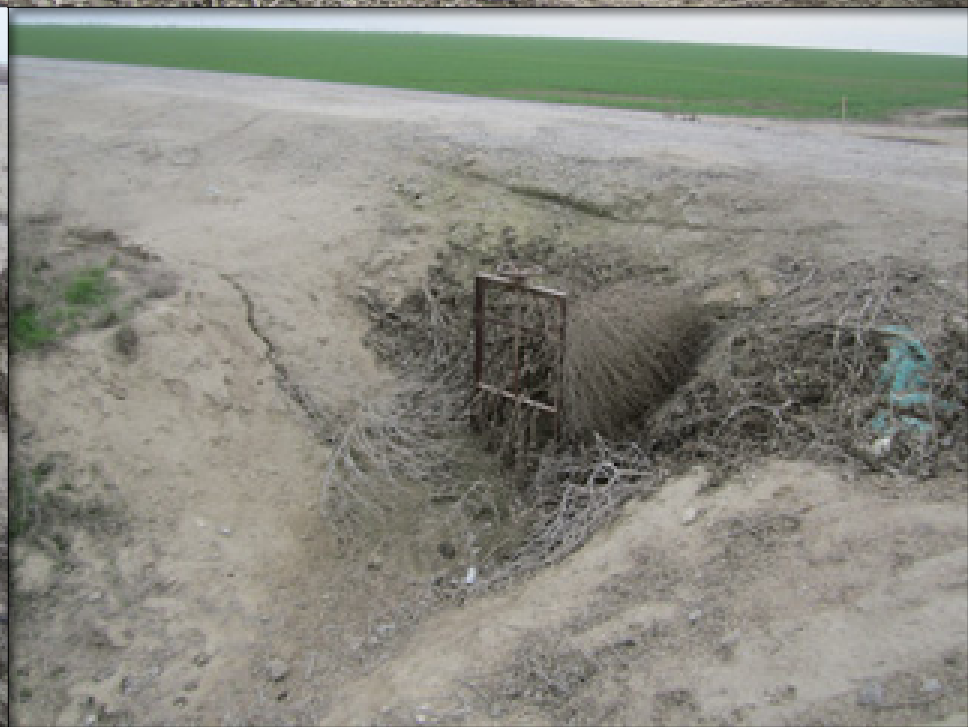
System: Berenda Slough left bank - Fresno River right bank System Rating: Unacceptable Approved SWIF/LOI: No PL 84-99 RP Eligibility: Inactive	<div>Chowchilla River - Berenda Slough left bank (CHW4)</div> <div>Fresno River - right bank (FRN1)</div>							
General	Operations and Maintenance Manuals	M	M						
	Emergency Supplies and Equipment	M	M						
	Flood Preparedness and Training	M	M						
Levee - Items Affecting PL 84-99 RP Eligibility	Encroachments	U	U						
	Closure Structures	NA	NA						
	Slope Stability	M	M						
	Erosion/Bank Caving	U	U						
	Animal Control	U	U						
	Culverts/Discharge Pipes	NA	NA						
	Underseepage Relief Wells/Toe Drainage Systems	NA	NA						
Levee Embankment - Other Items	Vegetation Growth	U	U						
	Sod Cover	M	M						
	Settlement	M	M						
	Depressions/Rutting	U	M						
	Cracking	A	A						
	Riprap Revetments & Bank Protection	NA	M						
	Revetments other than Riprap	NA	M

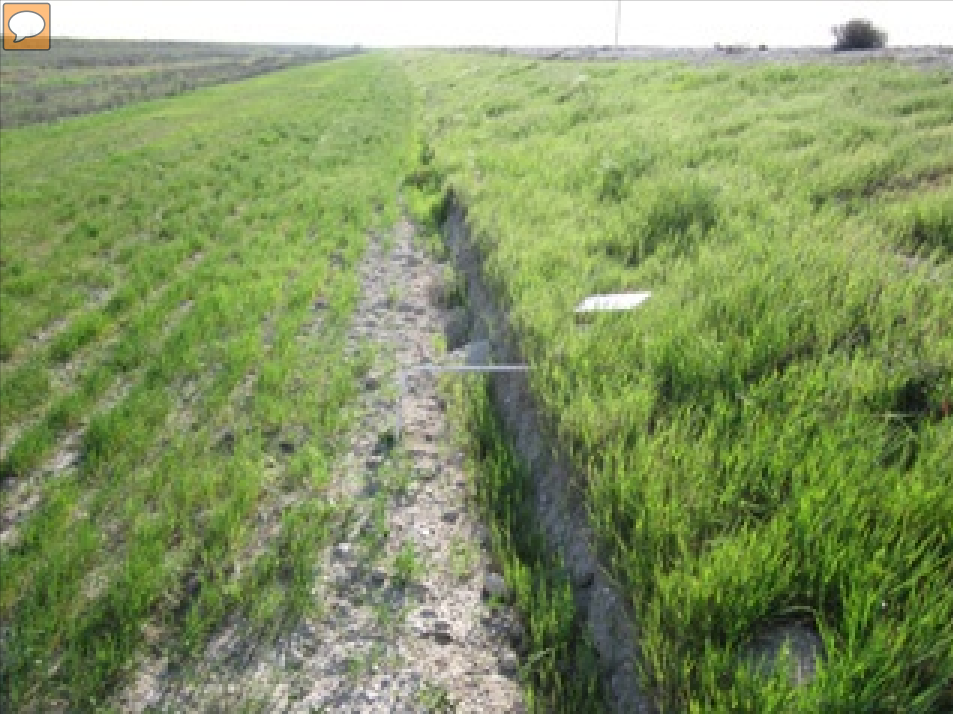
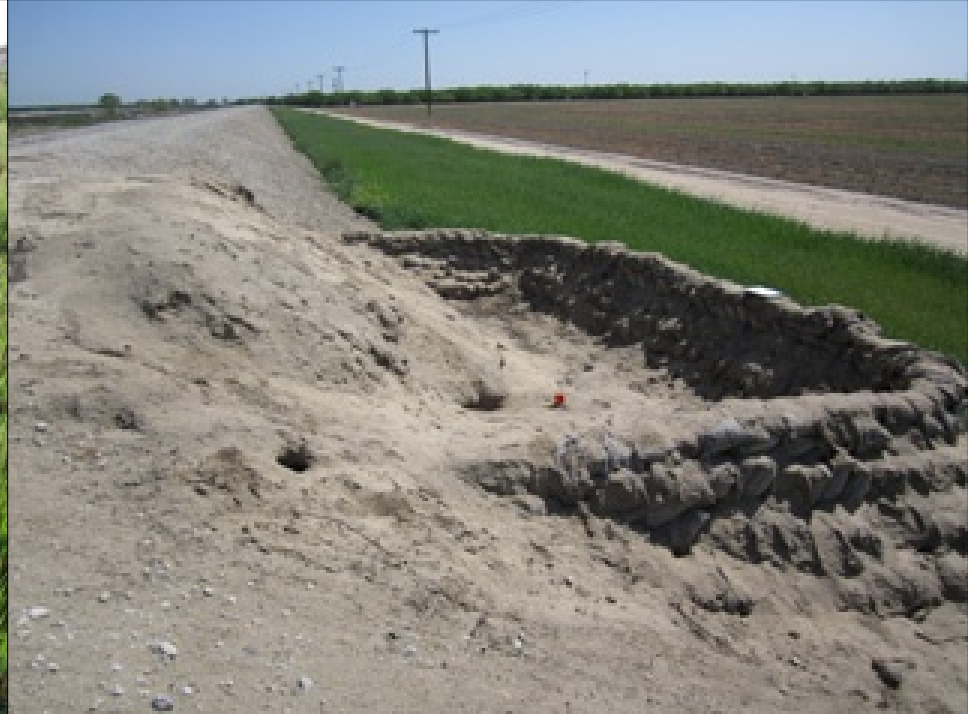
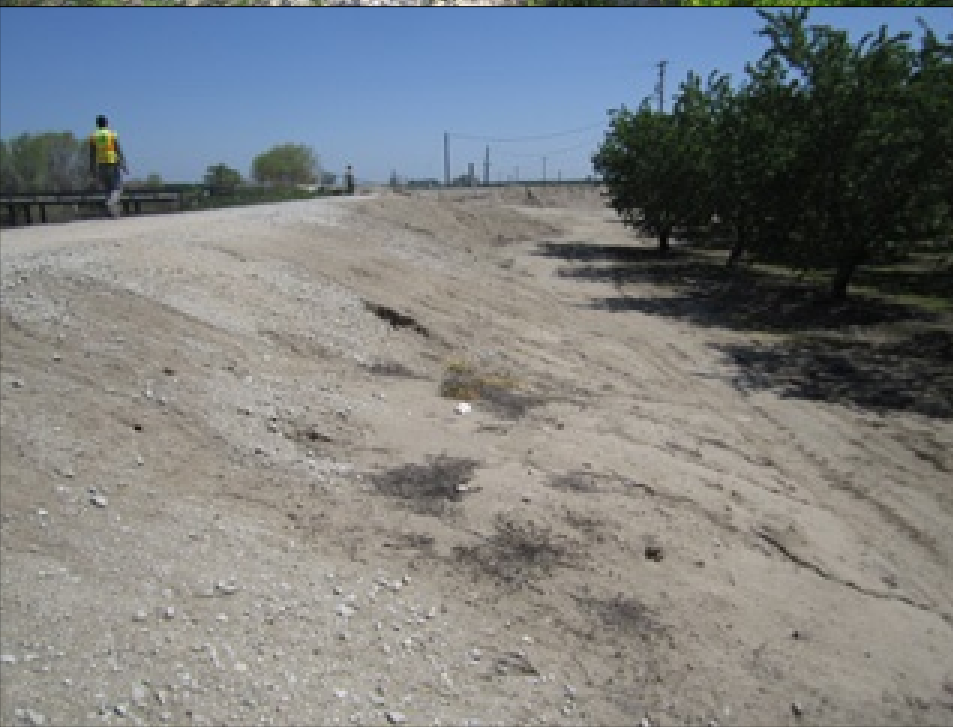
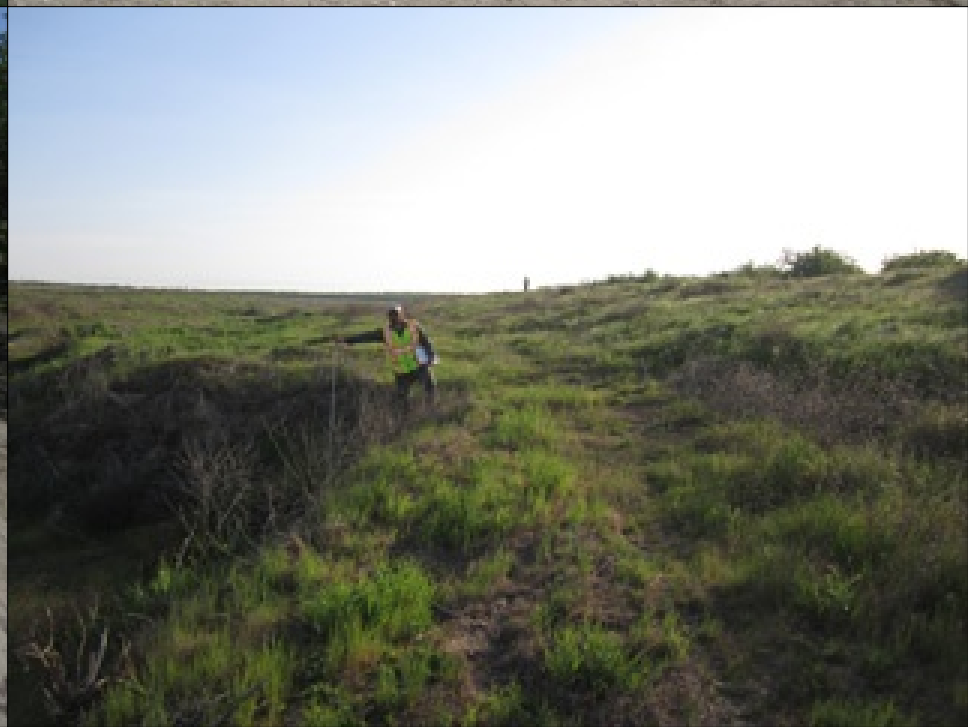
<p>System: Fresno River left bank</p> <p>System Rating: Unacceptable</p> <p>Approved SWIF/LOI: No</p> <p>PL 84-99 RP Eligibility: Inactive</p>	Fresno River left bank (FRN2)							
General	Operations and Maintenance Manuals	M							
	Emergency Supplies and Equipment	M							
	Flood Preparedness and Training	M							
Levee - Items Affecting PL 84-99 RP Eligibility	Encroachments	U							
	Closure Structures	NA							
	Slope Stability	U							
	Erosion/Bank Caving	U							
	Animal Control	U							
	Culverts/Discharge Pipes	NA							
	Underseepage Relief Wells/Toe Drainage Systems	NA							
Levee Embankments - Other Items	Vegetation Growth	U							
	Sod Cover	U							
	Settlement	M							
	Depressions/Rutting	U							
	Cracking	A							
	Riprap Revetments & Bank Protection	M							
	Revetments other than Riprap	NA							
	Seepage	U							
	<p><u>Legend</u></p> <p>A Acceptable</p> <p>M Minimally Acceptable</p> <p>U Unacceptable</p> <p>N/A Not Applicable</p>	<p>U Not likely to prevent performance in next flood event / Active</p> <p>U Serious deficiency noted in past inspection report has not been corrected within the established timeframe / Inactive</p> <p>U Likely prevents performance in next flood event / Inactive</p>
