**Meeting of the Central Valley Flood Protection Board**

**Staff Report – Encroachment Permit**

**Reclamation District 2093/Trust for Public Land**

**Authorize the degrading of non-project private levees within the Yolo Bypass,  
Yolo County**

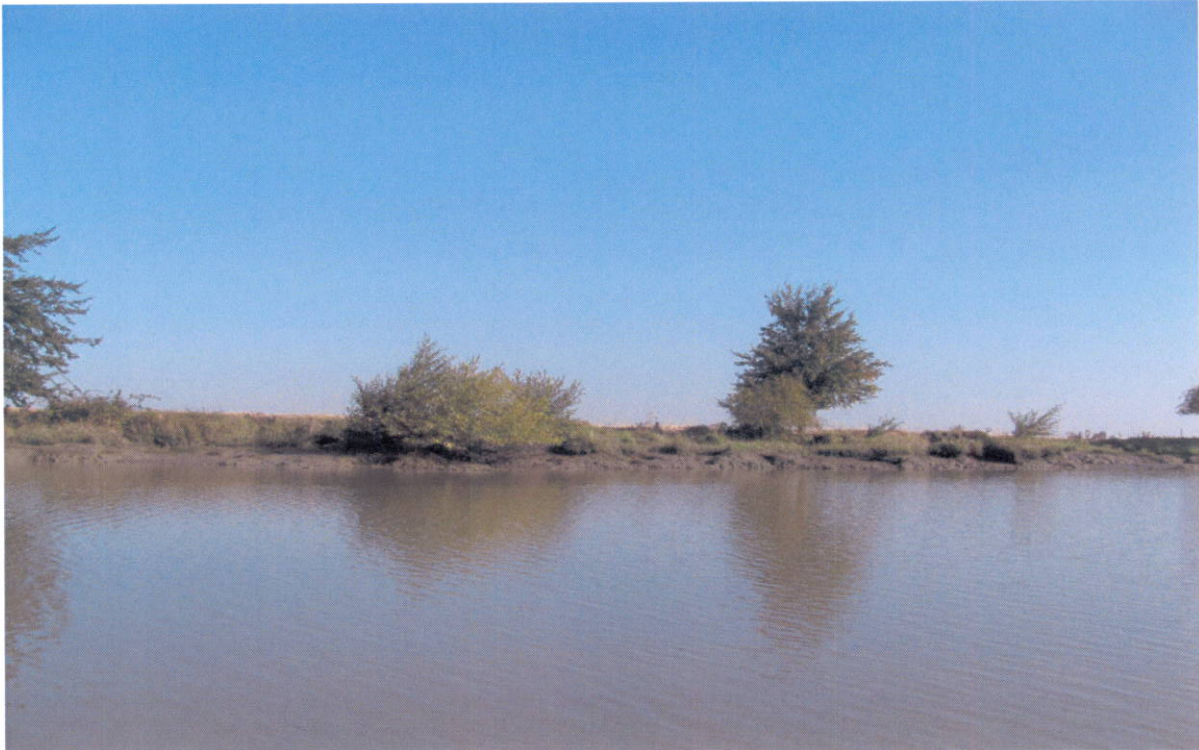
Representative area where tidal bench will be created north of slough

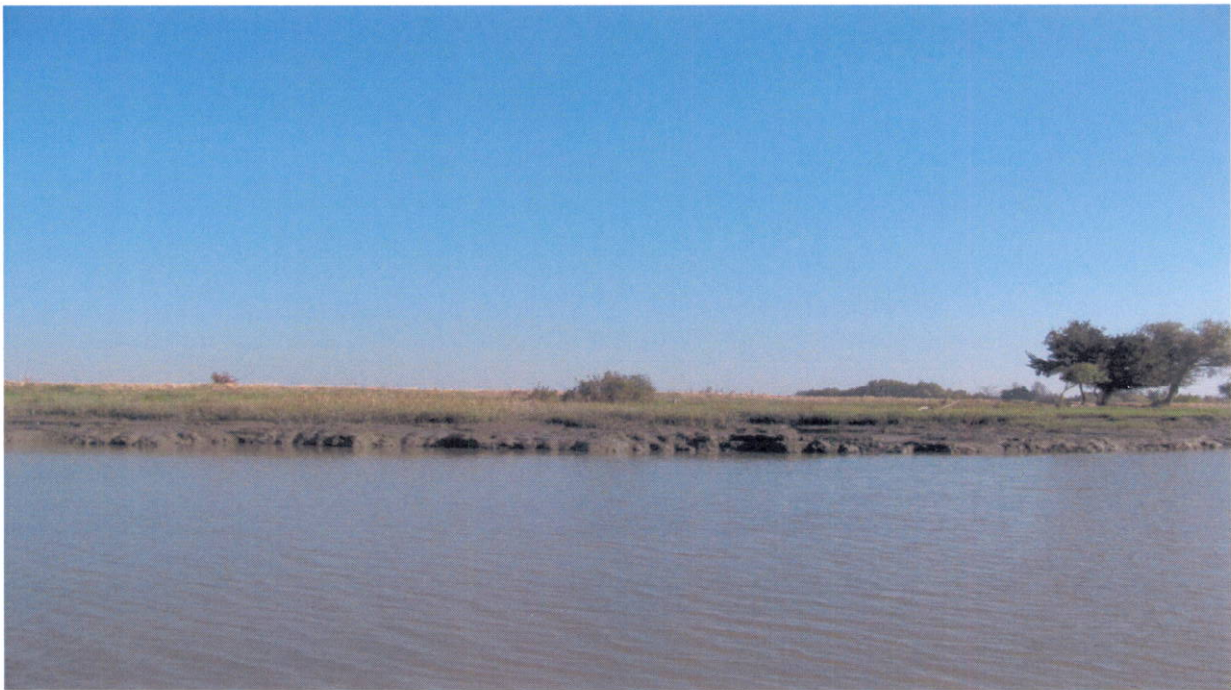
Representative area where tidal bench will be created north of slough

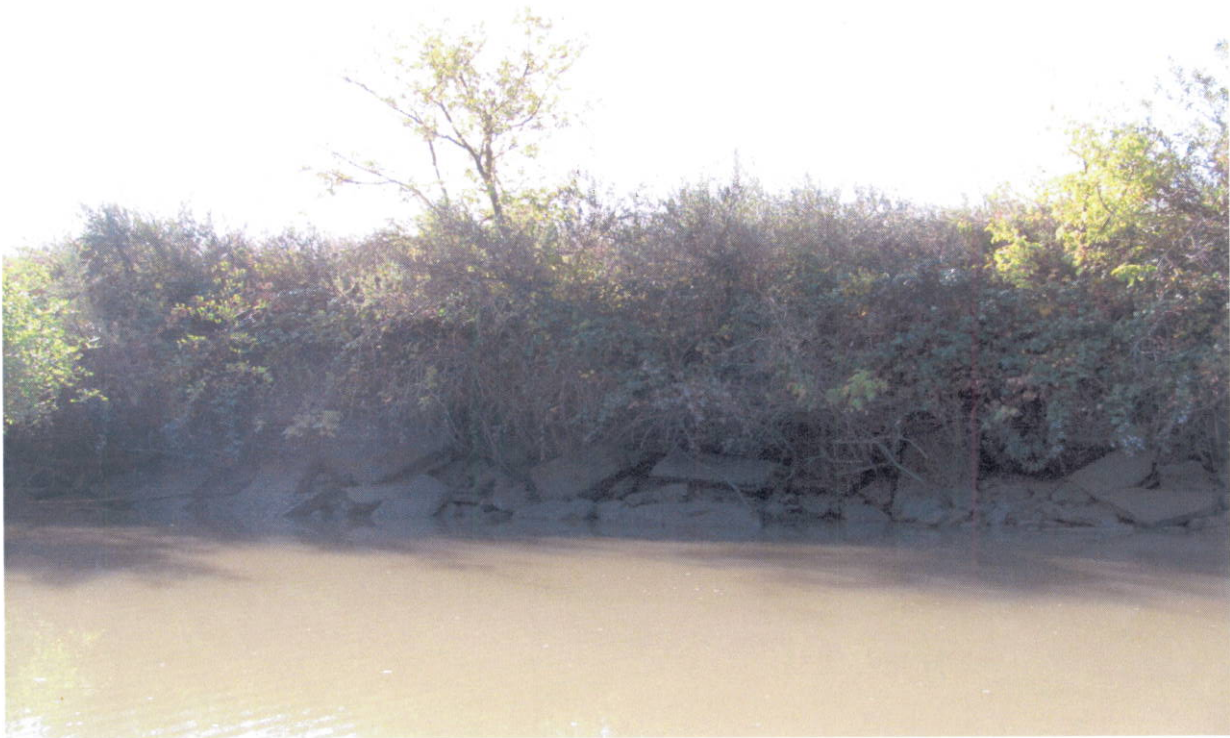
Representative photo of levee and rock to be removed/degraded

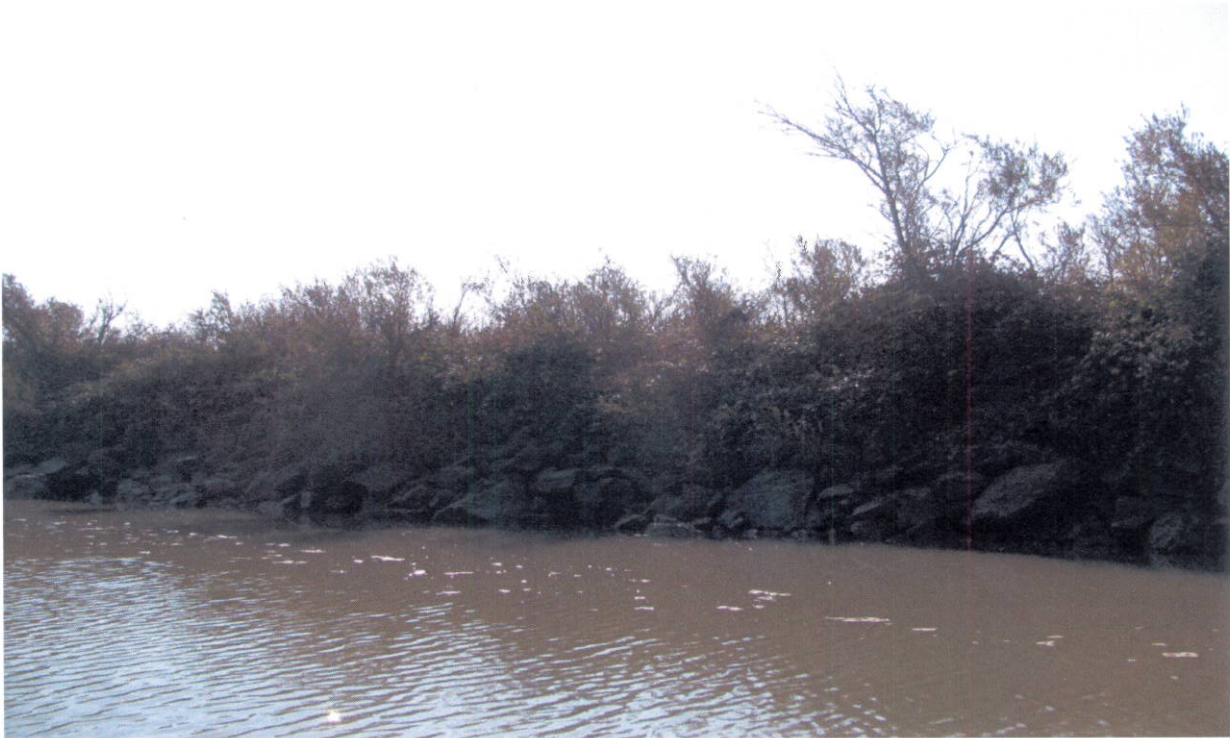
Representative photo of levee and rock to be removed/degraded

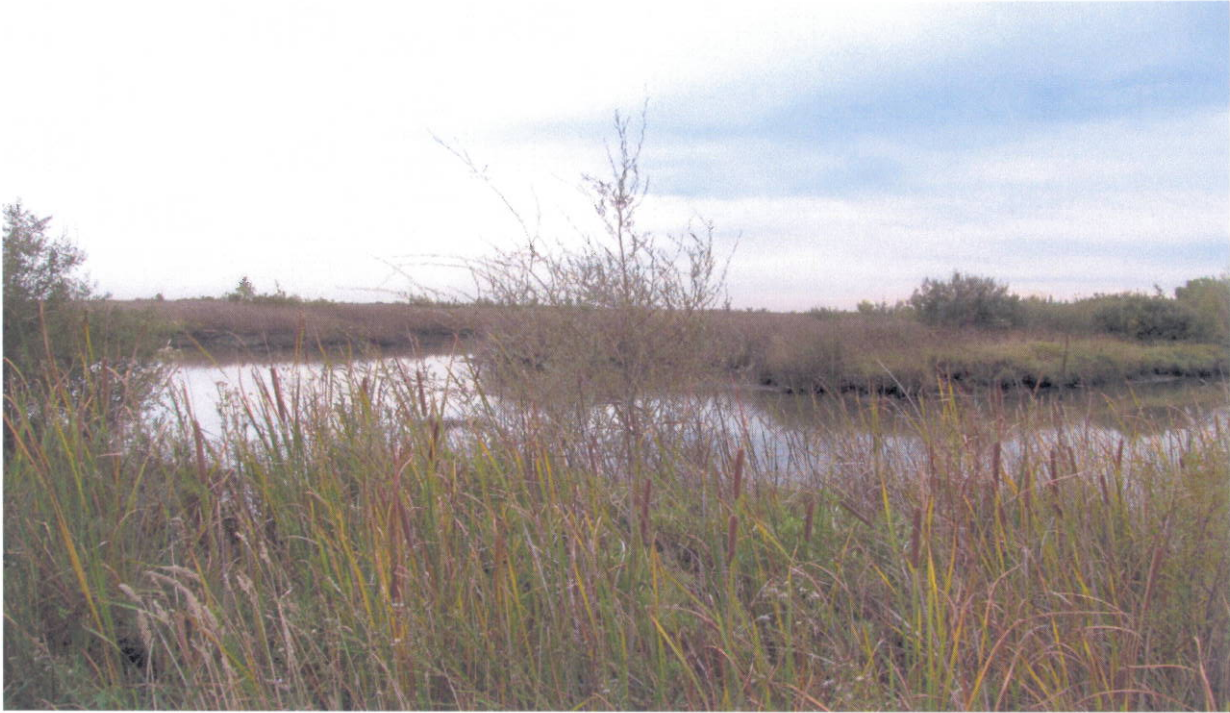
Representative photo of existing flooded habitat on the interior of the island

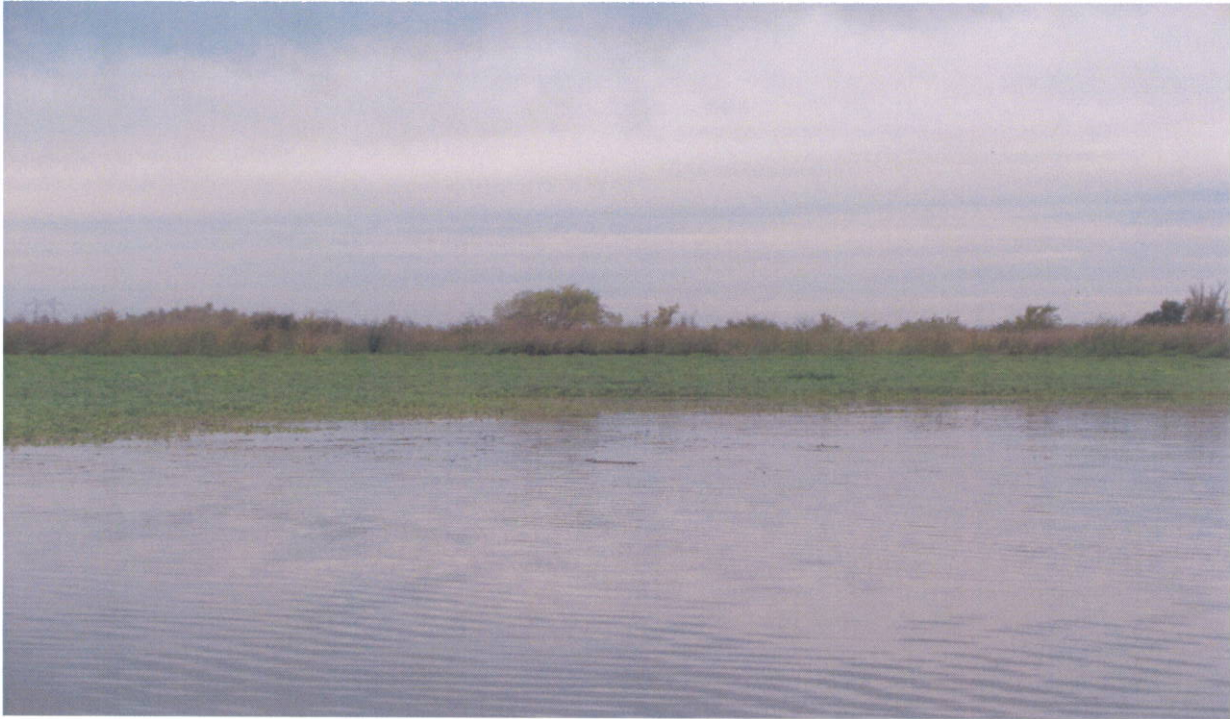
Representative photo of existing flooded habitat on the interior of the island

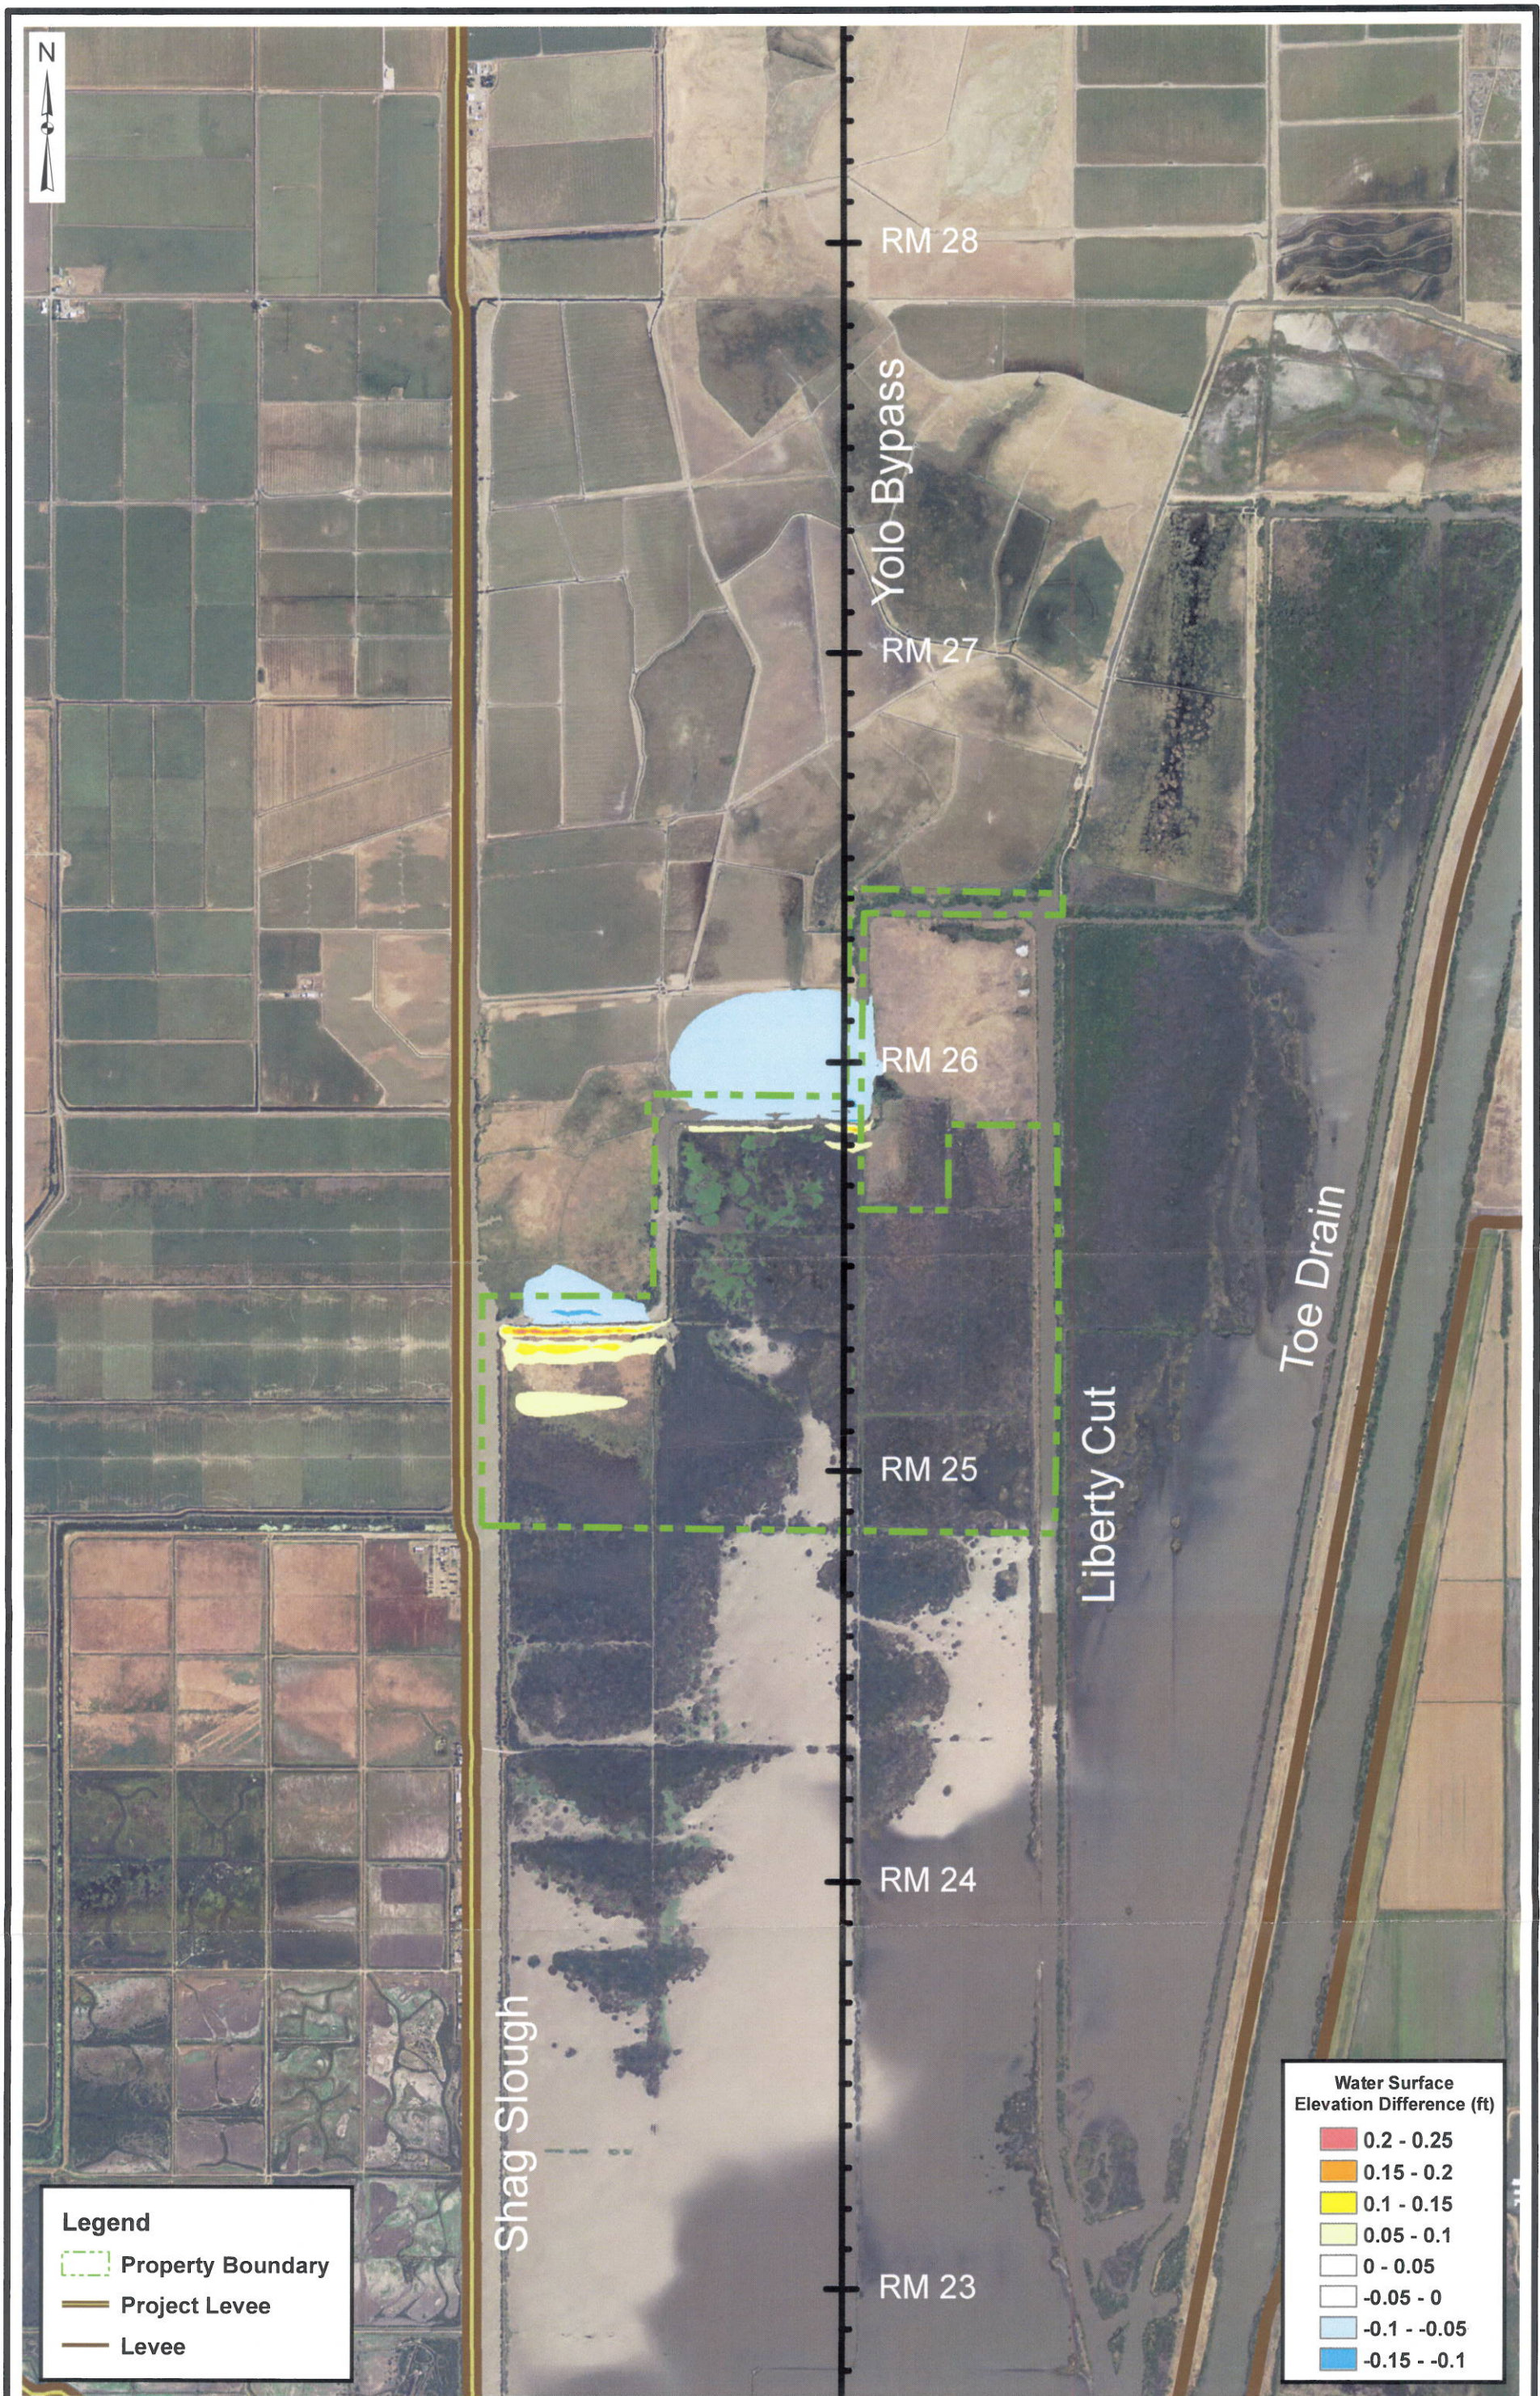
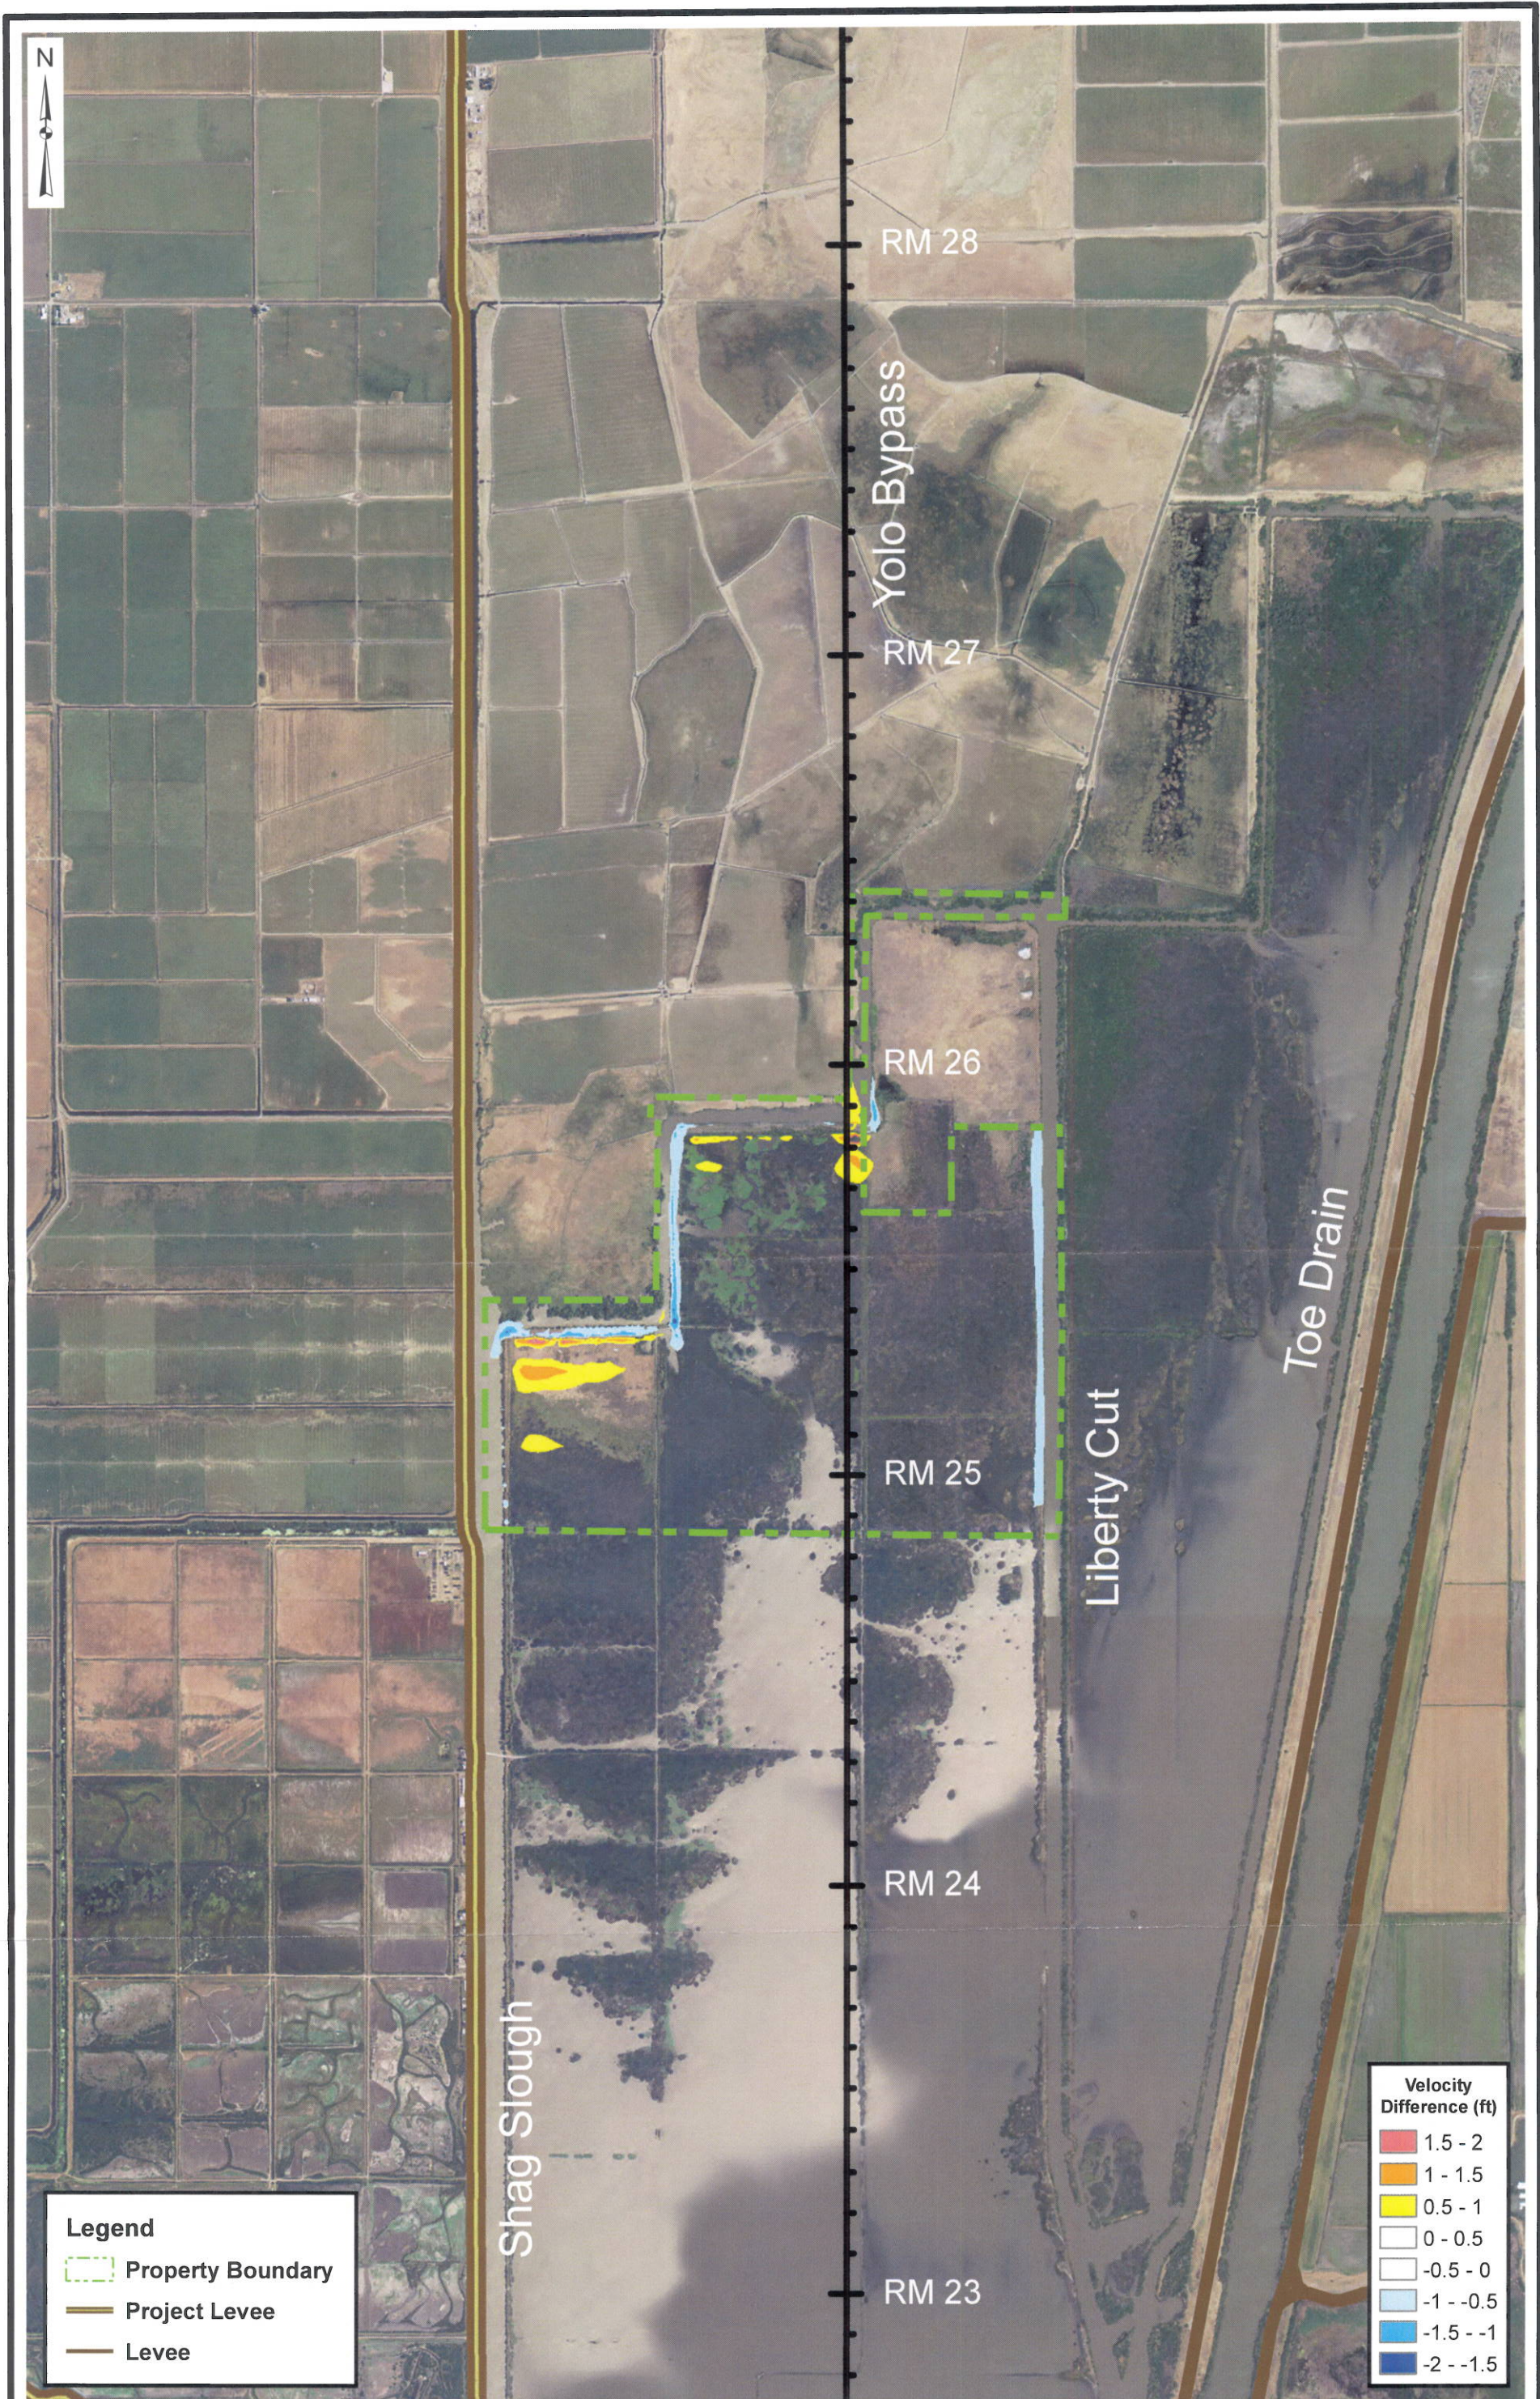
Figures 3 and 4 show the water surface and velocity difference plots. The water surface difference and velocity plots were generated by subtracting the variables from the without project condition from the project condition simulation. A positive value indicates the project caused an increase in the variable. And conversely, a negative number indicates the project caused a decrease in the variable.

Figures 3 and 4 show that the proposed project would have a localized hydraulic impact. The majority of the hydraulic impacts are localized to the project boundaries and there are no impacts along the State-Federal Project levees of the Yolo Bypass. The localized water surface impacts are on the order of 0.15 foot increase where the levee is degraded and a decrease in water surface elevation of 0.1 upstream of the levee degrade. Velocities in Shag Slough and Liberty Cut are localized to areas where the existing north south levee remains intact. The velocity would decrease by as much as 1.5 fps. Velocities would increase just downstream of the levee degrade and are on the order of 1 to 2 fps. All of velocity impacts are localized to the project boundaries and there are no changes along the State-Federal project levees.
