Stream Gage Maintenance Project  
Mitigated Negative Declaration

California Department of Water Resources  
San Joaquin District  
Environmental Services Section

September, 2002

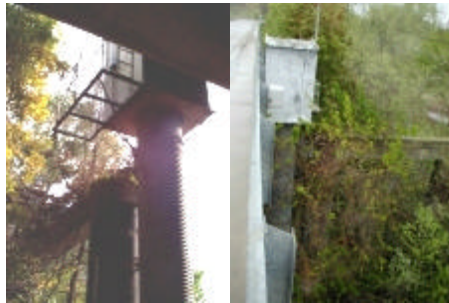
Station Number: B03175

Activities occurring once every five years to several times a year.	Activities conducted less than once every five years. Scheduled to occur within the next year.	Activities conducted less than once every five years but may occur within the next five years.
1. Flush can 2. Clean inside of house 3. Paint can/house 4. Re-mark bridge 5. Change float 6. Run levels	1. Intake line replacement

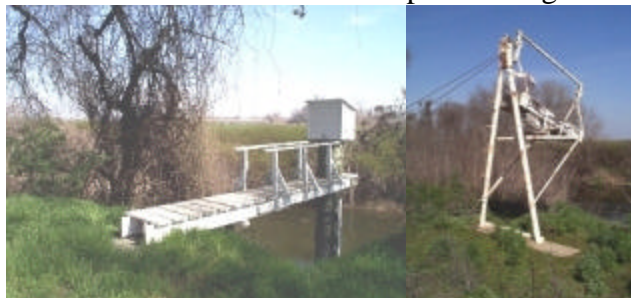
Activities occurring once every five years to several times a year.	Activities conducted less than once every five years. Scheduled to occur within the next year.	Activities conducted less than once every five years but may occur within the next five years.
1. Flush can 2. Clean inside of house 3. Paint can/house 4. Change float 5. Run levels	1. Walkway replacement 2. Cableway installation	1. Intake line replacement

This station was originally erected in 1950 only to be washed out later that same year. The current station has been in place since 1951. A cable car was reinstalled twice, once in 1981, and again in 1992. The existing cableway connects an A-frame to a tree on the opposite bank. The tree fell into the river during the 1997 floods and the cableway is scheduled for immediate replacement near the existing site. The proposed cableway will be approximately 30 feet above the ordinary high water mark.

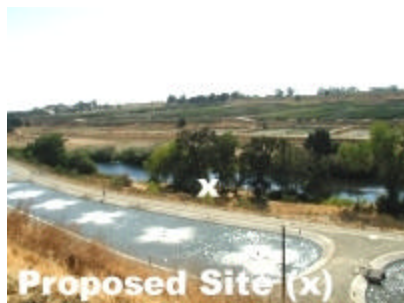
Activities occurring once every five years to several times a year.	Activities conducted less than once every five years. Scheduled to occur within the next year.	Activities conducted less than once every five years but may occur within the next five years.
<ol style="list-style-type: none"><li>1. Flush can</li><li>2. Clean inside of house</li><li>3. Paint can/house</li><li>4. Change float</li><li>5. Run levels</li></ol>	<ol style="list-style-type: none"><li>1. Installation of stream gage</li><li>2. Cableway installation</li><li>3. Staff gage installation</li></ol>

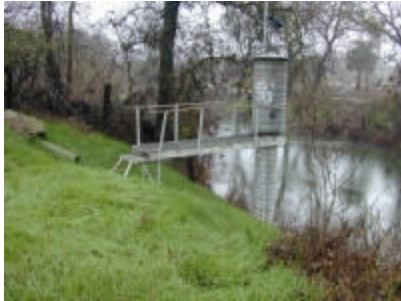
## 9. Merced River near Cressey

Activities occurring once every five years to several times a year.	Activities conducted less than once every five years. Scheduled to occur within the next year.	Activities conducted less than once every five years but may occur within the next five years.
1. Flush can 2. Clean inside of house 3. Paint can/house 4. Re-mark bridge 5. Change float 6. Run levels	1. Walkway replacement	1. Intake line replacement

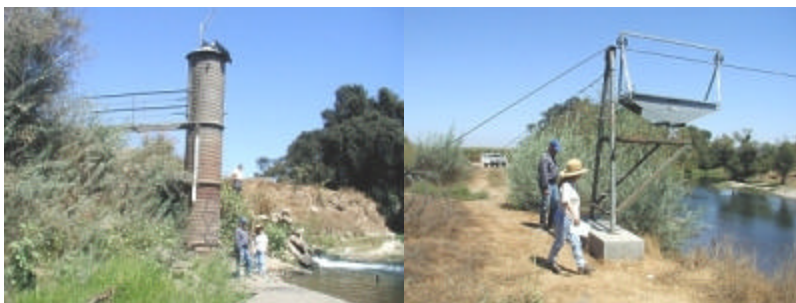
## 10. Merced River near Stevinson

Activities occurring once every five years to several times a year.	Activities conducted less than once every five years. Scheduled to occur within the next year.	Activities conducted less than once every five years but may occur within the next five years.
<ol style="list-style-type: none"><li>1. Flush can</li><li>2. Clean inside of house</li><li>3. Paint can/house</li><li>4. Change float</li><li>5. Run levels</li></ol>	<ol style="list-style-type: none"><li>1. Station replacement</li><li>2. Cable car installation</li></ol>

This station was erected in 1947. The gage is severely deteriorated at the base and could wash downstream in the next flood event. To maintain consistent data recording and prevent potential property damage and human hazards, the gage is scheduled for immediate replacement.

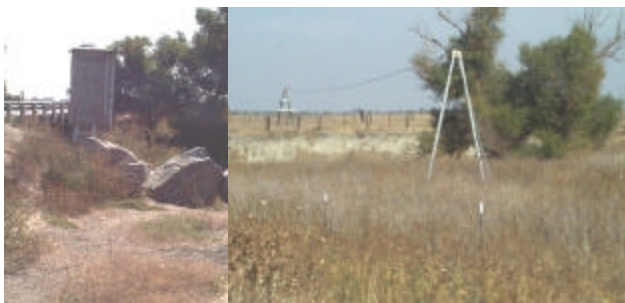
## 12. Salt Slough near Stevinson

Activities occurring once every five years to several times a year.	Activities conducted less than once every five years. Scheduled to occur within the next year.	Activities conducted less than once every five years but may occur within the next five years.
1. Flush can 2. Clean inside of house 3. Paint can/house 4. Change float 5. Run levels		1. Intake line replacement

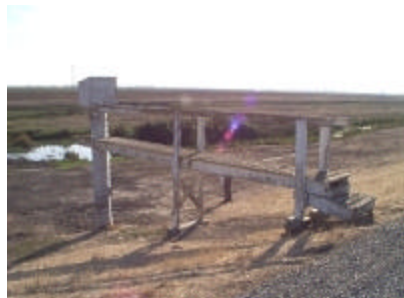
Activities occurring once every five years to several times a year.	Activities conducted less than once every five years. Scheduled to occur within the next year.	Activities conducted less than once every five years but may occur within the next five years.
1. Flush can 2. Clean inside of house 3. Paint can/house 4. Change float 5. Run levels	1. Walkway replacement 2. Intake line replacement 3. Can section/house replacement

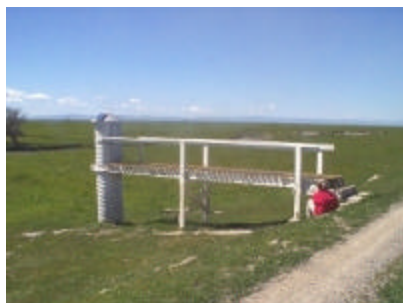
#### 14. Eastside Bypass below Mariposa Bypass

Activities occurring once every five years to several times a year.	Activities conducted less than once every five years. Scheduled to occur within the next year.	Activities conducted less than once every five years but may occur within the next five years.
1. Flush can 2. Clean inside of house 3. Paint can/house 4. Change float 5. Run levels	1. Walkway replacement	1. Intake line replacement

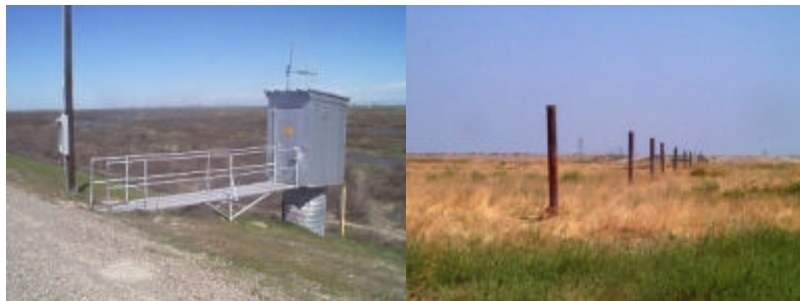
## 15. Eastside Bypass near El Nido

Activities occurring once every five years to several times a year.	Activities conducted less than once every five years. Scheduled to occur within the next year.	Activities conducted less than once every five years but may occur within the next five years.
1. Flush can 2. Clean inside of house 3. Paint can/house 4. Change float 5. Run levels	1. Pole replacement	1. Pole replacement
