**Meeting of the Central Valley Flood Protection Board
October 25, 2013
Staff Report – Encroachment Permit
Westervelt Ecological Services
Giant Garter Snake Preserve and Wetlands, Colusa County**

Consider approval of Permit No. 18845 (Attachment B)

Applicant proposes to develop a wetland and giant garter snake preserve; de-leveling portions of the site to create a managed-marsh complex; create interior berms 3 feet above existing grade; and utilize existing and new water control structures to efficiently direct water.

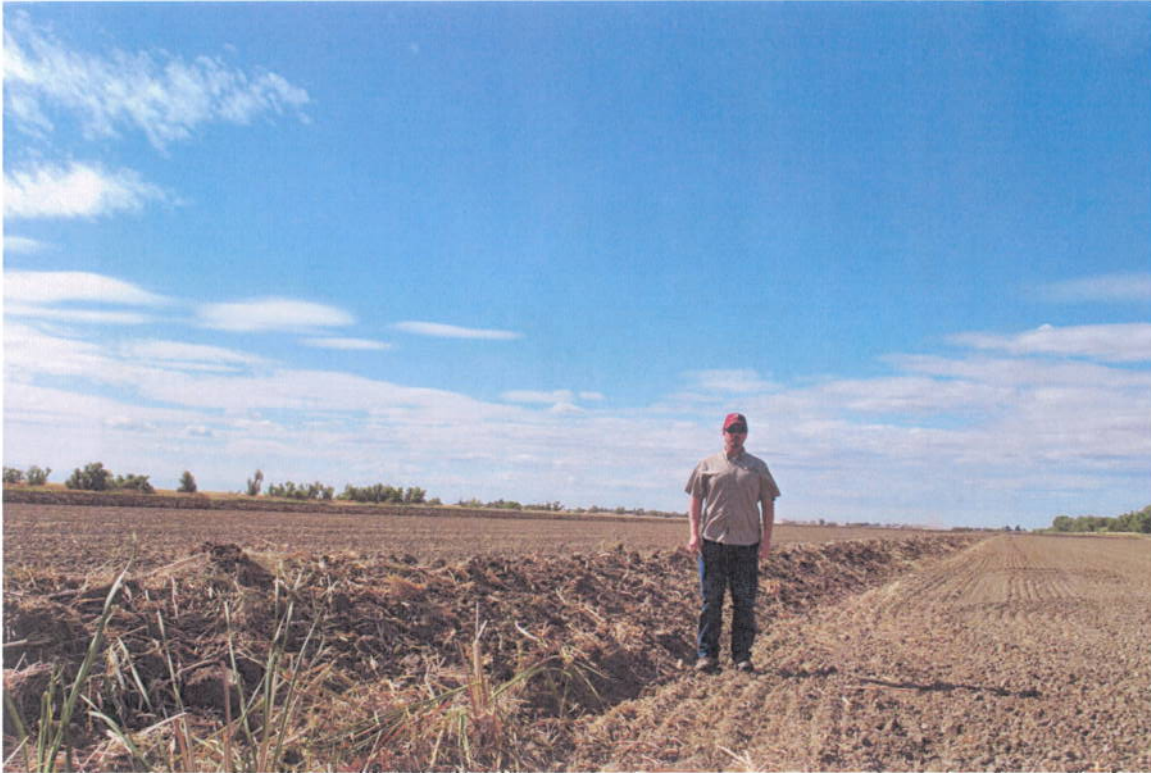
Photo 7: Typical Rice Berm, View from NW Corner

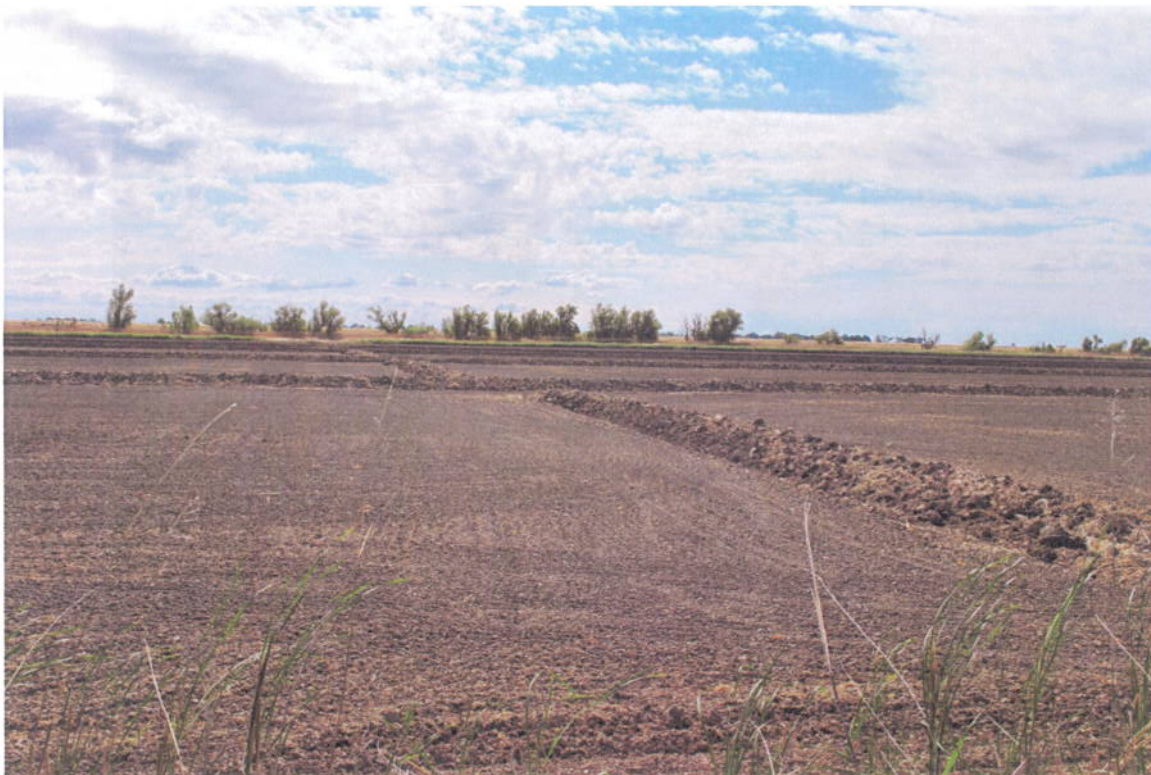
Photo 8: Typical Rice Berms, View from West to East

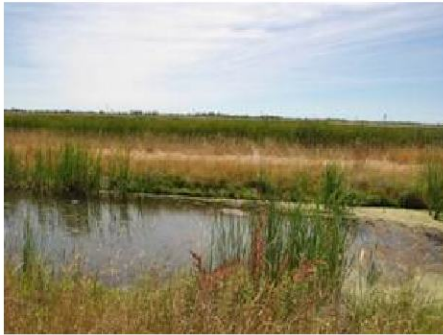
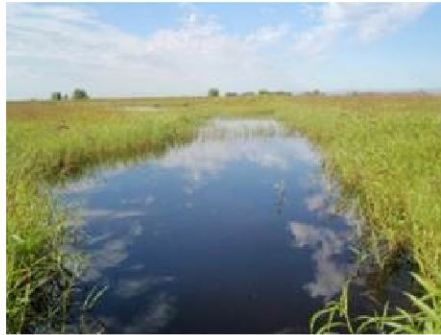
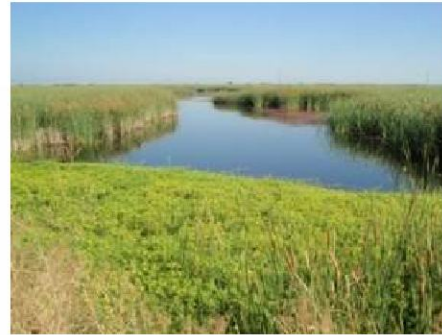
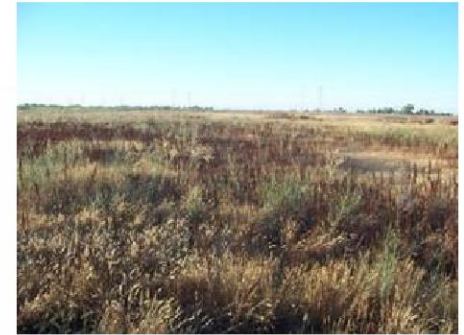
FIGURE 7
JULY 2013
Typical Habitat
Cross-section

Berms and Refugia

Semi-Permanent Marsh

Perennial Marsh and Open Water

Seasonal Wetland

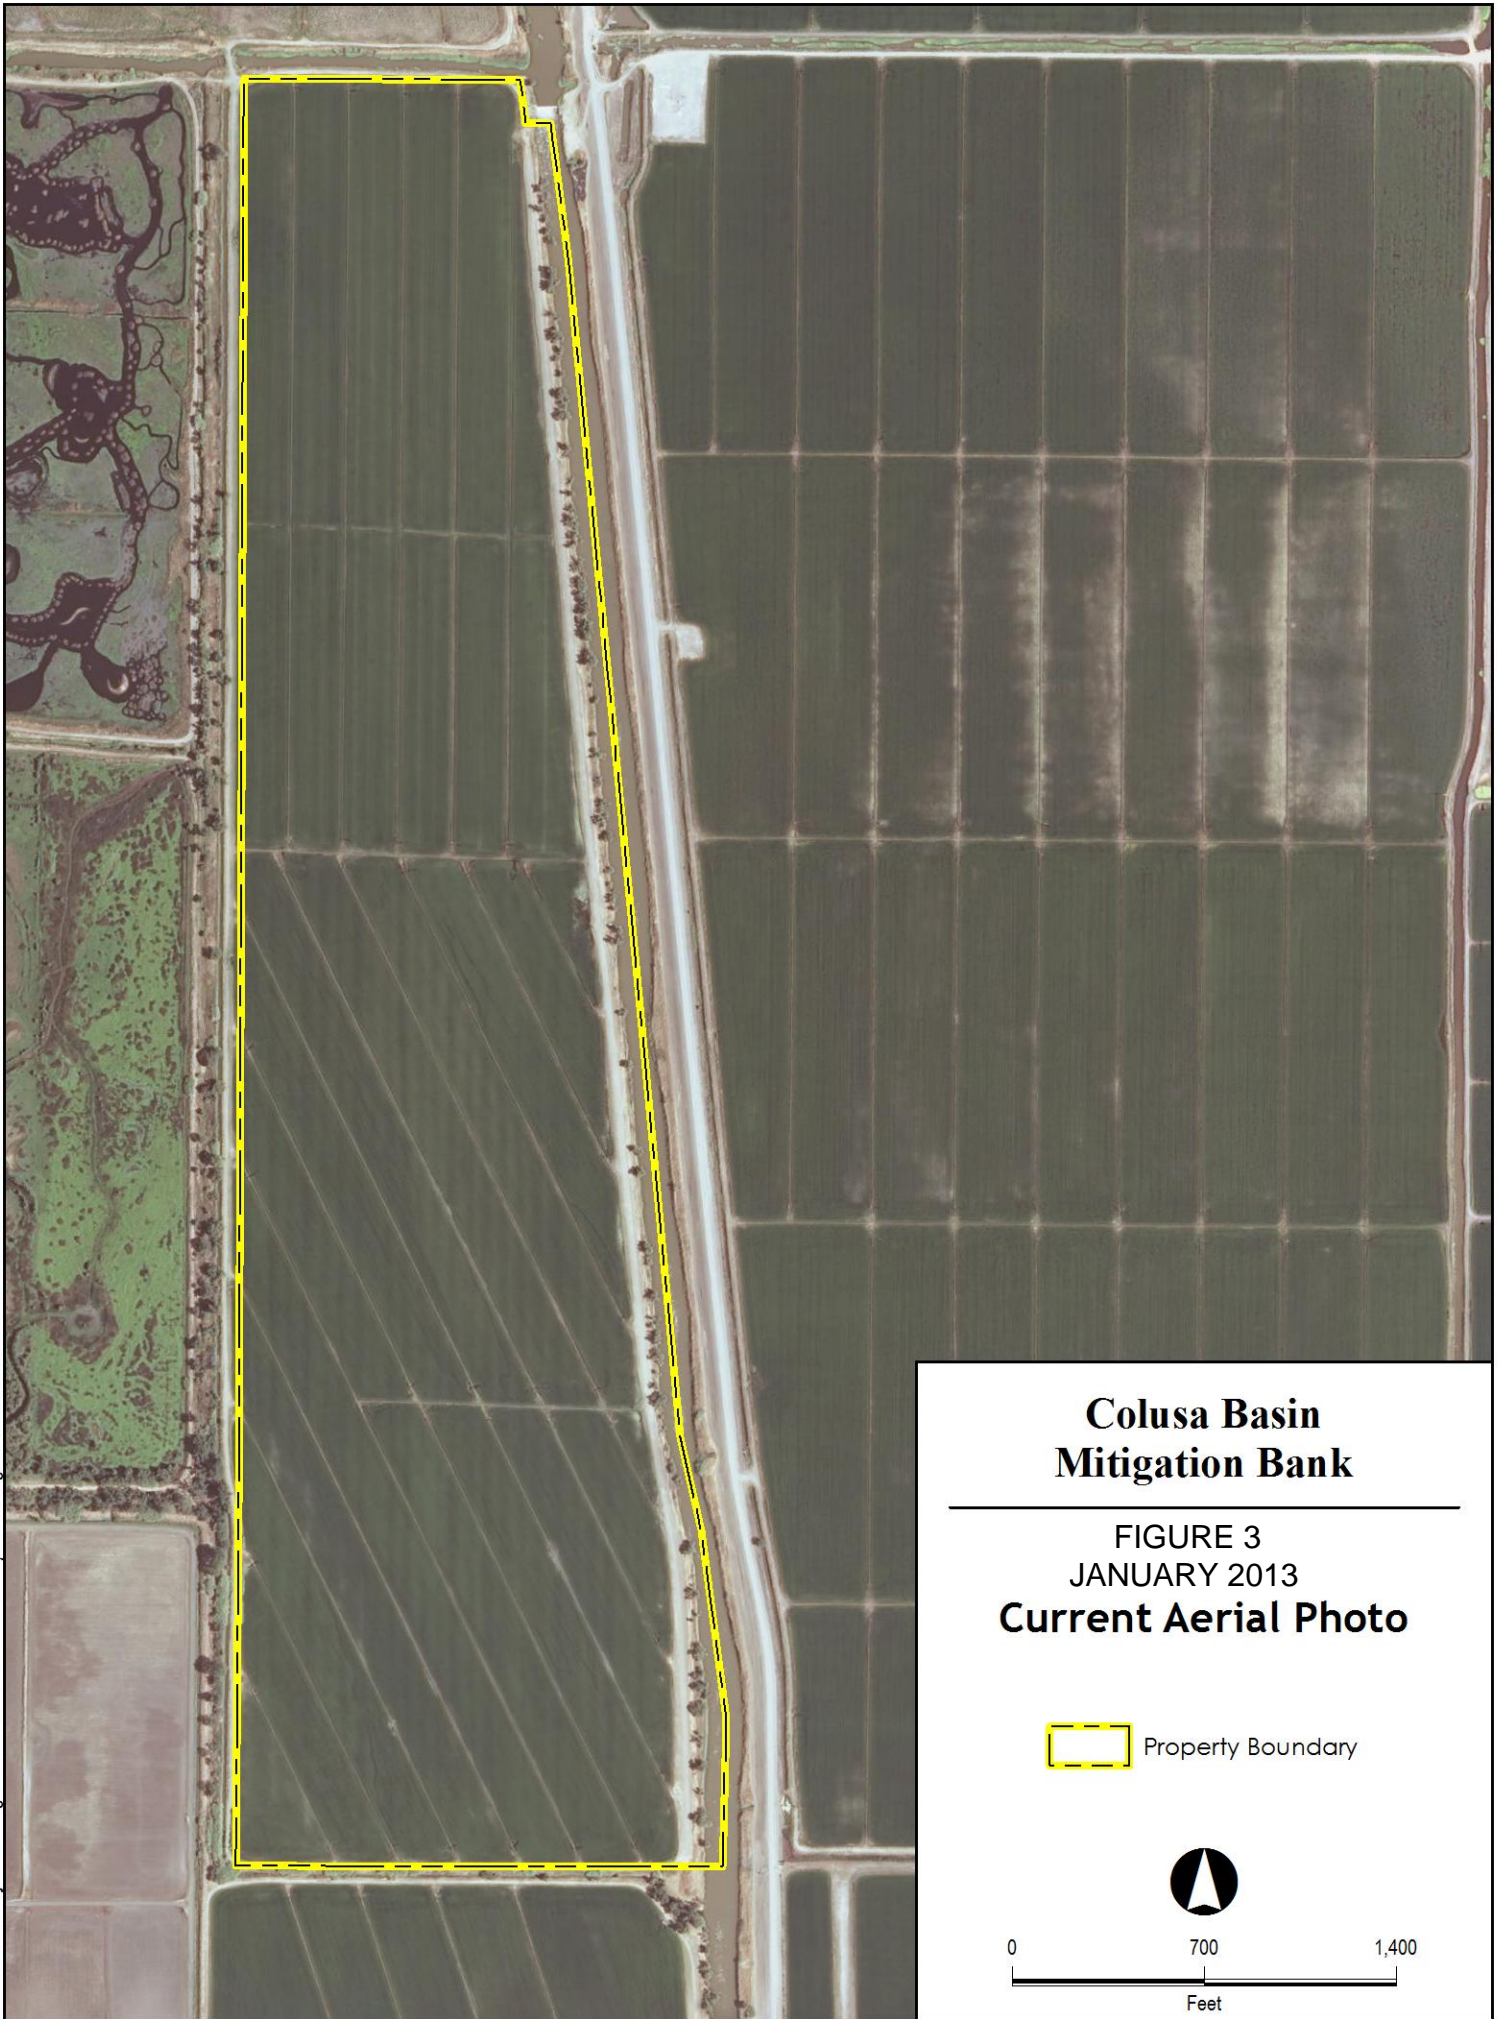
FIGURE 4
BANK PROPERTY MAP
JULY 2013

The topography is gently sloping (0 to 2% slopes) from west to east, and the entire Bank Property is currently divided into “checks” for rice cultivation (**Figure 4**). The land within the checks is either level or gently sloping (1%) and there are only 3 or 4 inches difference between the elevations of the checks.

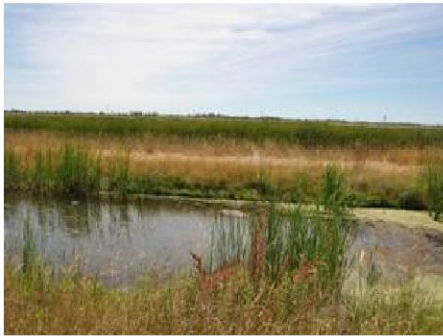
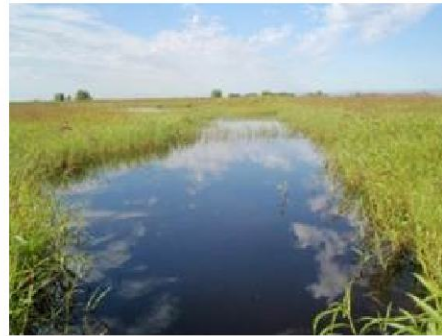
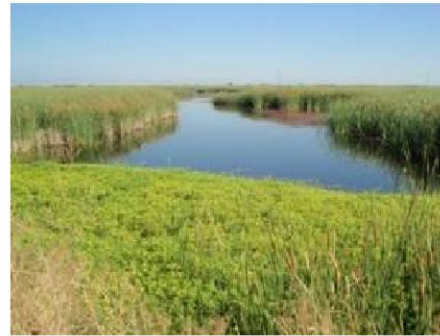
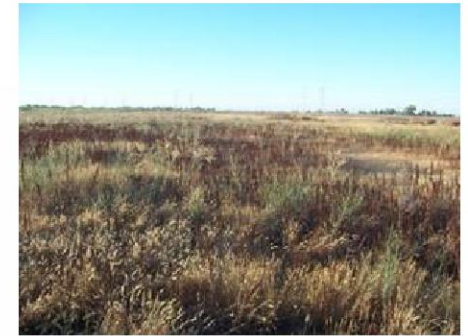
FIGURE 7
JULY 2013
**Typical Habitat
Cross-section**

Berms and Refugia

Semi-Permanent Marsh

Perennial Marsh and Open Water

Seasonal Wetland
