CEASE AND DESIST ORDER

Encroachment Location: 1672 W Bowman Road
French Camp, California 95231
San Joaquin River East Project Levee, Right (East) Bank, Unit 2
Levee Mile 4.18 to 4.35
Latitude: 37°51'46.33"N, Longitude: 121°19'10.74"W

Subject: **Notice of Violation – Noncompliant Encroachments**
Enforcement Action: No. 2014-790

**NOTICE OF VIOLATION****NONCOMPLIANT ENCROACHMENTS**

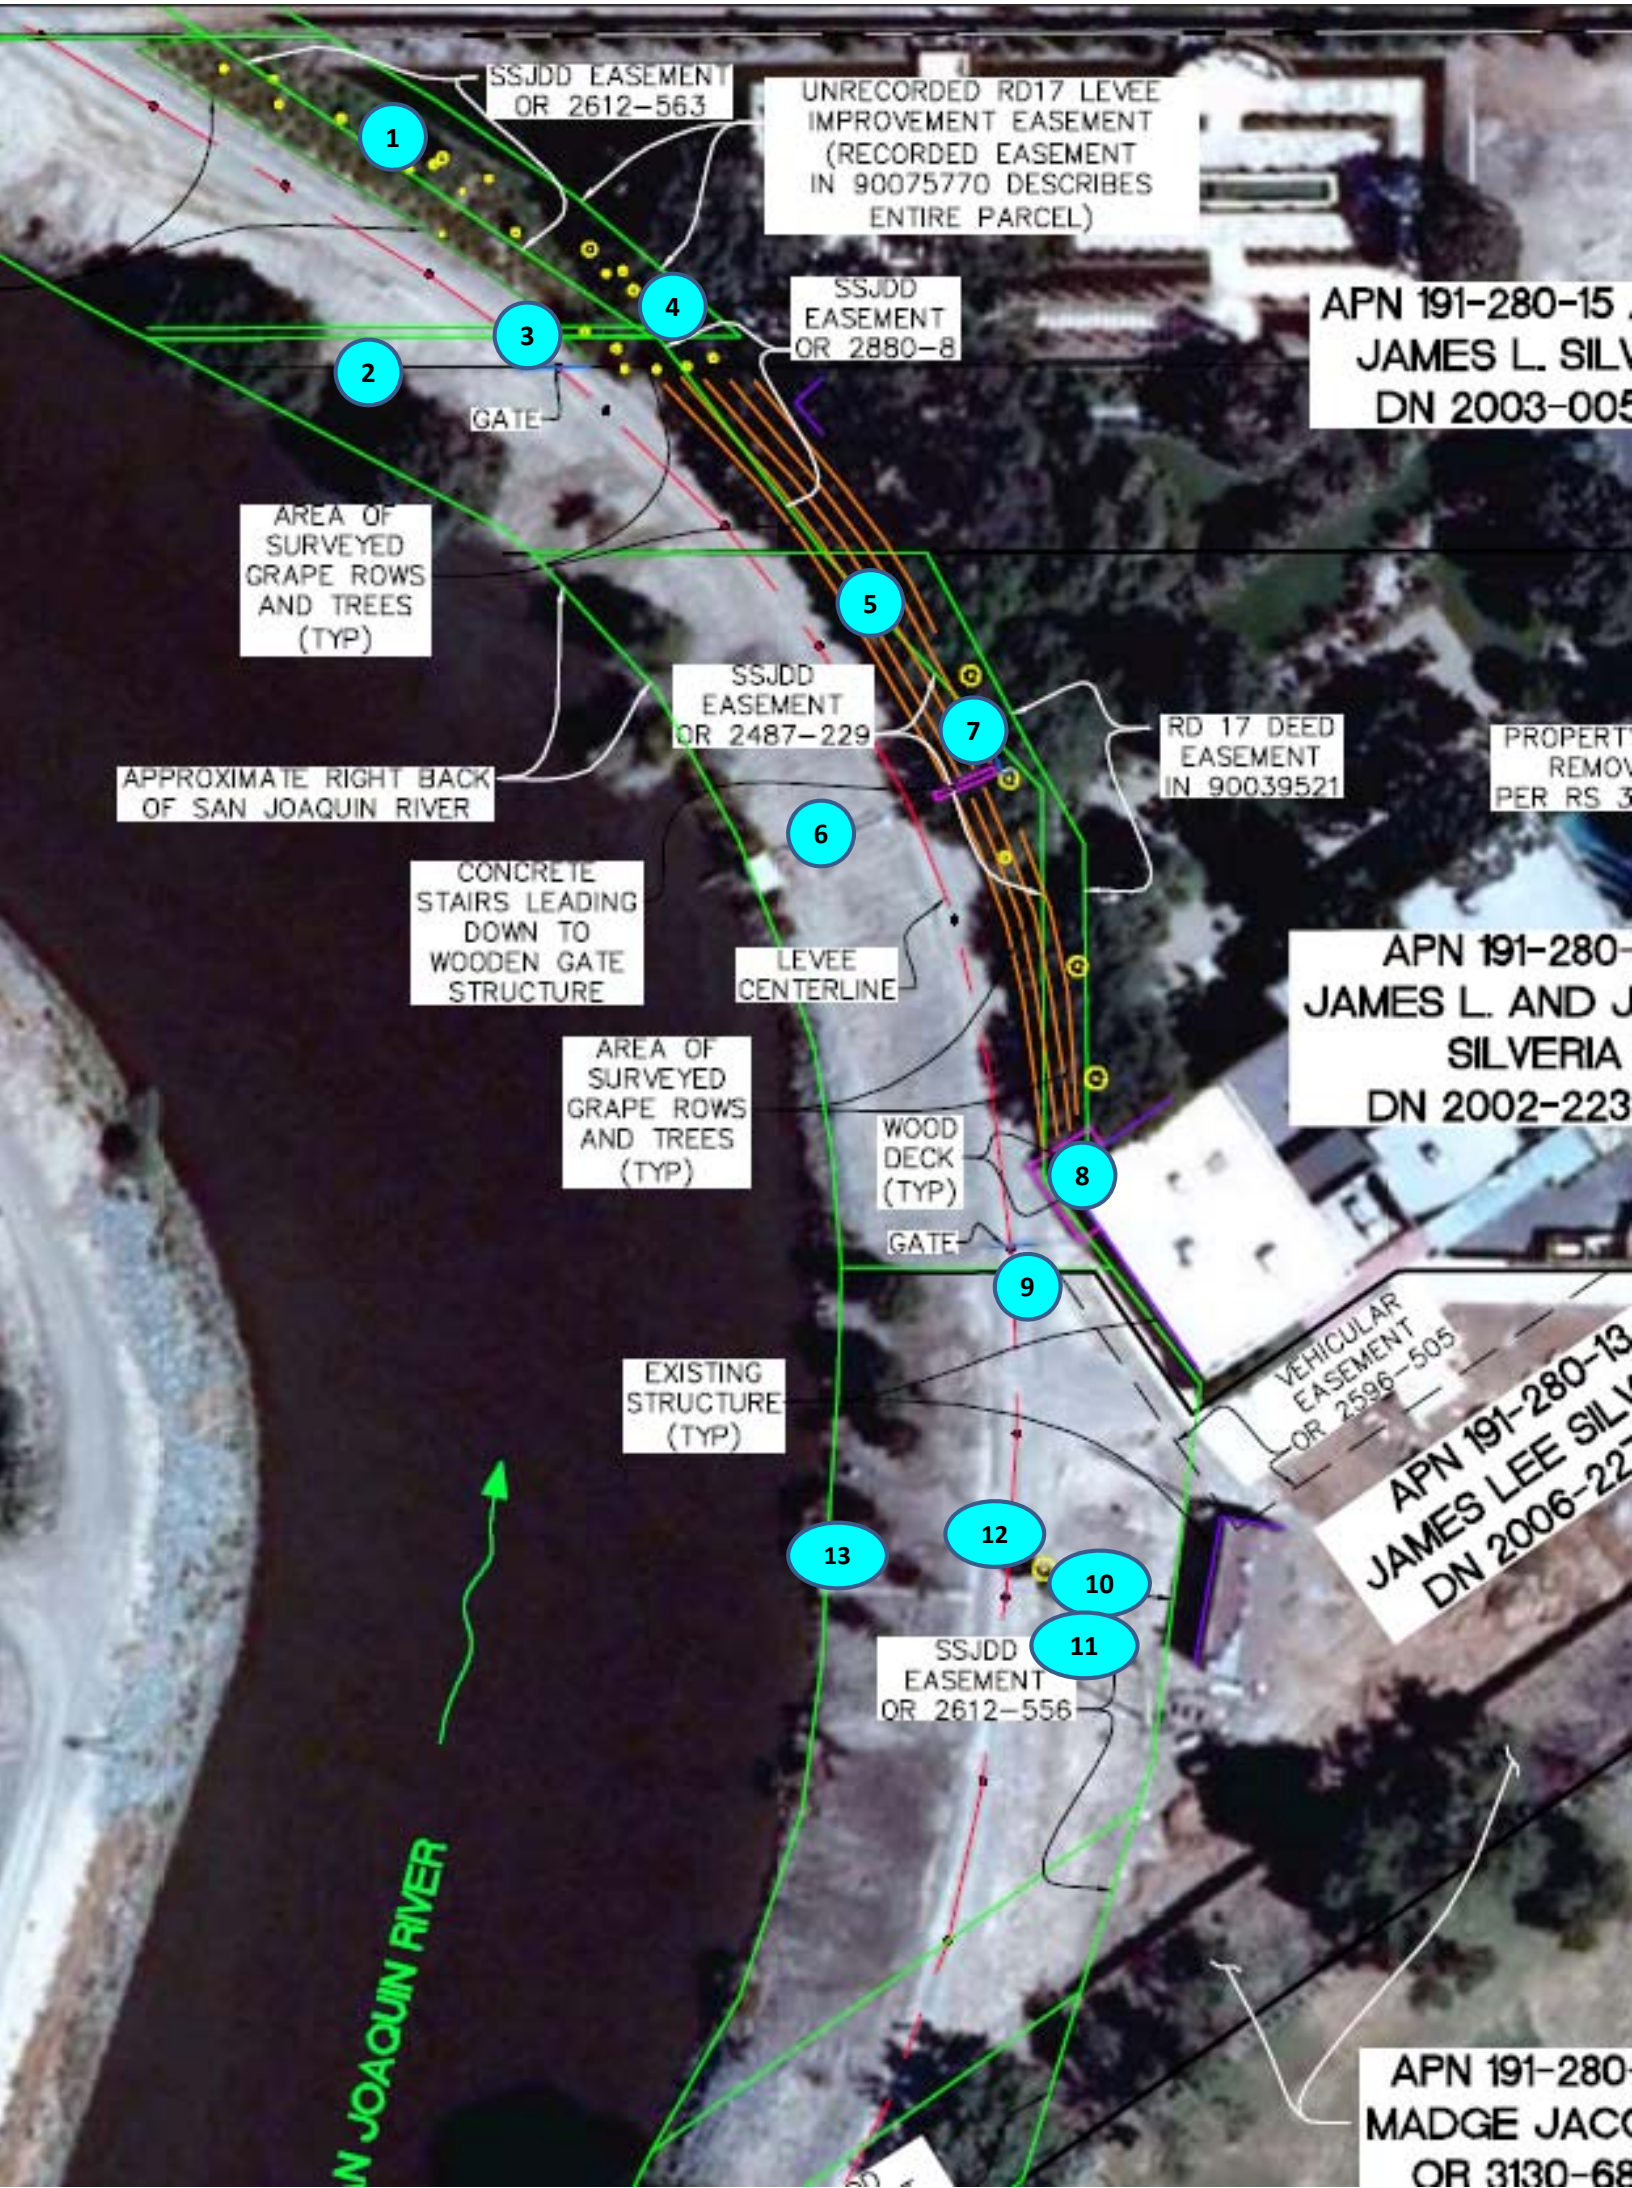
Encroachment Locations Map

1. Low dense landscaped shrubs, small trees and irrigation covering the landside slope.

1. Removal of shrubs, trees, and irrigation from landside levee slope.
2. The broken pipe associated with EP No. 15111 BD must be completely removed from the levee section.

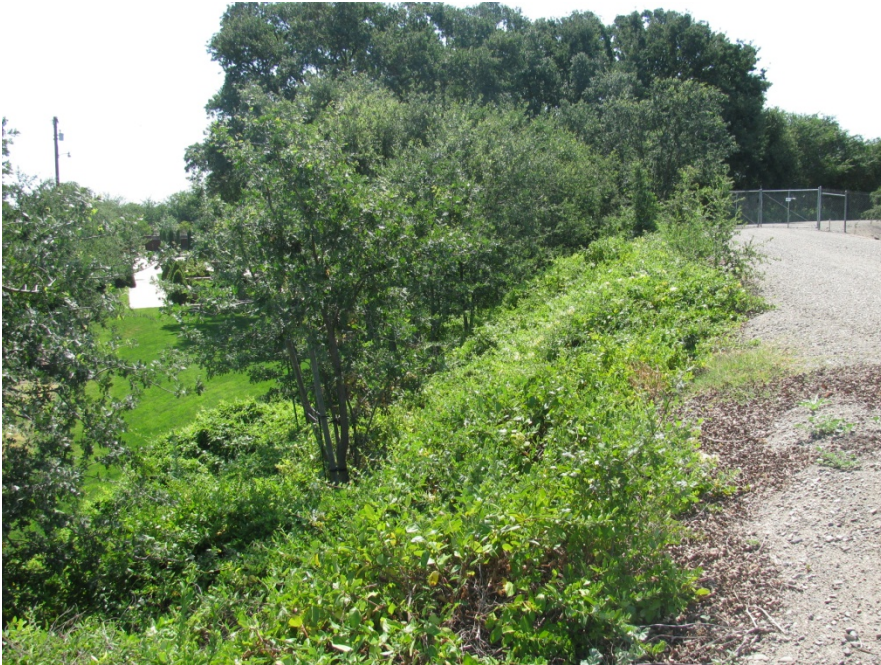
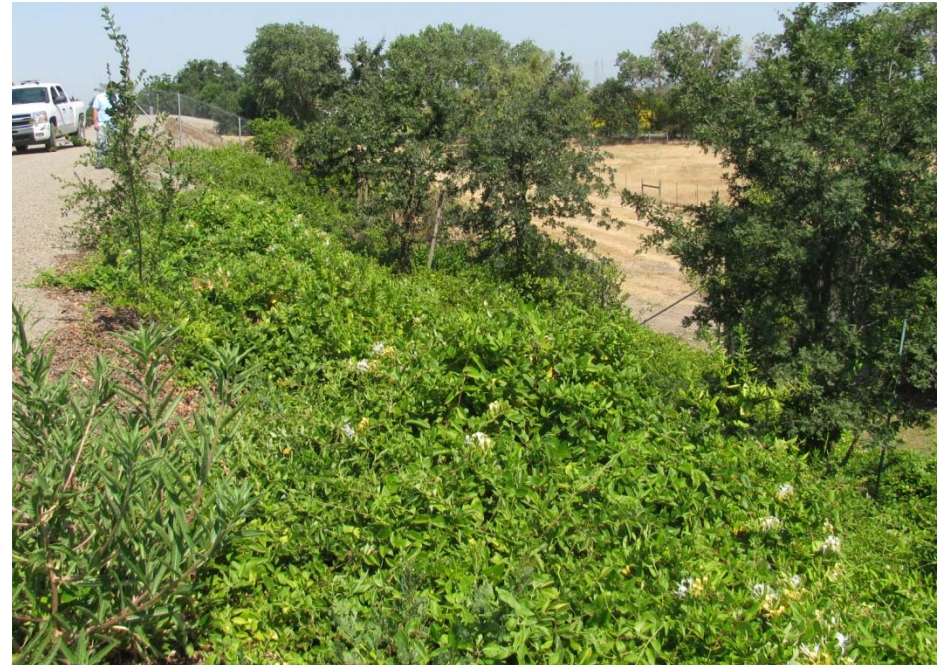
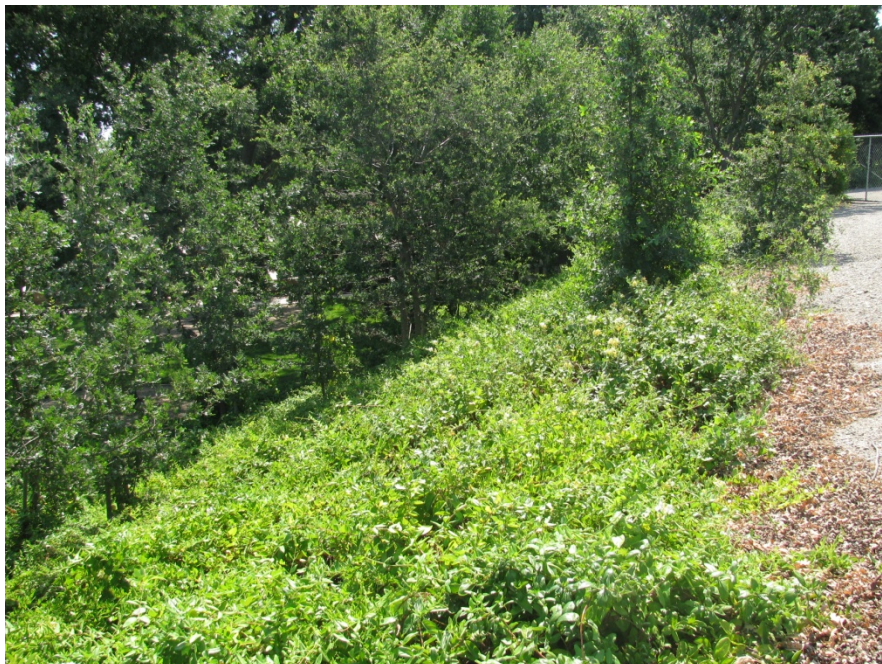
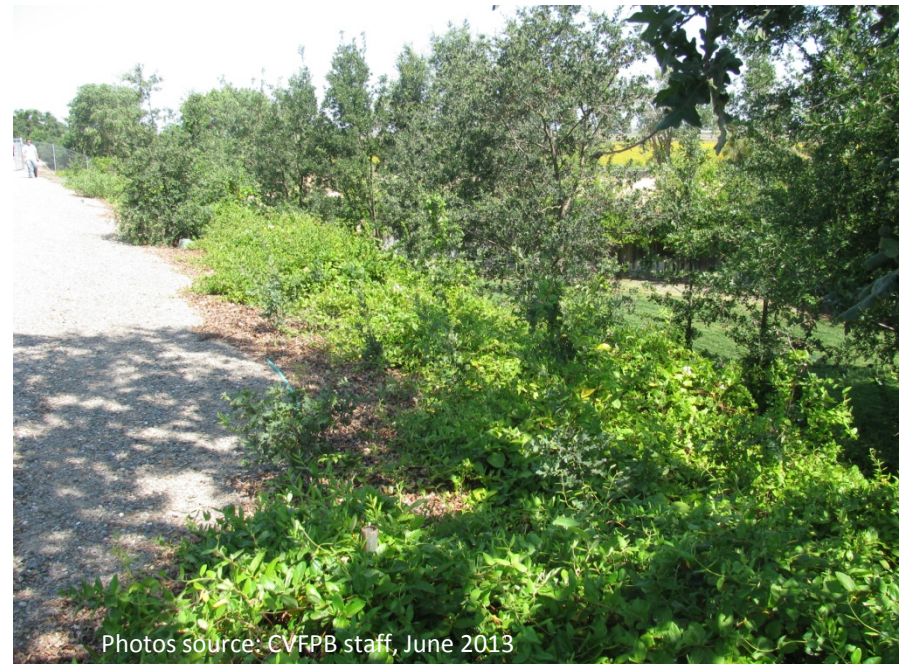
Item No.	Encroachment Description	CCR Title 23 Sections Violated	Levee Mile	(Office use only) USACE ID MOS2 2009
1.	Low dense landscaped shrubs, small trees and irrigation covering the landside levee slope prevent levee maintenance and obstruct the visual inspection of the levee slope and toe. No encroachment permits found that authorize this vegetation.	6(a), 131(c), 131(d), 131(f)(7)	4.18 to 4.27	199
2.	Broken 2-inch diameter pipeline and adjacent electrical conduit penetrating the levee from the waterside slope appears to be abandoned, but not properly removed.	124(a)	4.21	155
3.	Chain link fence crossing the levee impedes levee maintenance and flood fight procedures. No encroachment permits found that authorize this encroachment.	6(a)	4.21	154

1. The shrubs, trees, and irrigation must be removed from landside levee slope and within ten feet of the levee toe.
2. The broken 2-inch diameter pipeline must be completely removed from the levee section.

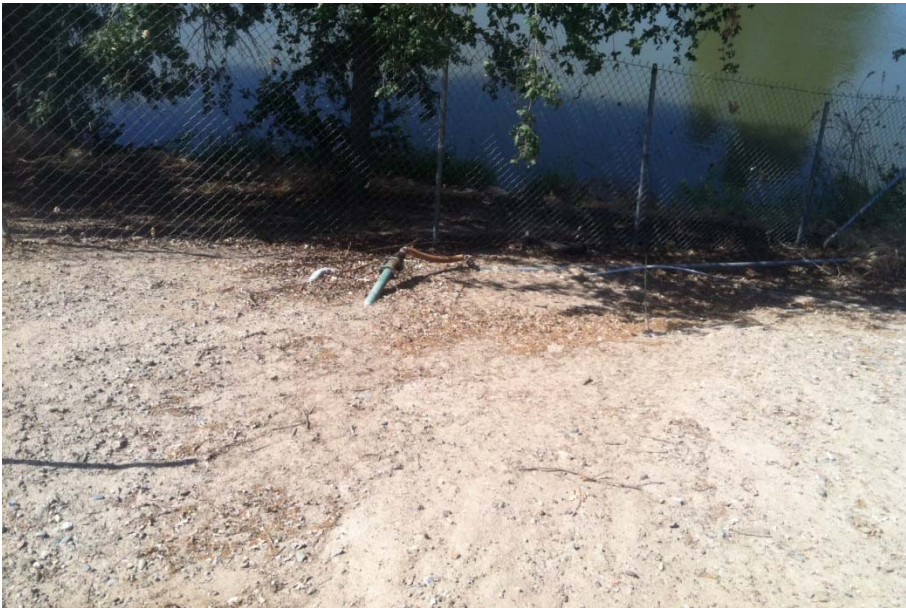
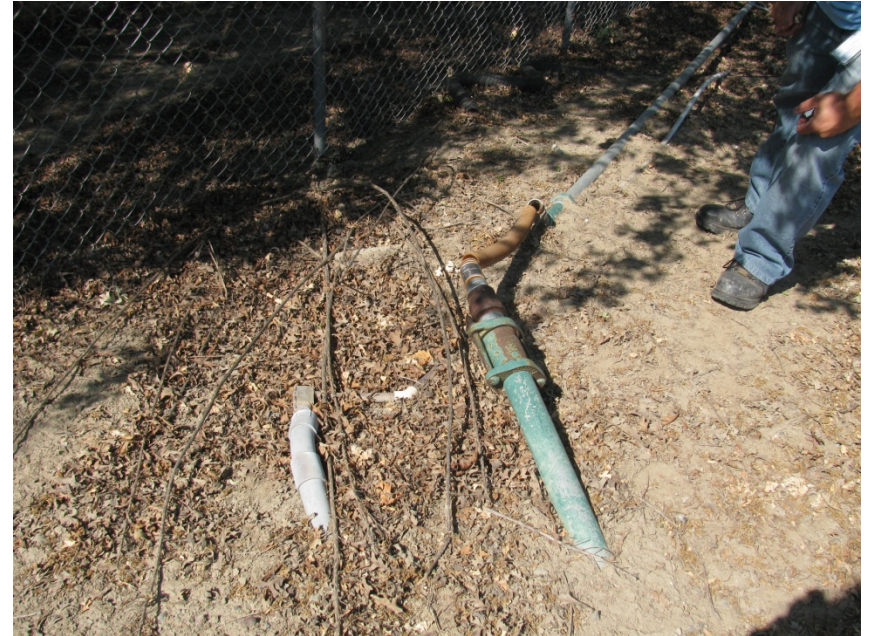
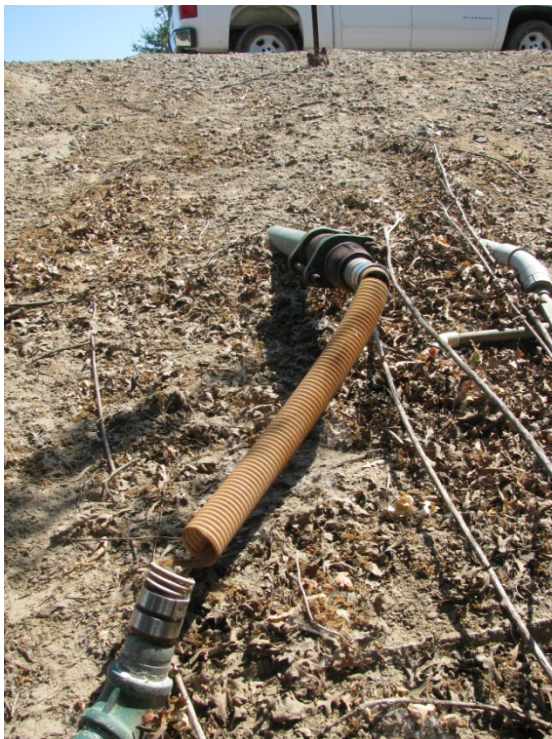
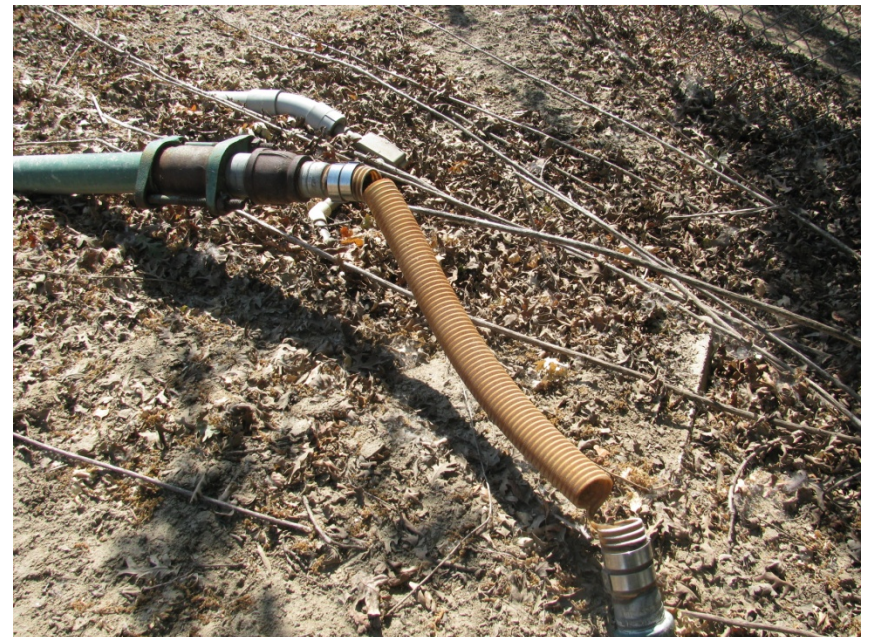
2. Broken 2-inch pipeline penetrating the levee from the waterside slope. EP 15111 GM

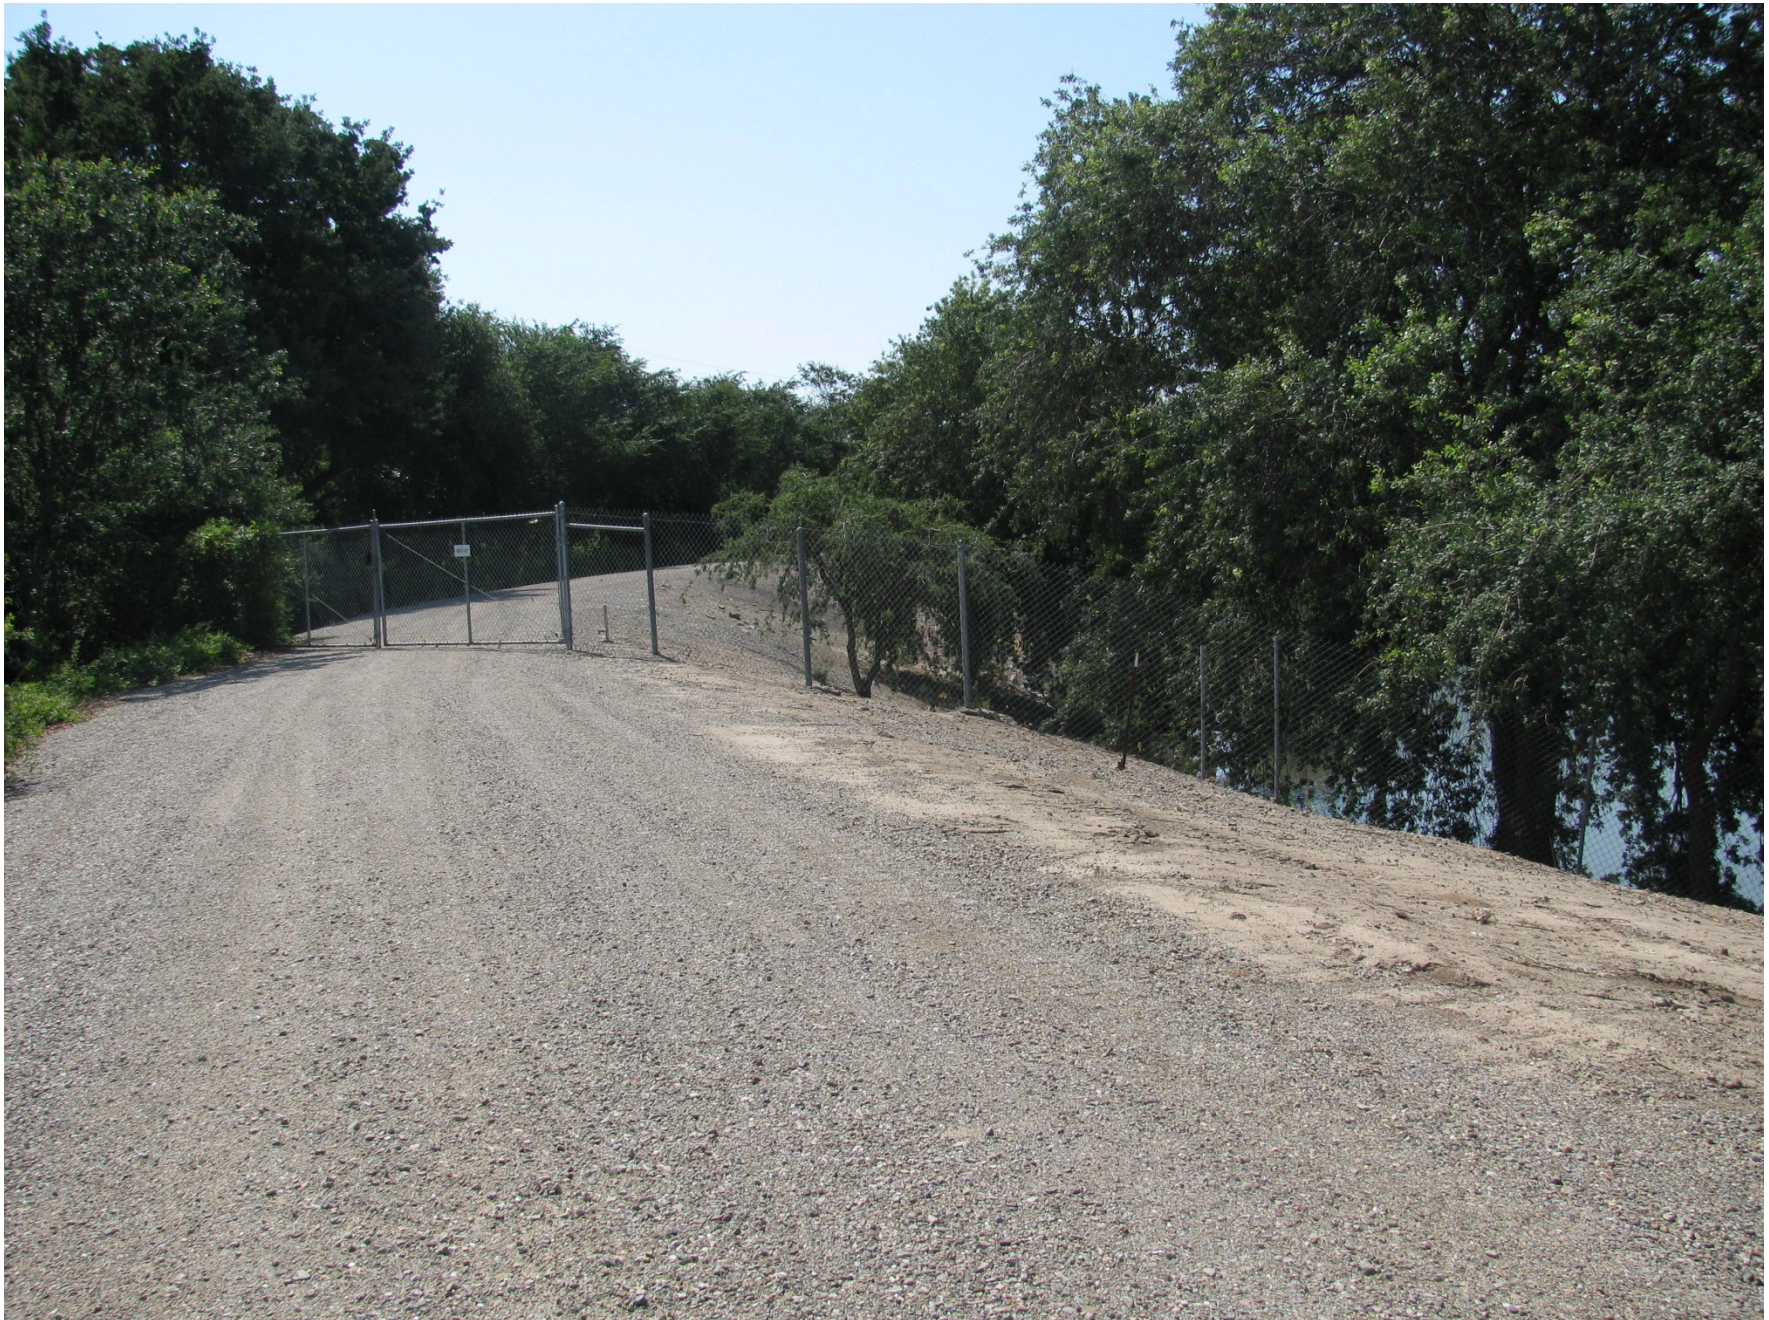
3. Chain link fence with gate crossing the levee at levee mile 4.21

3. Provide encroachment permit information for the chain link fence crossing the levee at levee mile 4.21. If none exists, remove the fence.
4. The tall trees planted within ten feet of the landside levee toe must be removed. Trees further away than 10 feet must be kept trimmed so that tree branches above the area within 10 feet of the levee toe are a minimum of 12 feet above the ground.

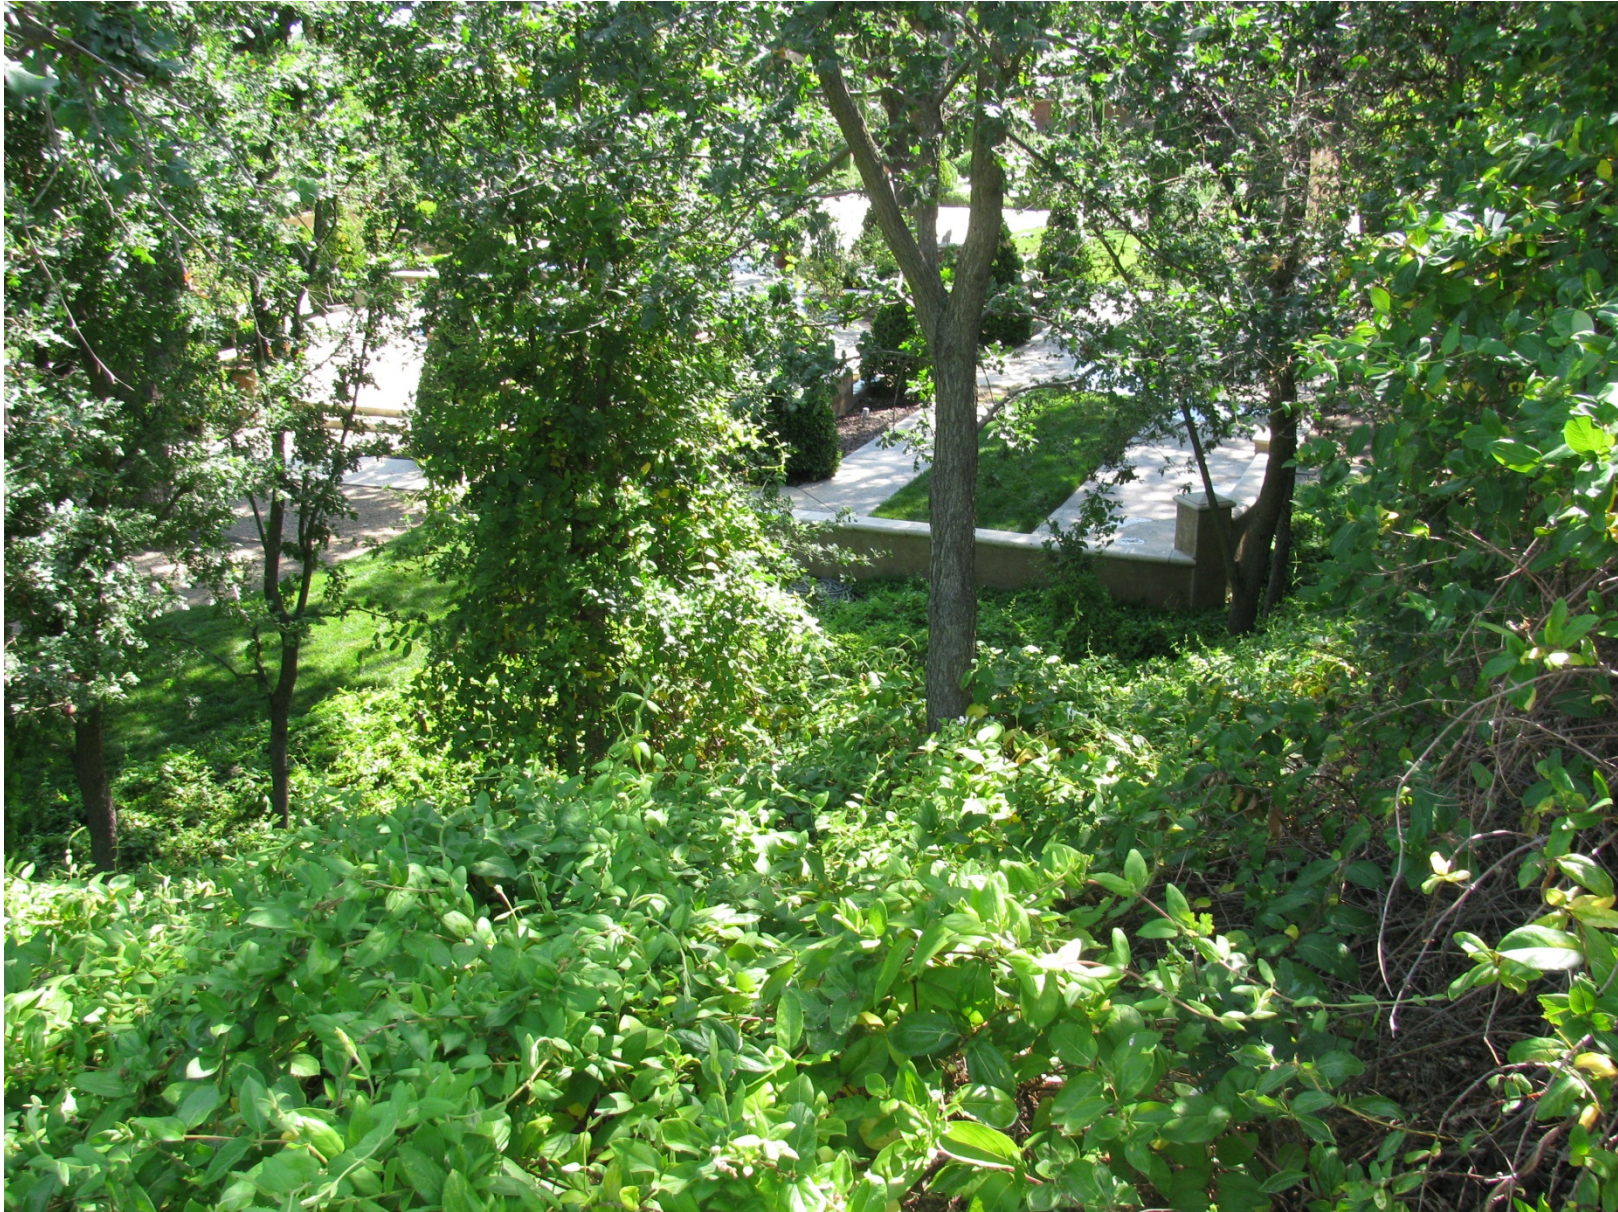
4.	Line of tall 18-inch- to 36-inch-diameter trees on and near the landside levee toe prevent levee maintenance access and obstruct the visual inspection of the levee slope and toe. No encroachment permits found that authorize these trees.	6(a), 131(c), 131(d), 131(f)(4), 131(f)(7)	4.22 to 4.27	197

4. Line of tall 18- to 36-inch diameter trees on and near landside levee toe

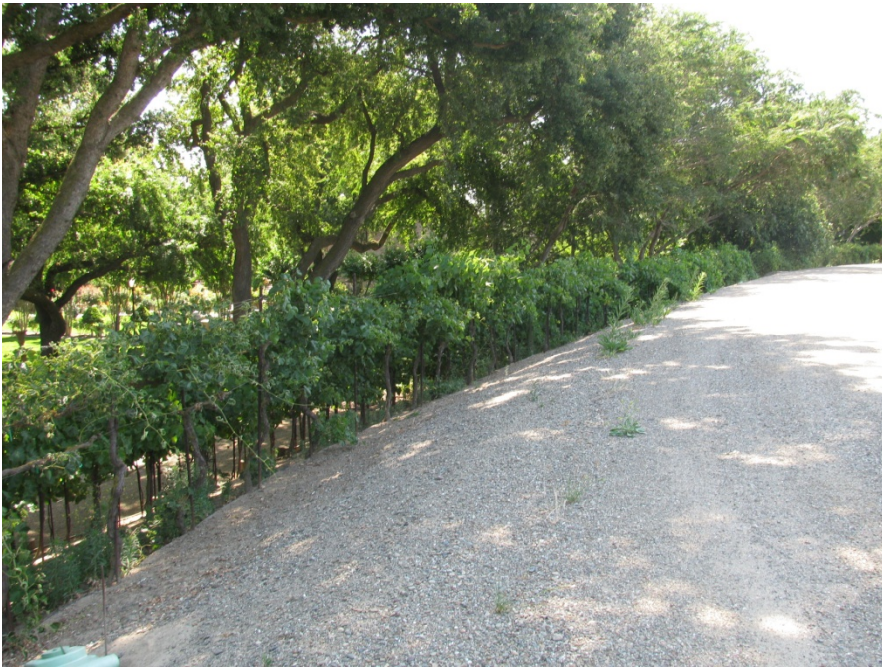
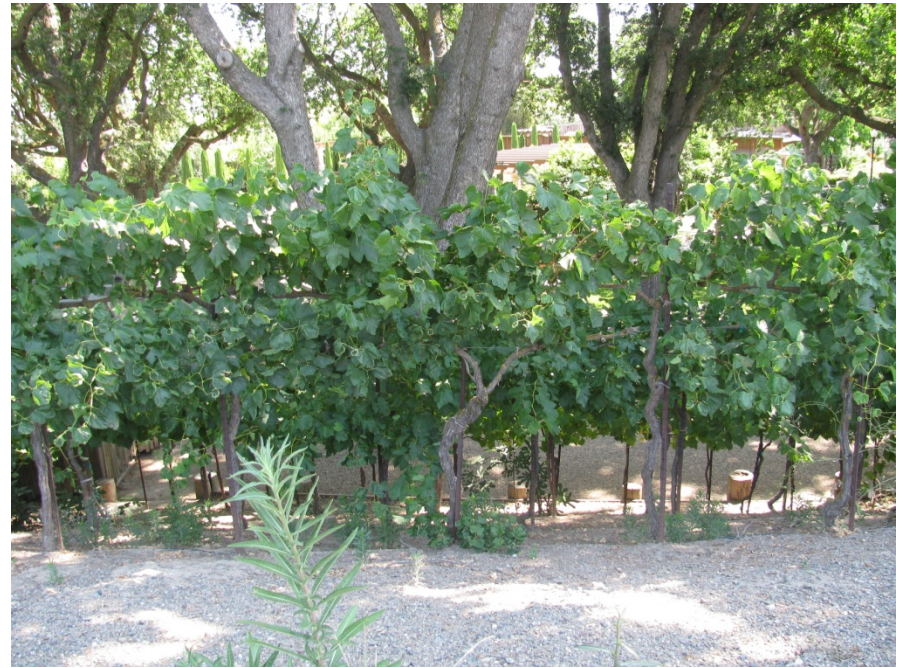
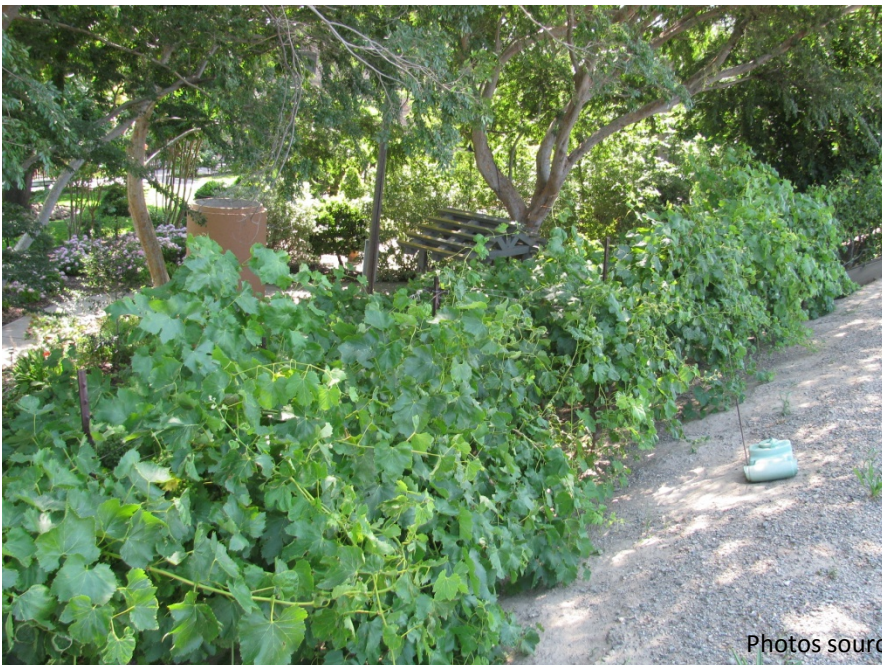
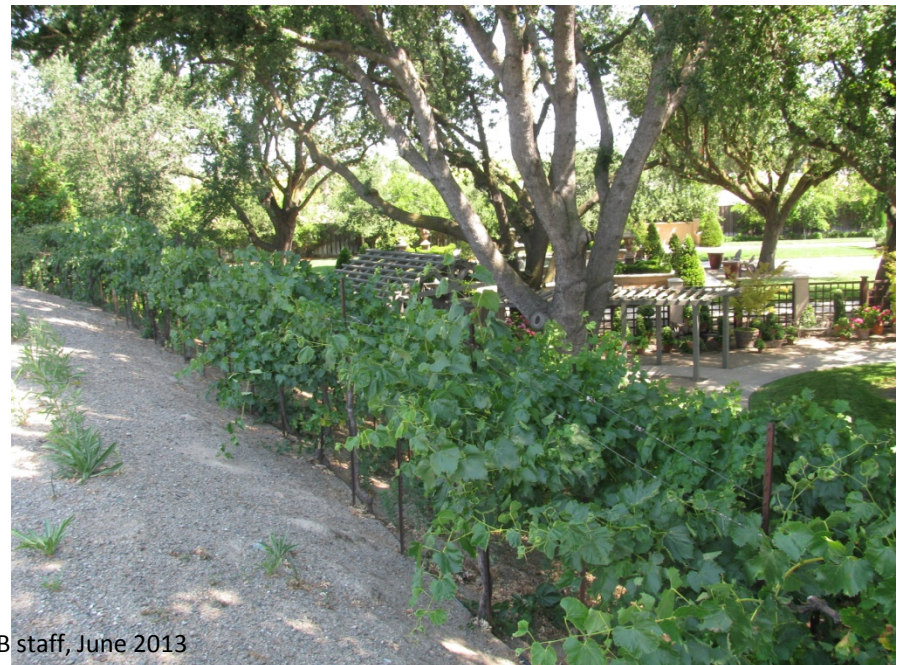
5.	Grapevine plants and associated stakes, irrigation, and retaining wall boards on the landside levee slope prevent levee maintenance access and obstruct the visual inspection of the levee slope. A November 4, 1994 order from the Reclamation Board (now the CVFPB) requires the removal of these encroachments.	131(c), 131(d), 131(f)(7)	4.22 to 4.27	196

5. Grapevine plants on the landside levee slope. Subject of past removal notices.

5. The grape vine plantings and all associated posts, irrigation, and wood retaining boards at the levee toe and the landside levee slope must be removed.

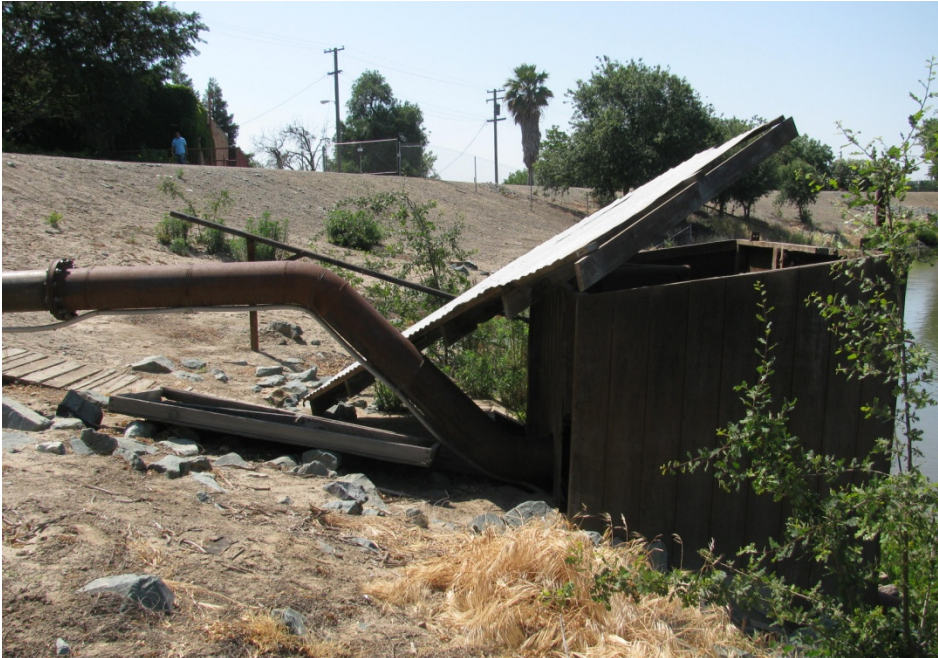
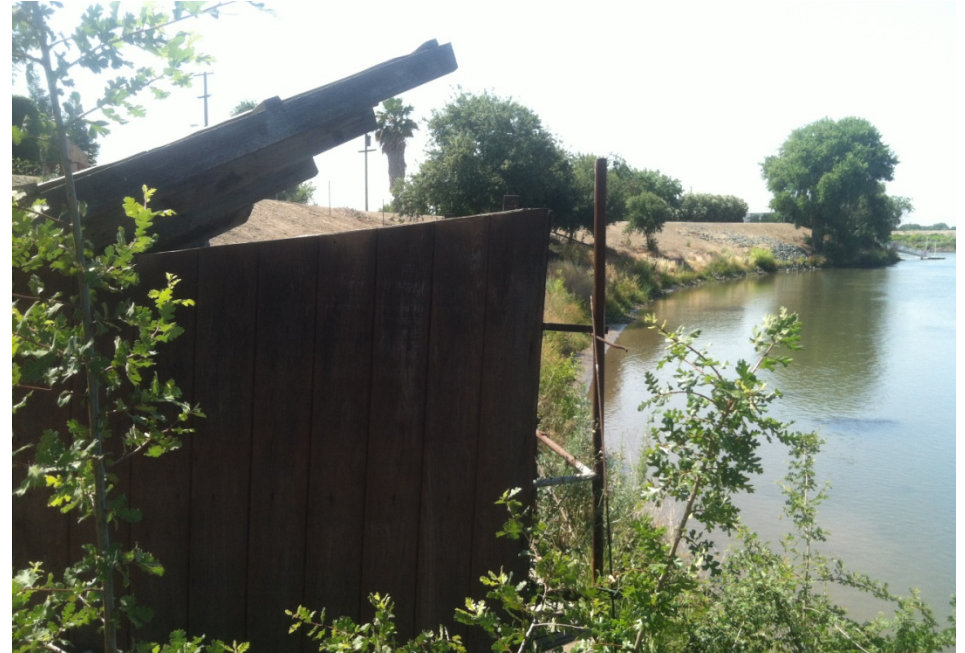
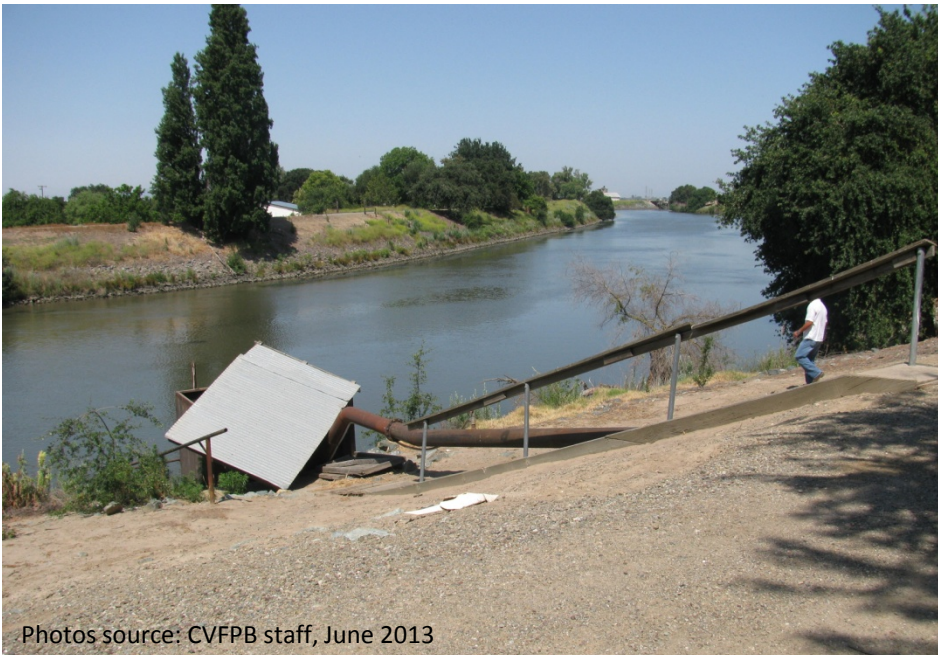
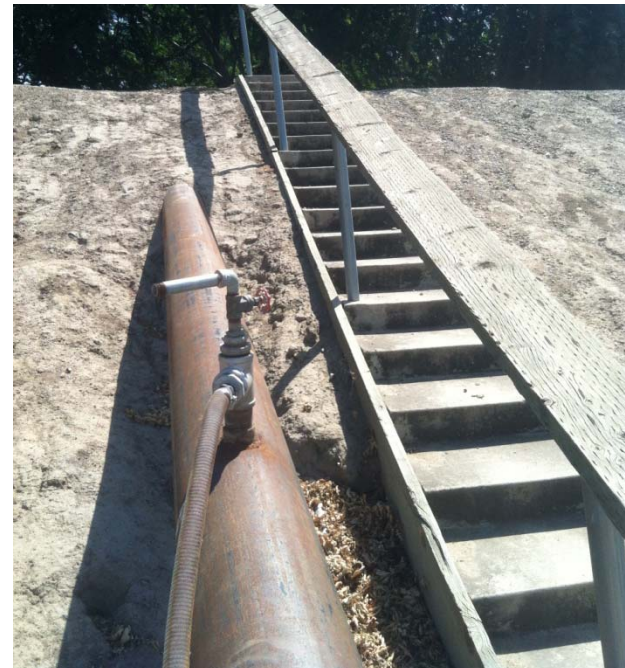
6.	The dilapidated pump house, concrete steps, handrail on waterside toe and slope are not compliant with Encroachment Permit (EP) No. 15112 BD Conditions 2, 28, and 31. The encroachment permit does not authorize construction of the concrete steps or handrail, and it requires suitable protective housing for the pump unit.	6(a), 137(c)(4), 137(c)(5), 137(c)(6)	4.25	202

6. Dilapidated pump house, concrete steps, handrail associated with EP No. 15112 BD

6. Encroachments associated with EP No. 15112 GM:
 - a. Remove the dilapidated pump house structure and handrail on the levee slope. The pump house may be rebuilt after an encroachment permit is obtained from the CVFPB.

- b. Provide CVFPB staff with pipe interior inspection results from within the last five years. If there are none available, you are required to have your pipe video inspected and provide the video inspection results to CVFPB staff.

- c. Apply for a name change for EP No. 15112 GM.
7. If you intend to keep the steps, you must apply for a permit to modify them to comply with CCR Title 23 Section 137(c). Otherwise, the steps must be completely removed and the levee slope re-shaped and compacted to match the surrounding slopes.

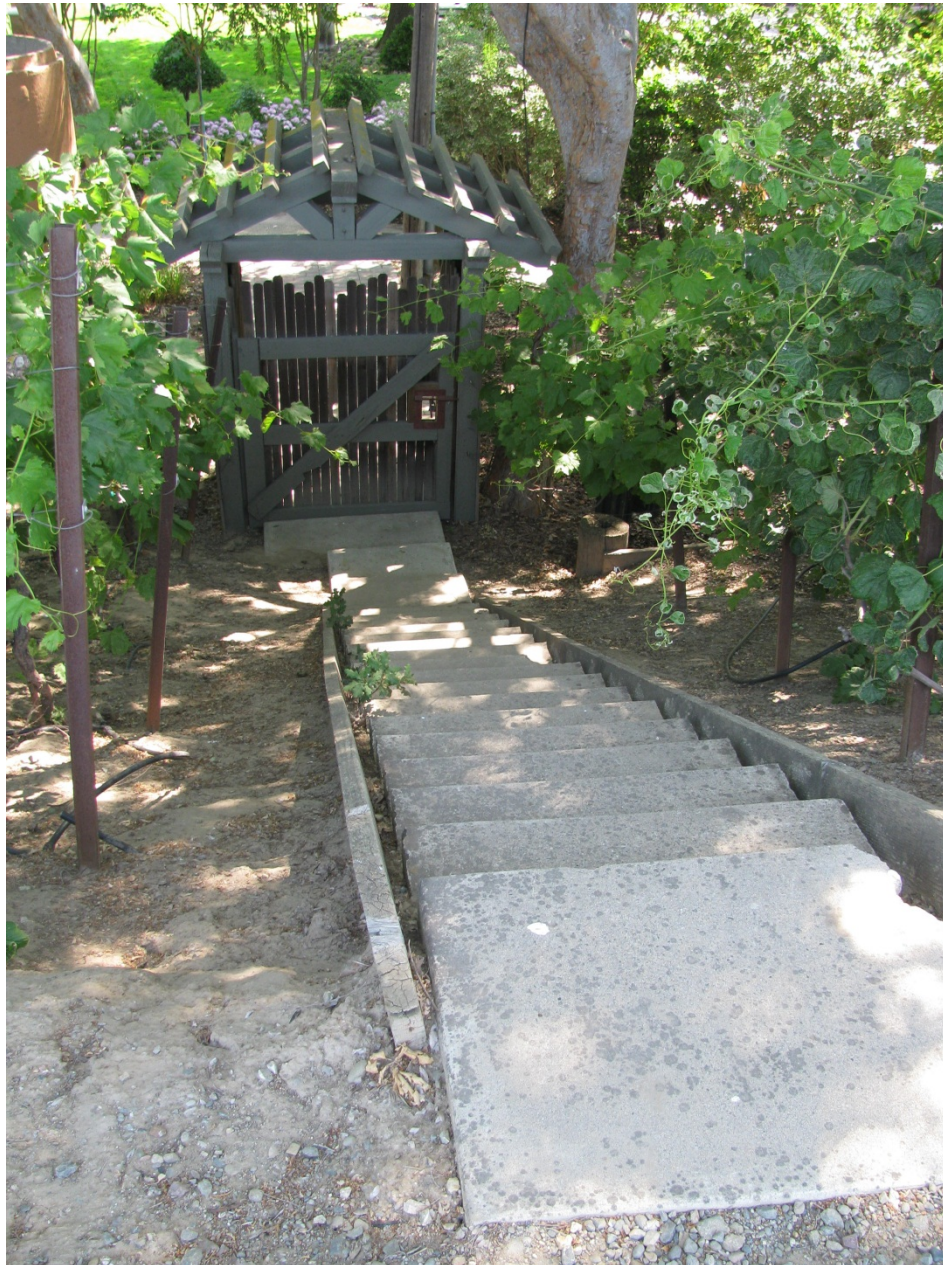
7.	Steps on landside slope, gate at landside toe. No permits found authorizing encroachments.	6(a), 126(a)(2), 137(c)(4)	4.25	n/a
8.	Wood deck, steps, concrete pad, and driveway attached to the brick building. No permits were found that authorize these encroachments.	6(a), 120(d), 137(d)	4.27 to 4.28	194

7. Steps on landside slope, fence at landside toe.

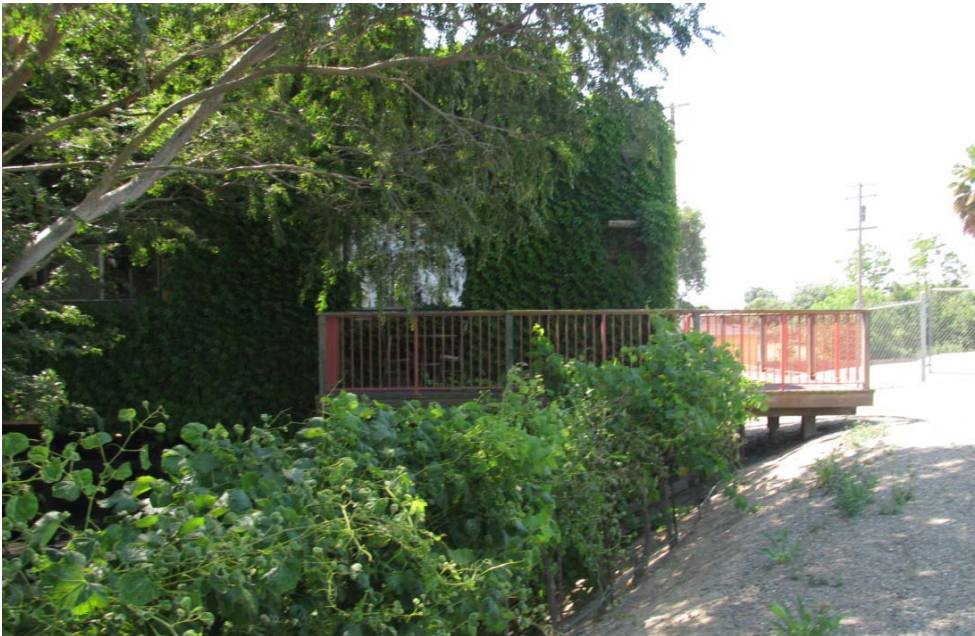
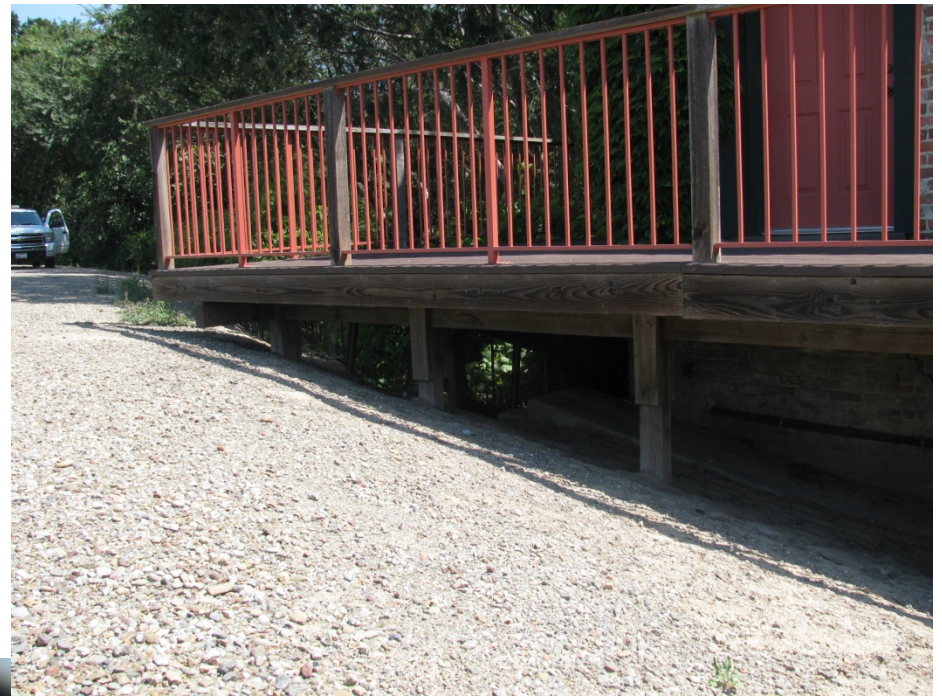
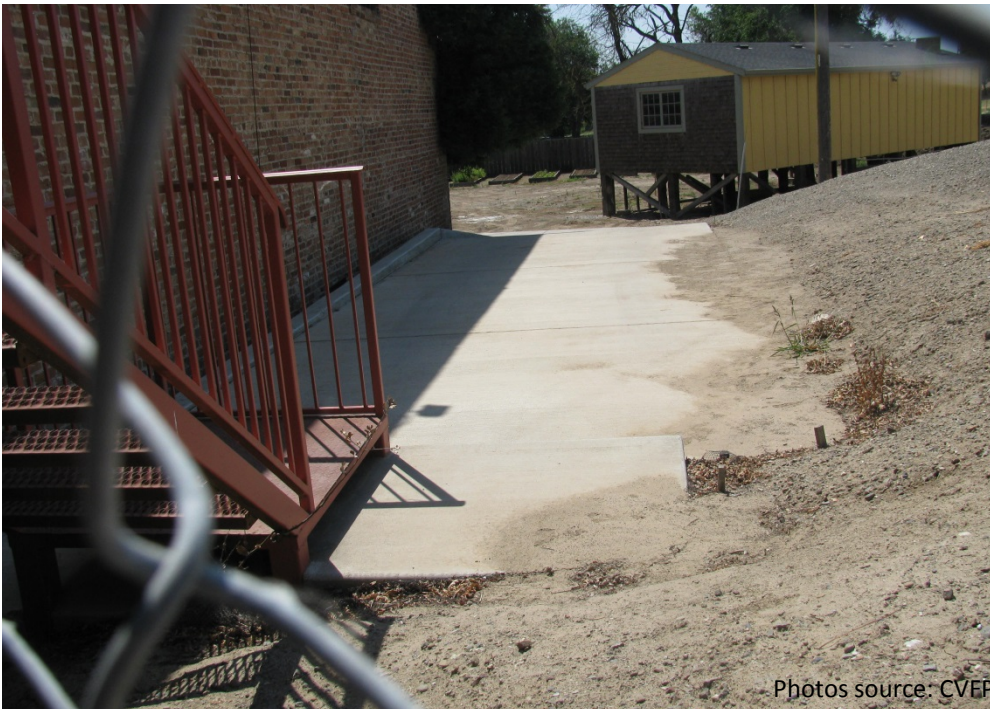
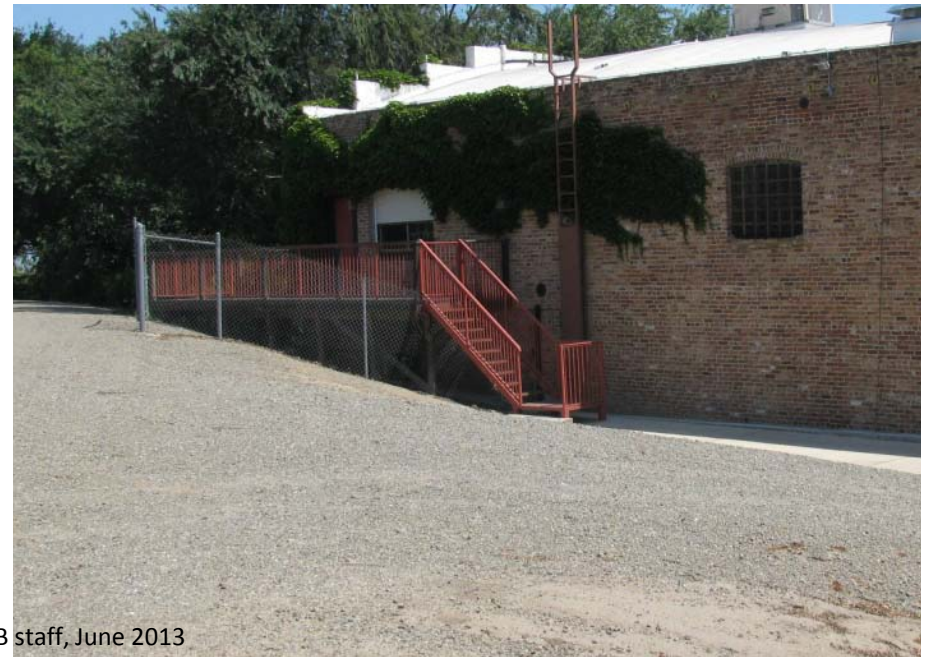
8. Wood deck, steps, concrete pad, and driveway attached to the brick building.

8. The unpermitted wood deck, steps, concrete pad, and driveway must be completely removed from the levee slope and from the easements held by the Sacramento-San Joaquin Drainage District and Reclamation District 17.
