CEASE AND DESIST ORDER

Encroachment Location: 1672 W Bowman Road
French Camp, California 95231
San Joaquin River East Project Levee, Right (East) Bank, Unit 2
Levee Mile 4.18 to 4.35
Latitude: 37°51'46.33"N, Longitude: 121°19'10.74"W

Subject: **Notice of Violation – Noncompliant Encroachments**
Enforcement Action: No. 2014-790

**NOTICE OF VIOLATION****NONCOMPLIANT ENCROACHMENTS**

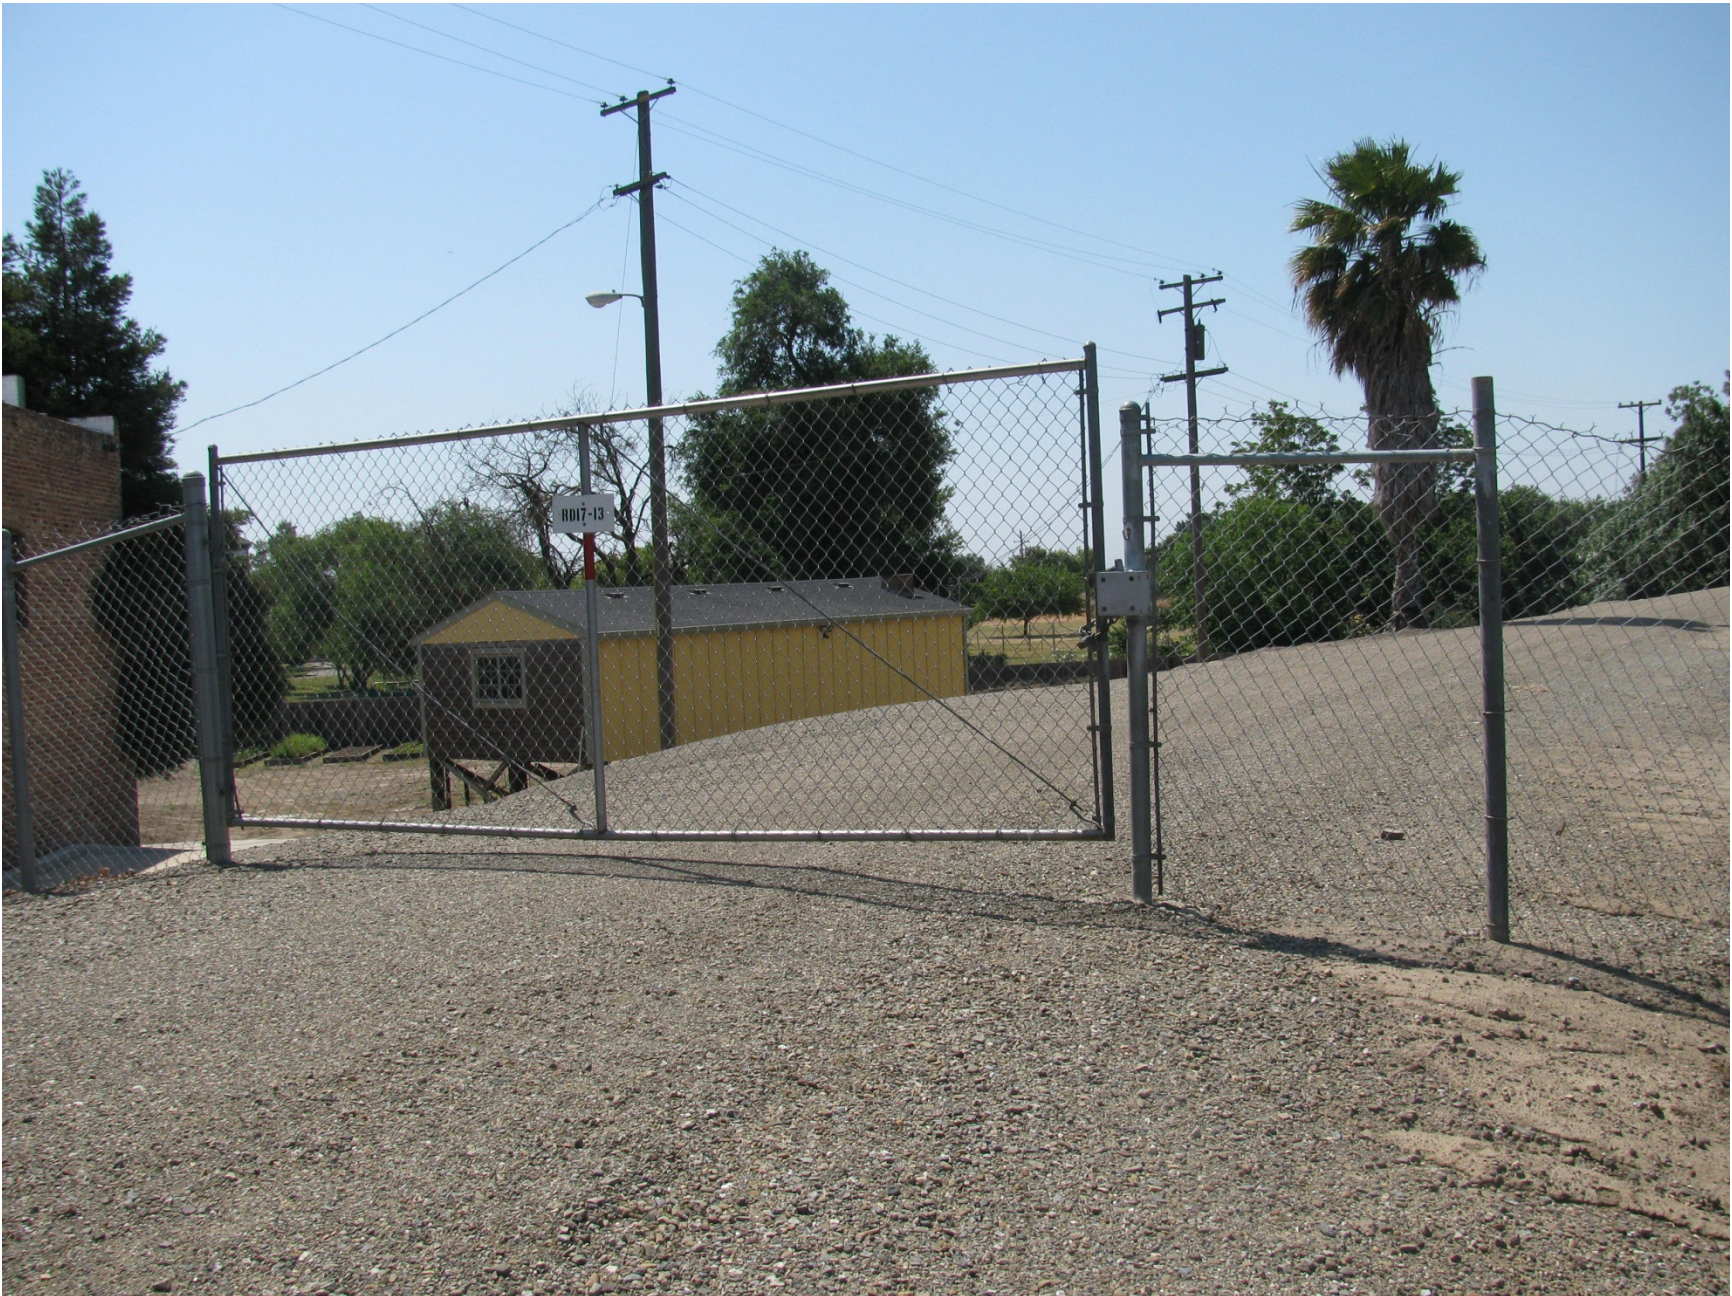
9.	Chain link fence crossing the levee with no encroachment permit found impedes levee maintenance and flood fight procedures.	6(a)	4.28	195
10.	Two-inch diameter steel pipe coming out of the landside slope appears abandoned, but not properly removed.	6(a), 124(a)	4.30	189

9. Chain link fence with gate crossing levee at levee mile 4.28.

9. Provide encroachment permit information for the chain link fence crossing the levee at levee mile 4.30. If none exists, remove the fence.
10. The two-inch diameter steel pipe in the landside slope does not have an encroachment permit, and therefore must be removed from the levee.

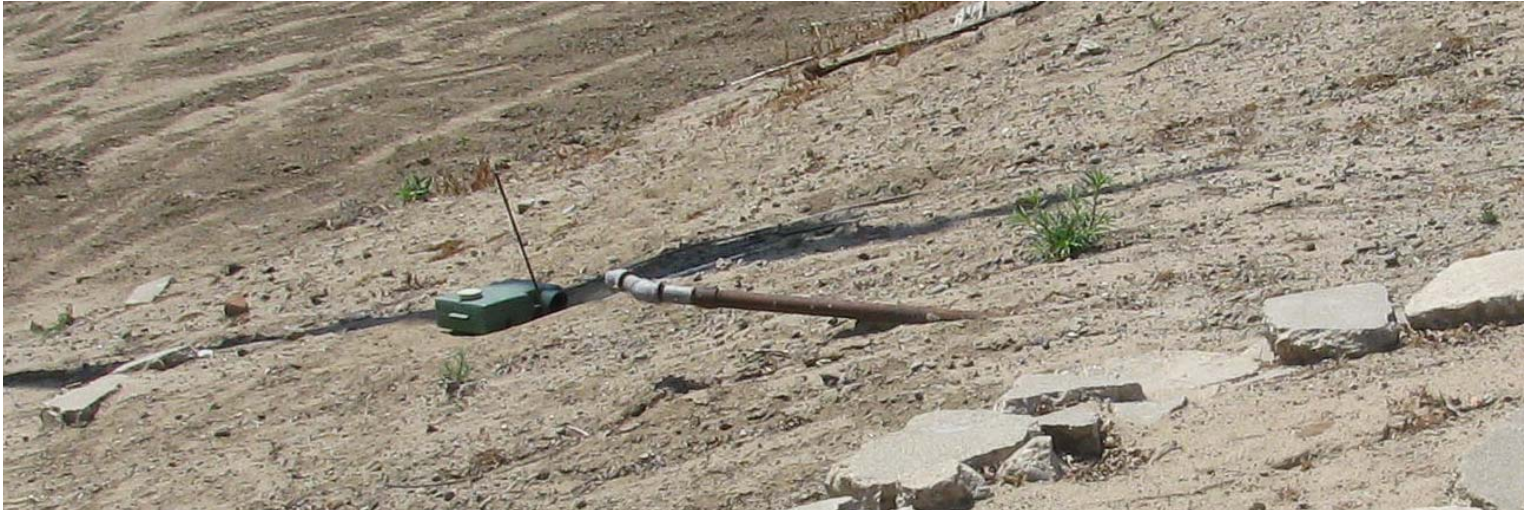
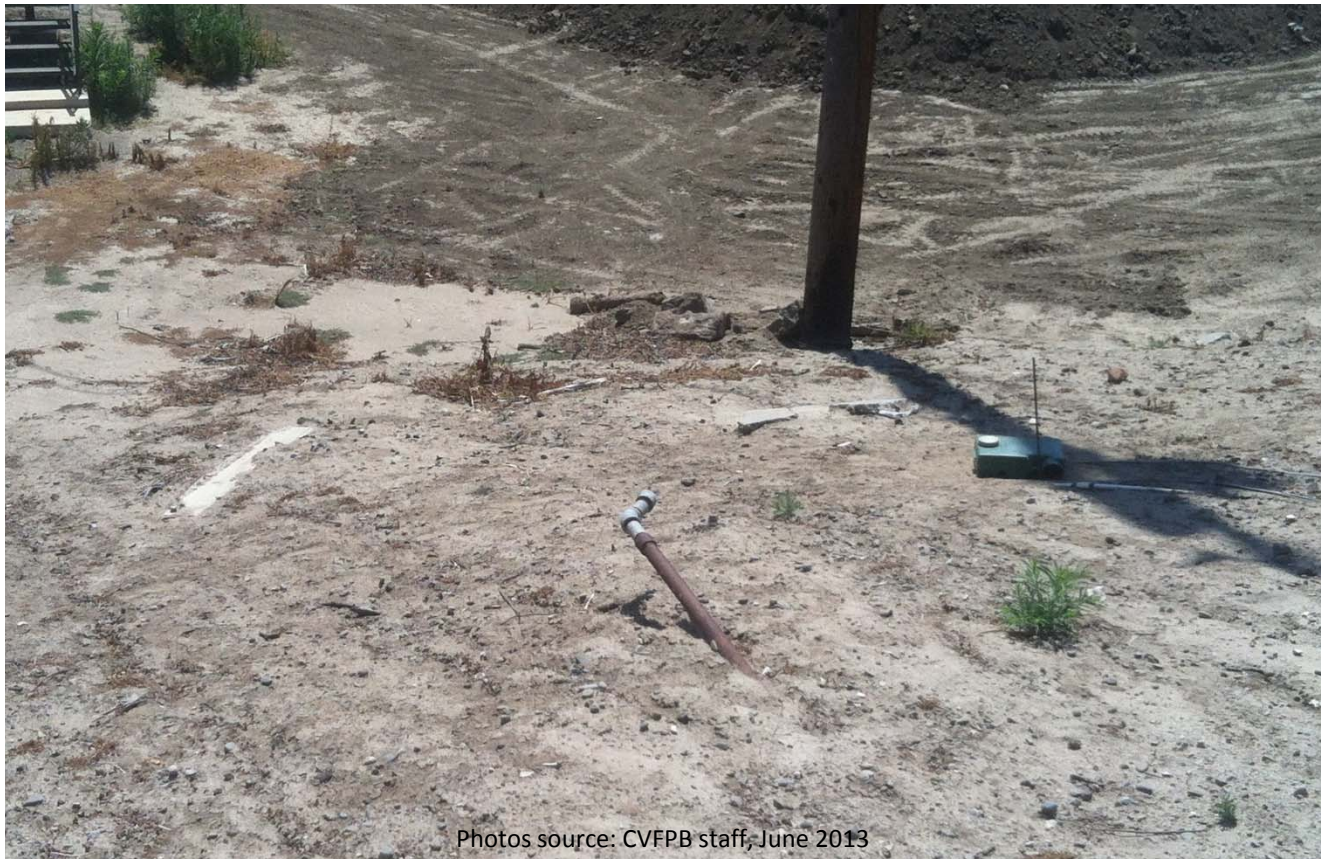
10. Two-inch steel pipe coming out of landside slope.

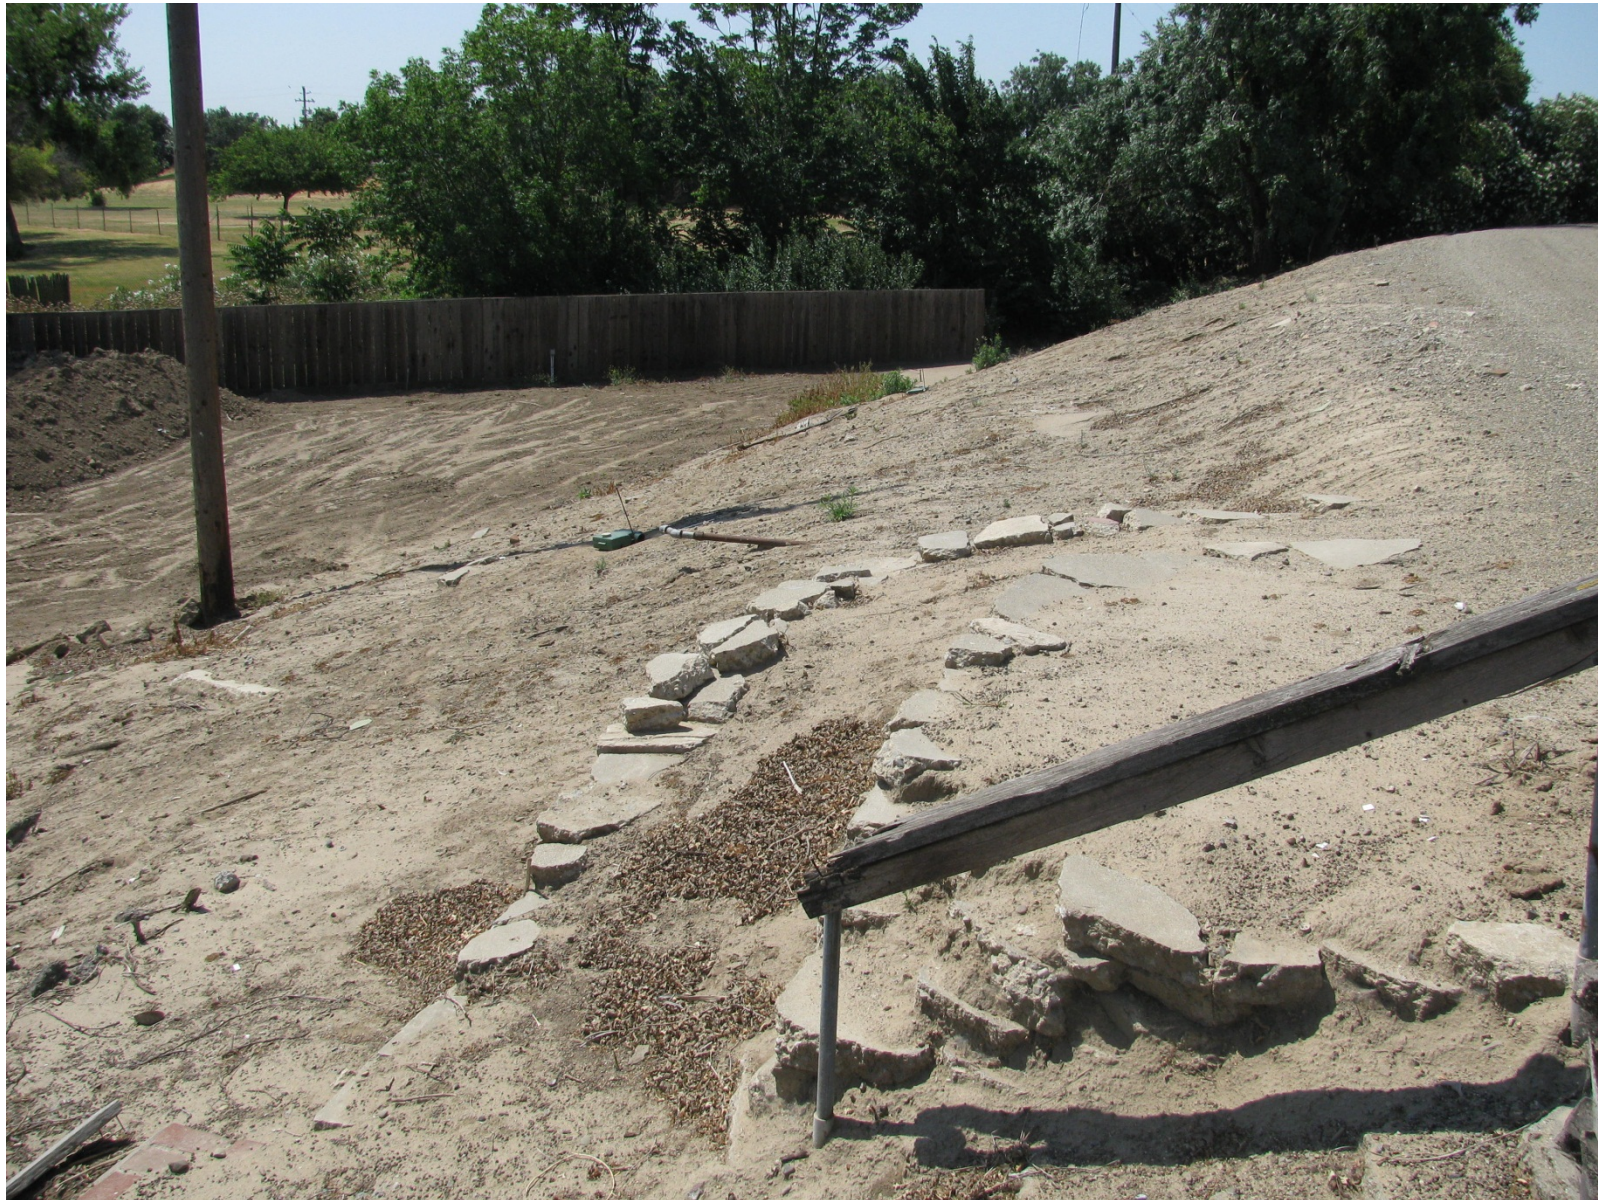
11.	Eroded steps with handrail and concrete-block retaining wall terracing the upper landside slope. No permits were found that authorize these encroachments. The encroachments are in poor condition and appear abandoned.	6(a), 125(a)(2)	4.30	190

11. Eroded steps with handrail and concrete-block retaining wall on upper landside slope

11. The eroded steps with handrail and concrete-block retaining walls on the landside slope must be removed from the levee.
12. The tropical tree, including its root ball, on the landside levee hinge must be removed from the levee.

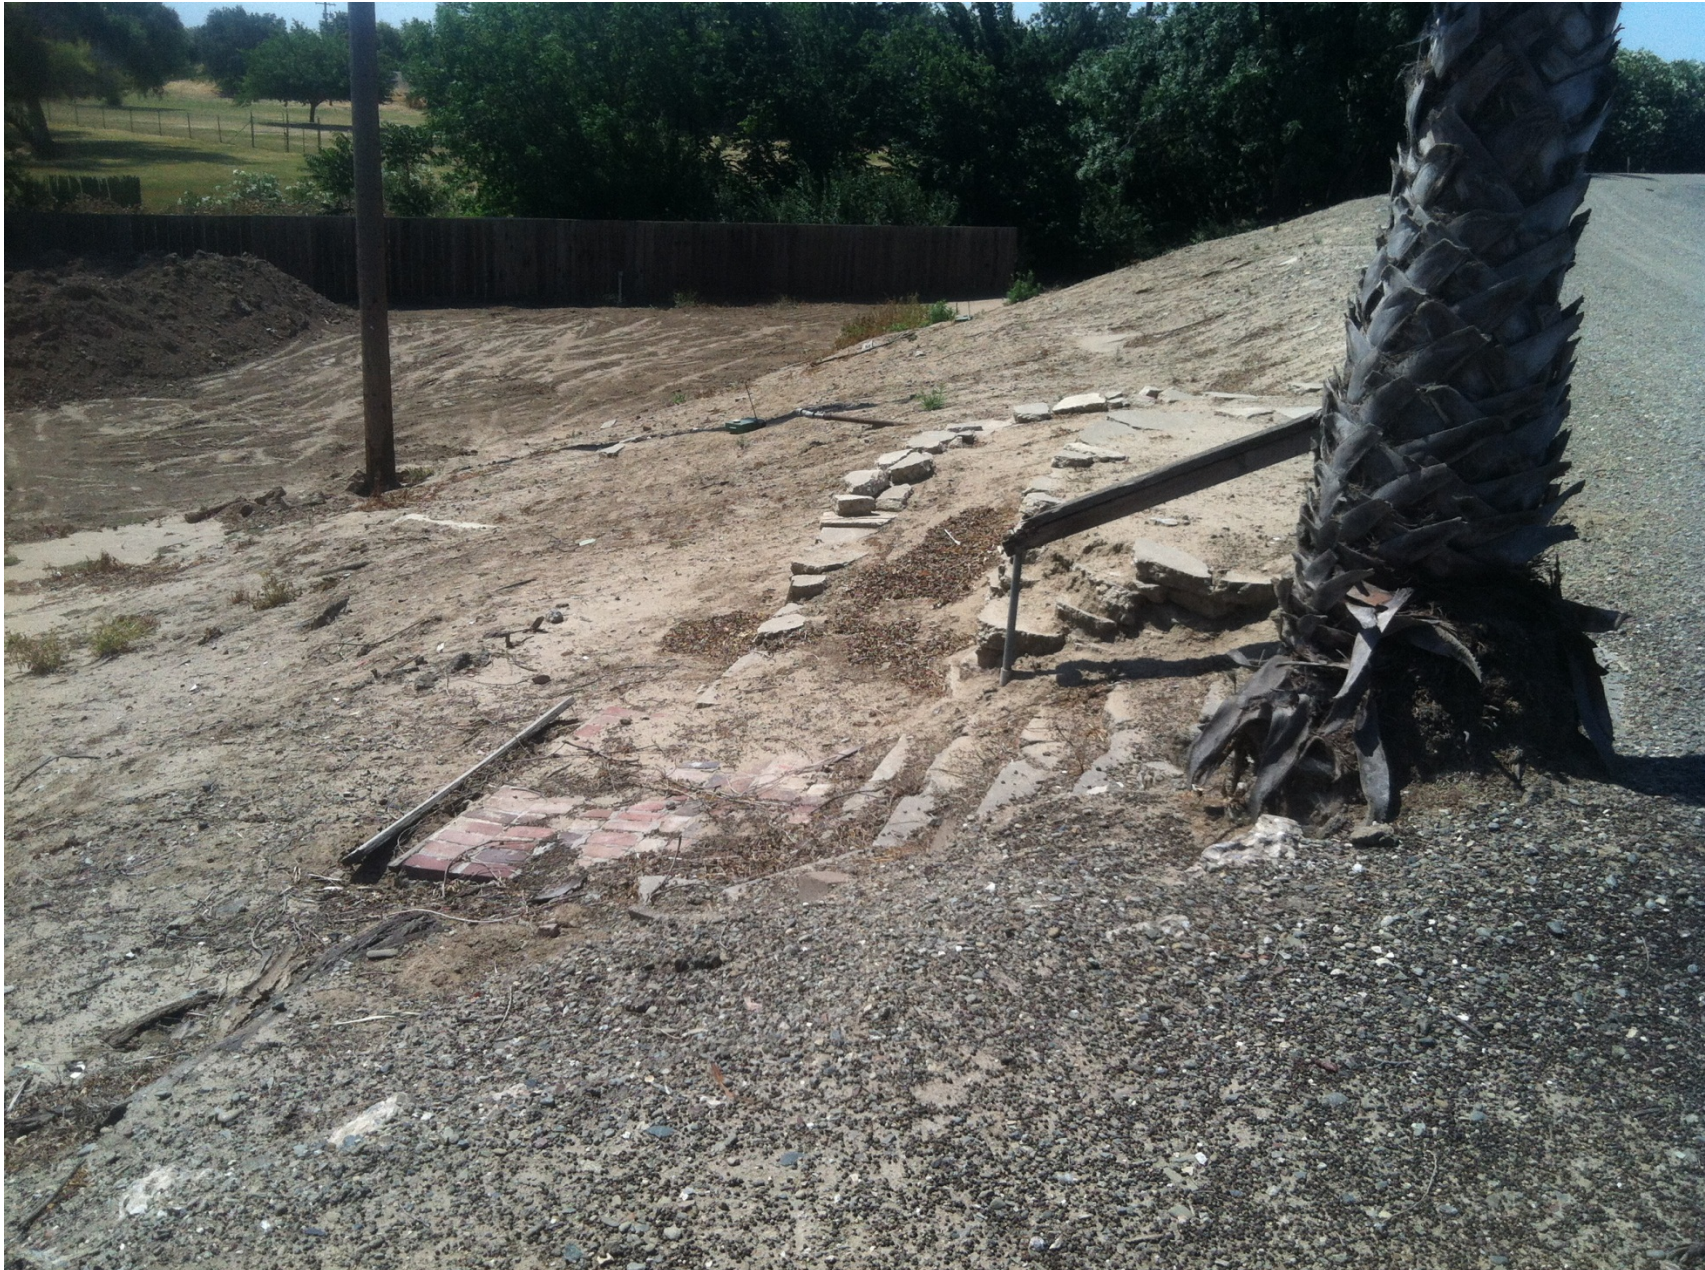
12.	Tall 18-inch-diameter tropical tree on landside hinge. No permits were found that authorize this encroachment.	131(f)(5)	4.30	191
13.	Wooden stairs with abandoned wood boat dock and fallen flag pole. No permits were found that authorize these encroachments. The encroachments are in hazardous condition and appear abandoned.	6(a), 127(a)(2)(A)(i)&(ii), 137(c)(4), 137(c)(5), 137(c)(6)	4.30	205

12. Tall 18-inch diameter tropical tree on landside hinge

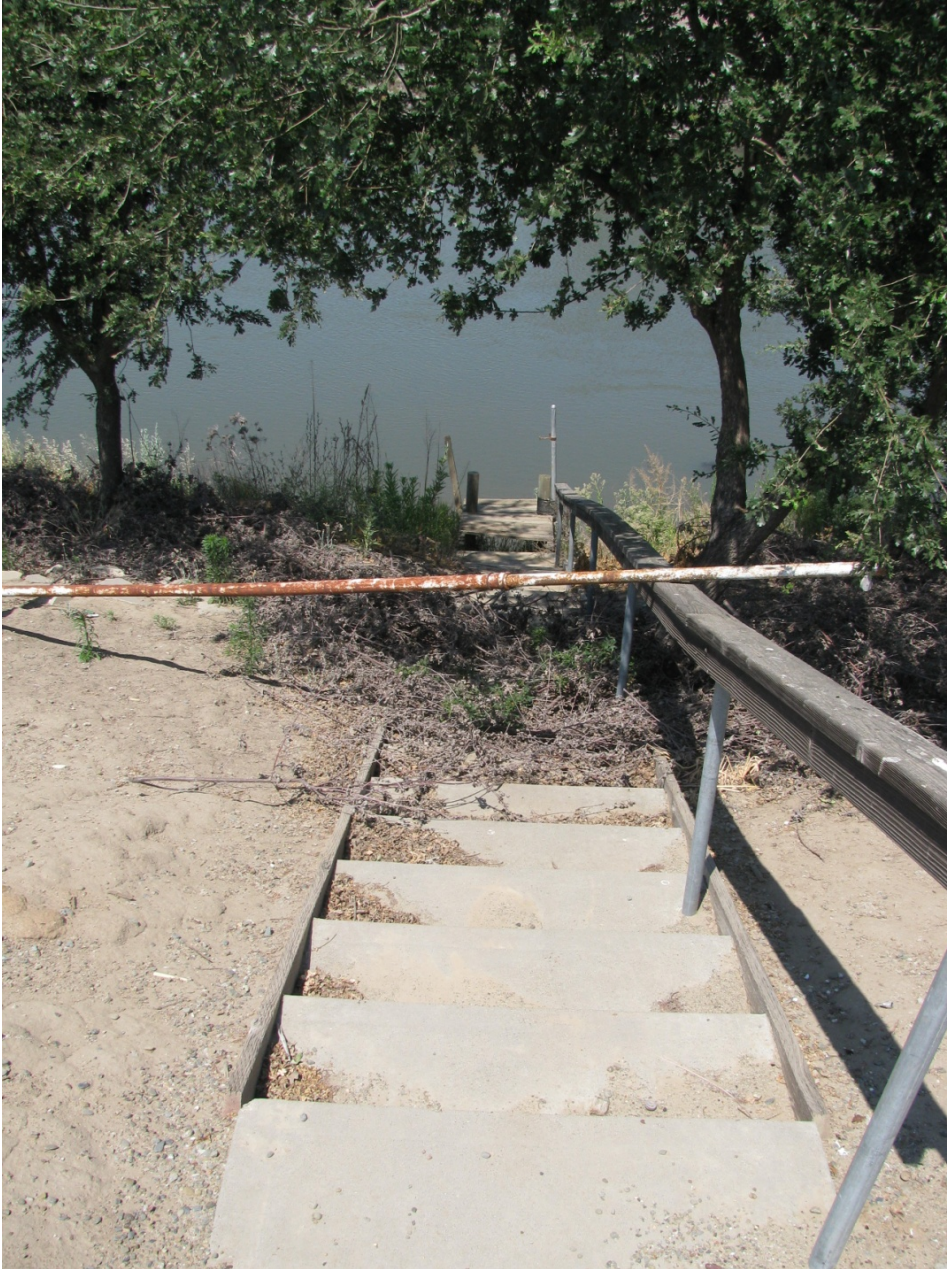
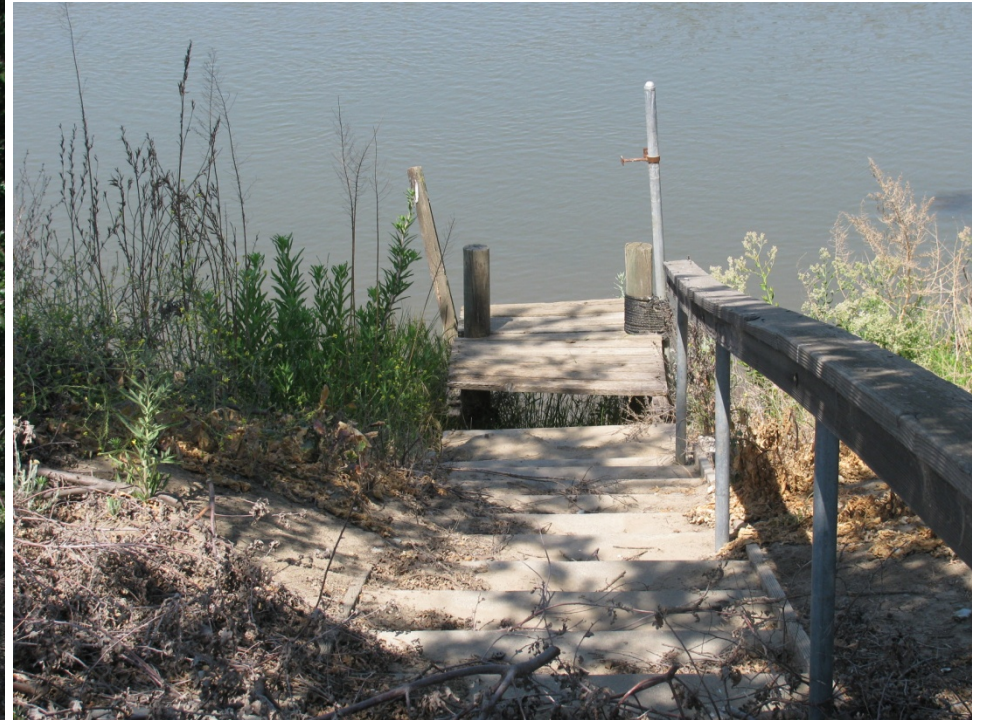
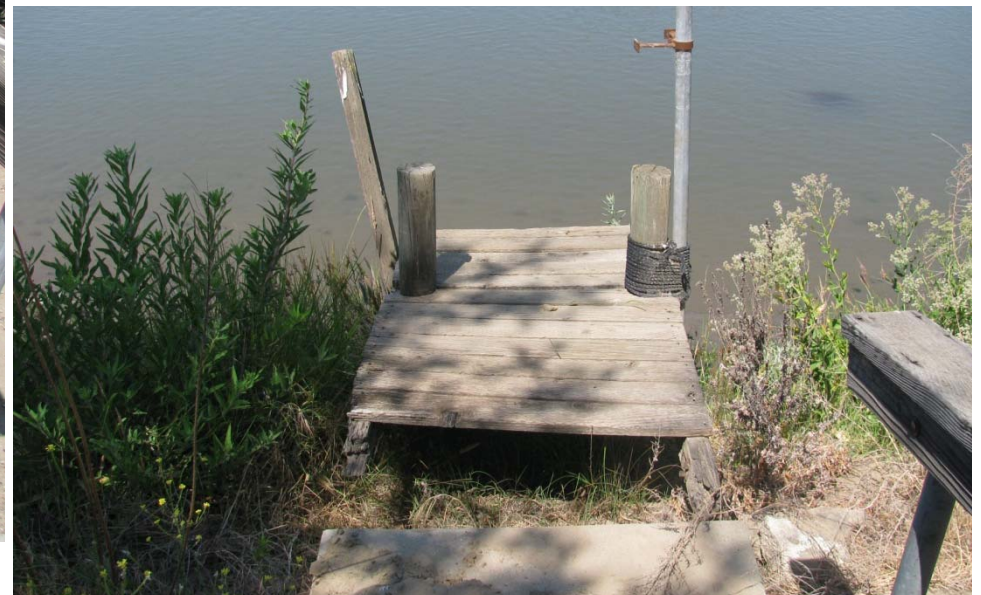
13. Wooden stairs with abandoned wood boat dock and fallen flag pole

13. The wooden stairs, abandoned wood boat dock, and fallen flag pole on the levee waterside must be removed.
14. Any excavation or voids must be backfilled and compacted, and the levee repaired in compliance with CCR Title 23. Any debris generated from the removal activities must be discarded out of the floodway and at least 10 feet away from the landside levee toe.
