**CEASE AND DESIST ORDER**

Subject: **Notice of Violation – Noncompliant Encroachments**  
**Enforcement Action: No. 2015-1200**

**NOTICE OF VIOLATION****NONCOMPLIANT ENCROACHMENTS****YOUR RESPONSE IS REQUIRED BY: April 10, 2015**

**Encroachment Location:** 3083 Garden Highway  
Sacramento, California 95833  
Sacramento River, Left (East) Bank, Unit 1  
Levee Mile 14.27  
Latitude: 38.624181 Longitude: -121.561103

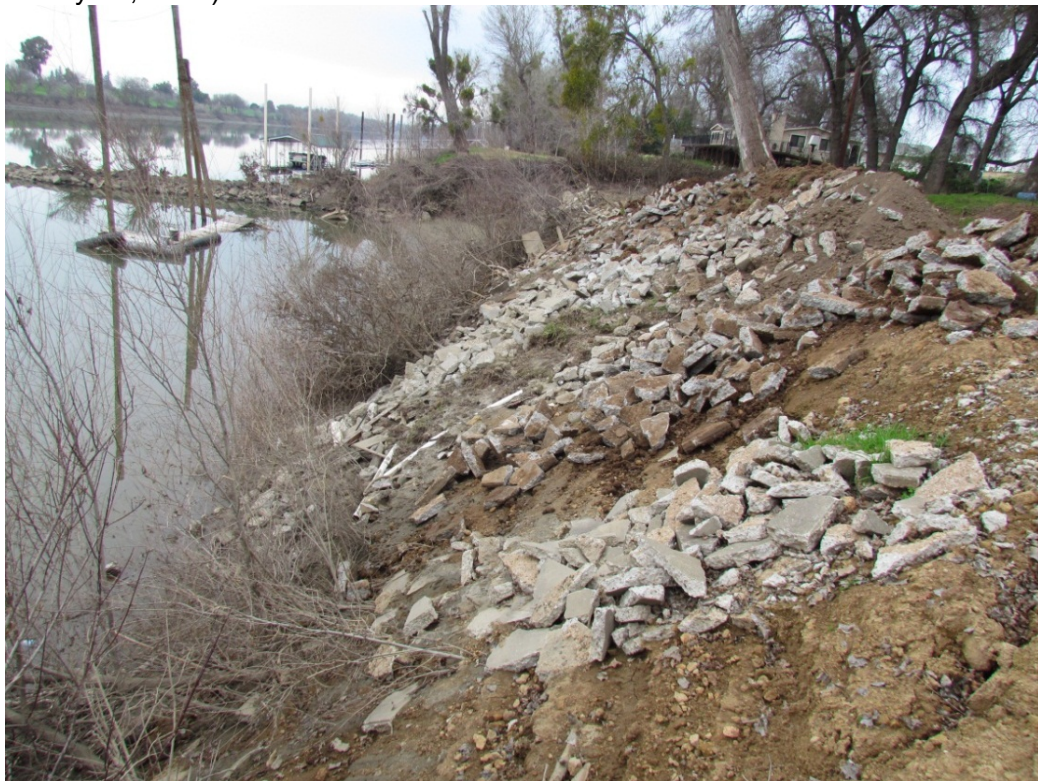
1. Soil and demolished concrete placed on the waterside levee berm and river bank in violation of California Code of Regulation (CCR) Title 23, Sections 6, 115(a), 115(d), and CWC Sections 8700 and 8710. The soil and demolished concrete may:
  - a. Reduce the flood-carrying capacity of the floodway.
  - b. Destabilize the riverbank.
  - c. Interfere with maintenance activities, inspections or flood fight activities.

Photo 1: Soil and demolished concrete placed on the waterside levee berm and river bank (DWR Inspection - January 28, 2015)

On or before April 10, 2015: Removal of the soil and demolished concrete on the waterside levee berm and river bank to a location outside of the floodway.

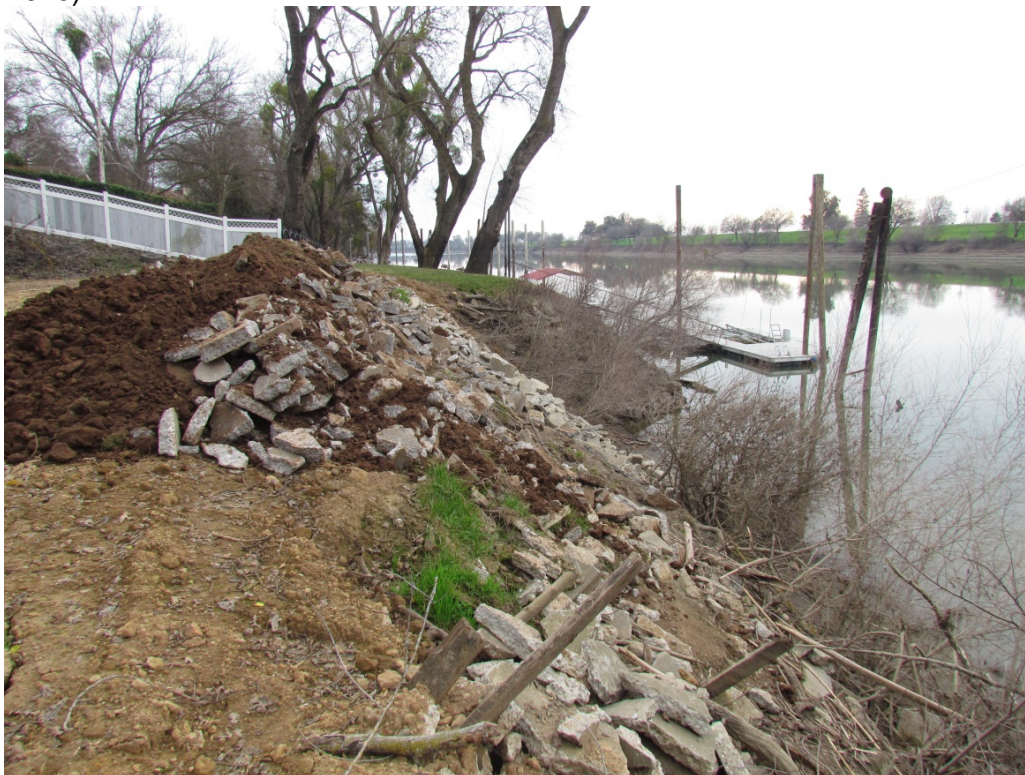
Photo 2: Soil and demolished concrete placed on the waterside levee berm and river bank (DWR Inspection – January 28, 2015)

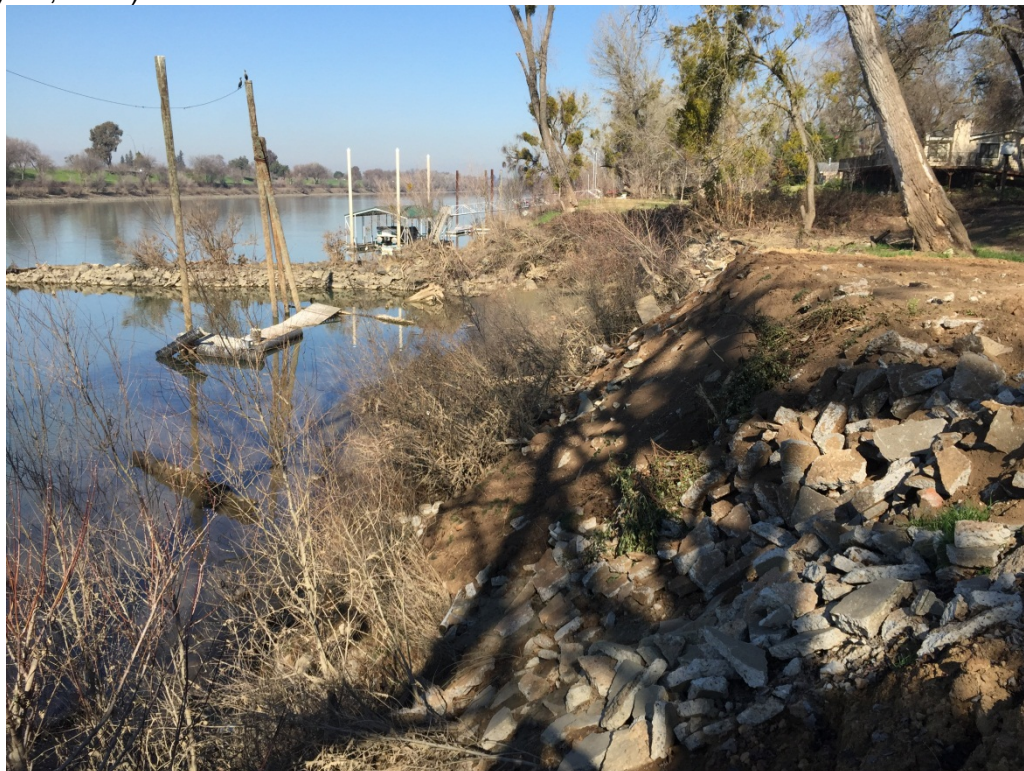
Photo 3: Soil and demolished concrete placed on the waterside levee berm and river bank (CVFPB site visit – January 30, 2015)
