**Meeting of the Central Valley Flood Protection Board
March 22, 2013**

Staff Report – Transmittal of Reclamation District 1001’s Letter of Intent for a System-Wide Improvement Framework to the U.S. Army Corps of Engineers

Sacramento and Sutter Counties

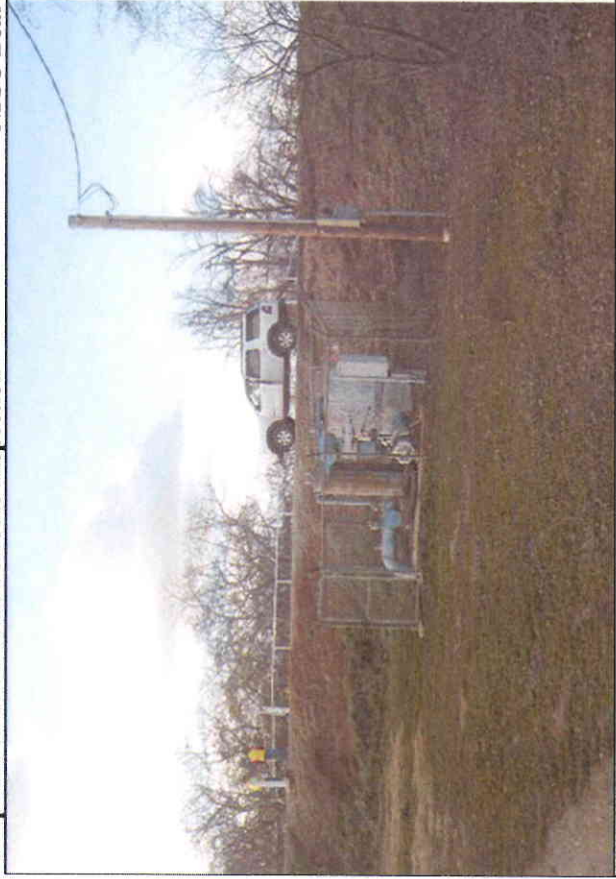
<p>Date Unknown: Currently pump is permitted and active. Pump, pipes and adjacent structures are maintained by the property owner. Levee Mile: 1.86</p>

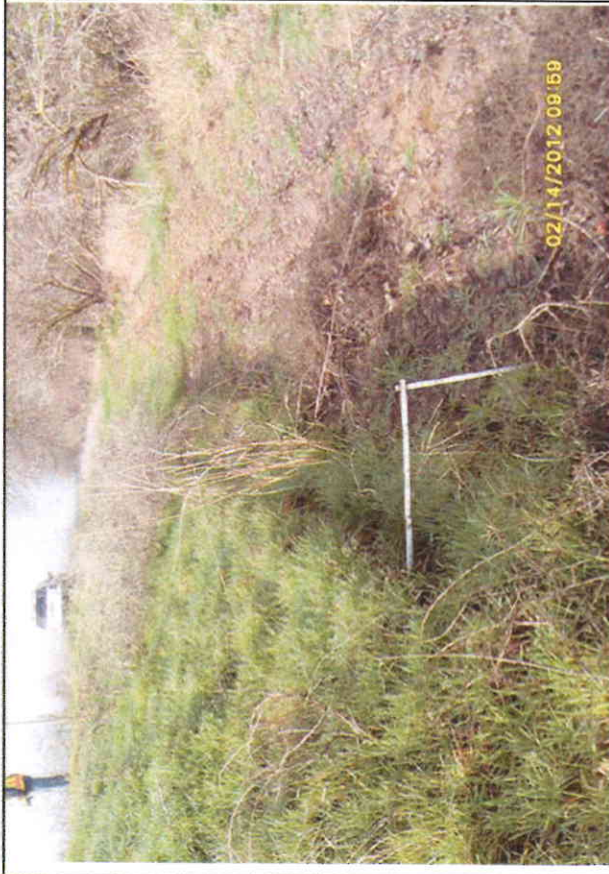
Inspect ID: NICU_2012_p_0165 Title: USACE_CESPK_NICU_2012_p_0165_1.jpg
Rated Item: 3. Encroachments Caption: Waterside toe cut, 2 feet deep, 200 feet long.
Likely due to maintenance vehicles. (U)

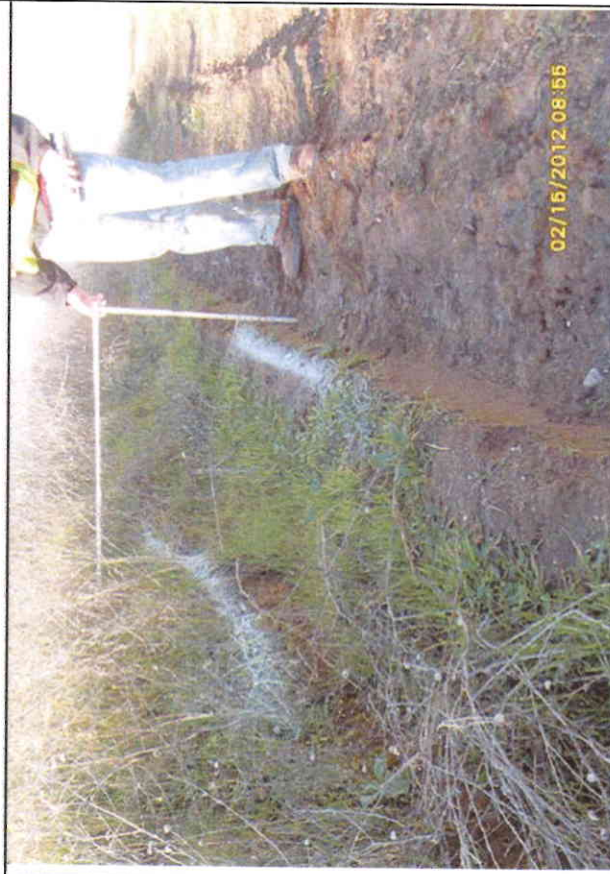
Inspect ID: NICU_2012_p_0324 **Title:** USACE_CESPK_NICU_2012_p_0324_1.jpg
Rated Item: 3. Encroachments **Caption:** Waterside toe cut, 2 feet deep, 100 feet long.
Likely due to maintenance vehicles. (U)

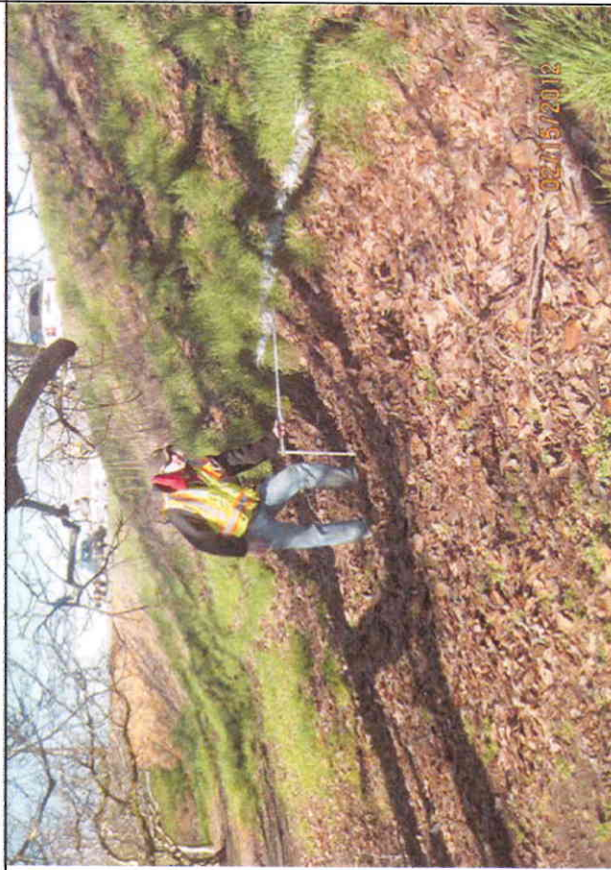
Inspect ID: NICU_2012_p_0347 **Title:** USACE_CESPK_NICU_2012_p_0347_1.jpg
Rated Item: 3. Encroachments **Caption:** Landside toe cut, 24 inches deep, about 100 to 150 feet long. (U)

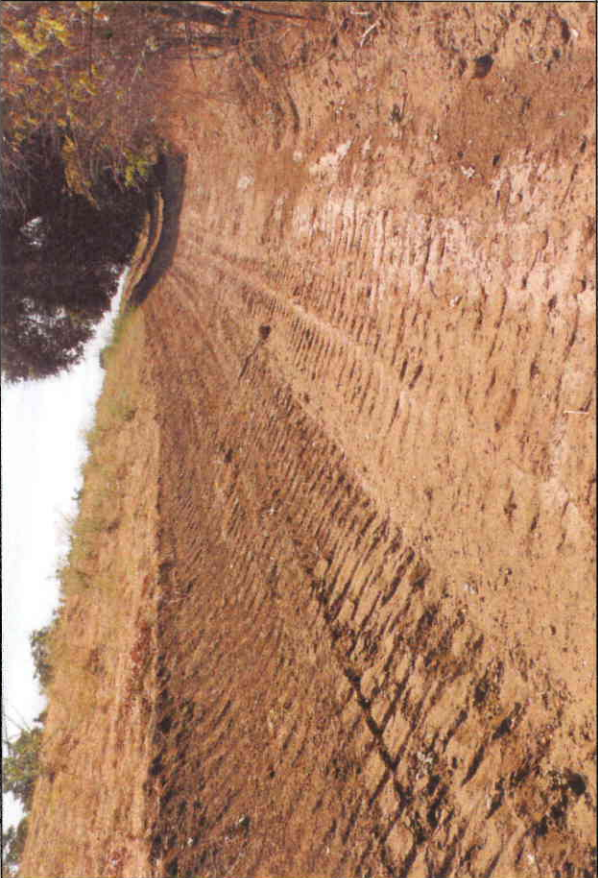
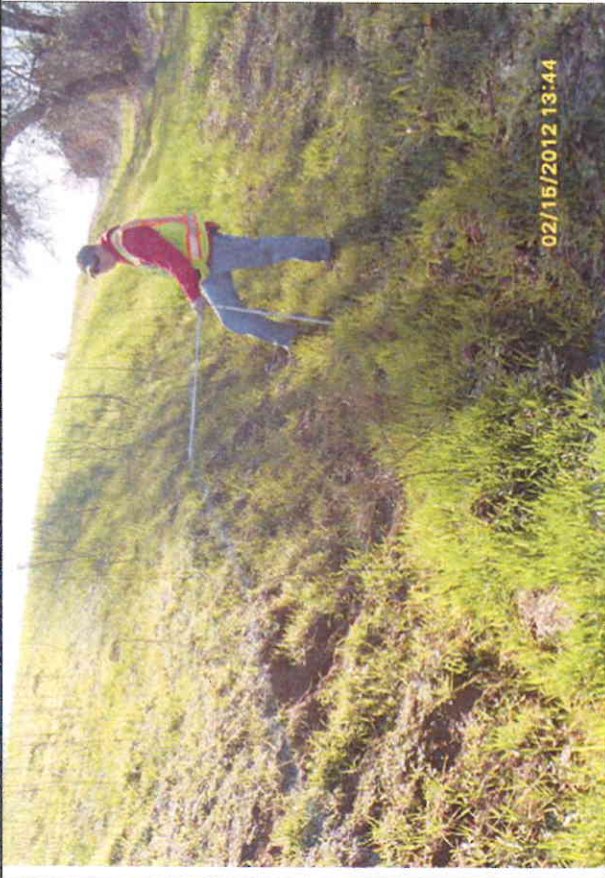
September 2012: Waterside toe cut removed Levee Mile: 7.74	
			Inspect ID: NICU_2012_p_0398 Title: USACE_CESPK_NICU_2012_p_0398_1.jpg Rated Item: 3. Encroachments Caption: Waterside toe cut, 48 inches deep, 20 feet long. Likely due to maintenance vehicles. (U)

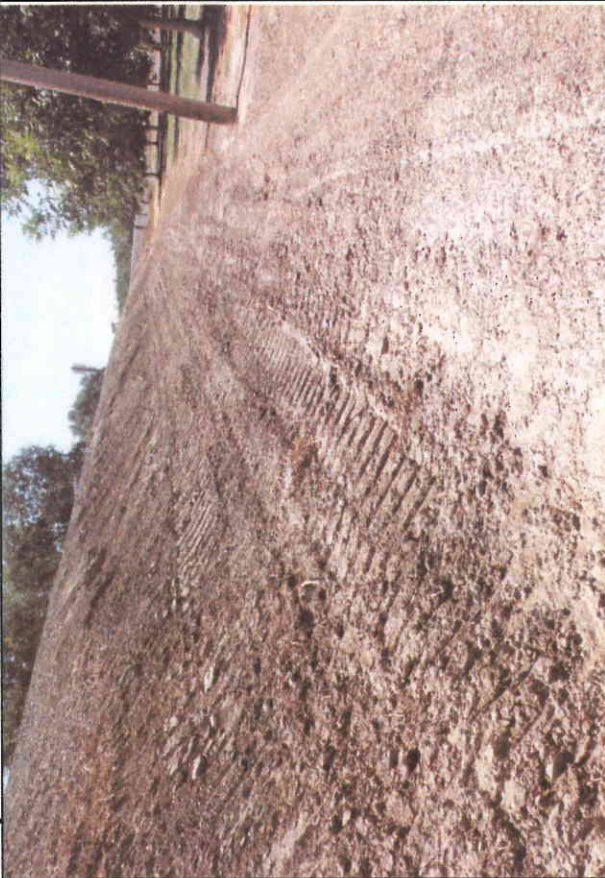
<p>September 2012: Landside toe cut removed Levee Mile: 2.74</p>	<p>Inspect ID: NIC1_2012_p_0076 Title: USACE_CESPK_NIC1_2012_p_0076_1.jpg Rated Item: 3. Encroachments Caption: Landside toe cut, 24 inches tall and 30 feet long. (U)</p>

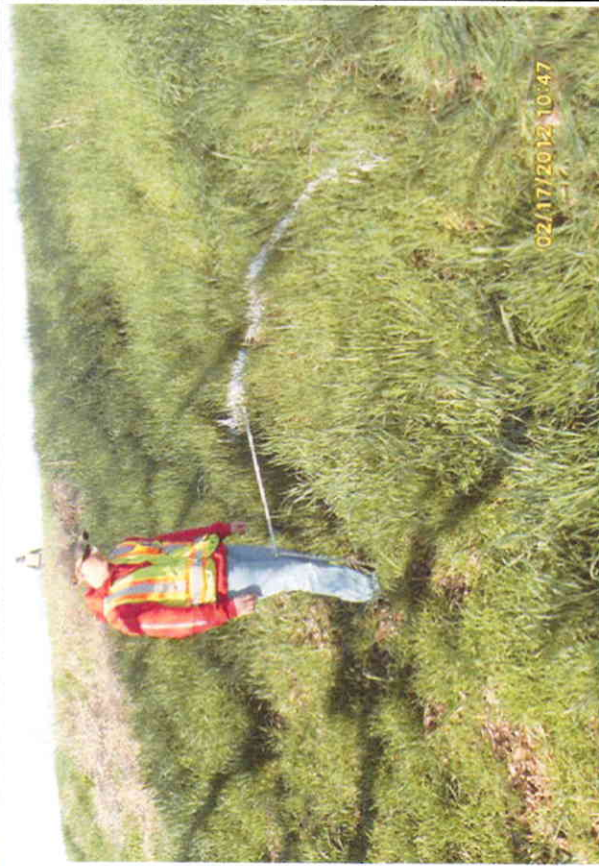
Inspect ID: NIC2_2012_p_0031 Title: USACE_CESPK_NIC2_2012_p_0031_1.jpg
Rated Item: 3. Encroachments Caption: Landside toe cut, up to 4 feet tall, 20 feet long.
(U)

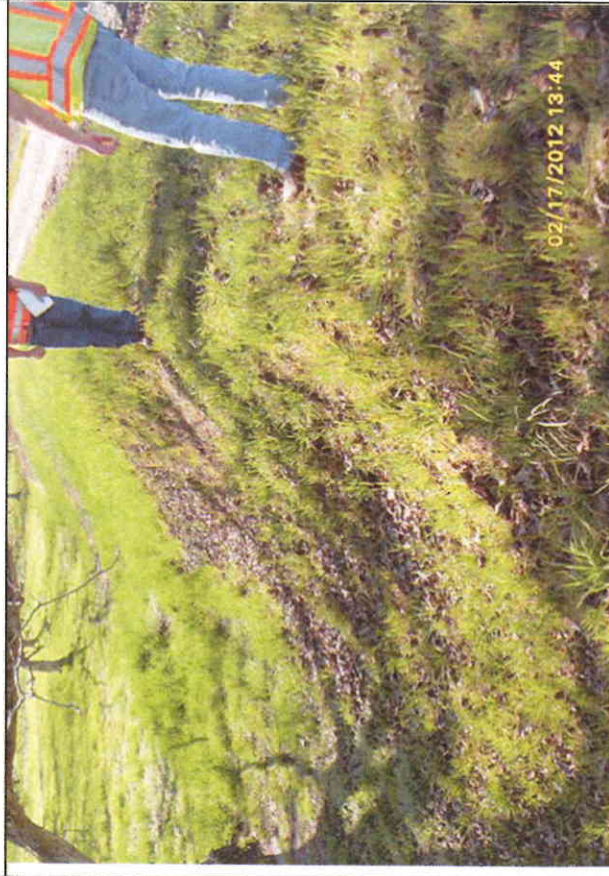
Inspect ID: NIC2_2012_p_0091 **Title:** USACE_CESPK_NIC2_2012_p_0091_1.jpg
Rated Item: 3. Encroachments **Caption:** Landside toe cut, about 5 feet tall, 30 feet long..
Landside slope is nearly vertical. (U)

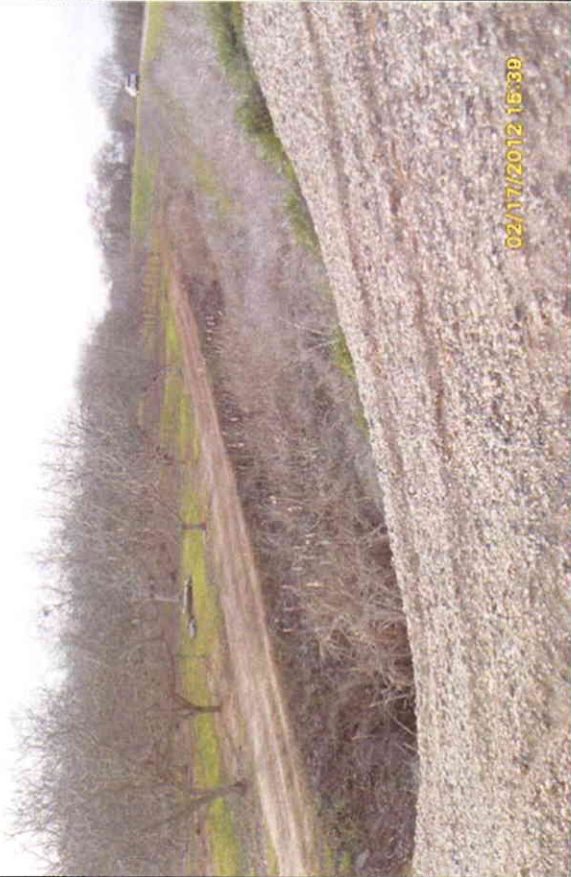
September 28, 2012: District drainage ditch currently in use to reclaim water as part of the District Drainage Facility. Levee Mile: 2.32

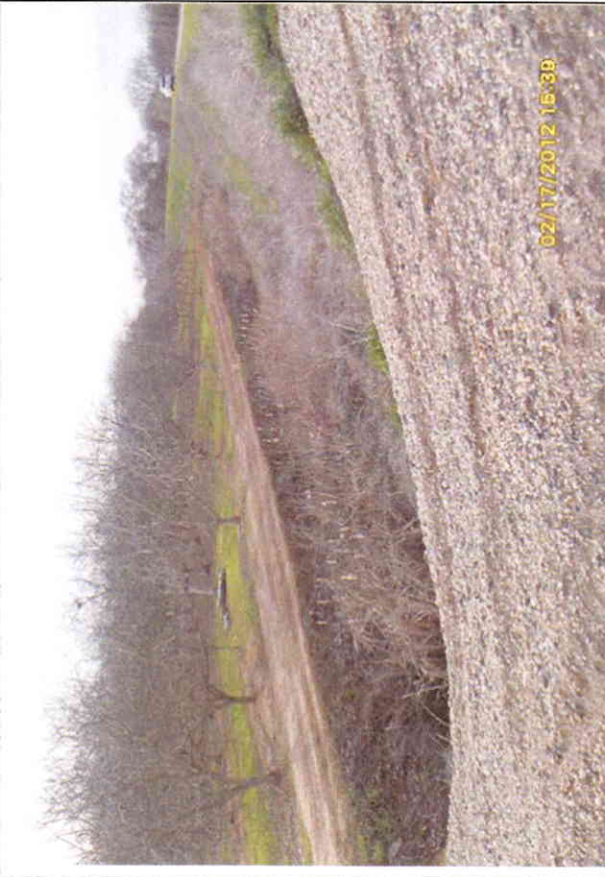
Inspect ID: NIC2_2012_p_0146 Title: USACE_CESPK_NIC2_2012_p_0146_1.jpg Rated Item: 3. Encroachments Caption: Start point. Ditch at toe, up to 12 feet wide and 5 feet deep. End point is (U)

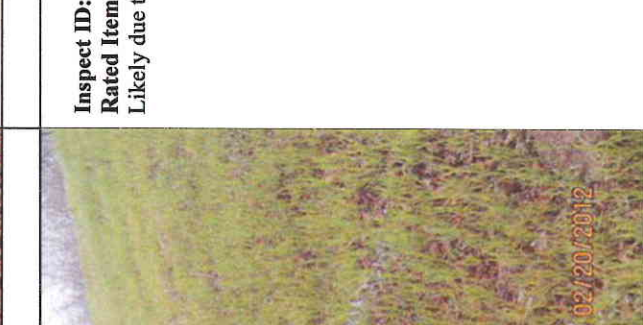
<p>Inspect ID: NIC2_2012_p_0172 Title: USACE_CESPK_NIC2_2012_p_0172_1.jpg Rated Item: 3. Encroachments Caption: Waterside toe cut, 24 inches tall, 50 feet long. Likely due to maintenance vehicles. (U)</p>

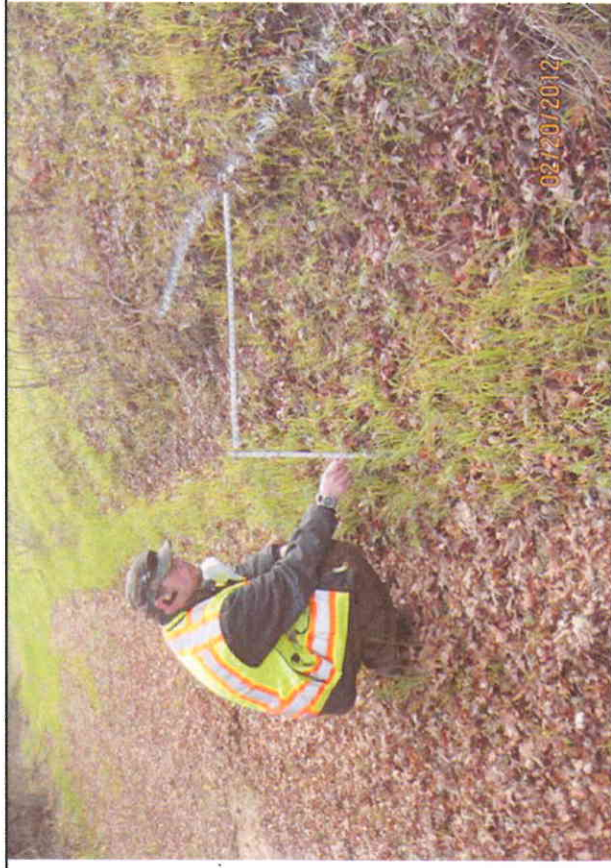
Inspect ID: NIC2_2012_p_0183 **Title:** USACE_CESPK_NIC2_2012_p_0183_1.jpg
Rated Item: 3. Encroachments **Caption:** Waterside toe cut, 24 inches tall, 100 feet long.-
Likely due to maintenance vehicles. (U)

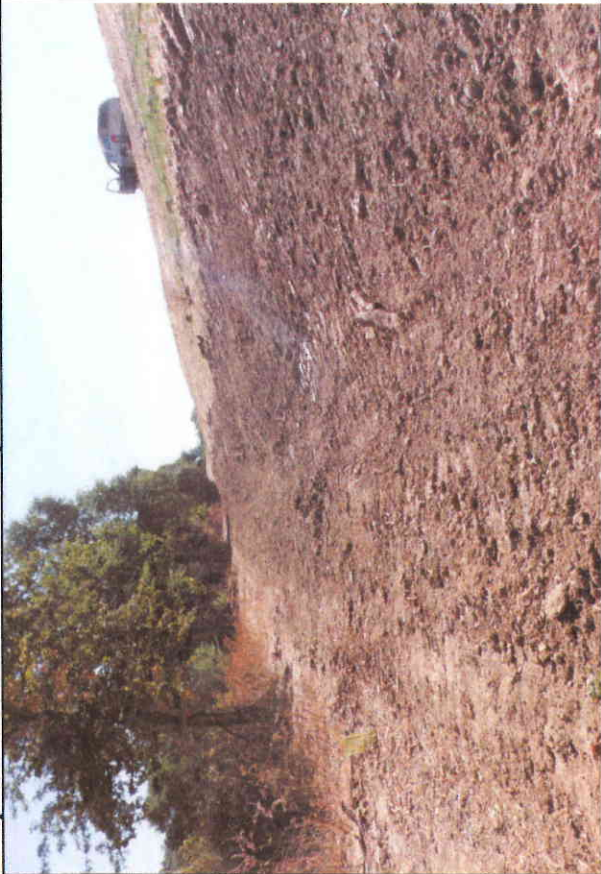
<p>September 2012: Waterside toe cut removed Levee Mile: 3.14</p>	<p>Inspect ID: NIC2_2012_p_0191 Title: USACE_CESPK_NIC2_2012_p_0191_1.jpg Rated Item: 3. Encroachments Caption: Waterside toe cut, 24 inches tall, 50 feet long.. Likely due to maintenance vehicles. (U)</p>

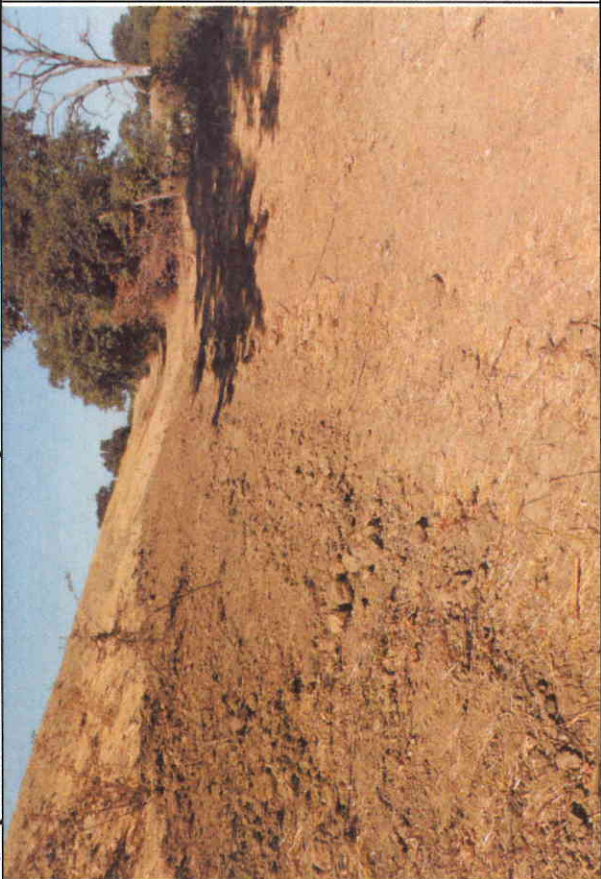
<p>September 2012: Waterside toe cut removed Levee Mile: 3.40</p>	<p>Inspect ID: NIC2_2012_p_0201 Title: USACE_CESPK_NIC2_2012_p_0201_1.jpg Rated Item: 3. Encroachments Caption: Waterside toe cut, 18 to 24 inches tall. Likely due to maintenance vehicles. (U)</p>

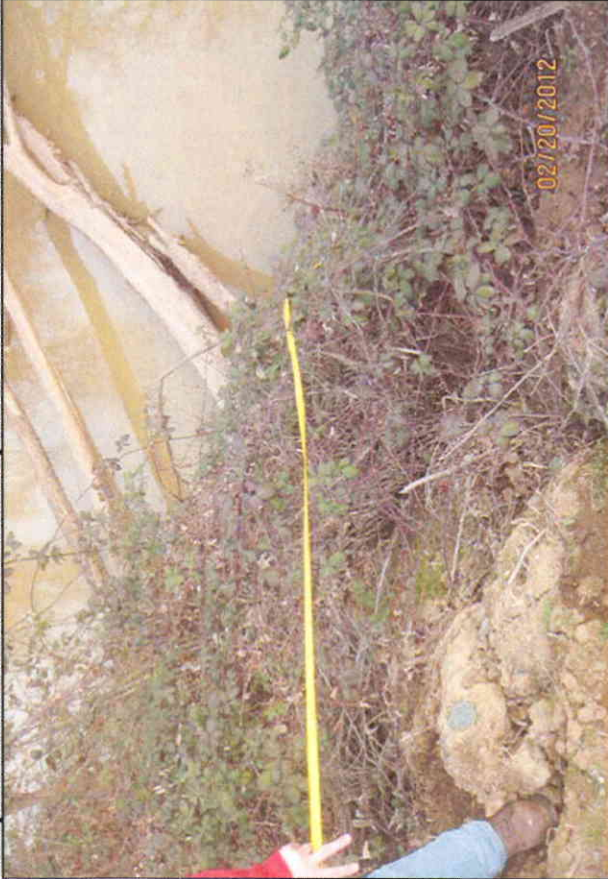
Erosion/Bank Caving

September 28, 2012: Currently management and staff are determining the most effective way to repair erosion/bank caving.
Levee Mile: 3.65

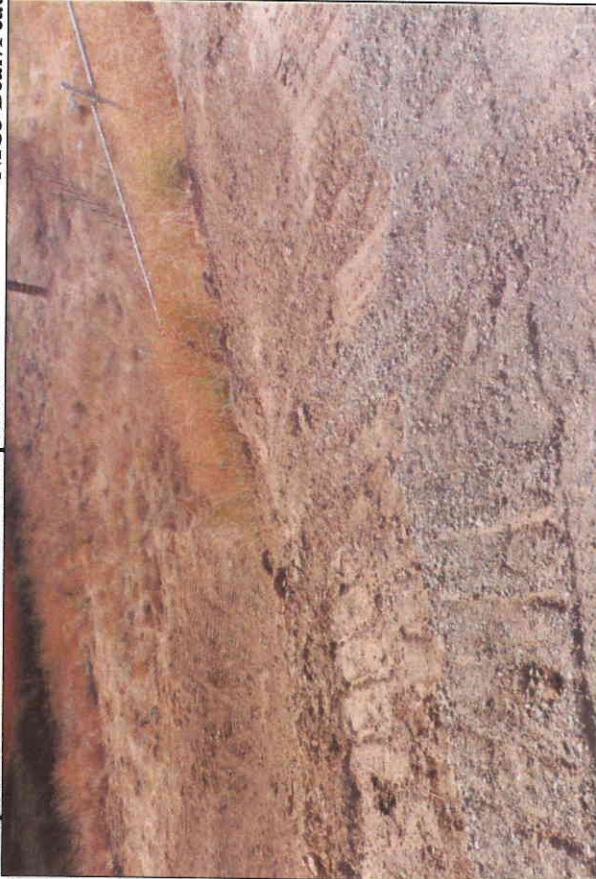
Sod Cover

**August 2012: Erosion rill corrected
Levee Mile: 10.03**

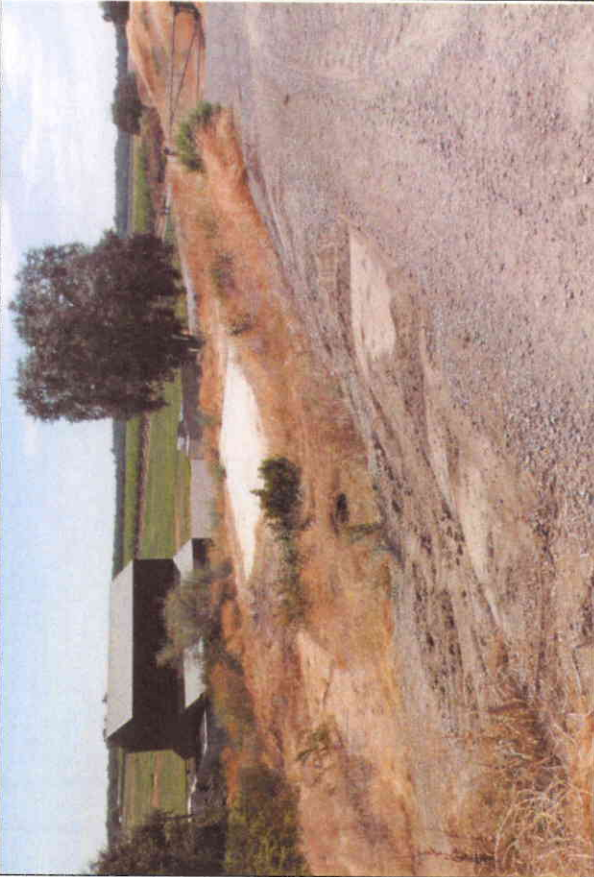
<p>Inspect ID: NIC3_2012_p_0136 Title: USACE_CESPK_NIC3_2012_p_0136_1.jpg Rated Item: 3. Encroachments Caption: 3 inch pipe through levee, part of pipe is PVC slip lined. No positive closure observed. Located less than a foot below crown. (U)</p>

<p>August 2012: Pipe removed Levee Mile: 11.89</p>

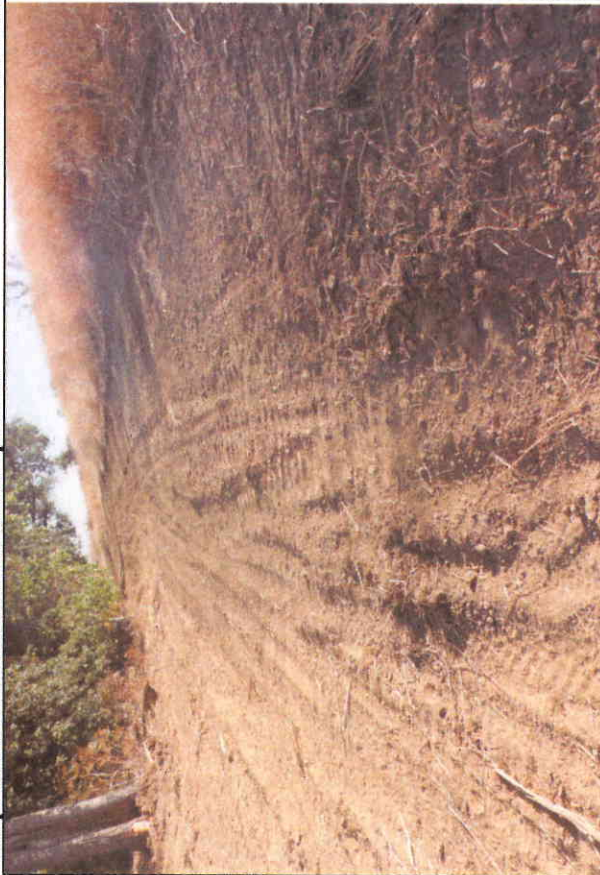
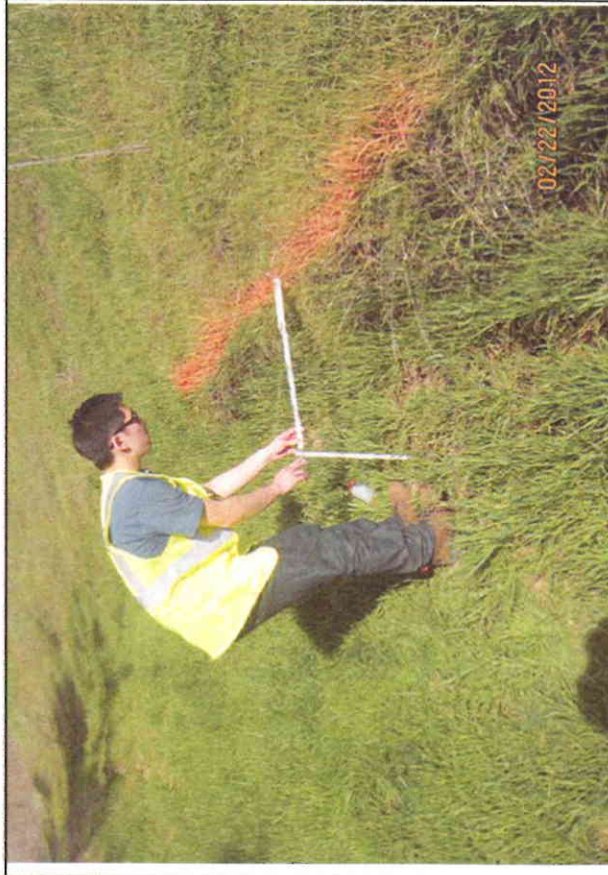
**Inspect ID: NIC3_2012_p_0150 Title: USACE_CESPK_NIC3_2012_p_0150_1.jpg
Rated Item: 3. Encroachments Caption: Waterside toe cut, 12 to 24 inches tall. Likely
due to maintenance vehicles. (U)**

**August 2012: Waterside toe cut removed
Levee Mile: 12.08**

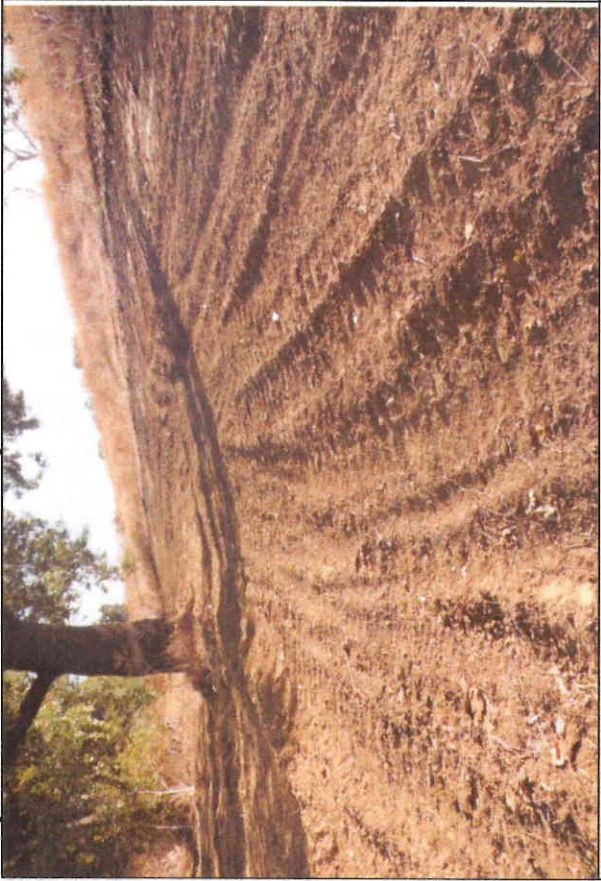
<p>August 2012: Waterside toe cut removed Levee Mile: 12.33</p>	<p>Inspect ID: NIC3_2012_p_0158 Title: USACE_CESPK_NIC3_2012_p_0158_1.jpg Rated Item: 3. Encroachments Caption: Waterside toe cut, up to 30 inches tall, 150 feet long. Likely due to maintenance vehicles. (U)</p>

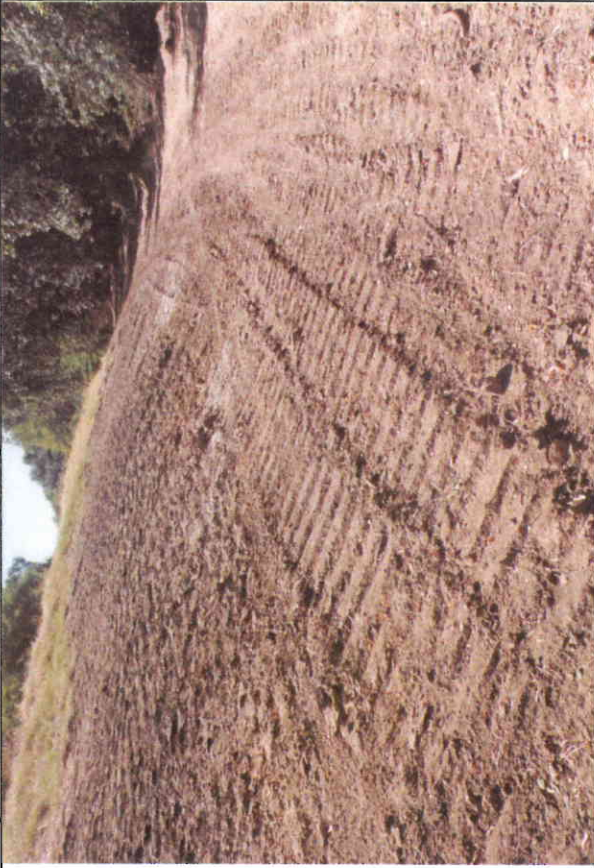
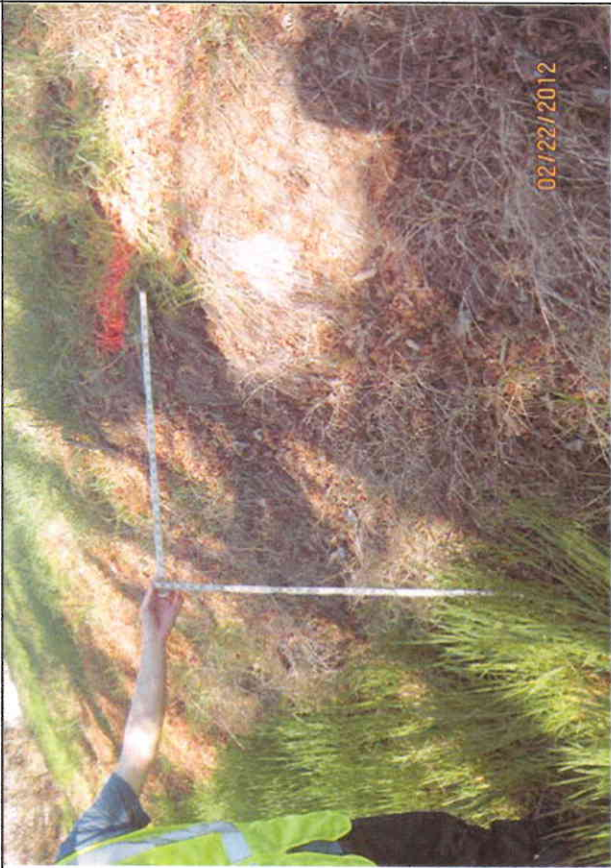
Inspect ID: NIC4_2012_p_0001 Title: USACE_CESPK_NIC4_2012_p_0001_1.jpg Rated Item: 3, Encroachments Caption: Start point. Vertical waterside toe cut up to 2.5 feet tall. Likely due to maintenance vehicles. End point is 21. (U)

August 2012: Waterside toe cut removed Levee Mile: .03

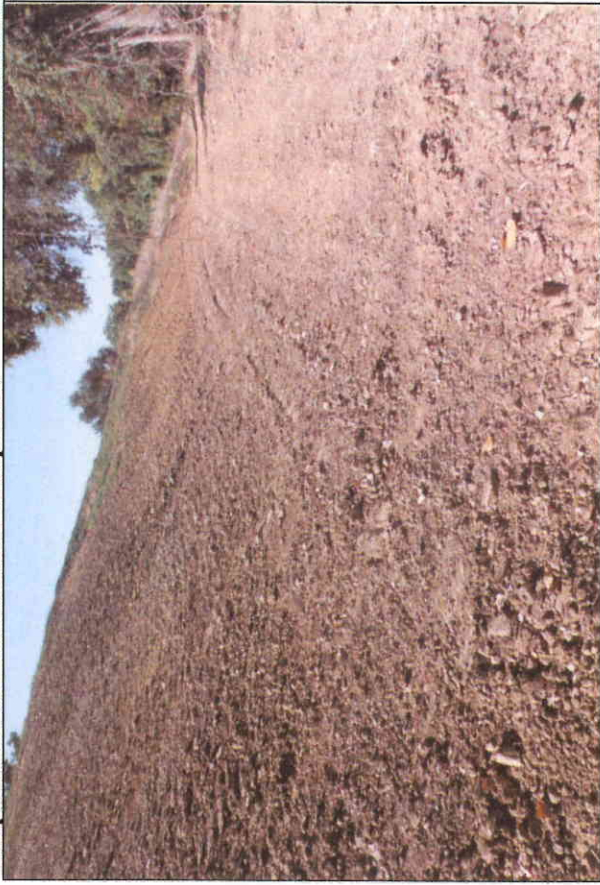
<p>August 2012: Waterside toe cut removed Levee Mile: 2.71</p>	<p>Inspect ID: NIC4_2012_p_0172 Title: USACE_CESPK_NIC4_2012_p_0172_1.jpg Rated Item: 3. Encroachments Caption: Start point. Vertical waterside toe cut 2 to 4 feet tall. Likely due to maintenance vehicles. End point is 207. (U)</p>

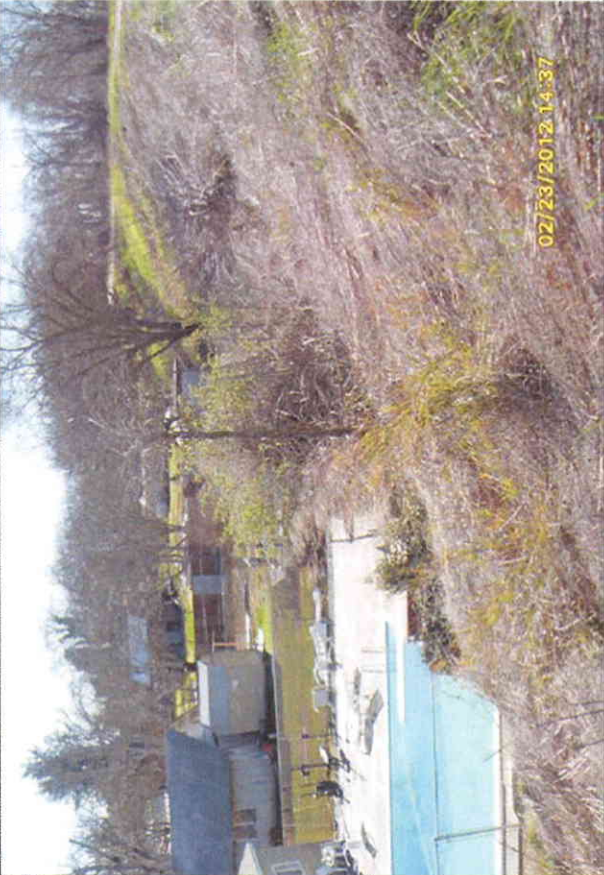
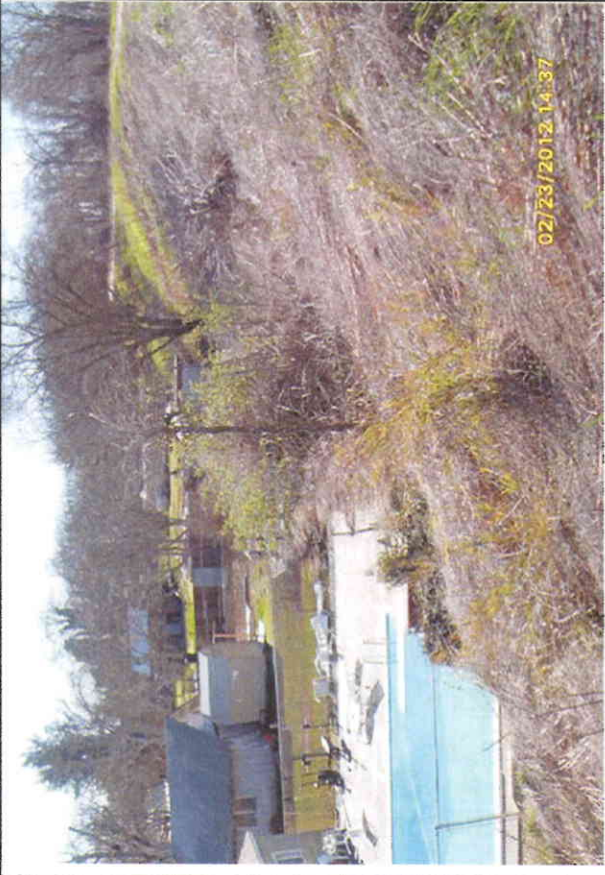
<p>1940's: Rectangular swimming pool located approximately 8 feet from landside toe was permitted and built in the 1940's prior to the Memo of Understanding (MOU) of 1957 design profile. Therefore swimming pool existed at the time the levee system was turned over to district. Levee Mile: 2.74</p>

<p>Inspect ID: NIC4_2012_p_0174 Title: USACE CESPK_NIC4_2012_p_0174_1.jpg Rated Item: 3. Encroachments Caption: Rectangular swimming pool located approximately 8 feet away from landside toe. (U)</p>

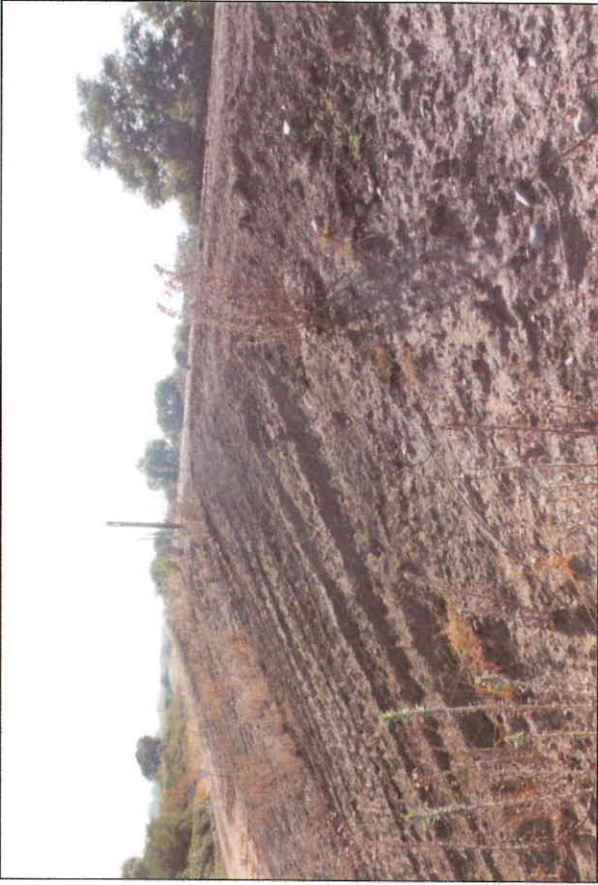
<p data-bbox="165 733 231 1078">August 2012: Footpath removed Levee Mile: 4.15</p> <p data-bbox="792 215 908 1078">Inspect ID: NIC4_2012_p_0248 Title: USACE_CESPK_NIC4_2012_p_0248_1.jpg Rated Item: 3, Encroachments Caption: Pedestrian footpath extending from landside toe to levee crown. Path is cut into the embankment up to 24 inches deep and up to 4 feet wide. (U)</p>

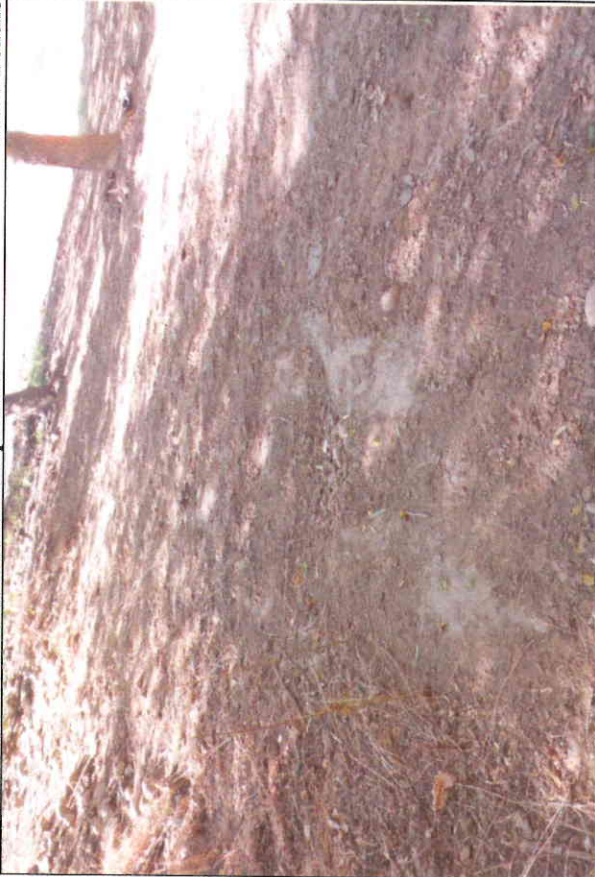
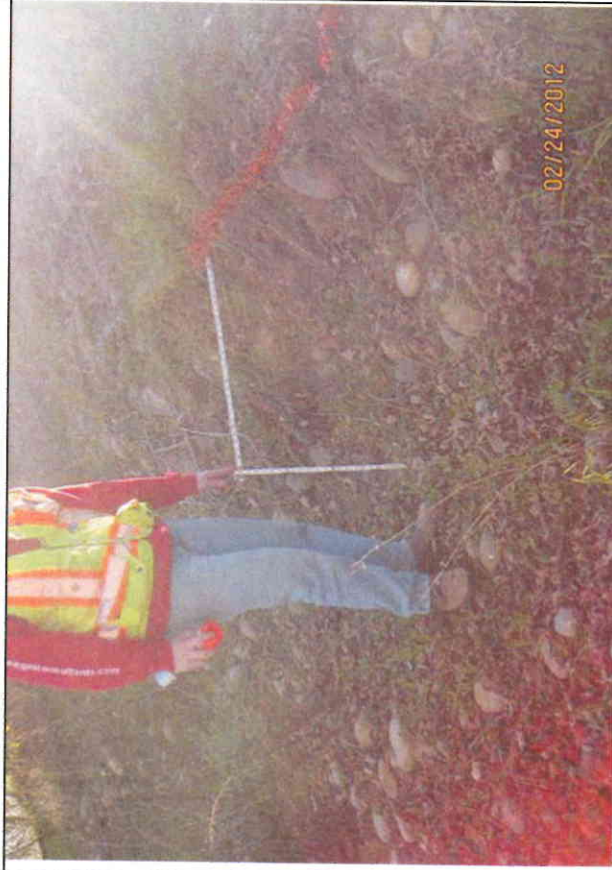
Inspect ID: NIC4_2012_p_0264 Title: USACE_CESPK_NIC4_2012_p_0264_1.jpg
Rated Item: 3. Encroachments Caption: Start point. Vertical waterside toe cut up to 24 inches tall. Likely due to maintenance vehicles. End point is 307. (U)

August 2012: Waterside toe cut removed
Levee Mile: 4.47

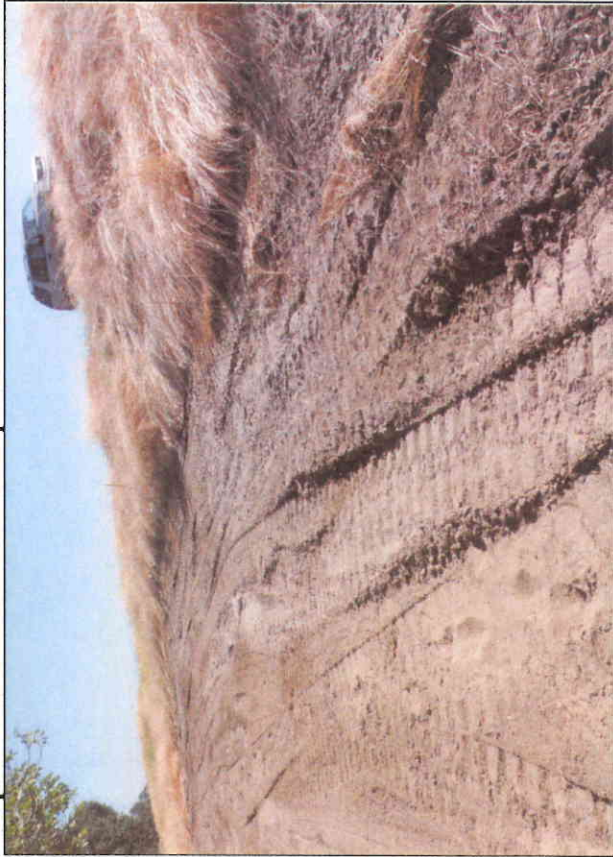
<p>September 2012: Waterside toe cut removed Levee Mile: 9.01</p>	<p>Inspect ID: NIC4_2012_p_0491 Title: USACE_CESPK_NIC4_2012_p_0491_1.jpg Rated Item: 3. Encroachments Caption: Vertical waterside toe cut up to 42 inches tall for a 50 foot stretch. Likely due to maintenance vehicles. (U)</p>

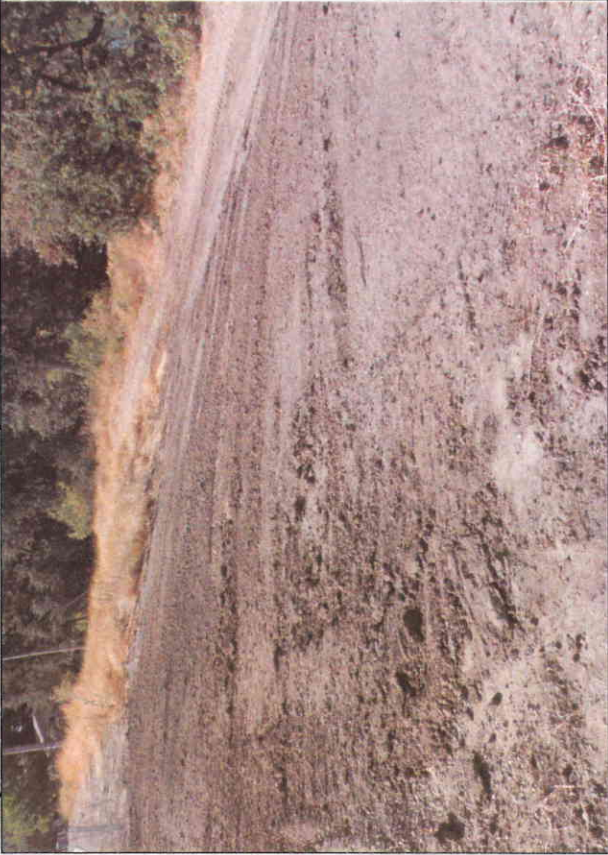
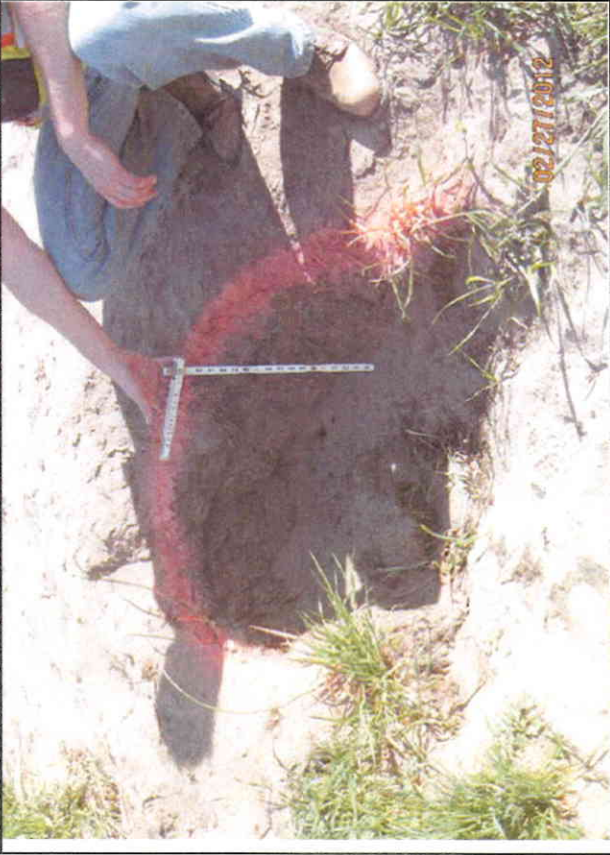
<p>Inspect ID: NIC4_2012_p_0522 Title: USACE_CESPK_NIC4_2012_p_0522_3.jpg Rated Item: 3. Encroachments Caption: 10 foot diameter hole on waterside embankment to a depth of 3 feet. Second hole nearby, 30 inches diameter and 16 inches deep. (U)</p>

<p>September 2012: 10 foot diameter hole on waterside embankment to a depth of 3 feet, filled. Second hole nearby, 30 inches diameter and 16 inches deep, filled. 40 cubic yards of dirt added to levee. Levee Mile: 9.61</p>

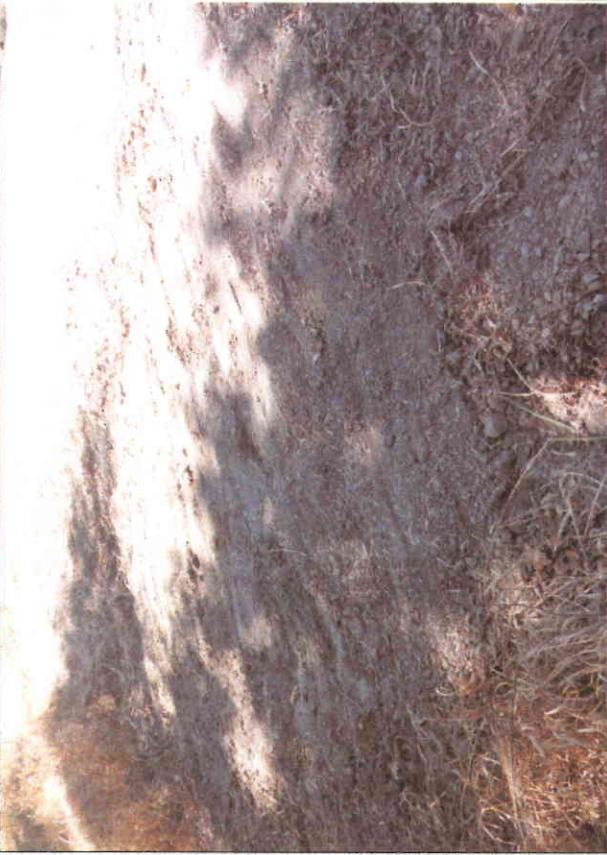
Inspect ID: NIC4_2012_p_0534 Title: USACE_CESPK_NIC4_2012_p_0534_2.jpg Rated Item: 3. Encroachments Caption: 2.5 foot deep, 3.5 foot wide hole at landside hinge likely due to excavation. Possibly a removed gate foundation. (U)

September 2012: 2.5 foot deep, 3.5 foot wide hole at landside hinge, filled. Levee Mile: 9.74

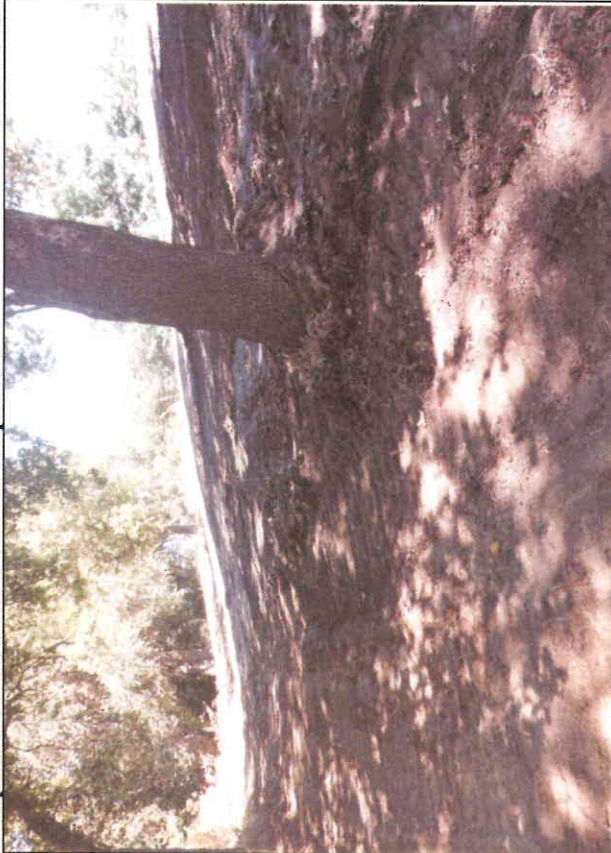
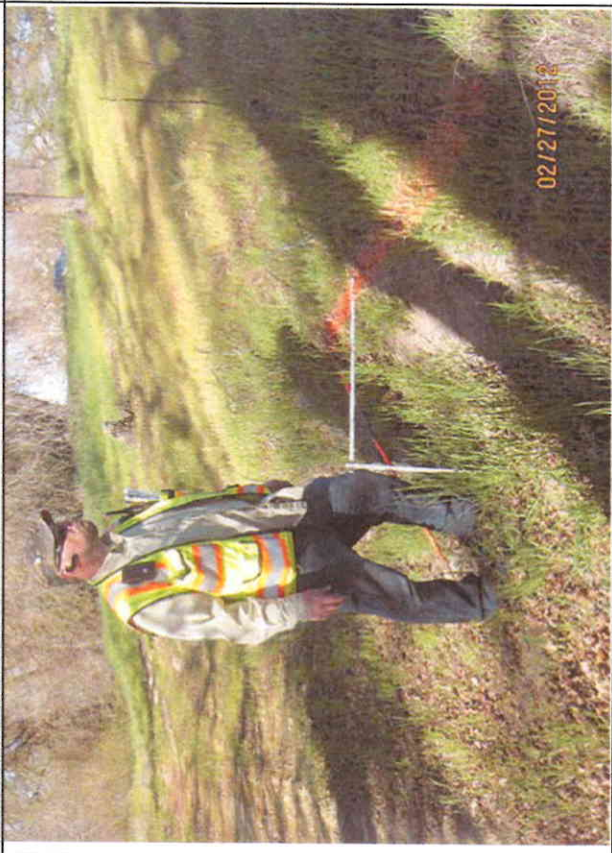
September 2012: Waterside toe cut removed Levee Mile: 9.81
Inspect ID: NIC4_2012_p_0541 Title: USACE_CESPK_NIC4_2012_p_0541_1.jpg Rated Item: 3. Encroachments Caption: Start point. Vertical waterside toe cut up to 42 inches tall for a 50 foot stretch. Likely due to maintenance vehicles. End point is 565. (U)

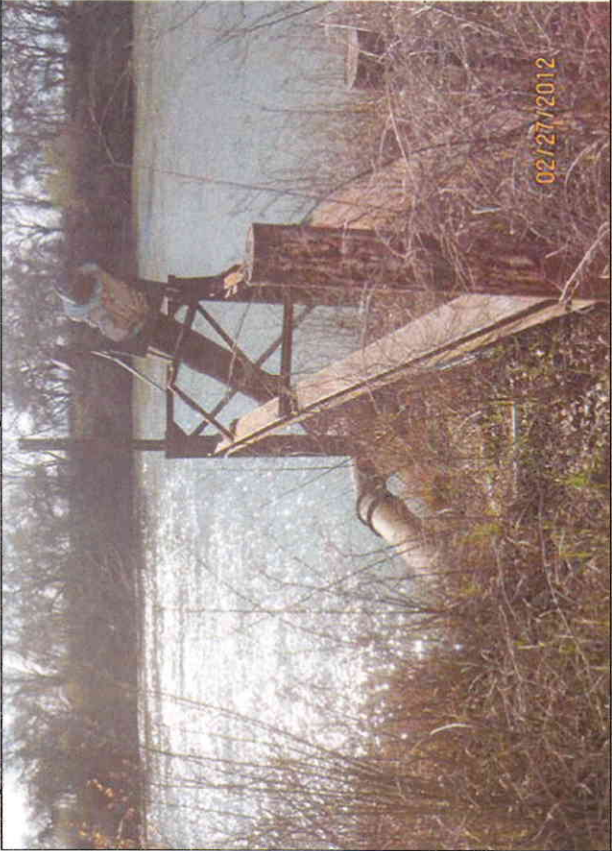
Inspect ID: NIC4_2012_p_0549 **Title:** USACE_CESPK_NIC4_2012_p_0549_3.jpg
Rated Item: 3. Encroachments **Caption:** 12 inch pipe through levee. Slant pump on waterside bank to 24 inch standpipe at landside toe. No positive closure on waterside shoulder. Pipe broken near siphon breaker on landside embankment. No inspection records available. (Permit No. 3297) (U)

RD 1001 Response: Currently negotiating with property owner for removal and repair of the pipe through levee. Pipe is permitted (Permit No. 3297) and may be considered operable.

September 28, 2012: Currently negotiating with property owner for removal and repair of pipe.
Levee Mile: 10.02

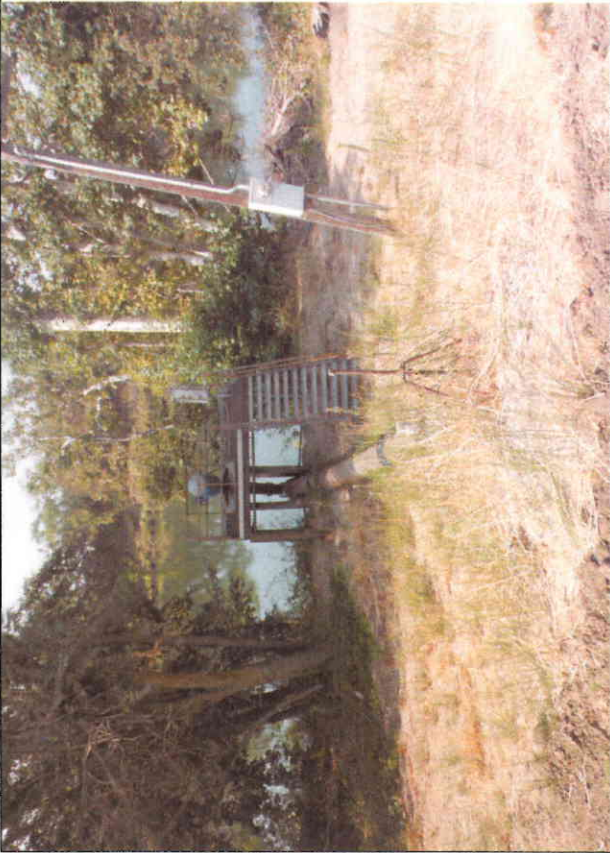
<p>Inspect ID: NIC4_2012_p_0560 Title: USACE_CESPK_NIC4_2012_p_0560_1.jpg Rated Item: 3. Encroachments Caption: 18 inch pipe through levee. Waterside slant pump removed and being reconstructed. No positive closure device observed. Siphon break on landside hinge. Utility poles on landside slope and near waterside toe. No inspection record available (Permit 1881) (U)</p>

<p>May 2012: Currently pump is permitted and active. Pump, pipes and adjacent structures are maintained by the property owner. Levee Mile: 10.24</p>

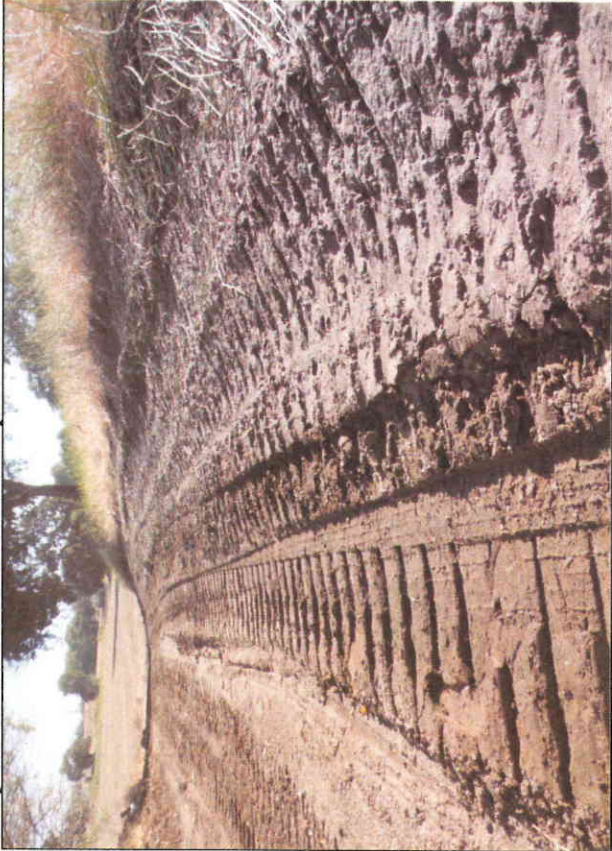
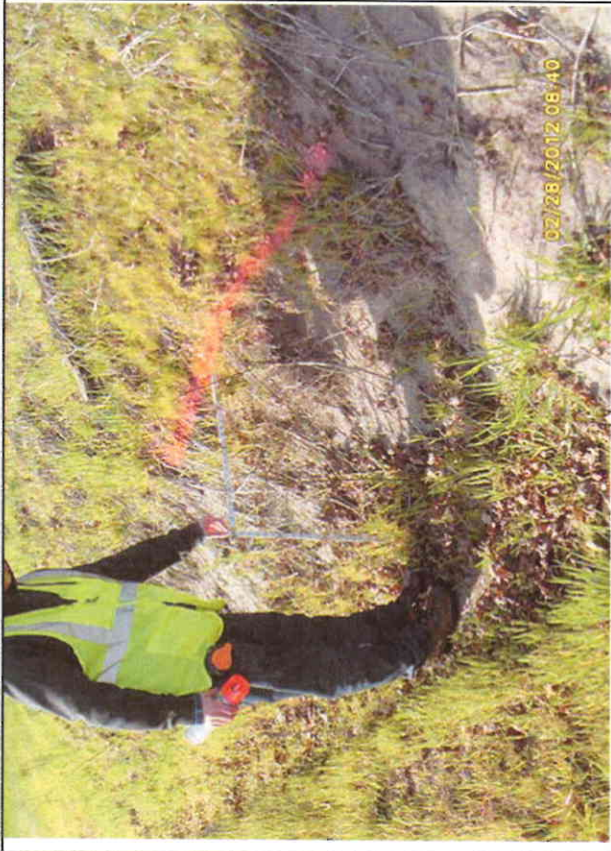
Inspect ID: NIC4_2012_p_0614 Title: USACE_CESPK_NIC4_2012_p_0614_1.jpg
Rated Item: 3. Encroachments Caption: Vertical landside toe cut up to 24 inches tall for a 100 foot stretch. (U)

September 2012: Landside toe cut removed
Levee Mile: 11.20
