**Meeting of the Central Valley Flood Protection Board
March 22, 2013**

Staff Report – Transmittal of Reclamation District 1001’s Letter of Intent for a System-Wide Improvement Framework to the U.S. Army Corps of Engineers

Sacramento and Sutter Counties

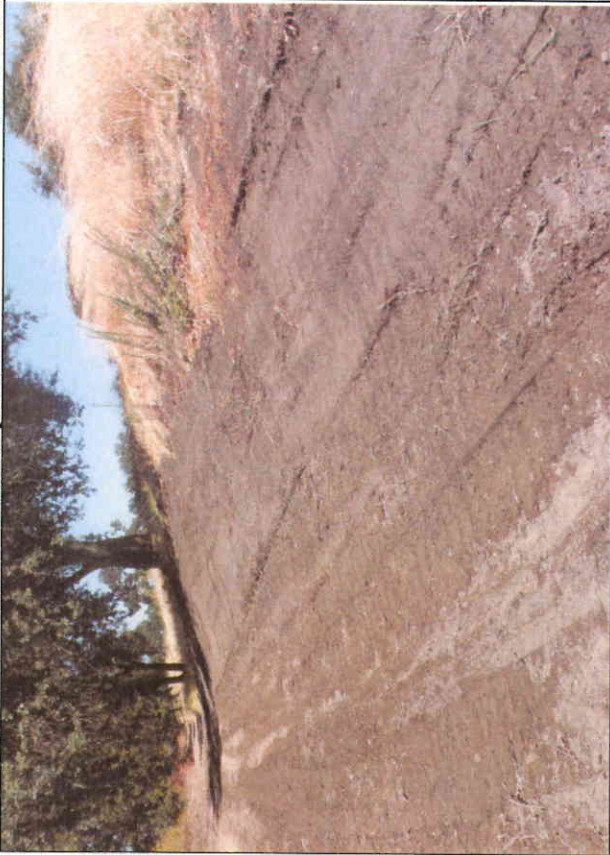
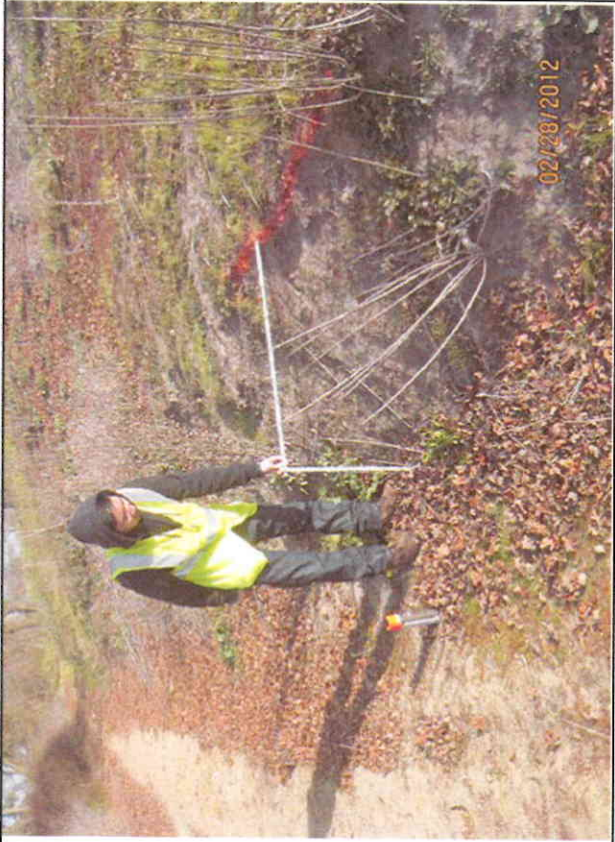
Inspect ID: NIC4_2012_p_0624 Title: USACE_CESPK_NIC4_2012_p_0624_1.jpg Rated Item: 3. Encroachments Caption: Vertical waterside toe cut up to 24 inches tall for a 50 foot stretch. Likely due to maintenance vehicles. (U)

September 2012: Waterside toe cut removed Levee Mile: 11.37

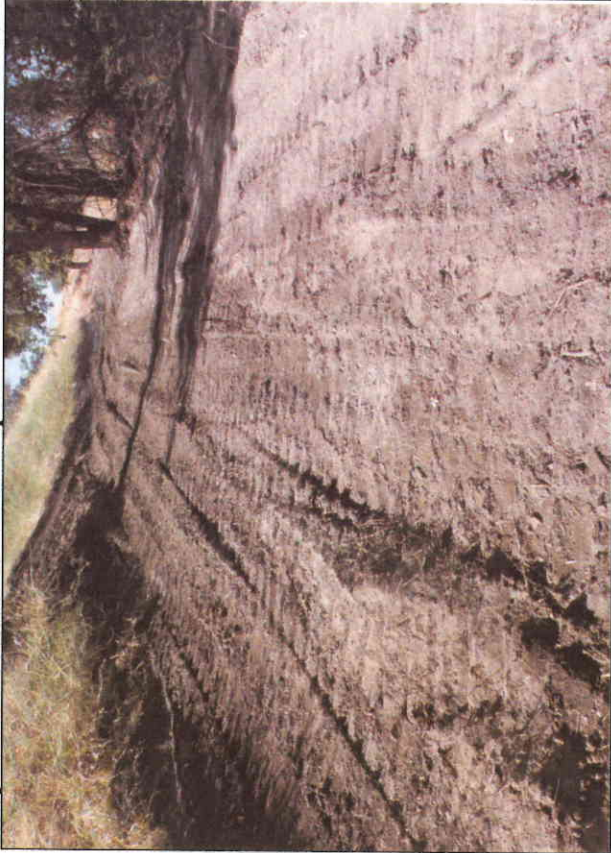
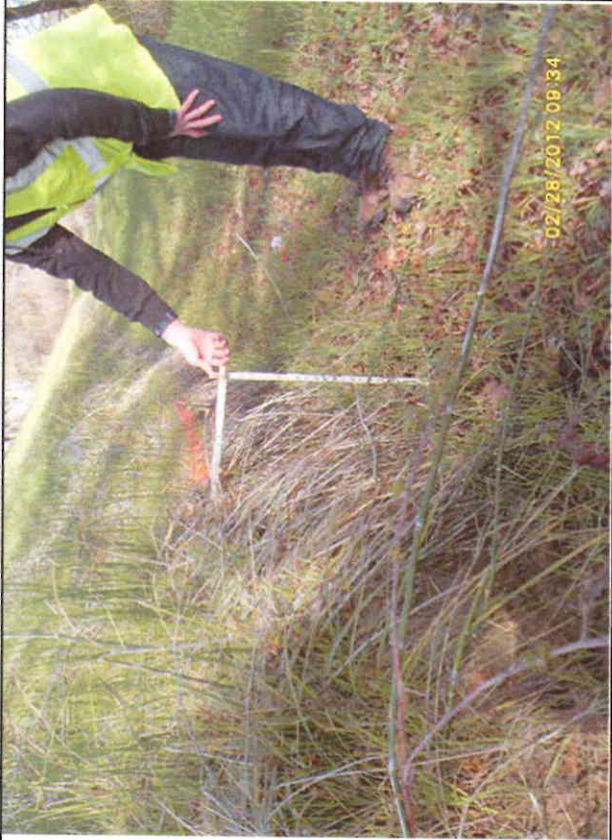
<p>Inspect ID: NIC4_2012_p_0631 Title: USACE_CESPK_NIC4_2012_p_0631_1.jpg Rated Item: 3. Encroachments Caption: Vertical landside toe cut 6 to 24 inches tall for a 100 foot stretch. (U)</p>

<p>September 2012: Landside toe cut removed Levee Mile: 11.65</p>

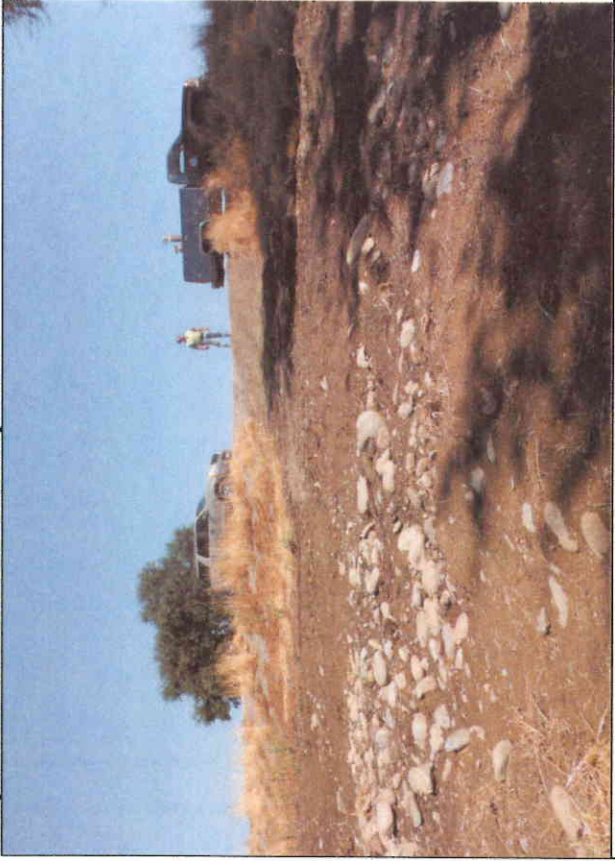
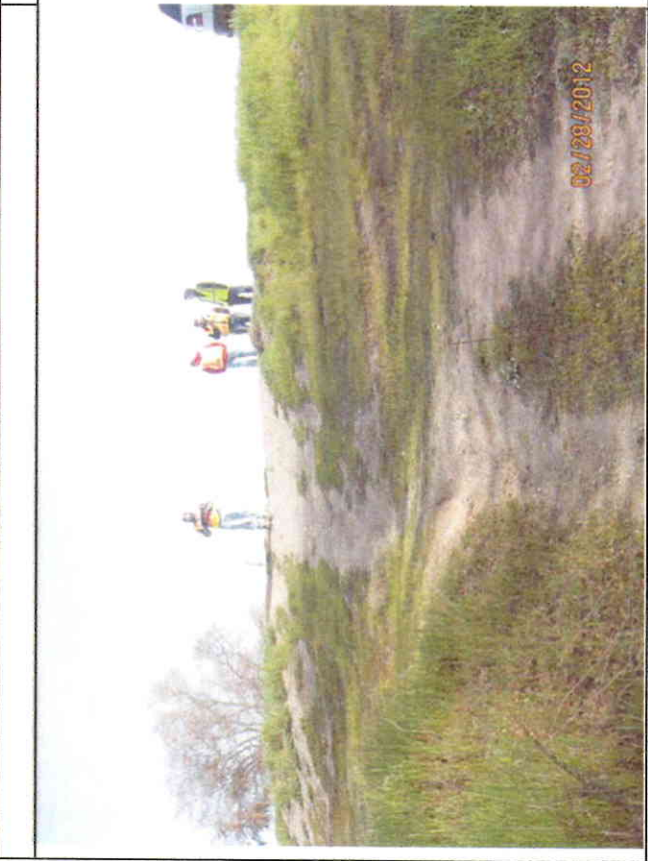
<p>September 2012: Pedestrian footpath extending from waterside toe to levee crown removed. A "Driving or Climbing on Levee Prohibited" and a "No Dumping" signs were erected on waterside crown. Levee Mile: 12.03</p>	<p>Inspect ID: NIC4_2012_p_0655 Title: USACE_CESPK_NIC4_2012_p_0655_1.jpg Rated Item: 3. Encroachments Caption: Pedestrian footpath extending from waterside toe to levee crown. Path is cut into the embankment up to 2 feet deep and 10 feet wide. (U)</p>

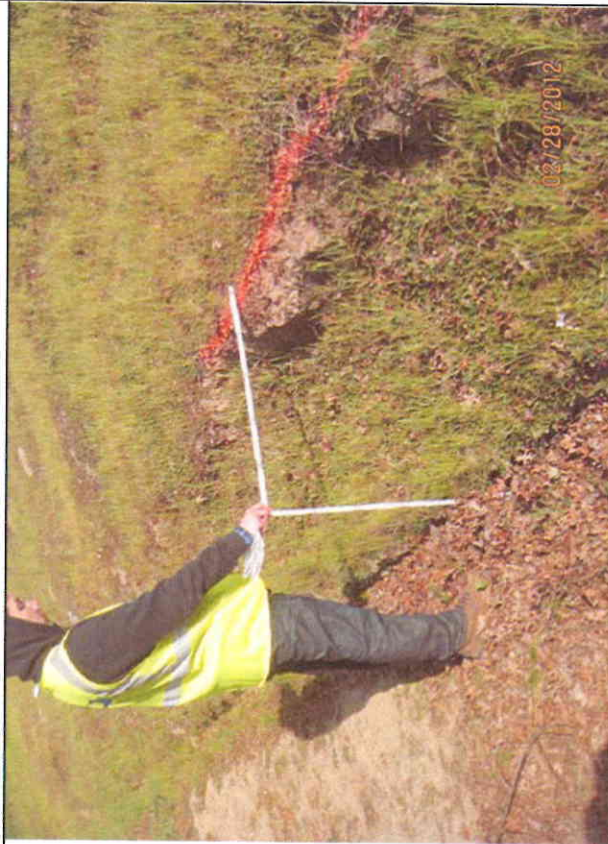
Inspect ID: NIC4_2012_p_0656 **Title:** USACE_CESPK_NIC4_2012_p_0656_1.jpg
Rated Item: 3. Encroachments **Caption:** Vertical waterside toe cut up to 30 inches tall for a 50 foot stretch. Likely due to maintenance vehicles. (U)

September 2012: Waterside toe Cut removed.
Levee Mile: 12.06

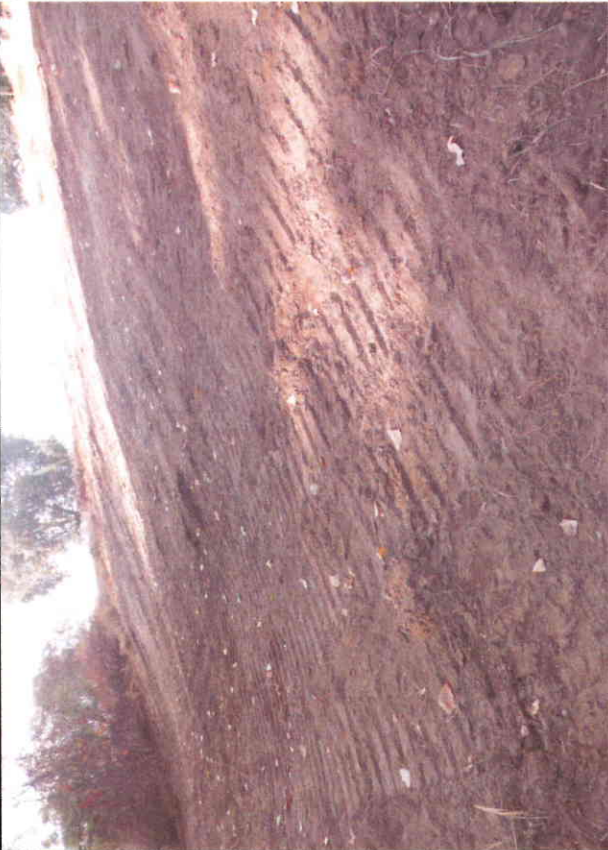
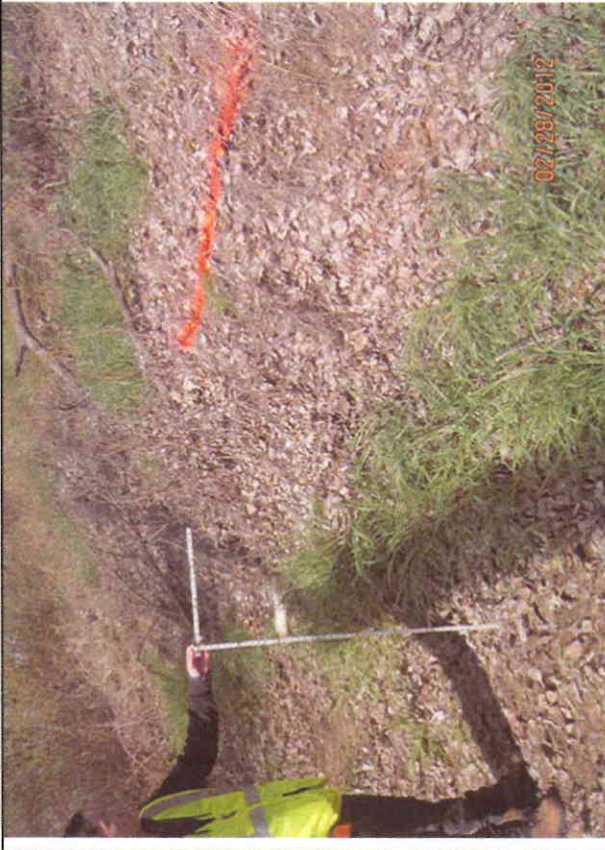
Inspect ID: NIC4_2012_p_0671 Title: USACE_CESPK_NIC4_2012_p_0671_1.jpg Rated Item: 3. Encroachments Caption: Vertical waterside toe cut up to 48 inches tall. Likely due to maintenance vehicles. (U)

September 2012: Waterside toe cut removed. Levee Mile: 12.42

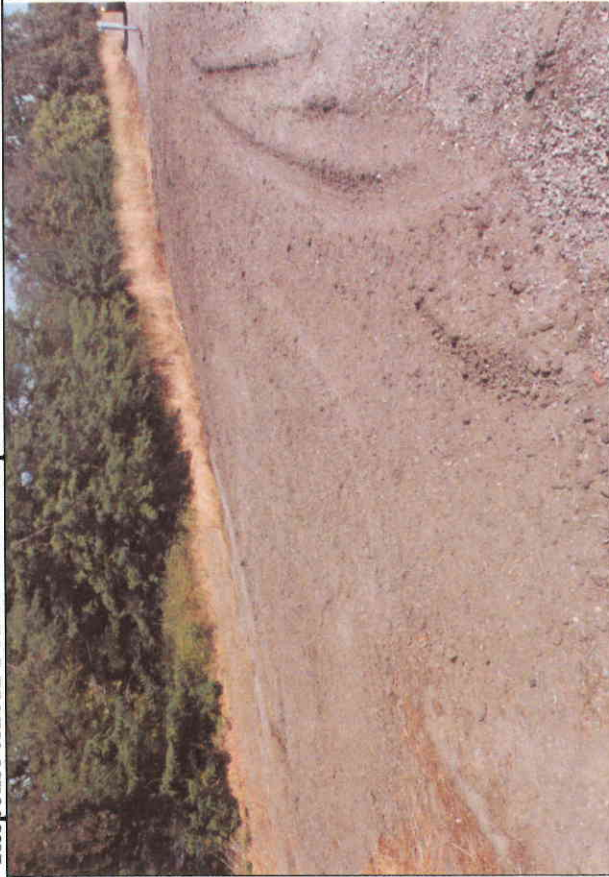
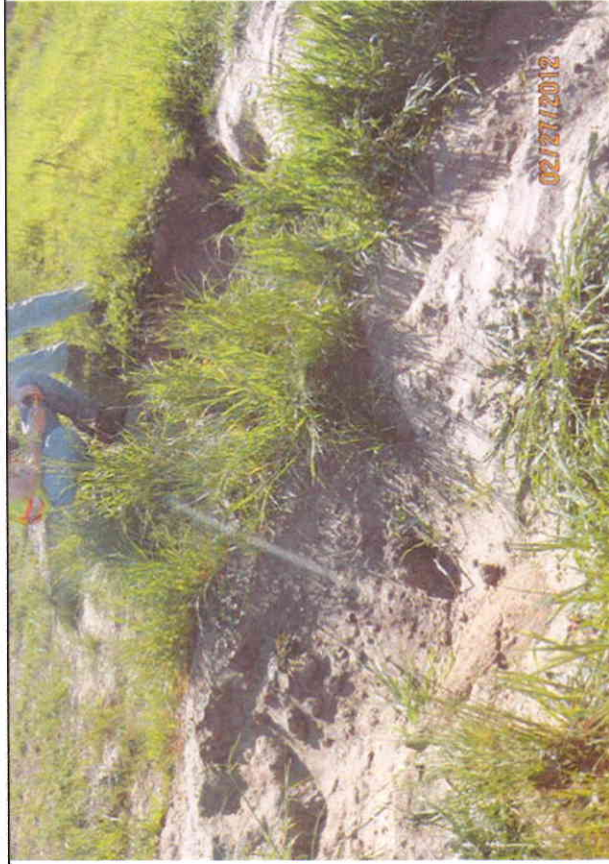
Inspect ID: NIC4_2012_p_0517 **Title:** USACE_CESPK_NIC4_2012_p_0517_2.jpg
Rated Item: 8. Depressions/ Rutting **Caption:** Rutting on waterside embankment up to 24 inches deep, 5 feet wide, and 20 feet long. (U)

September 2012: Rutting on waterside embankment up to 24 inches, 5 feet wide, and 20 feet long, filled. 20 cubic yards of dirt added to levee.
Levee Mile: 9.57

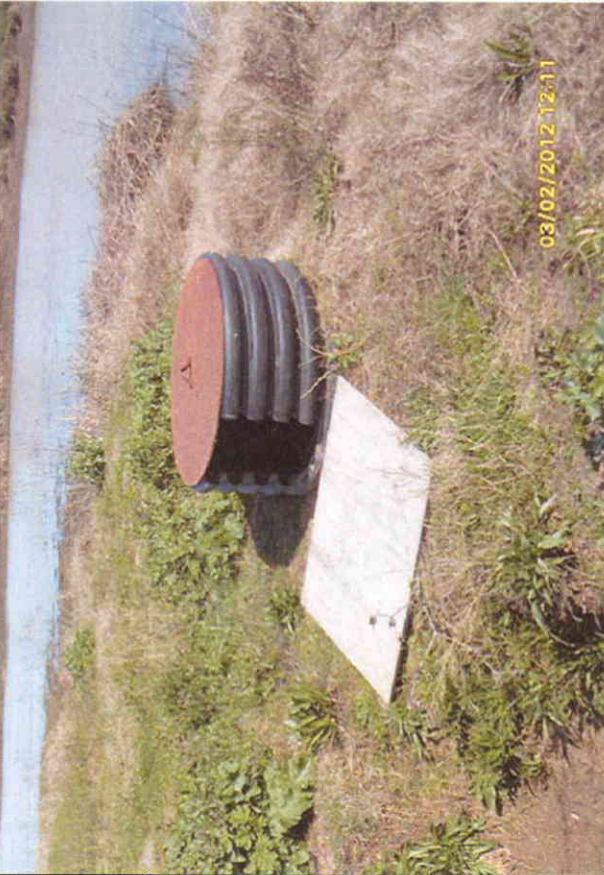
<p>September 2012: Currently pump is permitted and active. Pump, pipes and adjacent structures are maintained by the property owner. Levee Mile: 2.29</p>

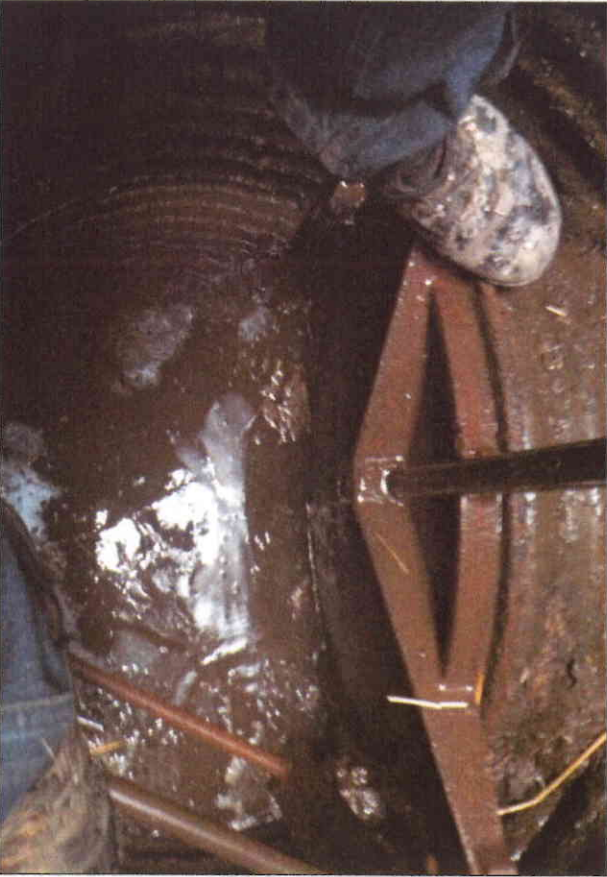
<p>Inspect ID: NIC6_2012_p_0084 Title: USACE_CESPK_NIC6_2012_p_0084_1.jpg Rated Item: 3. Encroachments Caption: 24 inch pipe through levee. Slide gate in CMP riser at waterside hinge. Slide gate appears to be inoperable. Cannot determine if gate is open or closed. No inlet or outlet observed for the pipe. No inspection records available. (U)</p>

<p>September 2012: Slide gate in CMP riser at waterside hinge is closed as shown in picture. Levee Mile: 3.29</p>

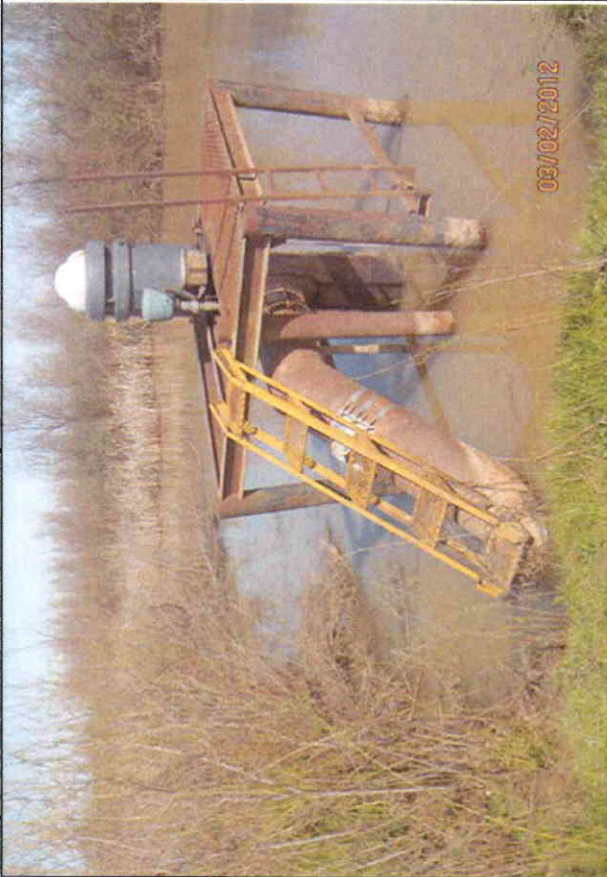
Inspect ID: NIC6_2012_p_0087 Title: USACE_CESPK_NIC6_2012_p_0087_1.jpg
Rated Item: 3. Encroachments Caption: 16 inch pipe through the levee. No positive closure device observed. Air break on landside hinge. Landside outlet is on the other side of the road. (Permit 13153) (U)

May 2012: Currently pump is permitted and active. Pump, pipes and adjacent structures are maintained by the property owner.
Levee Mile: 3.44

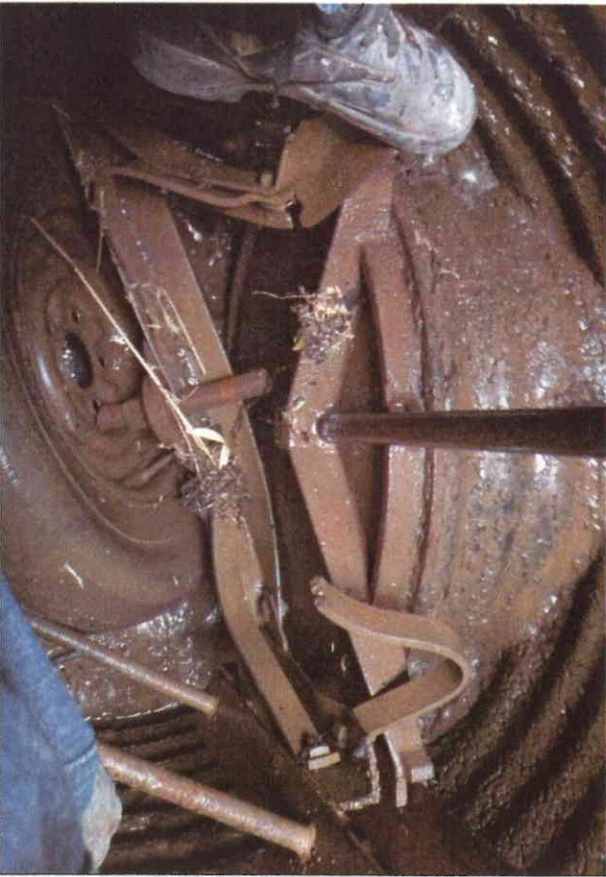
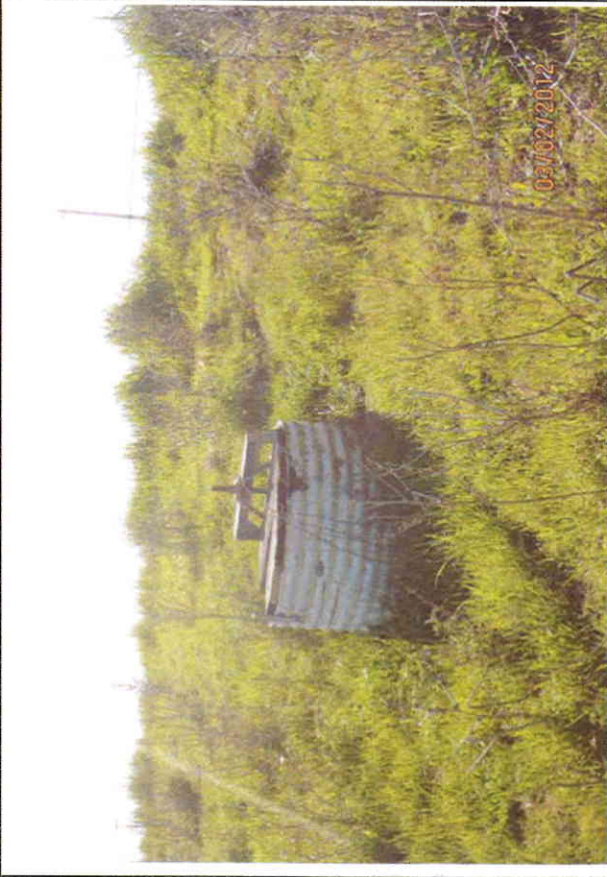
<p>September 2012: Slide gate in CMP riser at waterside hinge is closed as shown in picture. Therefore no flow will continue to concrete head/wing wall on the landside. Levee Mile: 3.60</p>	
		<p>Inspect ID: NIC6_2012_p_0091 Title: USACE_CESPK_NIC6_2012_p_0091_1.jpg Rated Item: 3. Encroachments Caption: 24 inch pipe through the levee for drainage. Slide gate in a 36 inch CMP riser at waterside hinge. No visible inlet/outlet on waterside. Concrete head/wing wall on the landside. Landside is almost completely buried by accumulated sediment. (U)</p>

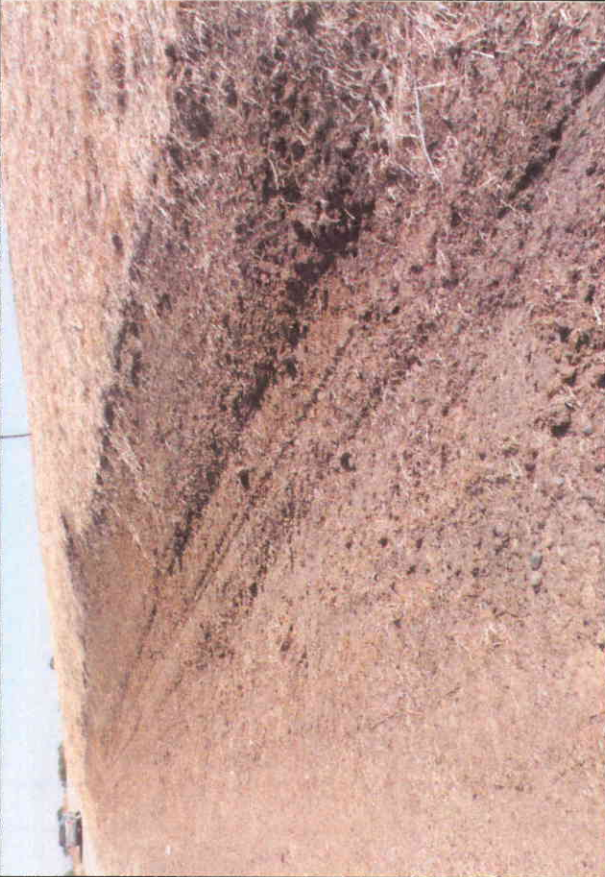
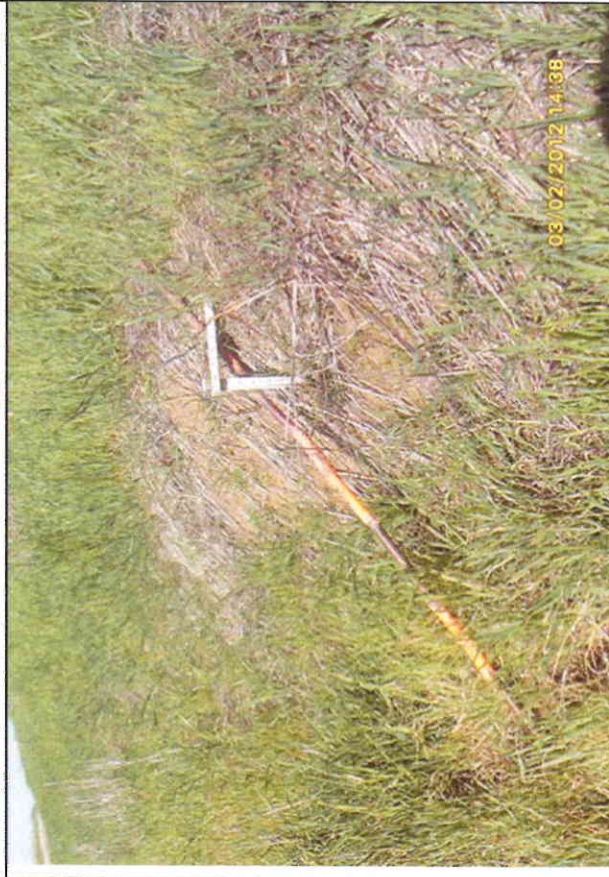
Inspect ID: NIC6_2012_p_0107 **Title:** USACE_CESPK_NIC6_2012_p_0107_1.jpg
Rated Item: 3. Encroachments **Caption:** Toe cut on landside. 18 to 24 inches tall with 1:1 slope over 100 feet. (U)

September 2012: Toe cut on landside removed
Levee Mile: 4.01

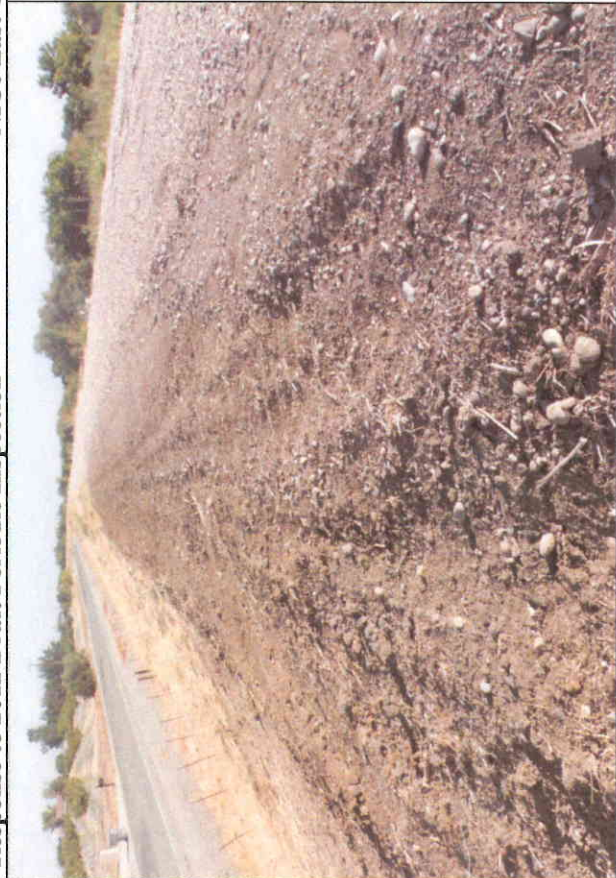
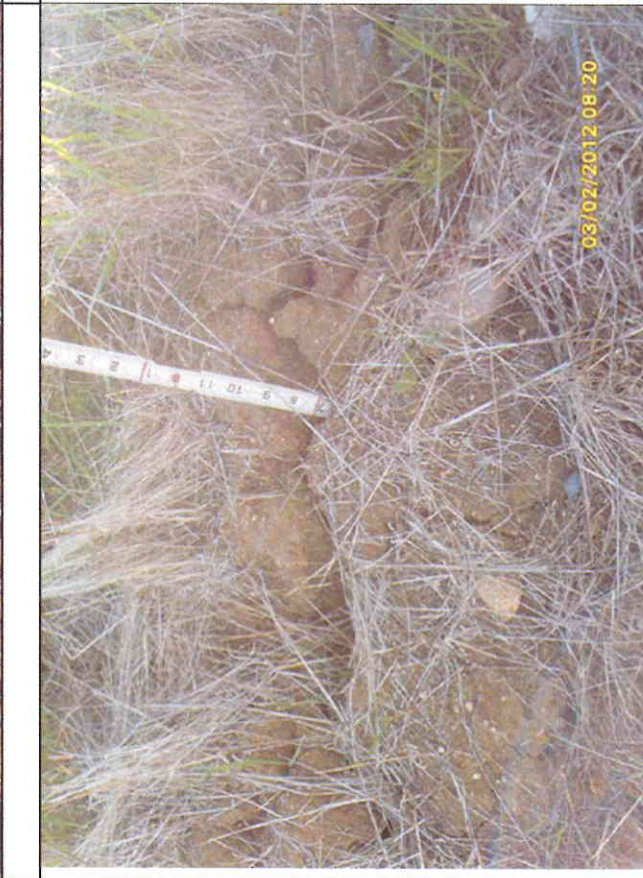
<p>September 2012: Typical shrinkage cracks, handled under routine maintenance, monitored under high water conditions. Cracking and or sloping addressed. Levee Mile: .55</p> <p>Inspect ID: NIC6_2012_p_0136 Title: USACE_CESPK_NIC6_2012_p_0136_2.jpg Rated Item: 5. Slope Stability Caption: Cracking (see point 27) along upper third of landside slope. 4 to 12 inches deep with up to 2 inch vertical displacement. (U)</p>

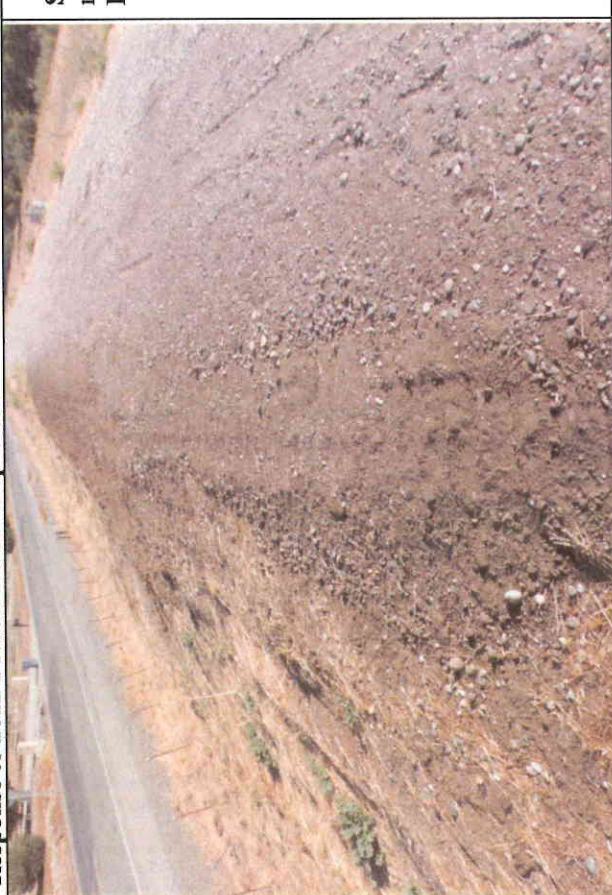
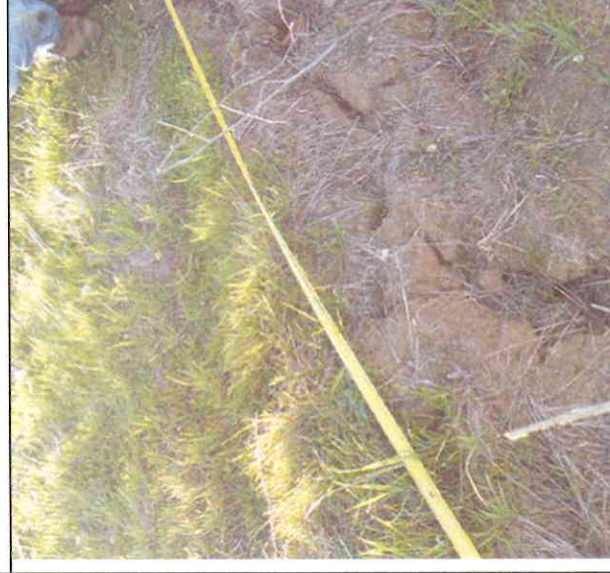
<p>Inspect ID: NIC6_2012_p_0027 Title: USACE_CESPK_NIC6_2012_p_0027_4.jpg Rated Item: 9. Cracking Caption: Cracking along upper third of landside slope. 4 to 12 inches deep with up to 2 inch vertical displacement. (U)</p>

<p>September 2012: Typical shrinkage cracks, handled under routine maintenance, monitored under high water conditions. Cracking and or sloping addressed. Levee Mile: .55</p>
