**Meeting of the Central Valley Flood Protection Board
November 18, 2016**

**Putah Creek Unit 1 – Yolo Bypass – Willow Slough Unit 2 Levee System: Letter of Intent to Submit a System-Wide Improvement Framework Plan to the U.S. Army Corps of Engineers
Yolo and Solano Counties**

The California Department of Water Resources (DWR) is developing the supporting material for the Letter of Intent (LOI) to develop a System-Wide Improvement Framework (SWIF) for the Putah Creek Unit 1 – Yolo Bypass – Willow Slough Unit 2 Levee System (System 641 per USACE) to regain eligibility in the P.L. 84-99 Rehabilitation and Inspection Program (RP). This attachment describes levee system deficiencies and system-wide issues that will be addressed under the SWIF to meet the interim eligibility criteria. The Putah Creek Unit 1 – Yolo Bypass – Willow Slough Unit 2 levee system is currently inactive in the RP.

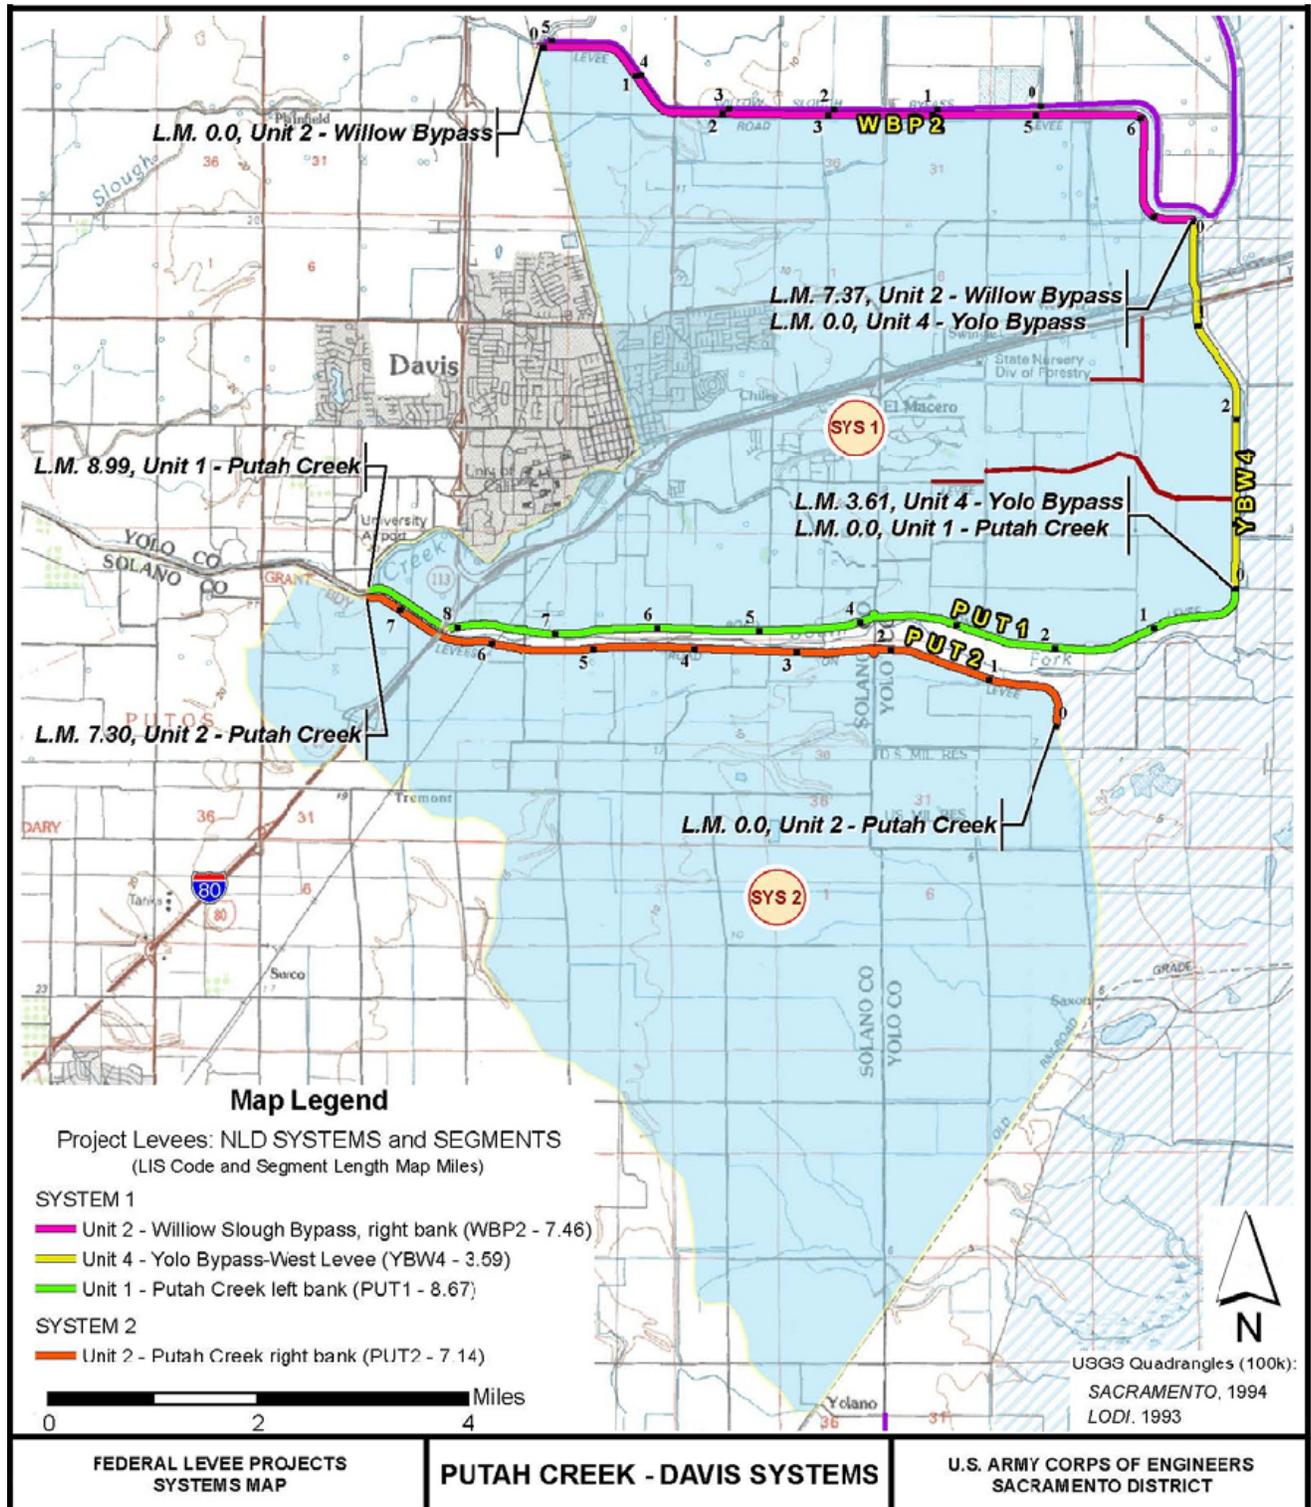
Figure 1: Putah Creek Unit 1 – Yolo Bypass – Willow Slough Unit 2 Levee Systems Location Map
 Source: USACE PI Report

The Putah Creek Unit 1 – Yolo Bypass – Willow Slough Unit 2 Levee System to be covered by the SWIF is listed in the National Database (NLD) under System 641 (NLD ID: 5205000641). The deficiencies identified by the USACE PI inspection program have resulted in an unacceptable rating for System 641. The System 641 includes three segments (as listed below) along the right bank of Willow Slough, the west levee of the Yolo Bypass, and the left bank of Putah Creek.

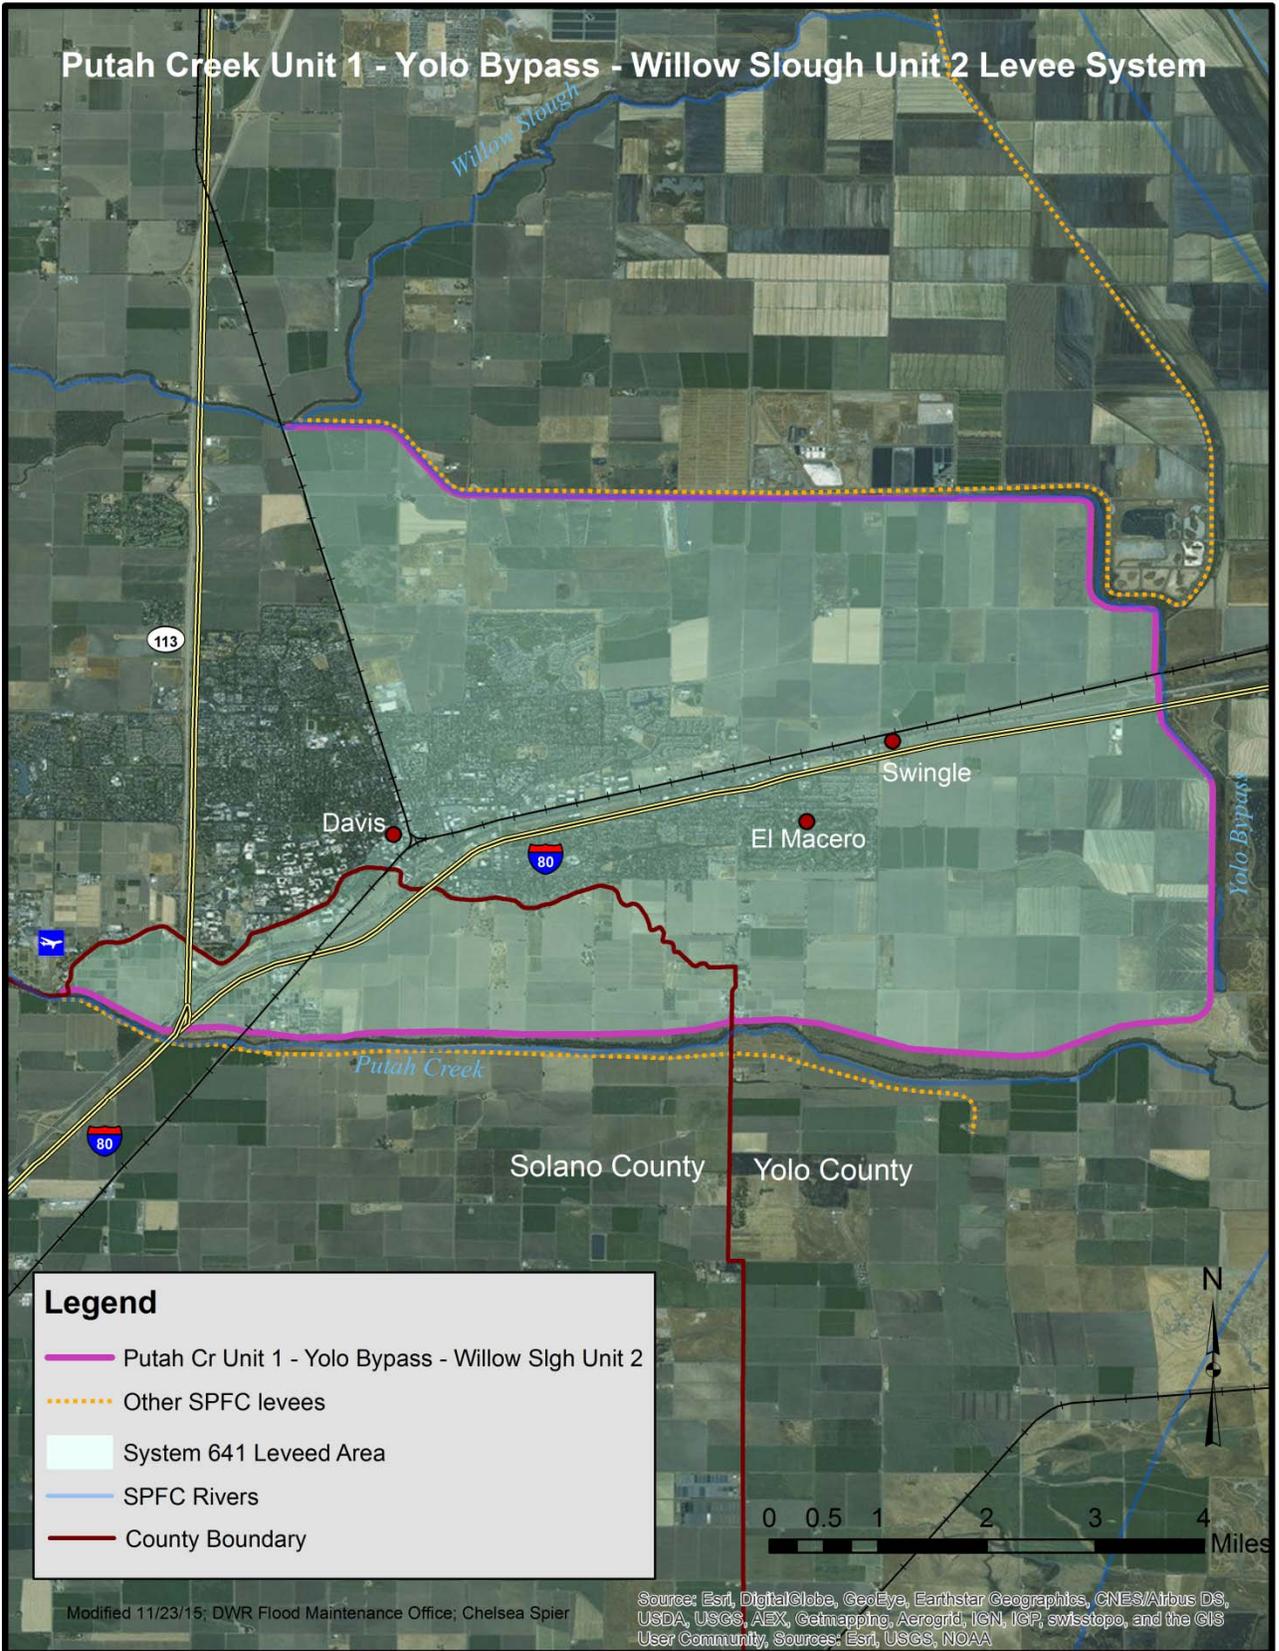
Figure 2: General Map Showing the Levee System 641 and Leveed Area
