DRAFT
PROGRAMMATIC ENVIRONMENTAL ASSESSMENT/FONSI
INITIAL STUDY/MITIGATED NEGATIVE DECLARATION

Lower Calaveras River Anadromous Fish Barriers Improvement Project

FISHBIO Environmental

**U.S. Fish and Wildlife Service and
Stockton East Water District**

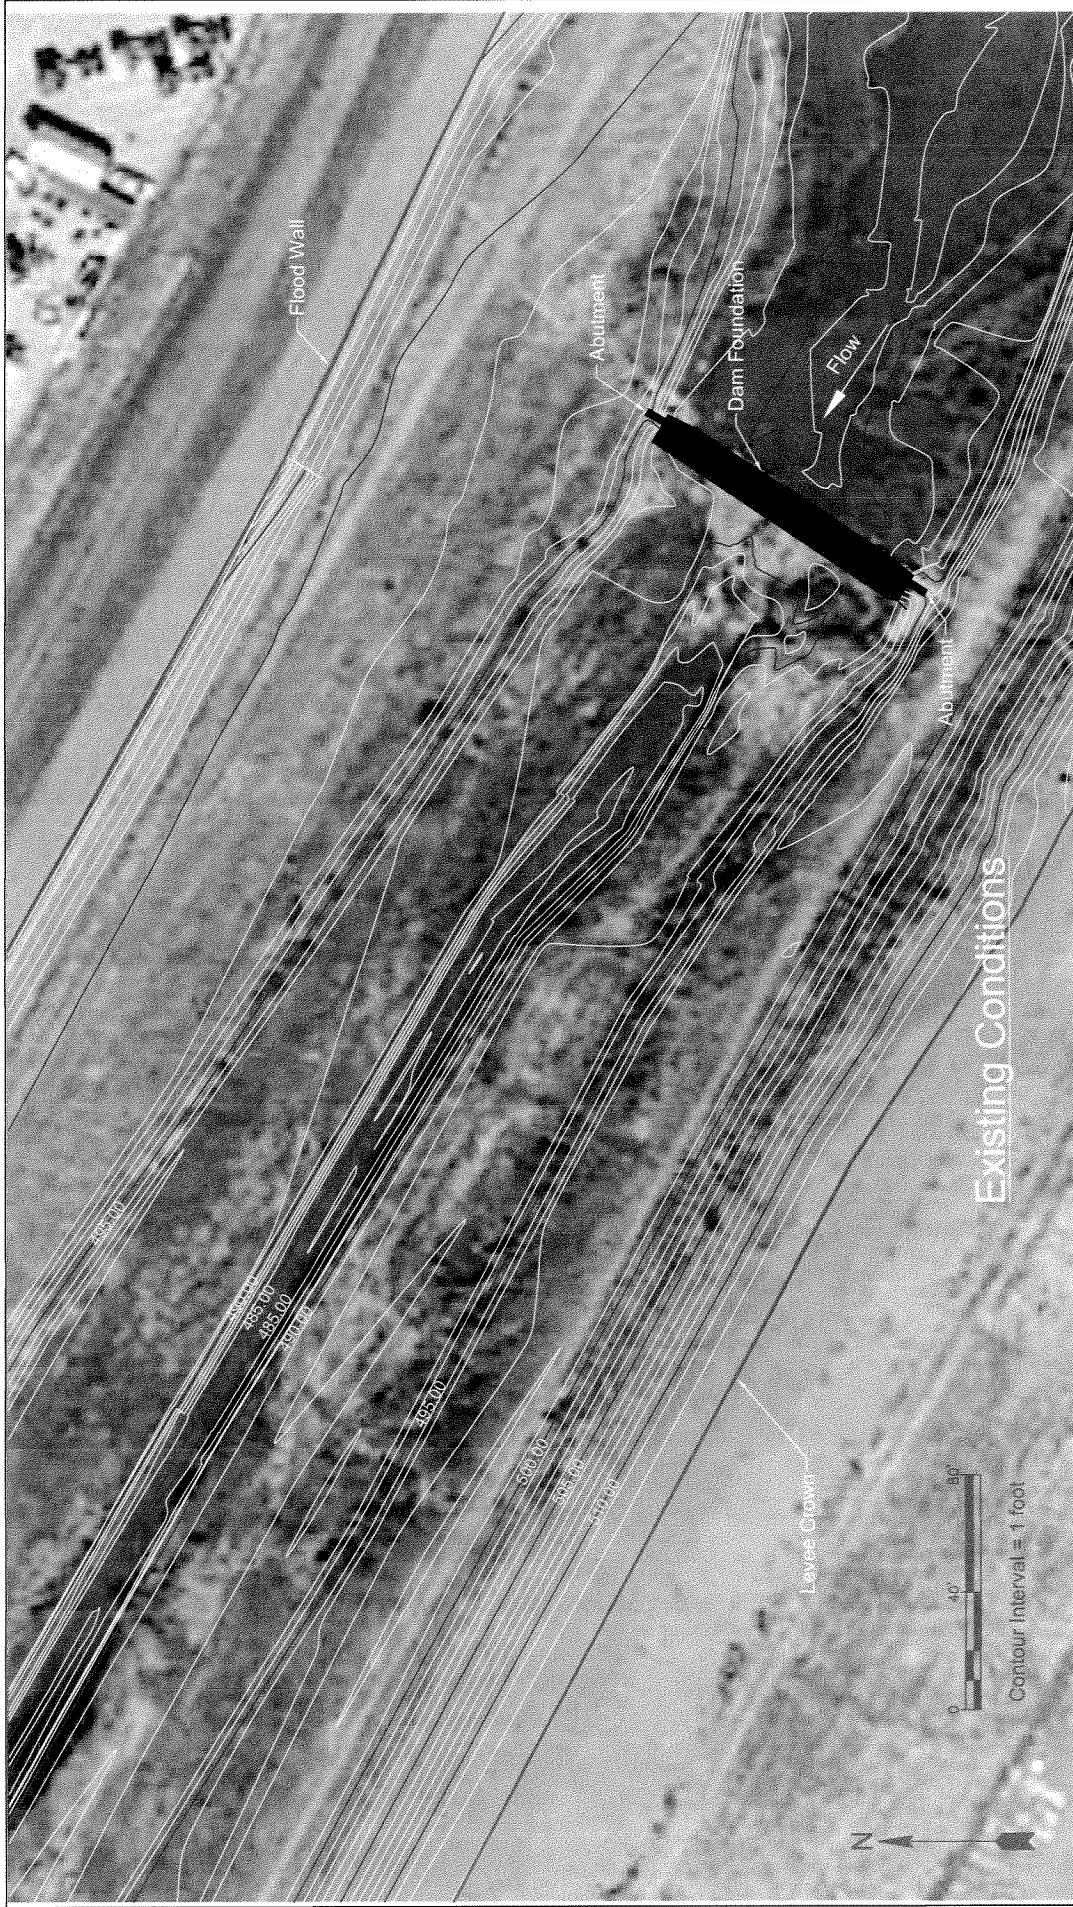
California Department of Water Resources Fish Passage Improvement Program	JOB NAME: Budiselich Flashboard Dam Fish Passage		DRAWN BY: RP	CHECKED BY: RB
			LOCATION: Calaveras River System- Stockton Diverting Canal		SCALE: See Drawing	
					DATE: May 2009	
					AGENCY:	
					SHEET	
			DESCRIPTION: Existing Conditions (Draft)		DWR	1

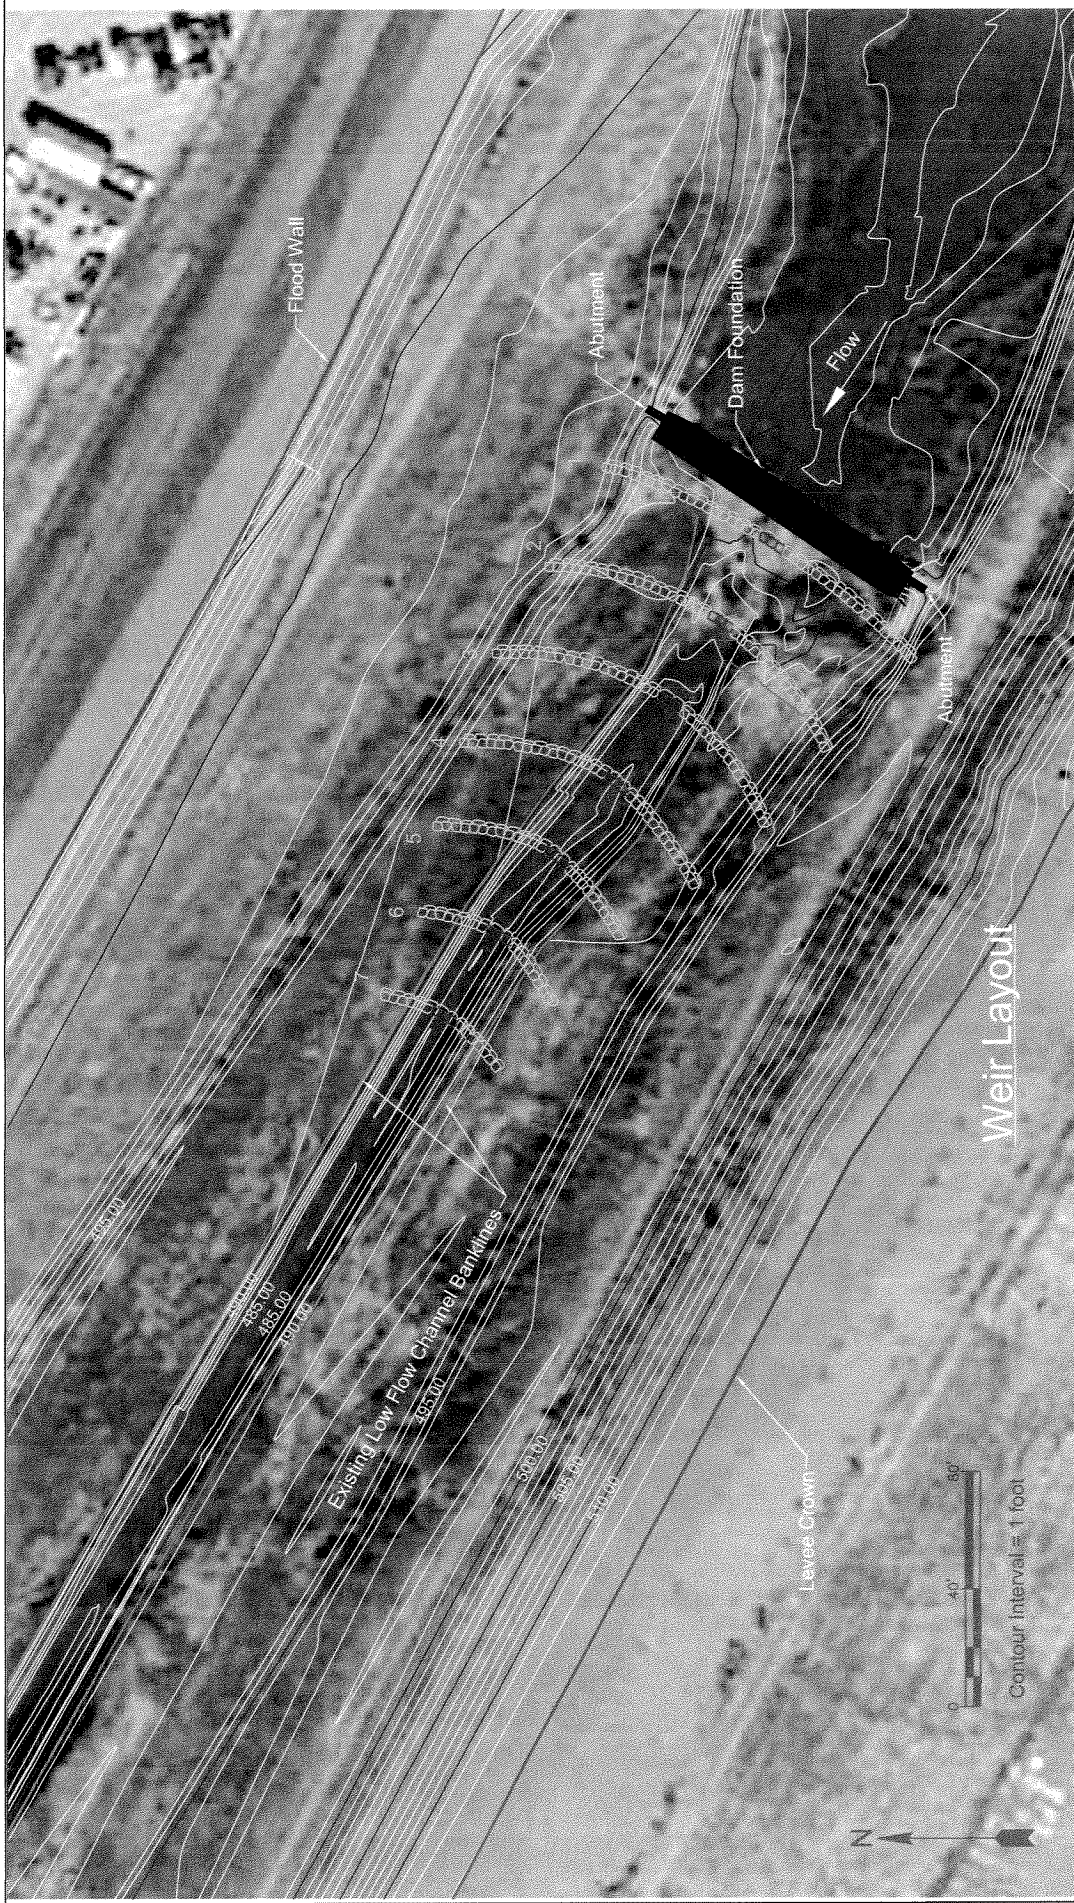
<p>NOTES:</p> <p>1. The low flow notch of each weir is indicated by the red boulders.</p>	 	<p>California Department of Water Resources Fish Passage Improvement Program</p>		<p>JOB NAME: Budiselich Flashboard Dam Fish Passage LOCATION: Calaveras River System- Stockton Diverting Canal</p>		DRAWN BY: RP	CHECKED BY: RB
		<p>DESCRIPTION: Roughened Channel Design (Draft)</p>		<p>SCALE: See Drawing DATE: May 2009</p>		<p>AGENCY: DWR</p>	
		<p>SHEET</p>		<p>2</p>		<p>2</p>	
		<p>2</p>		<p>2</p>		<p>2</p>

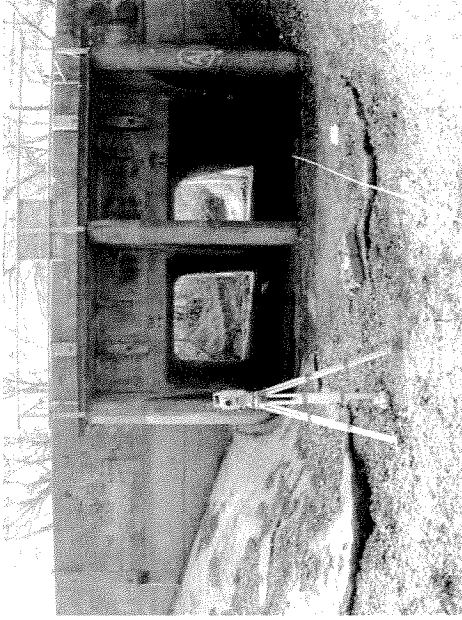
Photo D-1. Downstream at Clements Road Dam

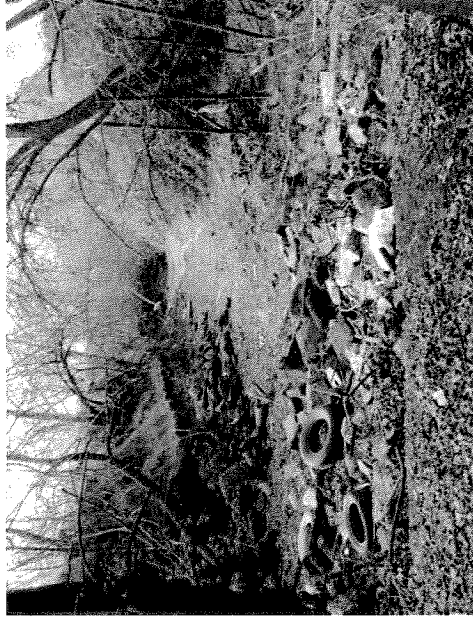
Photo D-3. Downstream channel from Clements Road Dam Outlet

The downstream channel is similar to the upstream, except for the area immediately downstream from the outlet apron (Photo D-3). From the edge of the apron, a 3-foot drop onto a steep cascade over concrete rubble, debris, and riprap extends 36 feet downstream (Photo D-4). Concrete rubble also lines the channel banks near the culvert outlet and along the left side of the river (facing downstream).

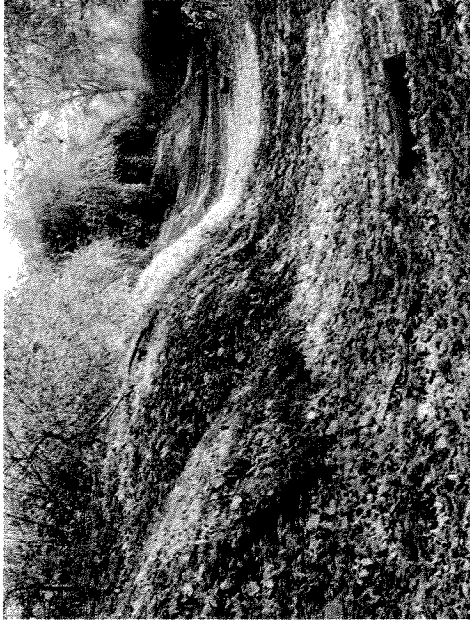
Photo D-2. Channel upstream from Clements Road Dam

The channel upstream of the culvert is somewhat meandering and well defined with a rounded trapezoidal cross section. Both the channel bed and lower banks are bare; grasses cover the mid- and upper side slopes (Photo D-2). There are many trees and bushes on top of the channel banks. The thalweg has an adverse slope leading up to the culverts.

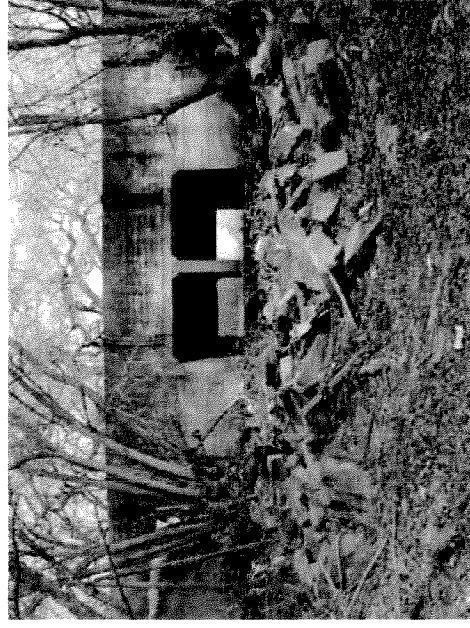
Photo D-4. Downstream of Clements Road Dam looking upstream

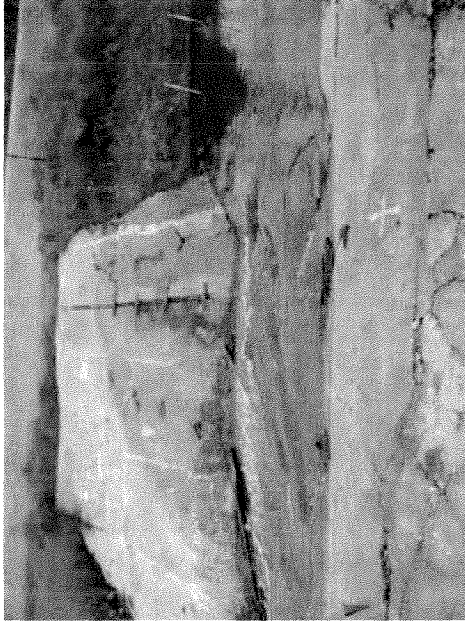
Photo D-5. Cherryland Flashboard Dam base

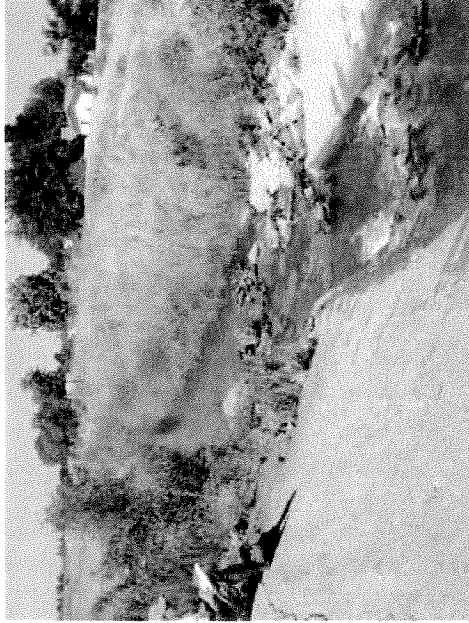
Photo D-7. Downstream end of Cherryland Flashboard Dam base

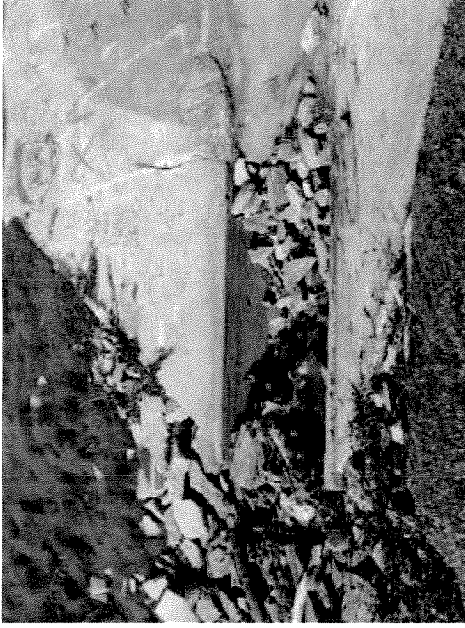
Photo D-6. Drop from dam base to river channel with no flow

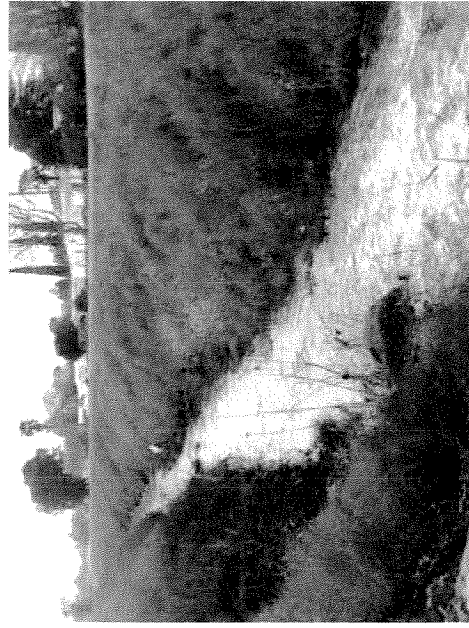
Photo D-8. Downstream from Cherryland Flashboard Dam

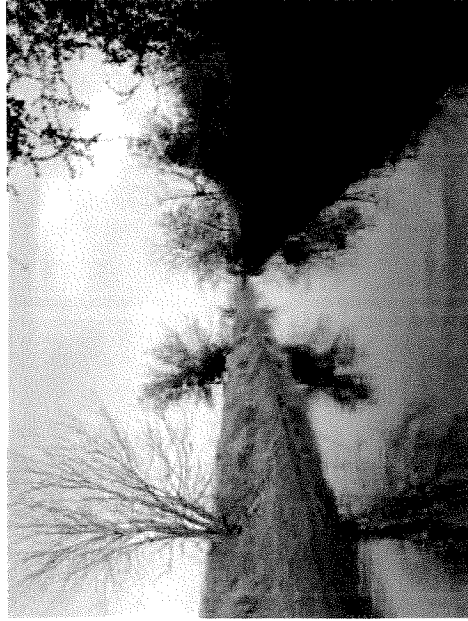
Photo D-11. Upstream from Cherryland Flashboard Dam

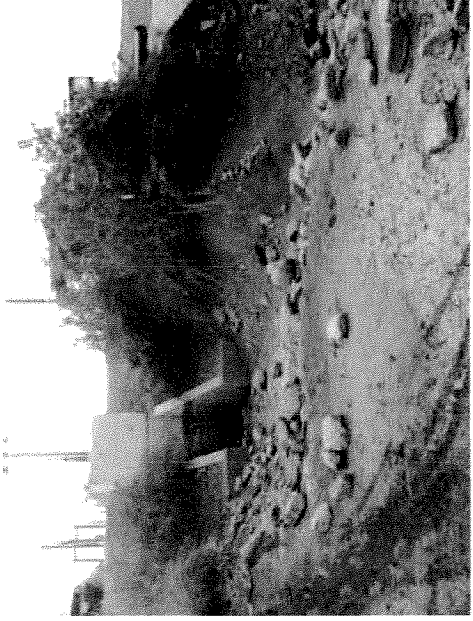
Photo D-10. The outlet of drainage canal upstream of Cherryland Flashboard Dam

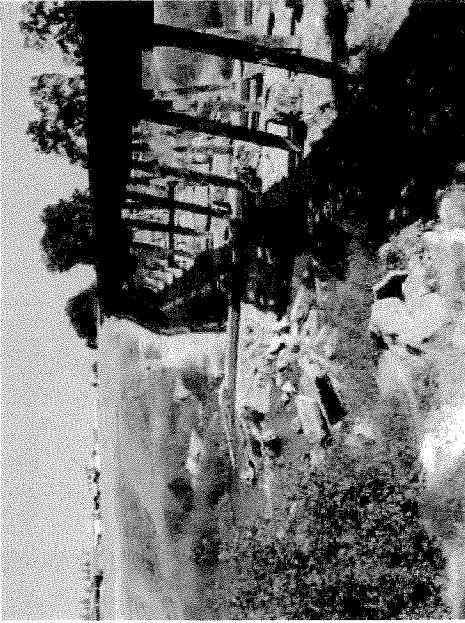
Photo D-13. Side view of CCTRR, apron, and flume from the left downstream bank

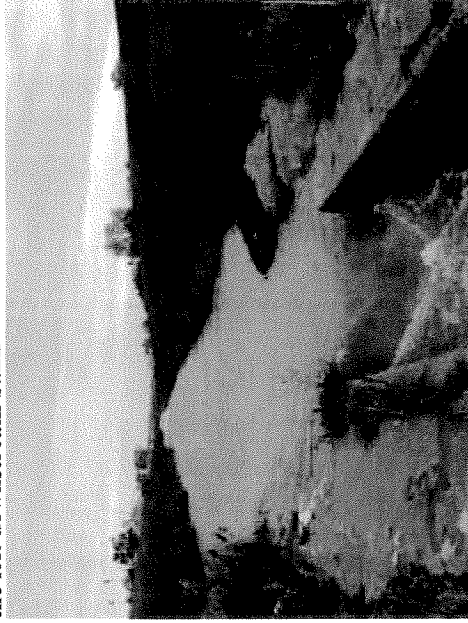
Photo D-15. Channel upstream of CCTRR showing the flume inlet

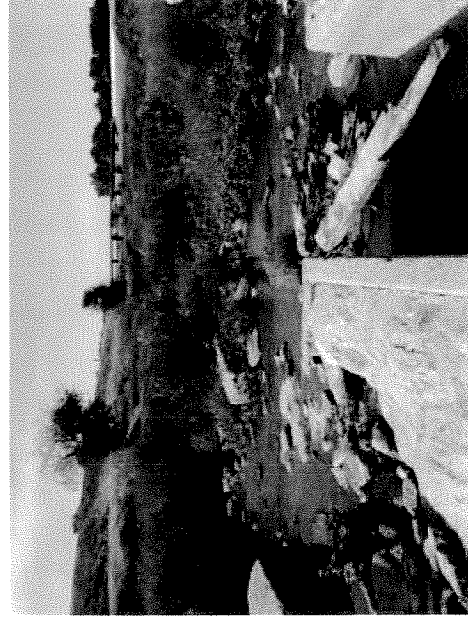
Photo D-16. View of the downstream channel from the CCTRR flume outlet

Downstream of the structure, the low-flow path meanders mildly within the confines of the straight, well-defined flood control channel (Photo D-16). The channel bed is similar to that of the bed upstream. A transitional shelf, immediately downstream of the structure, is littered with chunks of concrete riprap and vegetated with large clumps of grasses and reeds that clog the downstream channel (Photo D-16). Grasses and the occasional small tree grow on the low- to mid-levee banks thin out toward the top of the levee and provide little in the way of riparian habitat. Debris and vegetation clutter the active channel so water splits into multiple flow paths downstream of the flume.

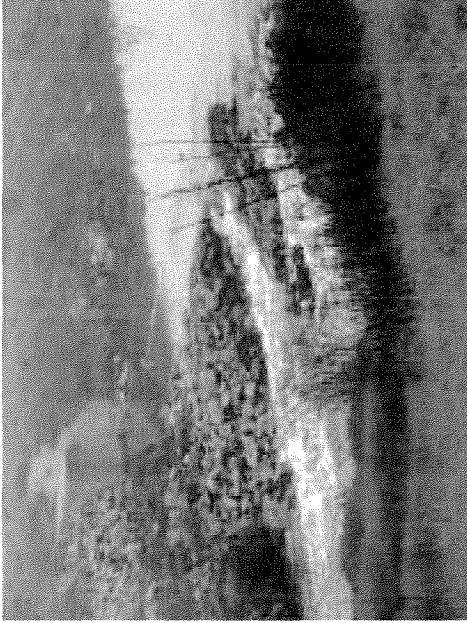
Photo D-17. Budiselich Dam, overview of upstream from the downstream left bank

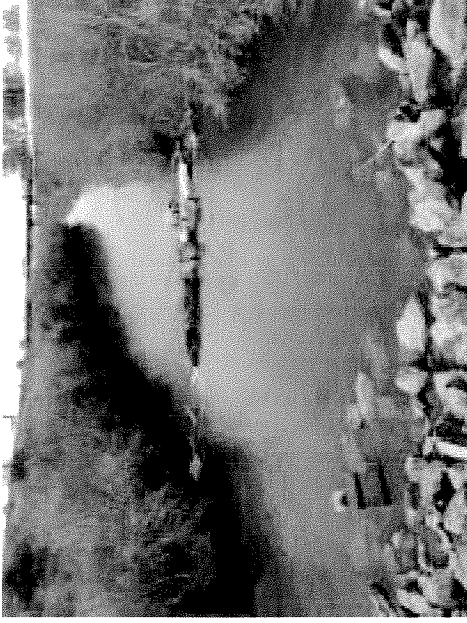
Photo D-18 Channel downstream from Budiselich Dam riprap cascade

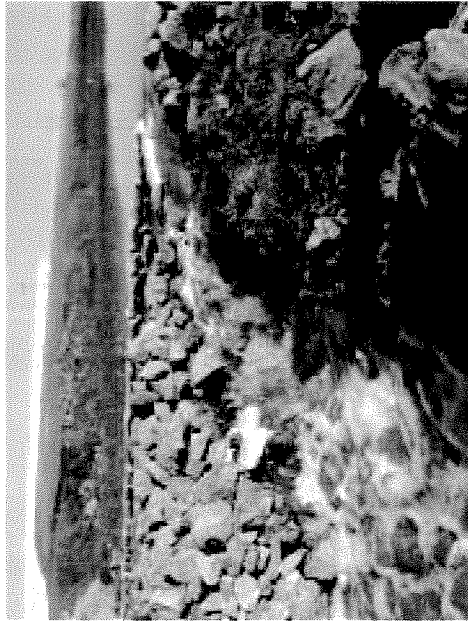
Photo D-19. At-grade view of riprap cascade downstream from Budiselich Dam

In fall of 2001, modifications were performed to provide temporary improvements to fish passage conditions at Budiselich Dam. Sandbags were placed along the edge of the concrete perpendicular to the direction of flow to increase the depth over the sill (Photo D-19). A portion of the riprap was relocated, and sandbags were placed to create a flow path for migrating salmonids and improve water depth through the riprap cascade (Photo D-20).

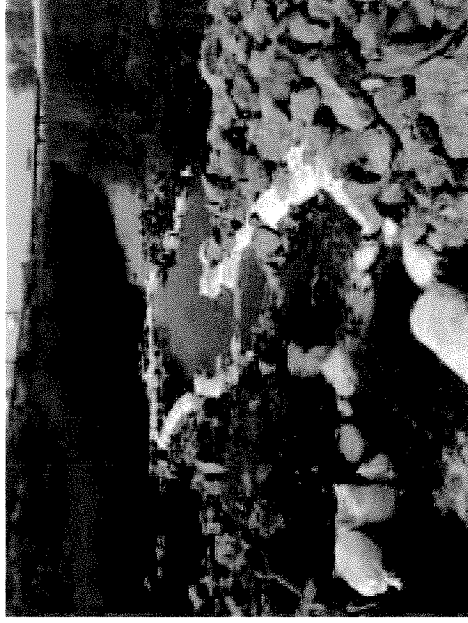
Photo D-20. Temporary modification of the channel downstream of Budiselich Dam

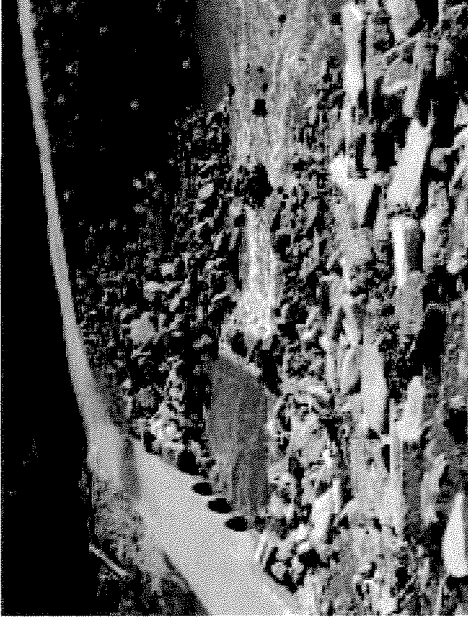
Photo D-22. Caprini LFC showing downstream apron

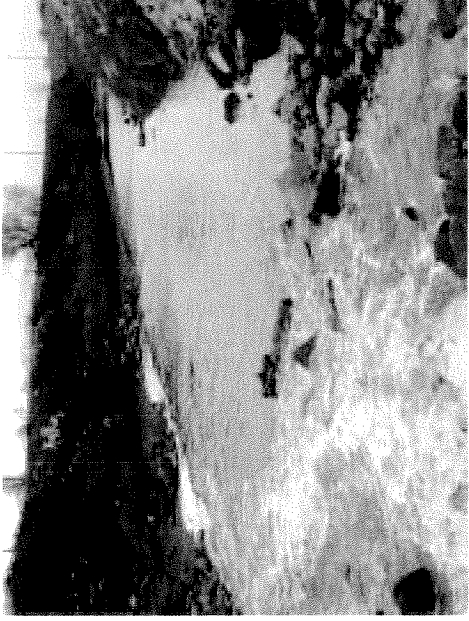
Photo D-24. Channel downstream of Caprini LFC during receding storm flows

The downstream channel is highly degraded (Photo D-24). A typical downstream cross section is composed of a muddy clay bottom and earthen levee banks with sparse vegetation. The active channel exhibits signs of scour at the toe of the levee with bare clay side slopes where riprap has scoured away resulting in a channel littered with rocky debris. The debris was likely placed to inhibit down-cutting and probably has been redistributed by high flows. The levee banks are heavily armored with rock slope protection. The downstream flow regime appears to be subcritical for a fair distance downstream, characteristic of a glide (Photo D-24).

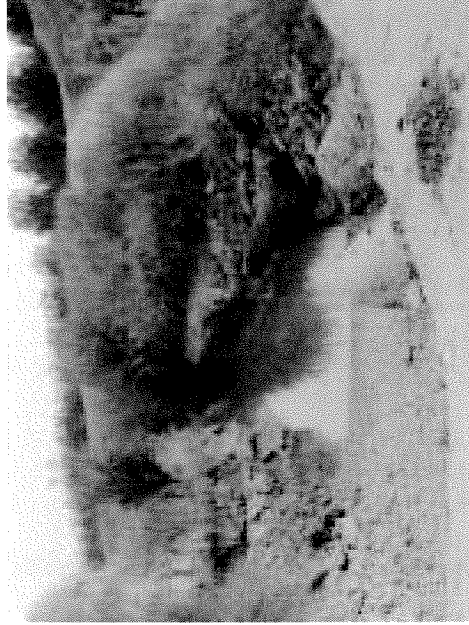
Photo D-27. Hogan Low-flow Road Crossing upstream channel

The bed of the upstream channel (Photo D-27) has degraded leaving the inlets of the culverts perched above the bed. A typical cross section is composed of a gravelly-clay bottom with some alluvial deposits of gravelly-silt at the culvert inlets. Weeds, grass, and occasional shrubs line muddy clay banks. Some riprap is present along the lower banks and bed leading up to structure particularly on the left bank adjacent to the structure. The upstream flow regime appears to be subcritical for a fair distance upstream, characteristic of a glide. The structure is the dominant controlling feature for the upstream pool.

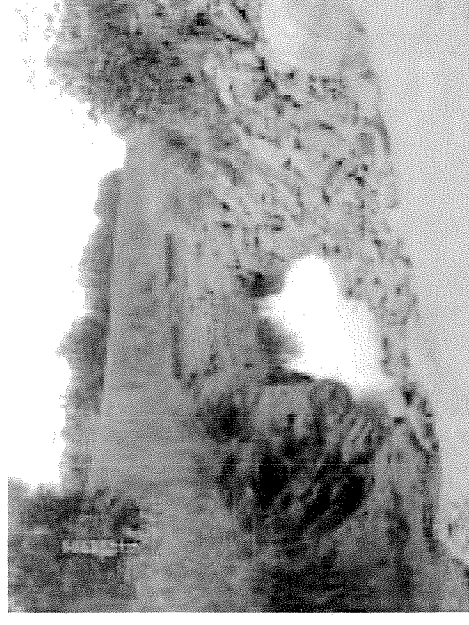
Photo D-28. Hogan Low-flow Road Crossing downstream channel

Downstream of the culverts riprap appears to have been scoured away. Although there are concrete pieces immediately downstream around the culverts, the rubble extends only sporadically for 100 feet. Riprap is spread intermittently across the 45 feet of channel width and along 50 feet of the right bank. Where the riprap has been scoured away, the downstream channel is also degraded. A typical cross section is composed of a muddy clay bottom and earthen levee banks with sparse vegetation. The active channel exhibits signs of scour with bare clay side slopes. Riprap covers the right bank (Photo D-28). Some of the riprap was likely placed to inhibit down cutting and has probably been redistributed by high flows. The top of the levee banks also are heavily armored with riprap. The downstream left bank is undercut where the roadway meets the left bank. The downstream flow regime appears to transition from a pool near the structure to a riffle a few hundred feet downstream.

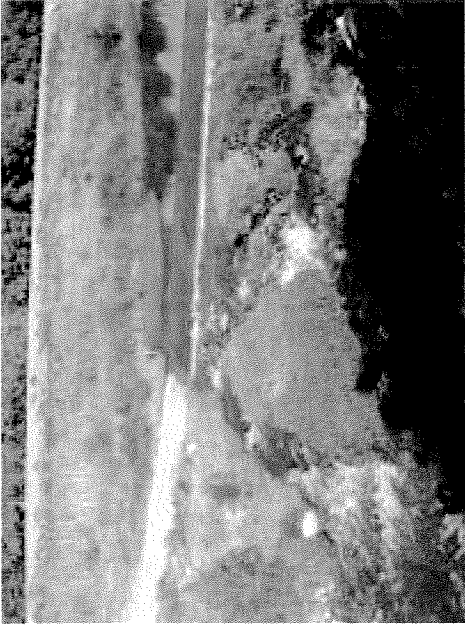
Photo D-33. View of Hosie Low-flow Road Crossing from top of levee

The Hosie LFC (Photo D-33) is on Mormon Slough near river mile 13.2. The crossing is situated in the active channel slightly skewed to the flow path and is elevated 1.5 feet above the downstream channel bottom (Photo D-34). The structure is made of a rectangular reinforced concrete pad of unknown thickness, about 160 feet long and 13 feet wide. The concrete pad is in poor condition showing signs of scour and exposed reinforcement wire (Photo D-321).

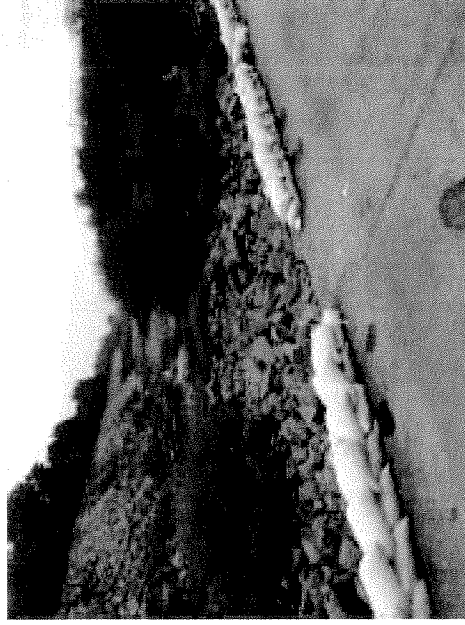
Photo D-35. View upstream across Hosie Low-flow Road Sandbags installed to provide temporary fish passage improvement.

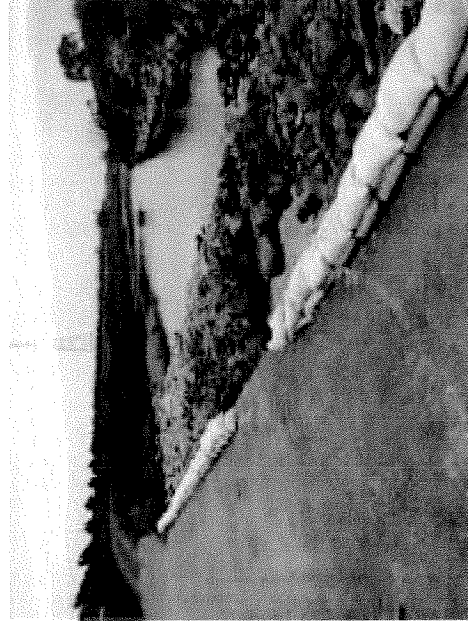
D-40. Watkins LFC 'dry' downstream channel

Some temporary solutions to improve fish passage were done at this site in fall of 2001. The rock pile along the downstream face of the structure (Photo D-40) was rearranged to provide a concentrated low-flow path over a rock cascade that loosely mimics a series of step pools. A sandbag dike was also placed along the downstream sill of the structure. The goal was better fish passage by improving the migration path to the structure, consolidate the widespread low flow water to a single concentrated flow path, and increase the water depth on the road. The modifications from 2001 should be checked and any necessary maintenance or sandbag replacement made to continue providing temporary fish passage improvement.

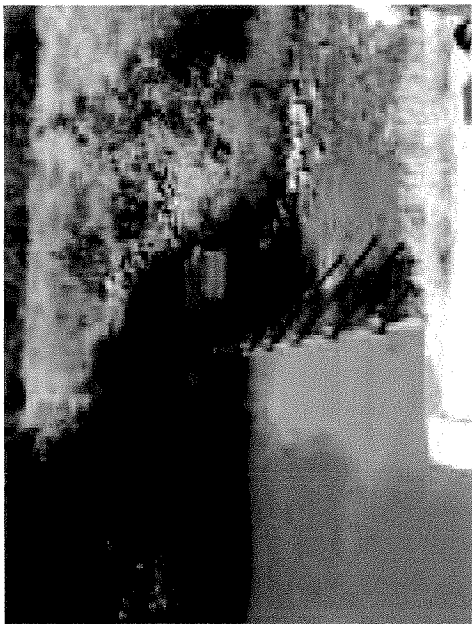
Photo D-44. Flashboards in at Panella Flashboard Dam

During irrigation season with 5-foot-high flashboards, the water surface difference between the dam crest and the plunge pool is 4.3 feet and the upstream wetted width is 62 feet (Photo D-44). The concrete dam base extends 8 feet downstream of the flashboards and is flush with the channel grade. Water spills over the flashboards into a shallow pool that is just over 6 inches deep at the base of the apron. A second pool 9 feet downstream is about 1.5-foot-deep. The 6-inch downstream plunge pool depth does not meet the minimum 2-foot requirement for juvenile salmonids.

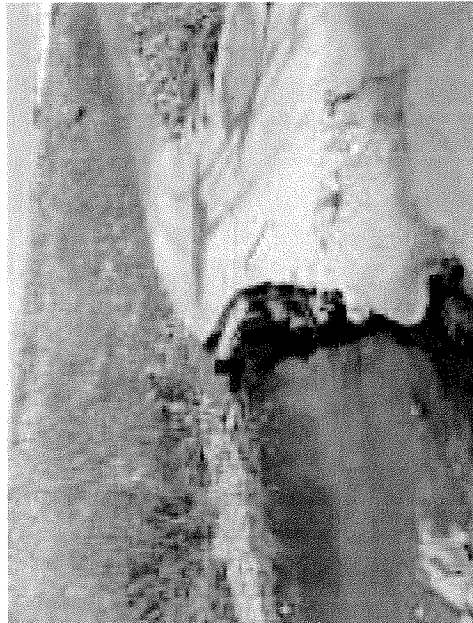
Photo D-47. View across downstream side of Fujinaka Low-flow Crossing

The downstream channel is similar to the upstream channel except the riprap extends partially across the channel and alluvial deposits are sparse. Between site visits, the riprap on the lower banks and toe sections immediately downstream of the structure had been scoured away (Photo D-47). The tail water control appears to be a small deposition zone. It is creating a riffle crest about 300 feet downstream from the structure where the flow of the downstream pool transitions from subcritical to supercritical flow. The riffle was composed of small cobbles and gravels. For a short distance, they seemed embedded before yielding to a dominant muddy clay substrate. Riprap scour protection lines the channel below the culverts and levee toes upstream and downstream of the low-flow crossing.

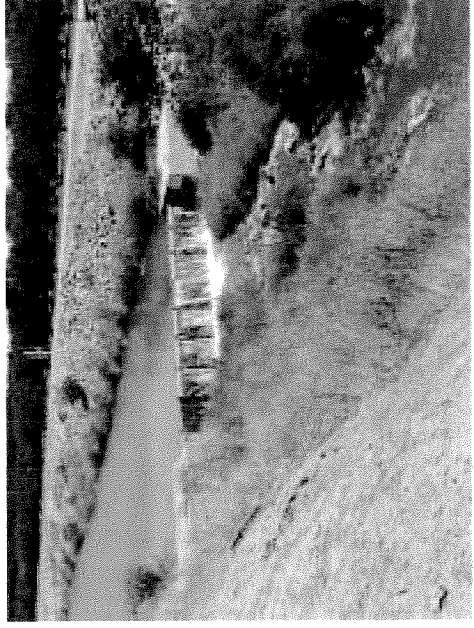
Photo D-51. Flashboards in place at Prato Flashboard Dam

With flashboards up during irrigation season, the upstream wetted channel width is 77 feet and flashboards span 46 feet across Mormon Slough (Photo D-51). The flashboards are about 7 feet high and the water surface difference between the dam crest and the plunge pool is about 6 feet. The plunge pool is a foot deep, which does not meet the 2-foot minimum depth for juvenile salmonids.

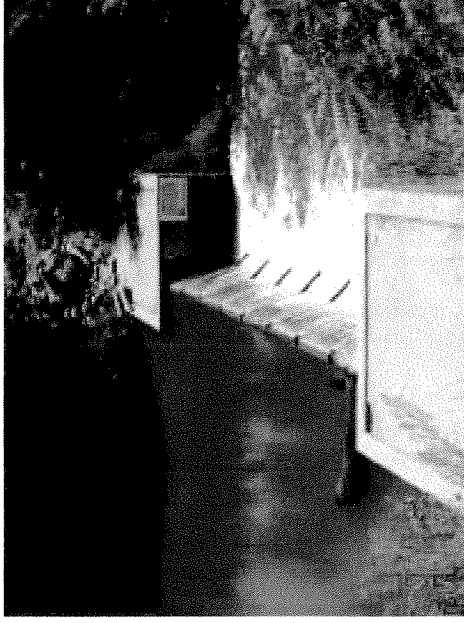
Photo D-56. Flashboards in place at Bonomo Flashboard Dam

During irrigation season with flashboards, the upstream wetted channel is 74 feet wide (Photo D-56). The flashboard dam is 42 feet wide. The water surface difference between the crest and plunge pool is about 5 feet and the plunge pool is 6 inches deep. The dam does not meet the minimum plunge pool depth of 2 feet for juvenile salmonids. We will use modeling results from Piazza Flashboard Dam to assess fish passage at Bonomo Flashboard Dam.

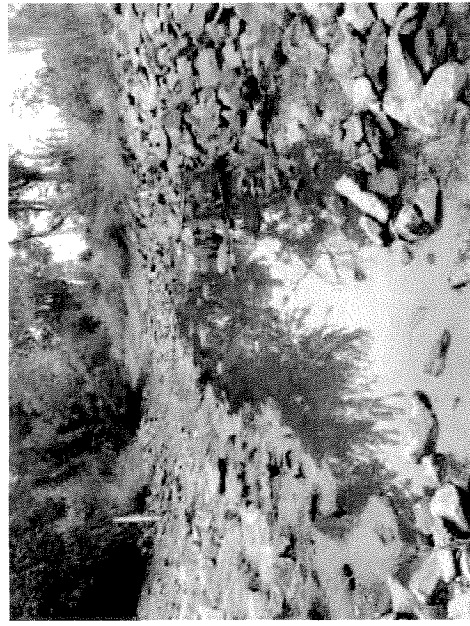
Photo D-96. McAllen Flashboard Dam upstream of McAllen Road Bridge

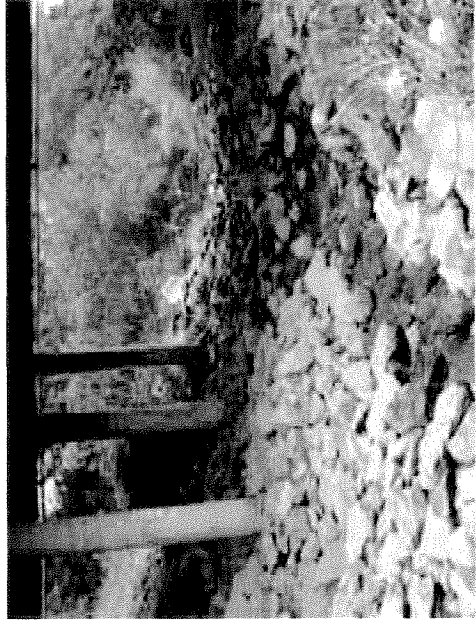
Photo D-97. Outfall pipes upstream of McAllen Flashboard Dam base

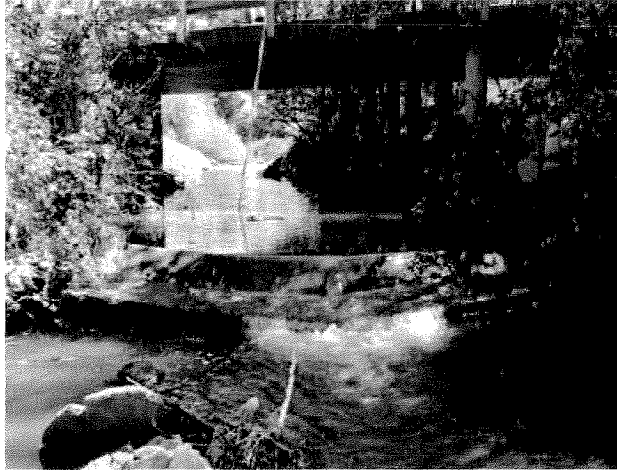
Photo D-100. Looking upstream at the Old DWR Gage Weir

The concrete weir spans 16 feet across the channel bottom in an arced chevron shape pointing in the downstream direction. The weir has an ogee shape; a rounded crest that slopes down then flattens, and is about 4 feet from upstream crest to downstream lip and 2.5 feet tall from centerline crest to toe (Photo D-100). Under low-flow conditions, there is a drop from the downstream edge of the weir to plunge pool surface.

The structure is a potential barrier to upstream fish migration. Until flows are high enough to backwater or submerge the weir, fish leaping onto the flat portion of the weir do not have sufficient water depth to proceed and leap over the rounded crest. Water velocity over the smooth concrete may also cause a fish to fall back after leaping onto the lower weir. Because the weir and gage are no longer in use, the structure should be removed.

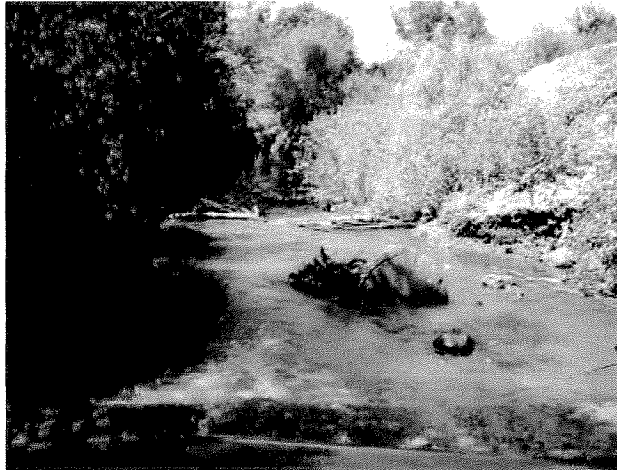
Photo D-101. Looking downstream from the Old DWR Gage Weir crest

Downstream from the weir, the silty bottom has riprap and scattered concrete rubble. Dense blackberry vines and trees overhang the channel on the left bank. The right bank has sparser blackberry cover and shows signs of bank erosion (Photo D-101). Trash and debris litter the channel bottom both up and downstream from the weir.

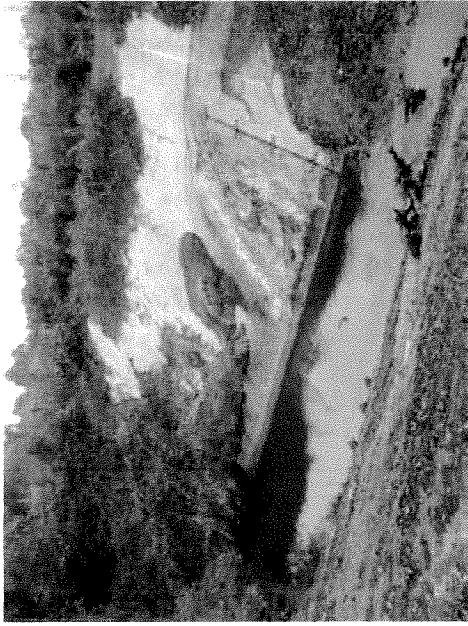
Photo D-102. Looking at the base of Tully Flashboard Dam

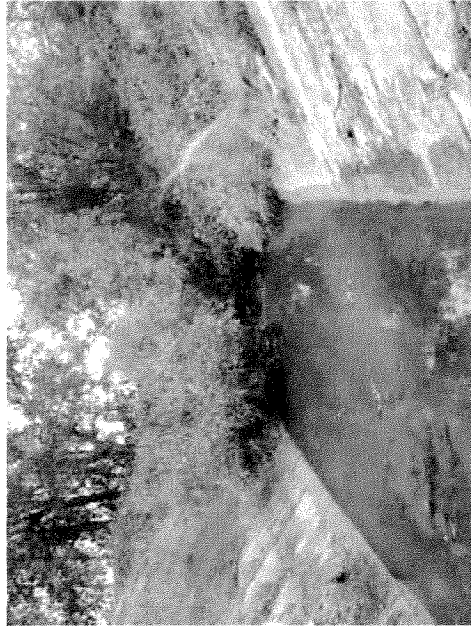
Photo D-104. Downstream from Tully Flashboard Dam

Immediately downstream of Tully Flashboard Dam, the channel is inundated with vegetation (Photo D-104). This vegetation constricts the river channel. The vegetation is a mixture of weedy grasses, weedy bushes, and riparian trees, and continues along the river channel downstream of Tully flashboard dam beyond Tully Road Bridge. Downstream from the dam, the river channel substrate gives way to silty clay with some woody debris. The downstream banks are steep and heavily vegetated. Downstream, riparian trees provide shade to the river channel.

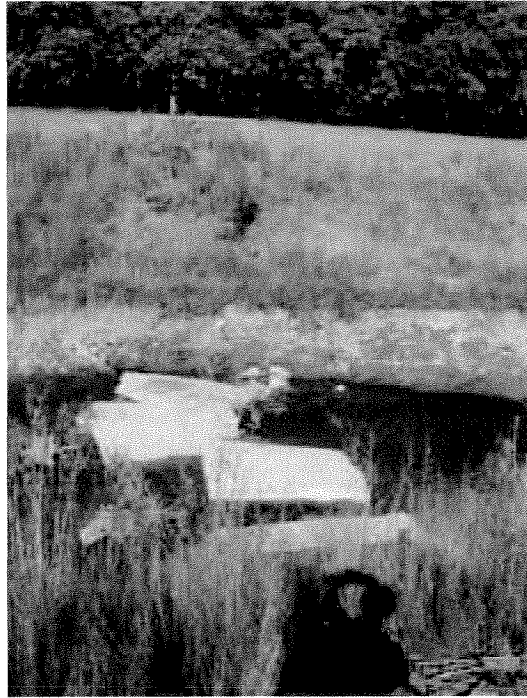
Photo D-109. Concrete slabs of remnant structure

There are concrete slabs on the channel bottom on Mormon Slough near river mile 12.7. We suspect they are remnants of an old bridge (Photo D-109). We did not measure or survey the site. The pieces of concrete might be a barrier to fish migration and should be removed.

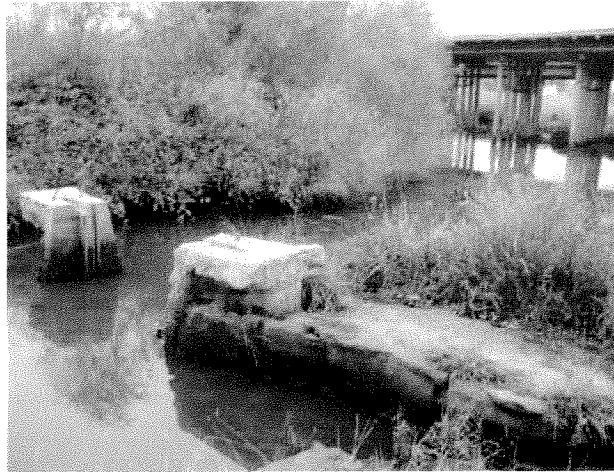
Photo D-113. Upstream face of concrete remnant structure

The concrete remnant structure upstream of Pacific Avenue Bridge, near river mile 3.9, appears to have been the foundation and abutments of a flashboard dam (Photo D-113). The opening between abutments is 8 feet wide, and the bankfull width is 60 feet. The structure has been washed away near the left bank and is no longer in use. Because the structure is no longer in use, it should be removed.

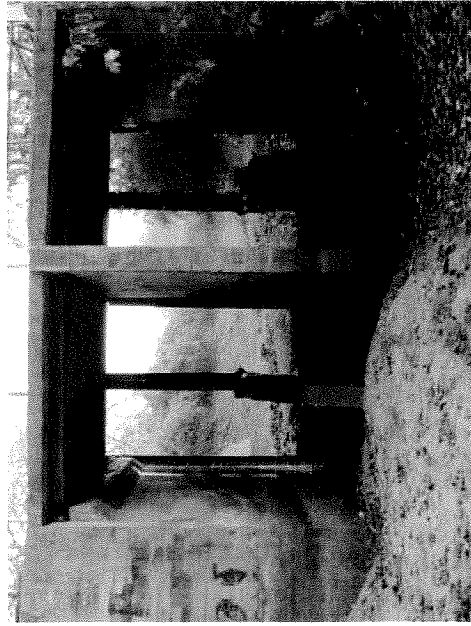
Photo D-117. Looking upstream at Pezzi Flashboard Dam

Pezzi Flashboard Dam has half-height buttress walls centered in each bay to provide support for the flashboards. Each bay and buttress has metal guide slots for installation of flashboards across the inlet of the structure to accommodate upstream water diversions during the irrigation season. The culvert bays are blocked with flashboards 7.3 feet high during the irrigation season (Photo D-120). The flashboards create a 7.2-foot water surface difference. The plunge pool downstream from the dam is about 4 feet from the dam face and greater than 5 feet deep.

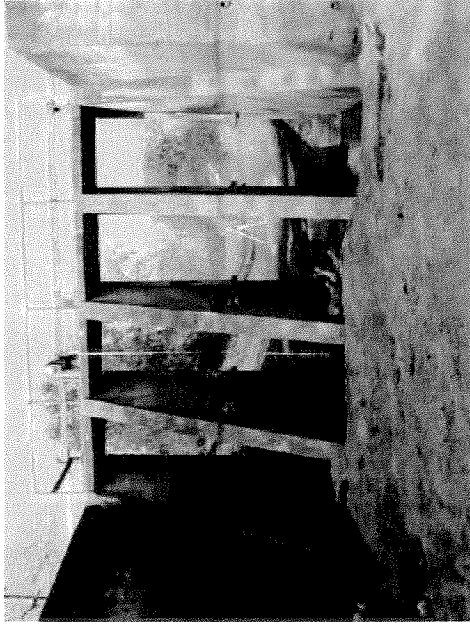
Photo D-121. View from downstream side of Murphy Flash-board Dam

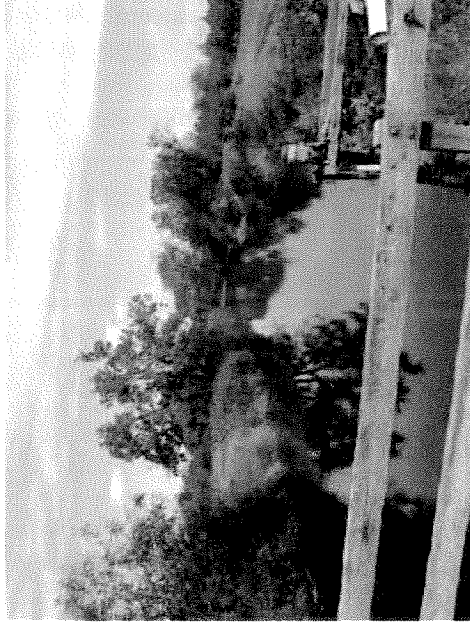
Photo D-123. Upstream view from top of Murphy Flash-board Dam with flashboards installed
