FINAL PROGRAMMATIC ENVIRONMENTAL ASSESSMENT/FONSI INITIAL STUDY/MITIGATED NEGATIVE DECLARATION

Lower Calaveras River Anadromous Fish Barriers Improvement Project

FISHBIO Environmental

U.S. Fish and Wildlife Service and Stockton East Water District

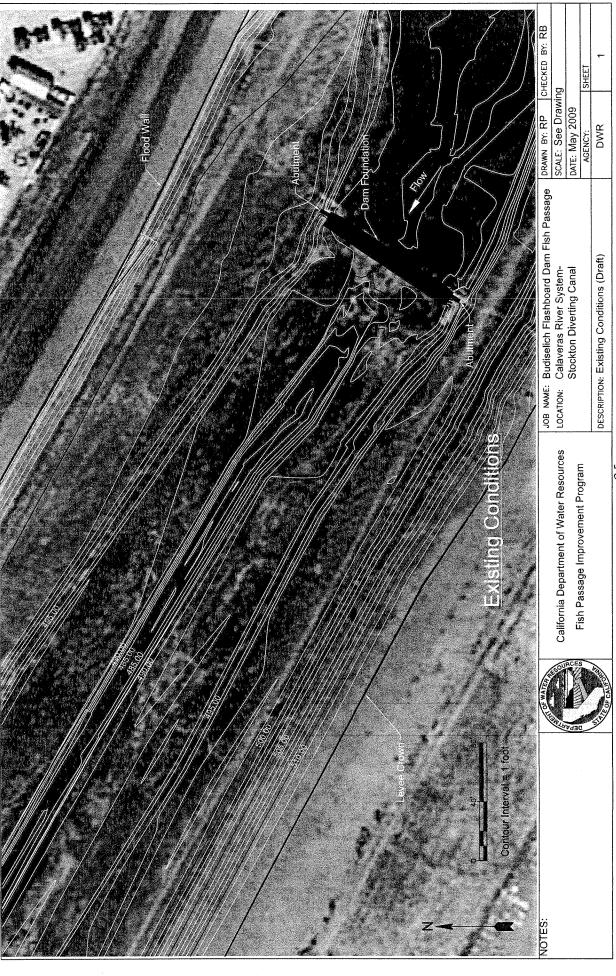
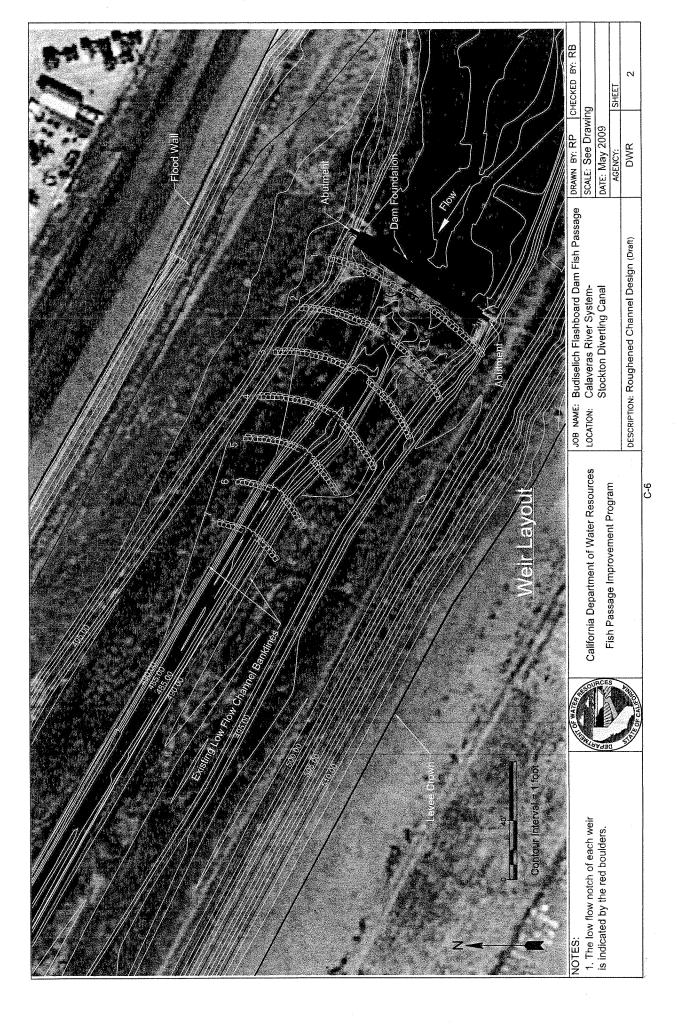
Final designs on the following pages were developed collaboratively with the following participants: SEWD, USFWS, CDFG, CDWR, USACE, and Fishery Foundation of California.

Barrier	Location RM	Property Owner	Structure Type	Proposed Design
Budiselich Flashboard Dam (BFBD)	7.5	SEWD	Flashboard Dam, shallow depth, steep slope	Rock ramp fishway and boulder weirs
Central California Traction Railroad Crossing (CCTRC)	6.5	CCTR	Bridge with footing apron, shallow depth	Install 7 grade control structures (i.e. boulder weirs)
Hosie Low Flow Crossing (HLFC)	18.7	SEWD	Concrete low flow road with no culverts, Riprap	Install new culvert and remove riprap
Caprini Low Flow Crossing (CLFC)	12.7	SEWD	Low flow road crossing, 3-3ft diameter culverts, velocity	Replace culverts install grade control structures

It should be noted that both preliminary and final designs have been prepared based on CDFG's and NMFS' design criteria and recommendations for boulder weir step pool fishway for adult and juvenile salmonids identified in *Design of Fish Passage Solutions* (CDWR [In Press]).
