**Meeting of the Central Valley Flood Protection Board  
December 19, 2014**

**Staff Report**

**Schneider Property Habitat Restoration Project  
(Madera County)**

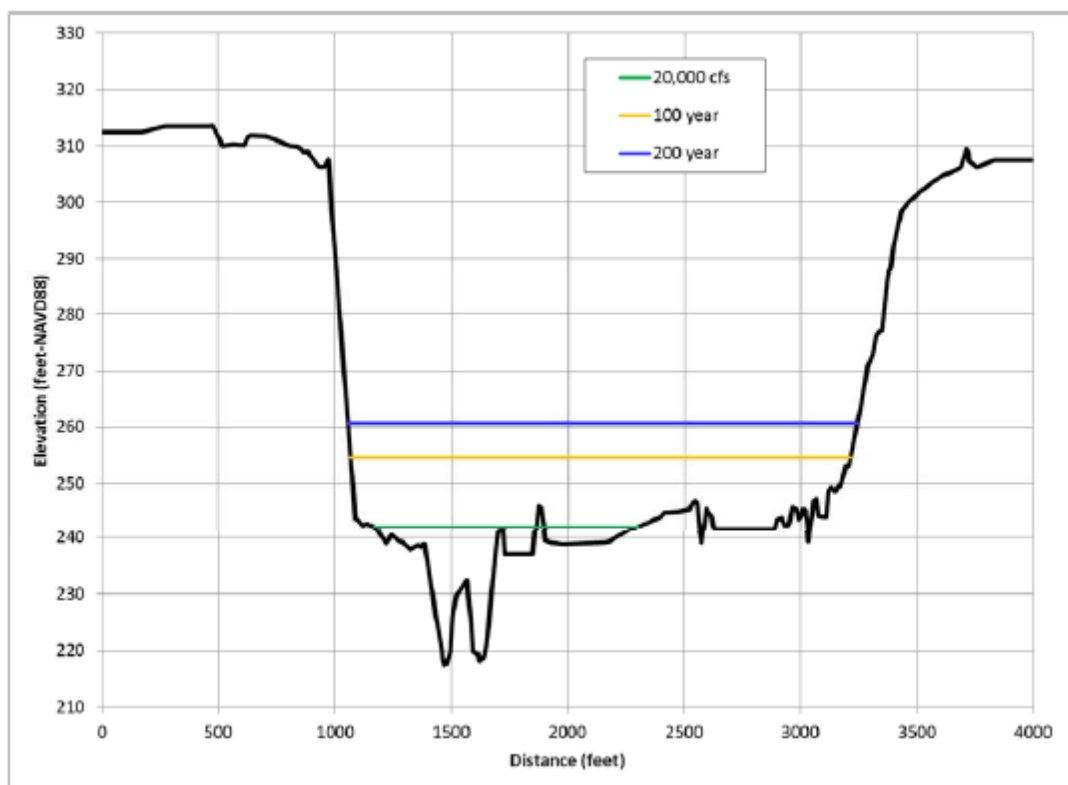
Figure 1: Comparison of water surface elevations from Board designated floodway flow (20,000 cubic feet per second), the 100-year flood (71,000 cubic feet per second) and 200-year flood (110,000 cubic feet per second) at the project location (Reference: see Attachment B, Exhibit D)

The computed water surface elevations and the differences in water surface elevations for the existing condition and project condition predict that the maximum increase is 0.14 foot for the Board's designated floodway design flow, 0.37 foot for the 100-year flood and 0.47 foot for the 200-year flood.

The hydraulic analysis results show that the water surface along the project reach is typically a minimum of 55 feet below the top of the adjacent bluffs for the Board's designated floodway flow, 45 feet below for the 100-year flood and 40 feet below for the 200-year event. Such a high freeboard is because the proposed project is located along a reach of the San Joaquin River contained by two high bluffs.

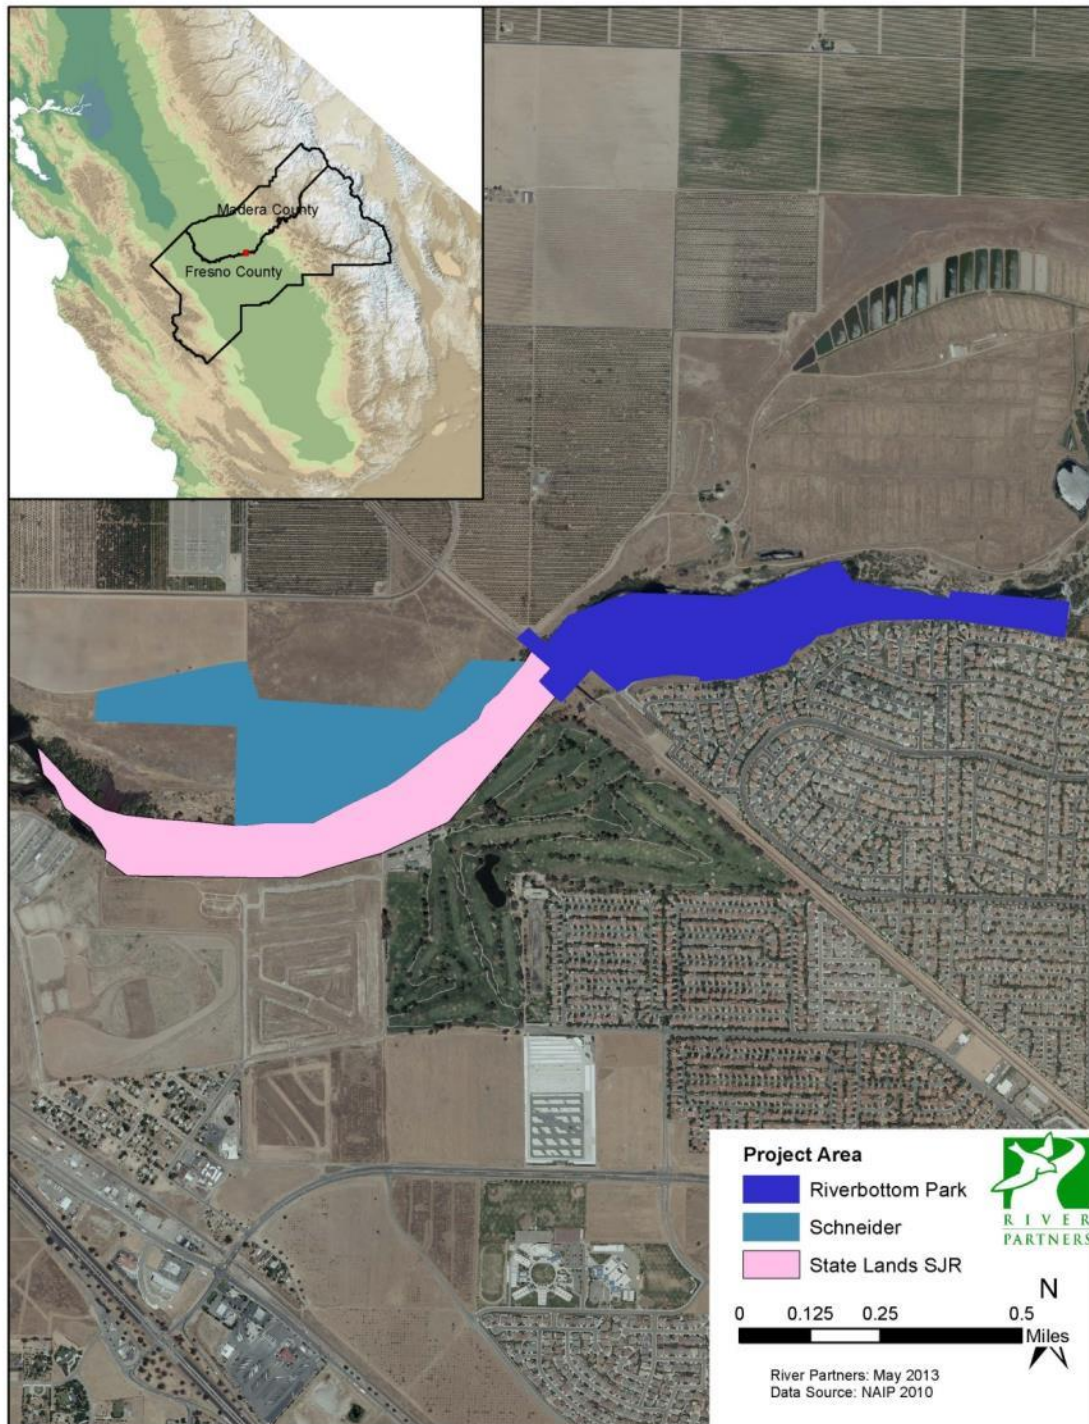
**Figure 1.** Project Location: Riverbottom Park and Schneider Ranch, Fresno and Madera County, California.

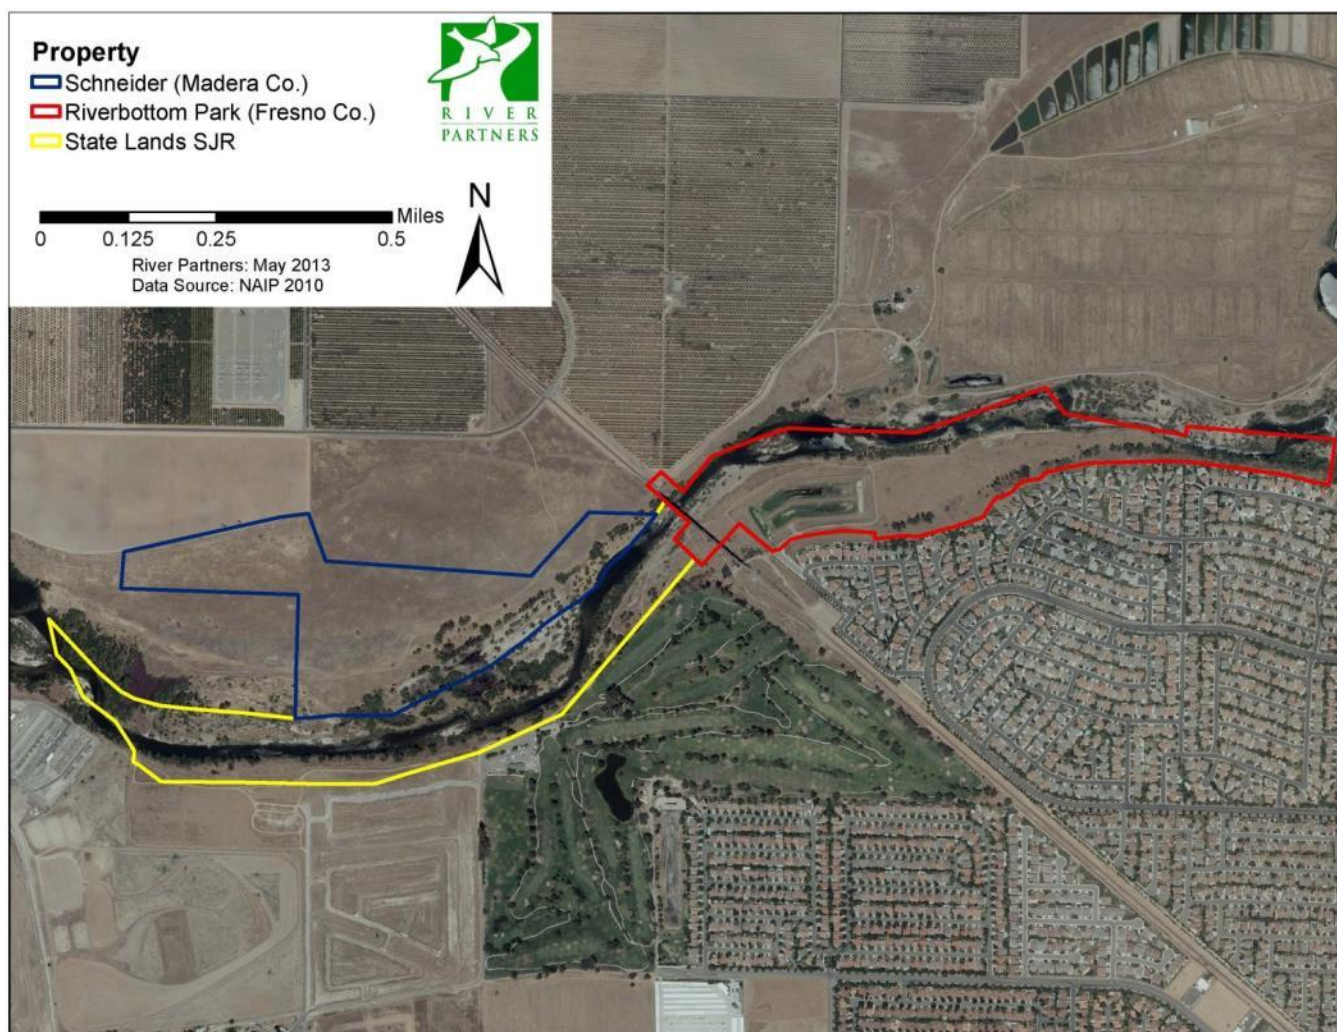
**Figure 2.** Project Boundaries for Riverbottom Park and Schneider Property, Fresno and Madera Counties, California.

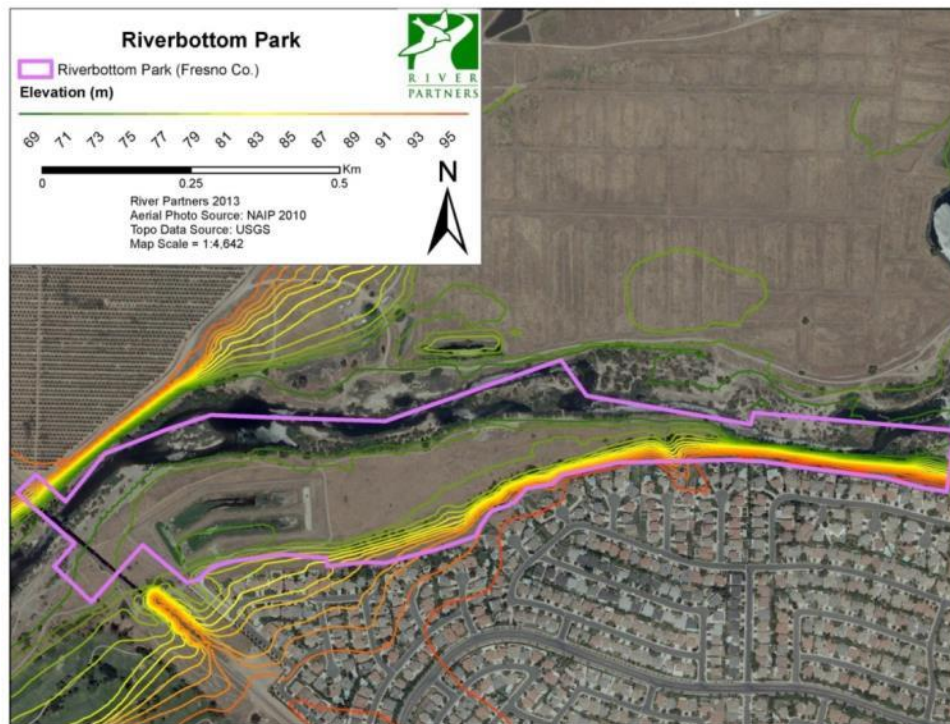
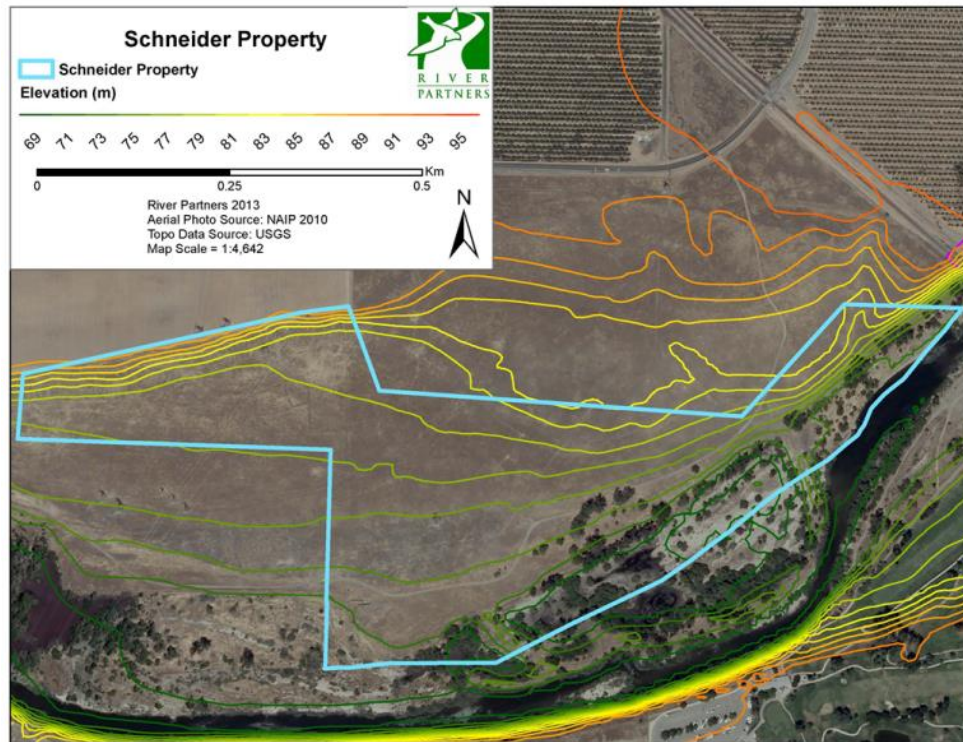
**Figure 3.** Topography, Riverbottom Park and Schneider Property, Fresno and Madera Counties, California.

Topography of Riverbottom Park has also been altered by human activity, but on a much smaller scale. Dating as far back as 1946, it does not appear that the Park has ever been mined for gravel or leveled for agriculture. The construction of the Burlington Northern Santa Fe Railroad crossing and Fresno Metropolitan Flood Control District ponds are human alterations to the Riverbottom Park project site that have little impact to the restoration since neither of those alterations are within the restoration footprint. Riverbottom Park is relatively level compared to the Schneider Property. The roughly 0.25 km floodplain increases in elevation by only 2 m in a southerly direction from the San Joaquin River, but rises steeply (20 m) at the bluffs to the southern edge of the Property (Figure 3).

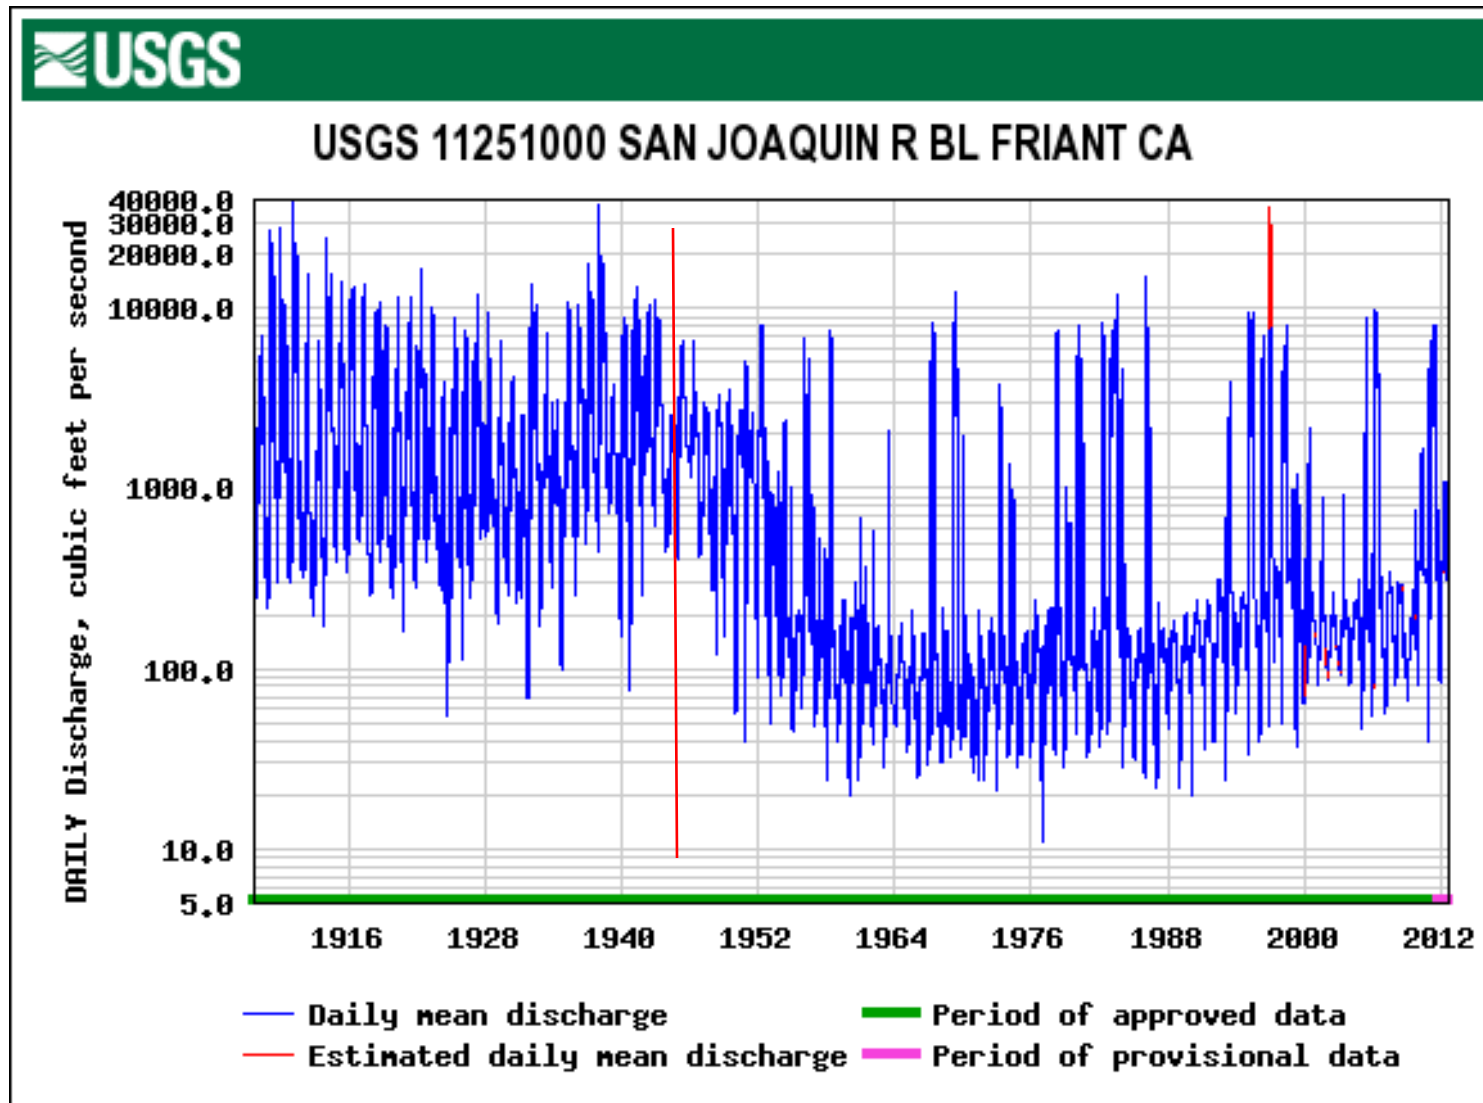
**Figure 5.** San Joaquin River stream flow below Friant Dam for the period of record 1907-2012. Vertical red line indicates 1944, the year Millerton Lake began to fill.

was completed, there were 25 peak events greater than 10,000 cfs, while in the 67 year post-dam period, only six events occurred of a magnitude greater than 10,000 cfs.

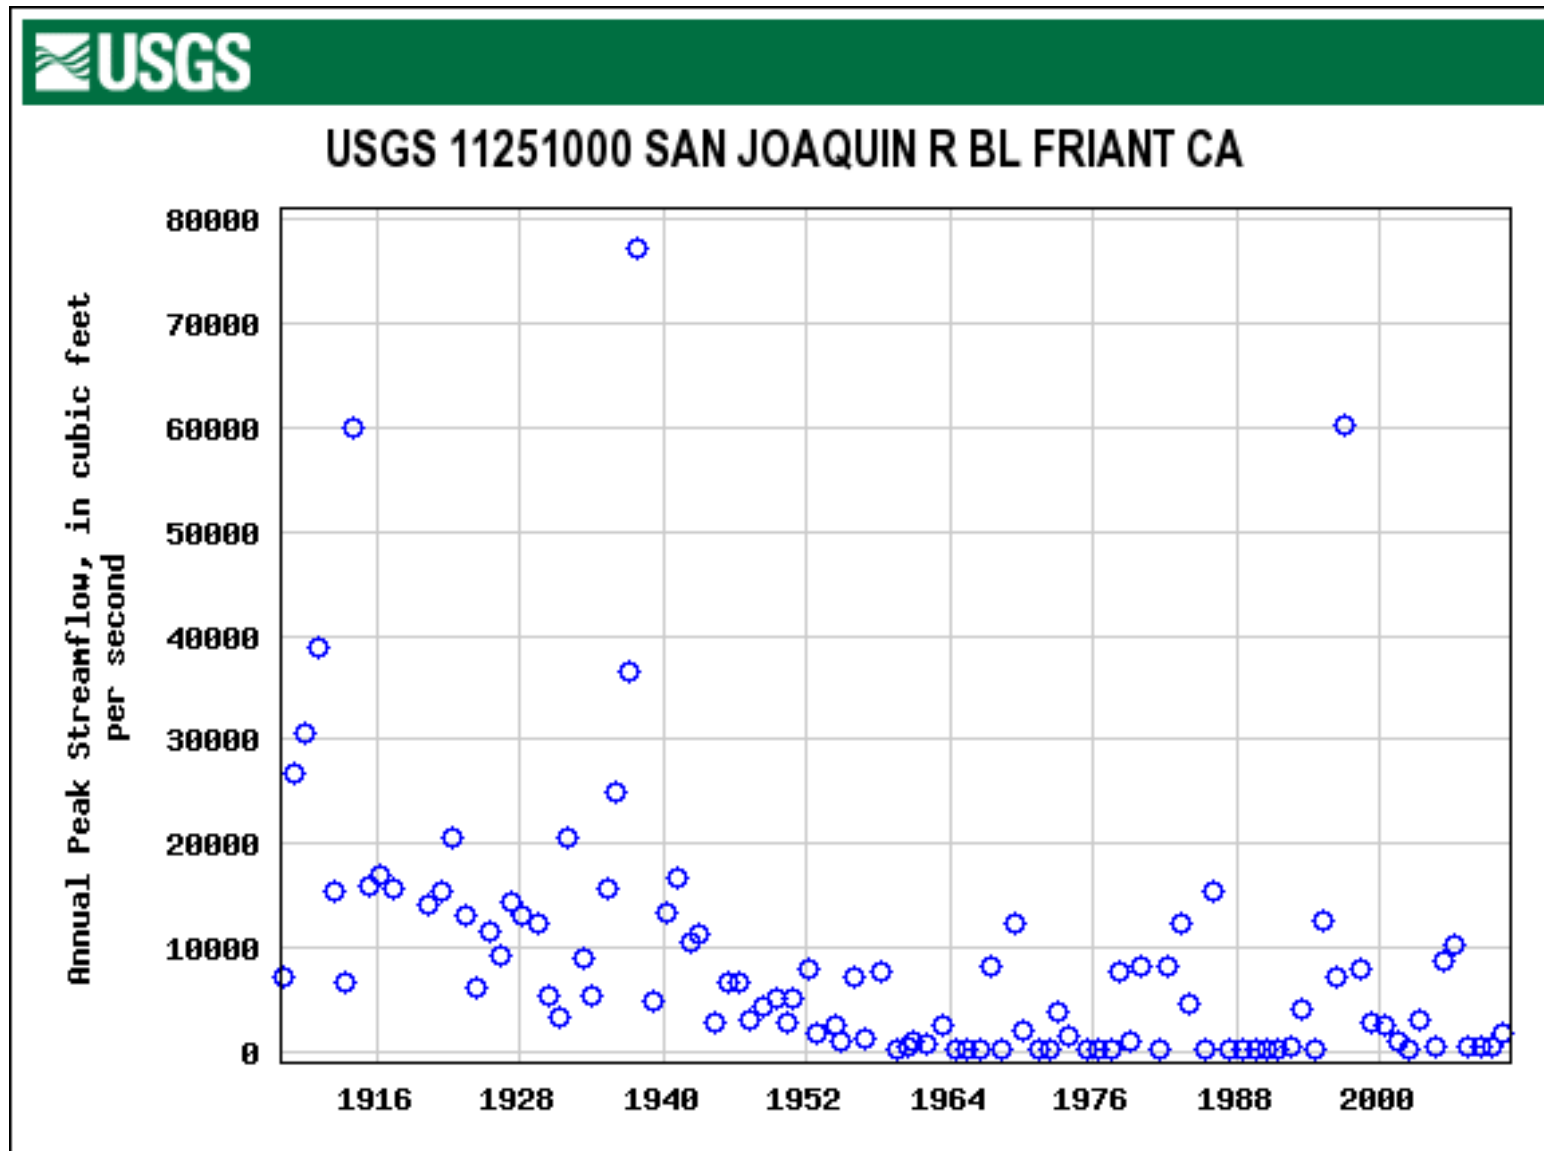
**Figure 6.** San Joaquin River annual peak stream flows below Friant Dam for period of record at gage #11251000.

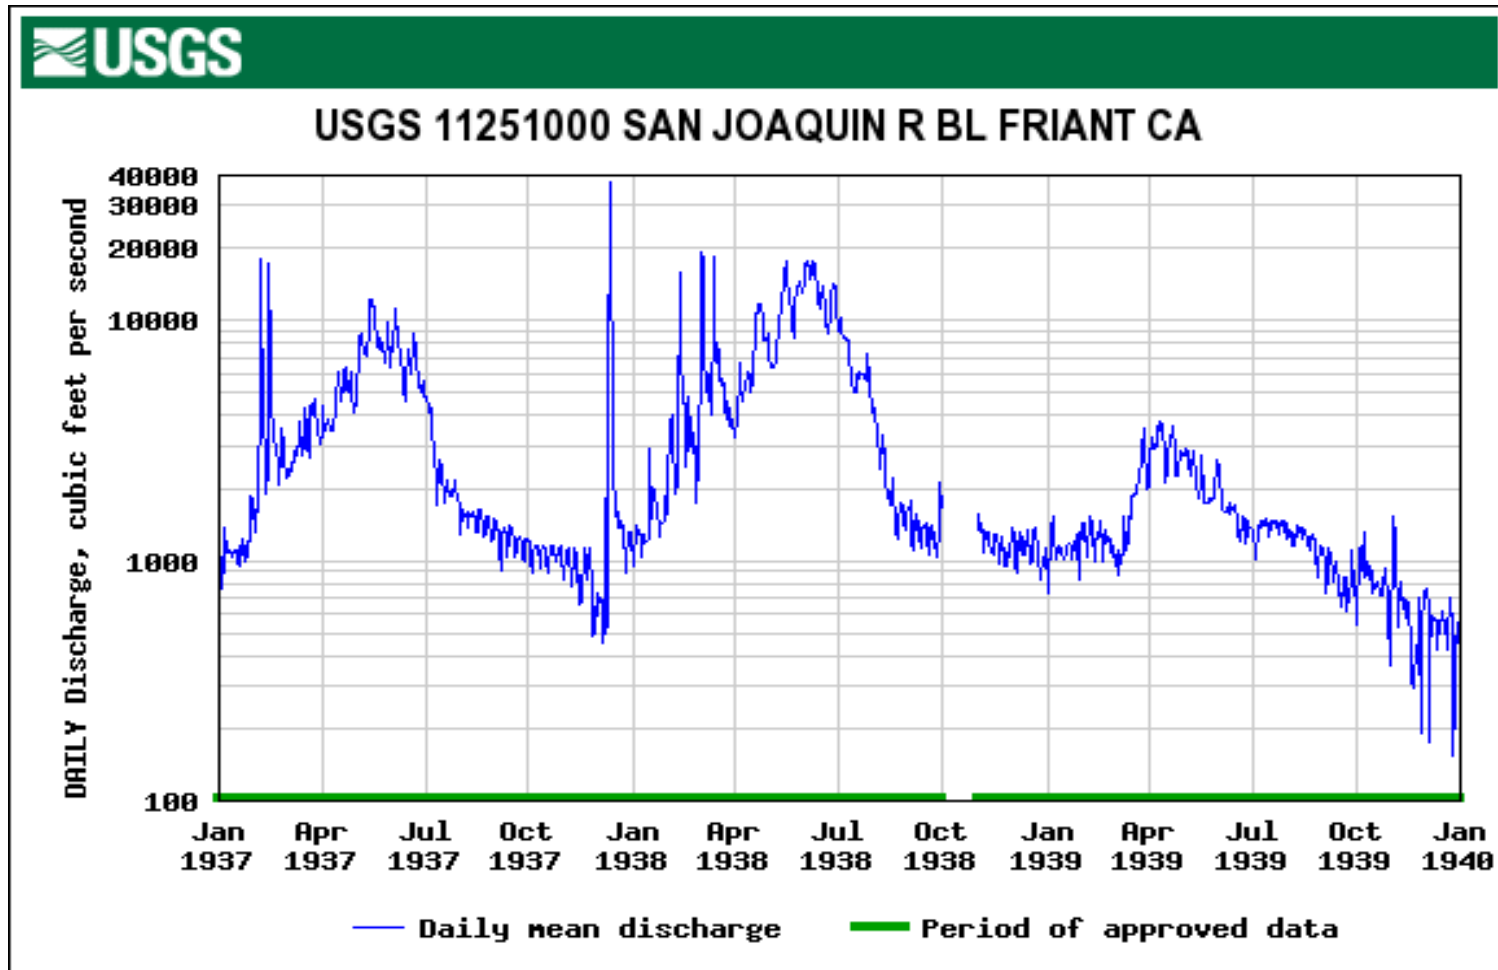
**Figure 7.** Hydrograph for water year 1937, showing the largest winter flood event prior to the construction of Friant Dam.

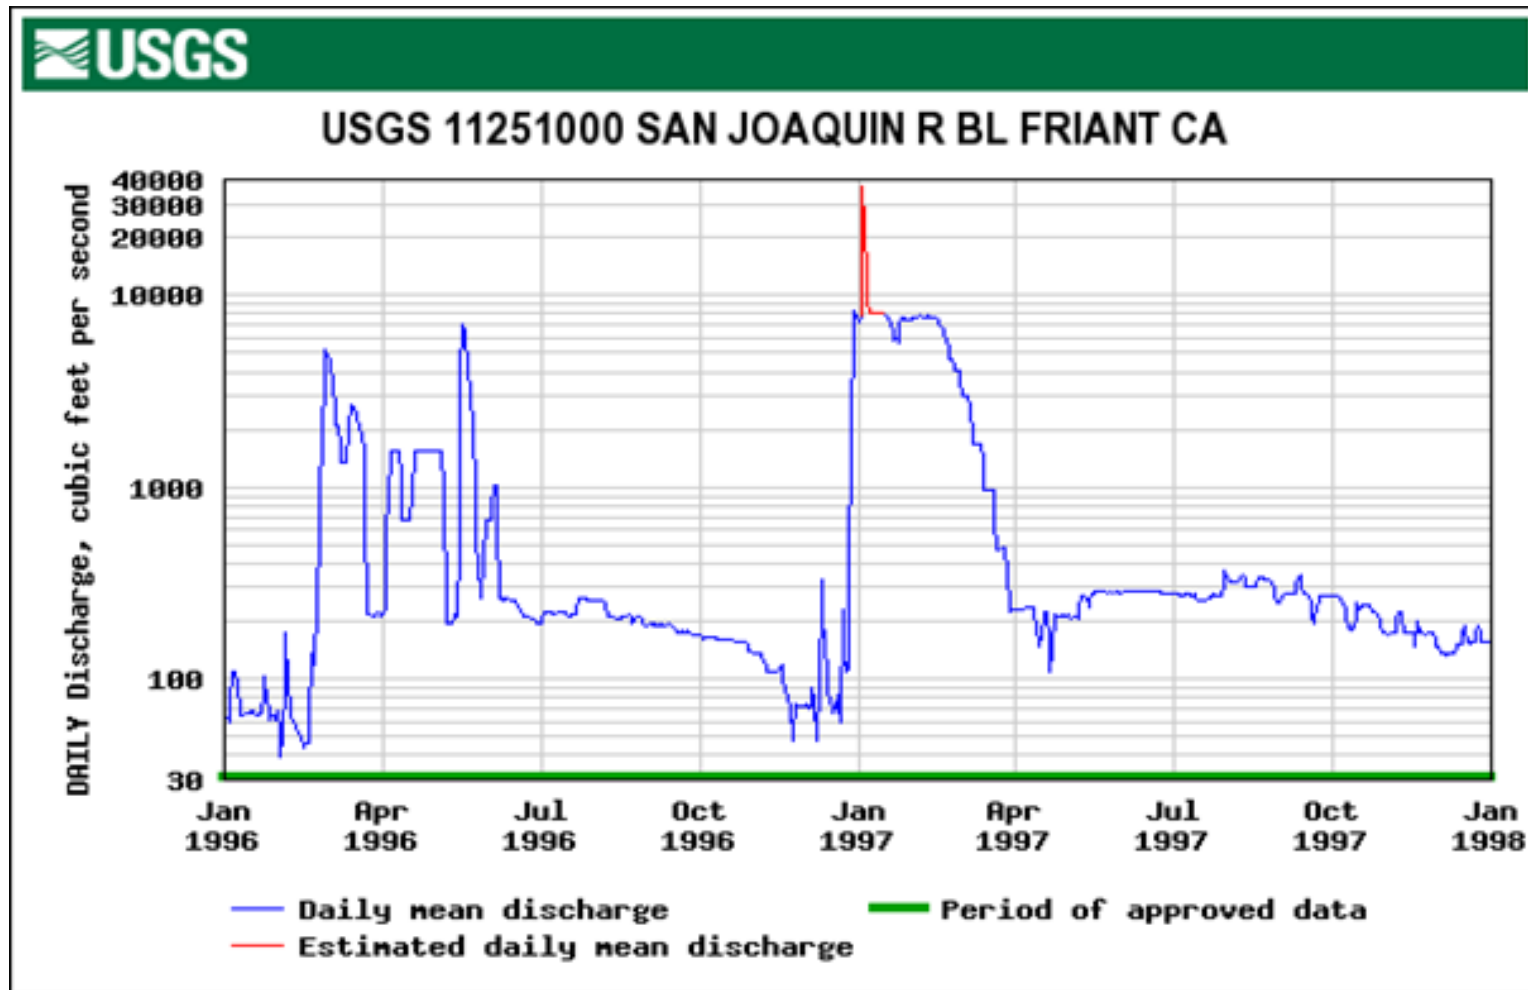
**Figure 8.** Hydrograph for water year 1997, San Joaquin River below Friant Dam, the largest flood event on record post dam construction.

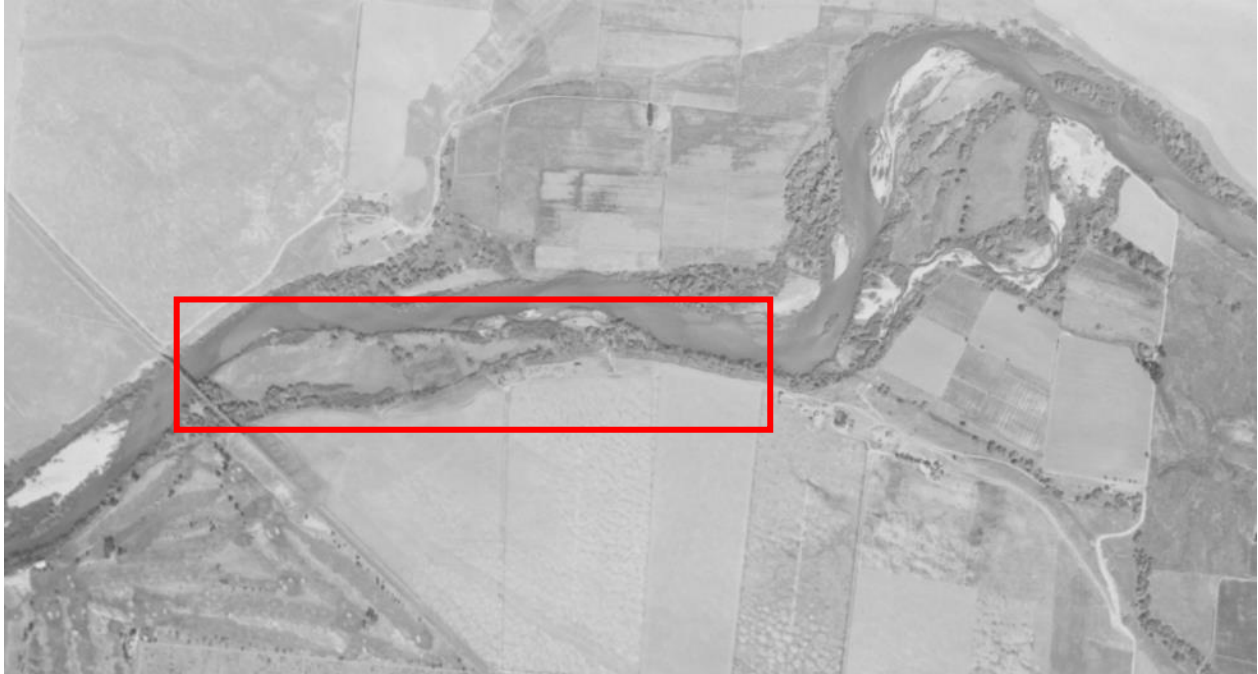
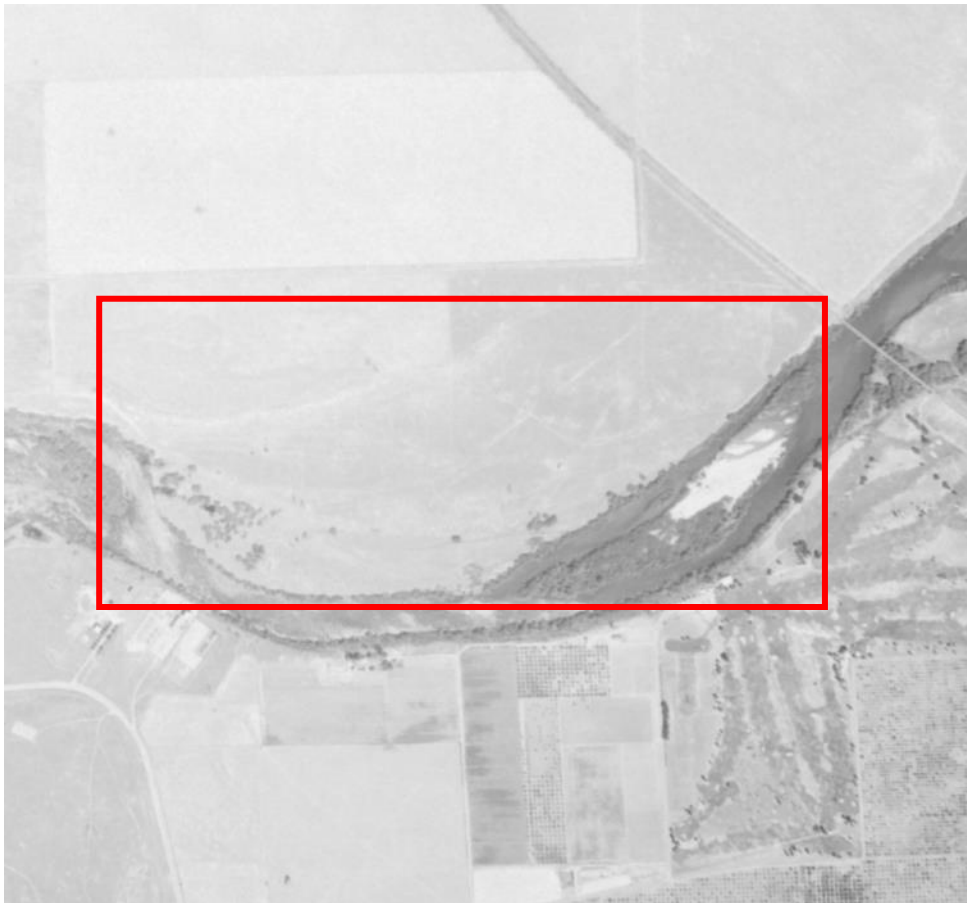
**Figure 9.** 1946 historic aerial photographs of Riverbottom Park (top) and Schneider Property (bottom), Fresno and Madera Counties, California. Courtesy of USGS.

the project area; Figures 9 and 10). Large portions of the river were excavated for sand and gravel leaving a severely-altered river system. Unauthorized cattle grazing still occurs on this site today.

Prior to the construction of Friant Dam in the 1940's, the Project site was still influenced by seasonal flooding. Lateral meander is evident in historic aerial photos dating back to 1946, which show active side channels, exposed sand bars, small oxbow lakes holding water, and visible scour and deposition patterns on the landscape (Figure 9). These ephemeral side channels provided habitat for the currently extirpated salmon that once flourished in the river. Remnants of a once lush riparian corridor are visible along the river channel, but after the construction of Friant Dam, changes in hydrology reduced the connection of native vegetation to the water table (Riverbottom Park) and gravel mining damaged floodplains (Schneider Property) (Figure 10). With the construction of the dam and the subsequent gravel operations, the river remained fixed over time in its main channel.

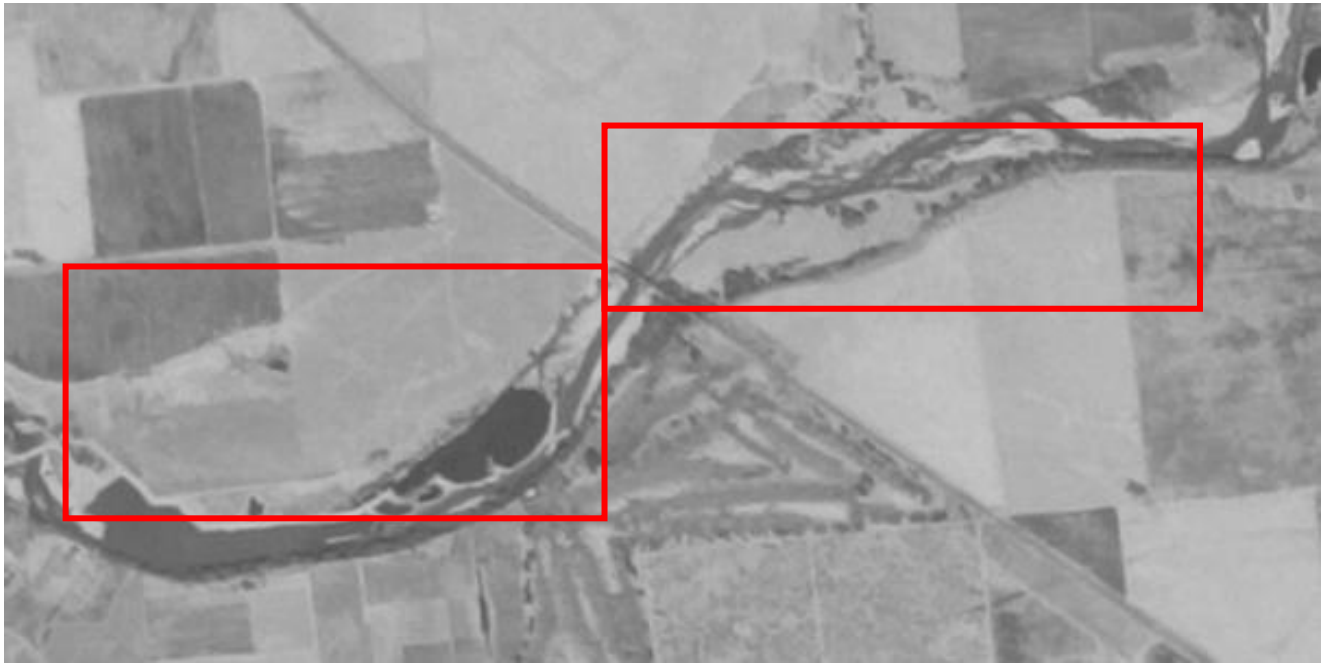
**Figure 10.** 1954 historic aerial photograph of Schneider Property (left) and Riverbottom Park (right), Madera and Fresno Counties, California. Courtesy of USGS.

Human activity has greatly altered the topography of the Project sites, especially the Schneider Property. As evident from historic photos, gravel pit mining in the 1950s lowered the floodplain on the Schneider Property near the river, leaving small permanent ponds and a channel that now floods around 2,500 cfs. The remainder of the Schneider Property has never been leveled for agriculture because of its slope. Elevations on the property range from 69 m a.s.l. at the floodplain and gravel pits to 91 m a.s.l. at the top of the bluffs on the northwest edge (Figure 3). The Schneider Property is characterized by a gradual slope, but exhibits steep sloping on the bluffs along the northwest and northeast borders of the property.

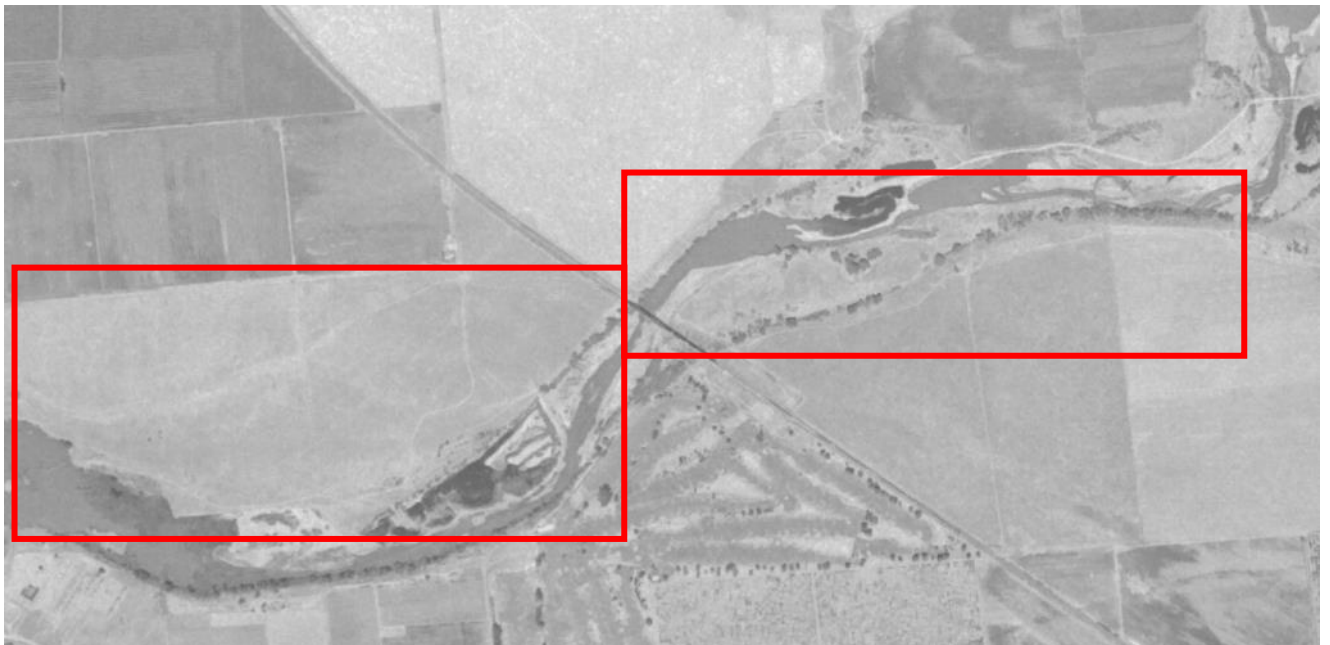
**Figure 11.** 1962 historic aerial photograph of Schneider Property (left) and Riverbottom Park (right), Madera and Fresno Counties, California. Courtesy of USGS.

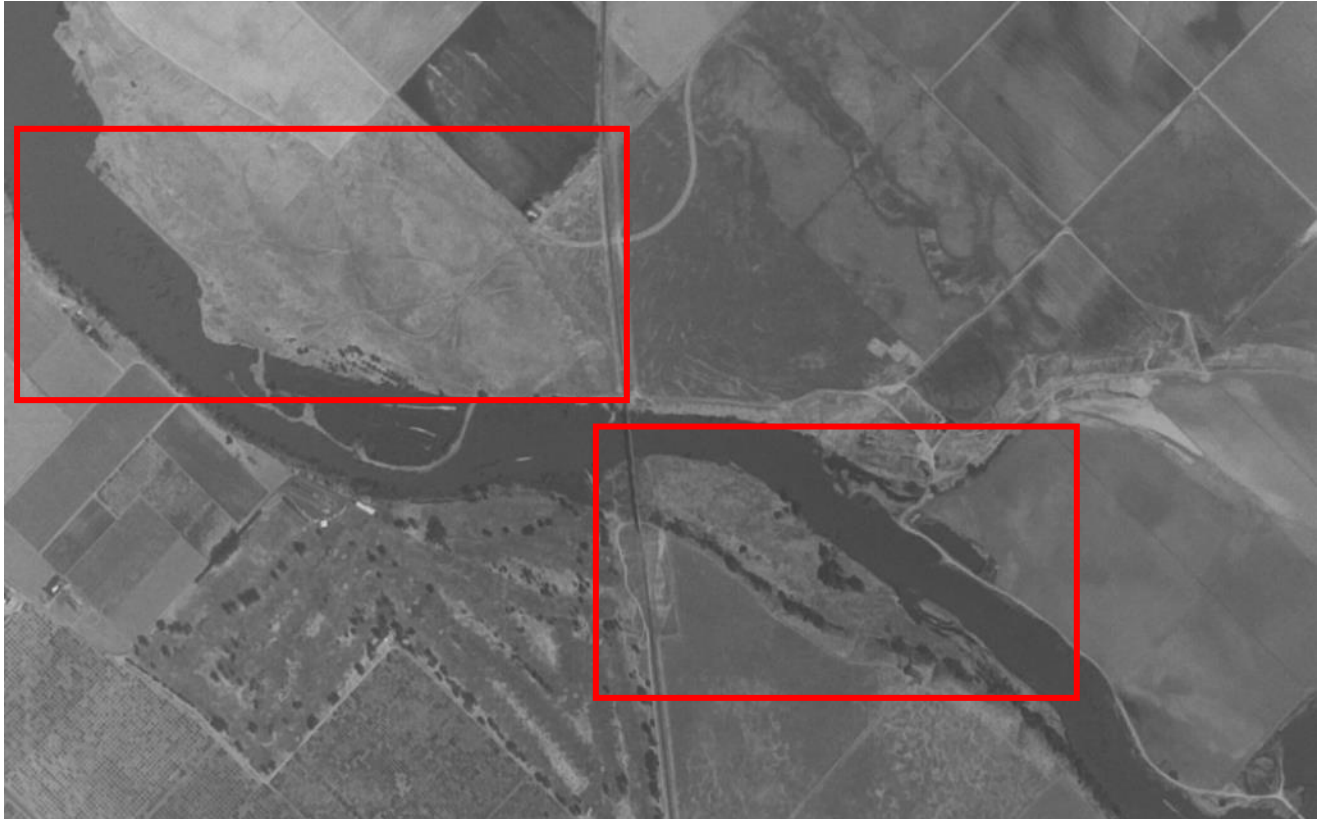
**Figure 12.** May, 23, 1969 historic aerial photograph of Schneider Property (left) and Riverbottom Park (right), during a high water event (8,500cfs), Madera and Fresno Counties, California. Courtesy of USGS.

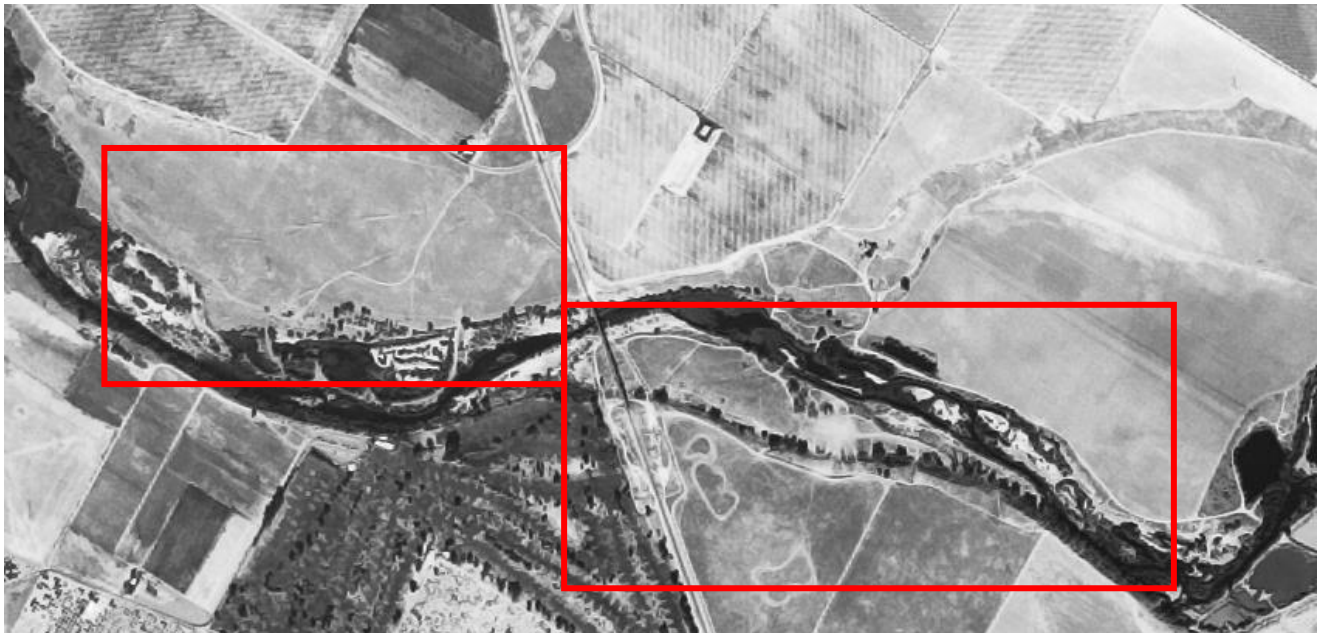
**Figure 13.** 1975 historic aerial photograph of Schneider Property (left) and Riverbottom Park (right), Madera and Fresno Counties, California. Courtesy of USGS.

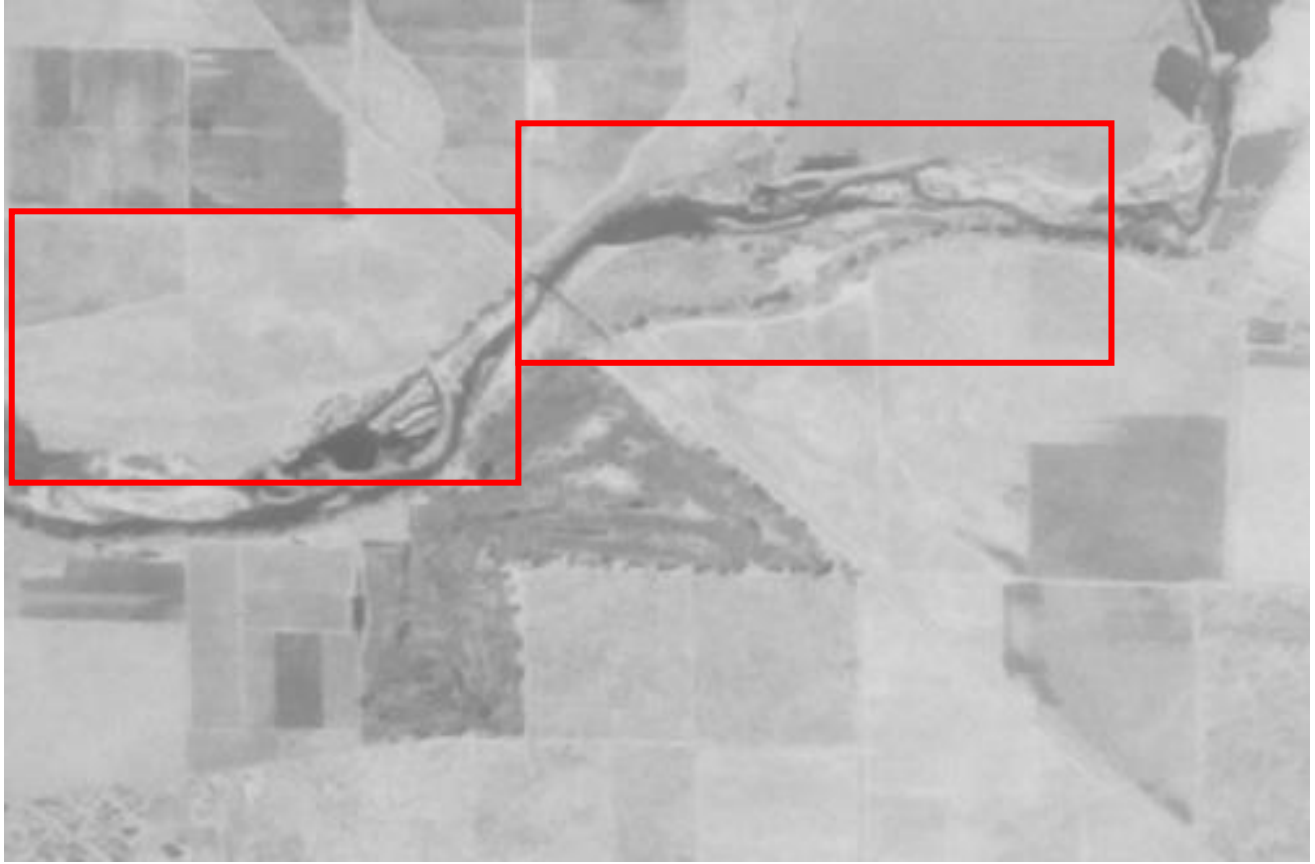
**Figure 14.** 1978 historic aerial photograph of Schneider Property (left) and Riverbottom Park (right), Madera and Fresno Counties, California. Courtesy of USGS.

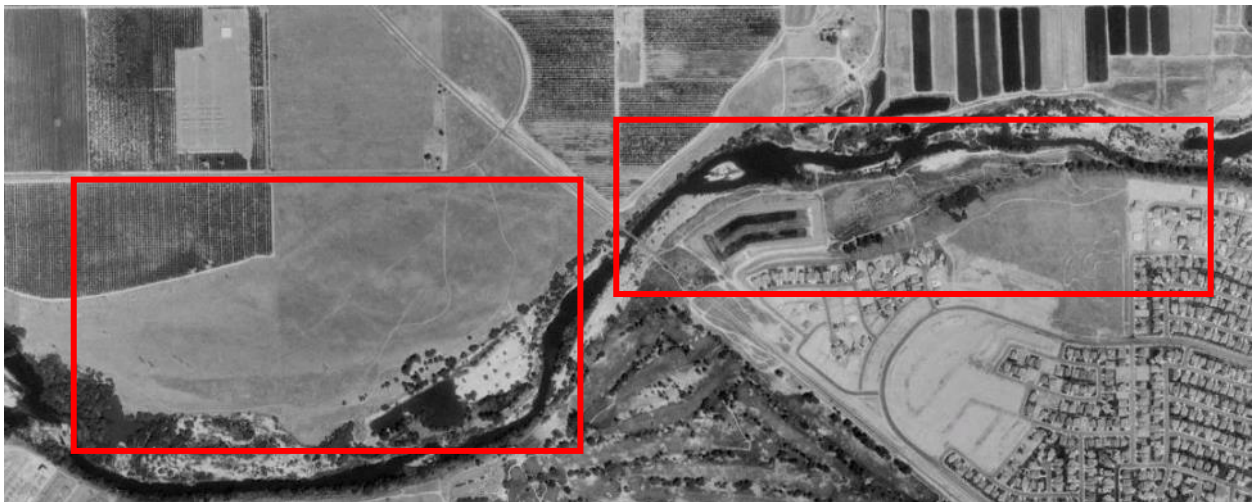
**Figure 15.** 1998 historic aerial photograph of Schneider Property (left) and Riverbottom Park (right), Madera and Fresno Counties, California. Courtesy of USGS. Notice the residential housing and percolation pond construction.

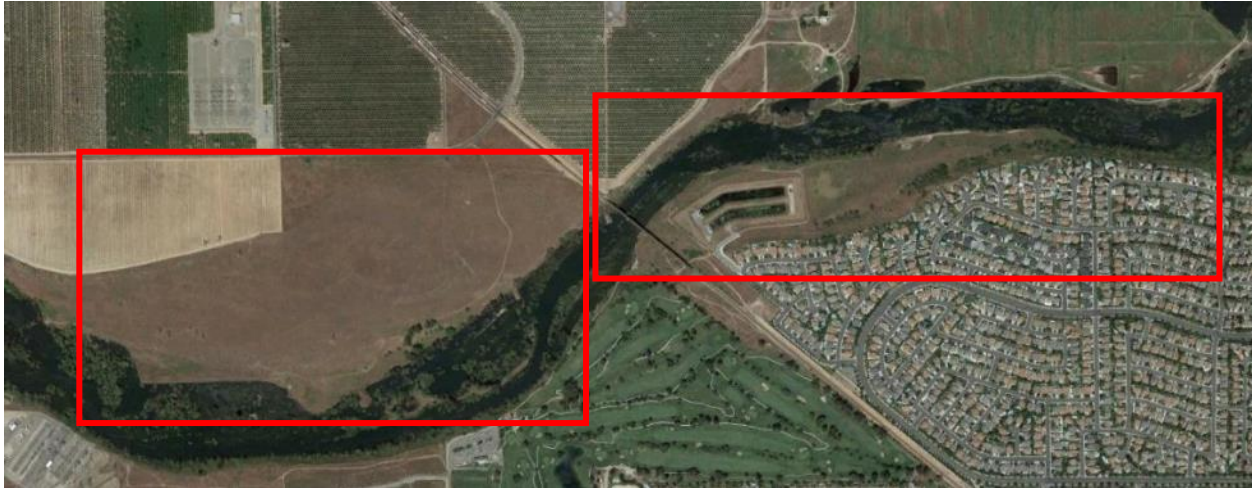
**Figure 16.** April 25, 2011 historic aerial photograph of Schneider Property (left) and Riverbottom Park (right), Madera and Fresno Counties, California. Documenting the 2011 flood. Courtesy of USGS .

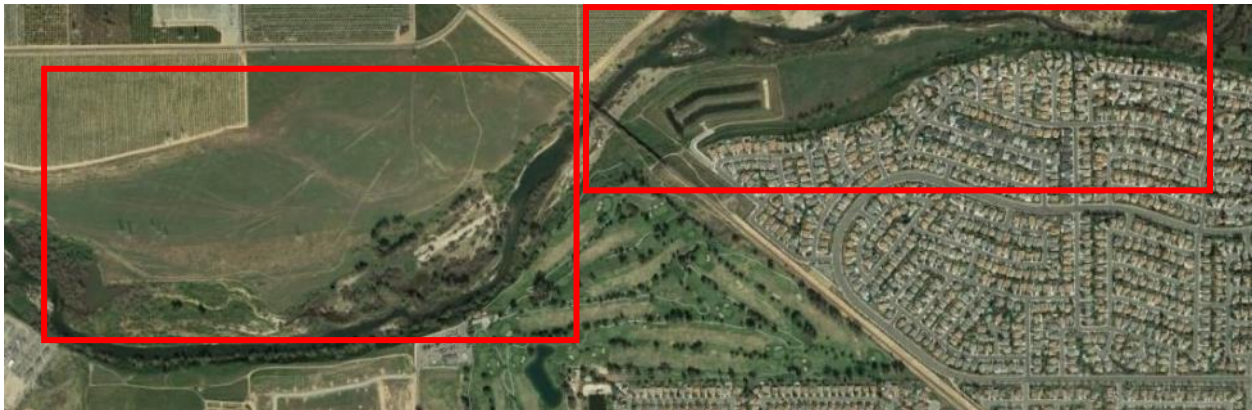
**Figure 17.** September 15, 2013 aerial photograph of Schneider Property (left) and Riverbottom Park (right), Madera and Fresno Counties, California. This photograph illustrates current site conditions. Courtesy of USGS and Google Earth.

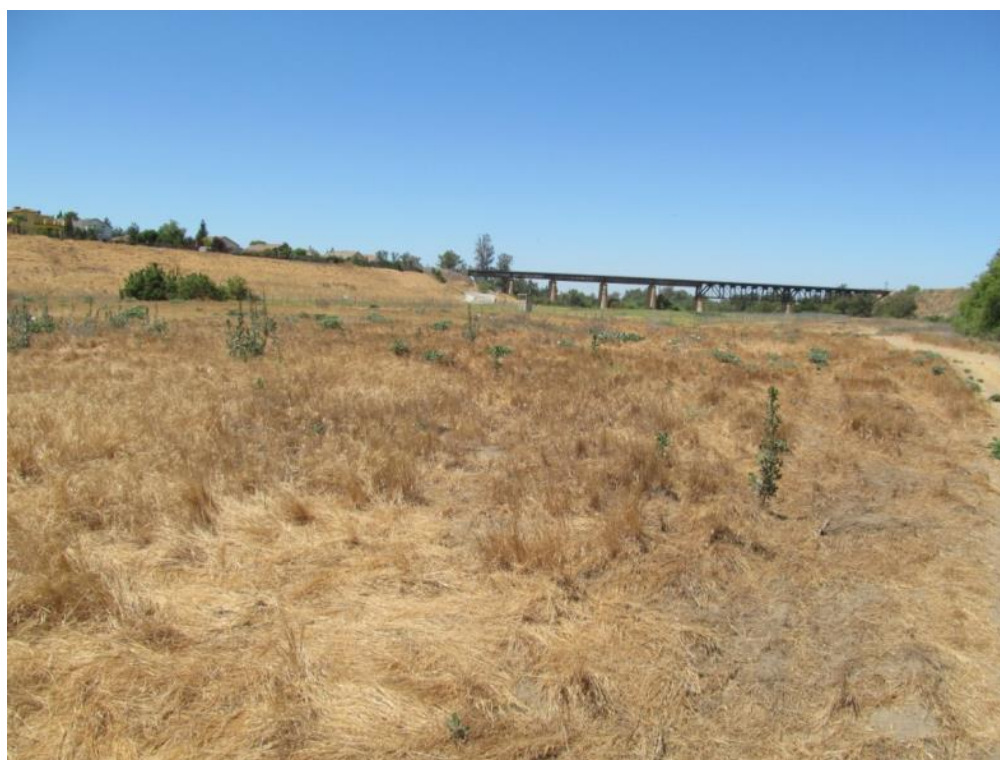
**Figure 18.** Invasive annual grasses currently dominate this upland field targeted for restoration at Riverbottom Park, Fresno County, California.

Currently, both project sites are dominated by a mixture of invasive weeds, primarily ripgut brome (*Bromus diandrus*), Italian rye (*Festuca perennis*), and yellow starthistle (*Centaurea solstitialis*) on the floodplains and uplands away from the river edge (Figure 18). Wild oat (*Avena fatua*), black mustard (*Brassica nigra*), and Bermuda grass (*Cynodon dactylon*) are present to a lesser degree in the uplands. Annual invasive weeds have a general life strategy in which they absorb near-surface soil moisture quickly in early spring, then die back as thatch that shades native seedlings. As a result, annual invasive weeds tend to strongly compete with native seedlings for both water and light. Under current conditions, without active restoration, it is unlikely that native vegetation will recolonize the Project area. Large stands of tree of heaven (*Ailanthus altissima*) can be found along the base of the north facing bluffs at Riverbottom Park, interspersed with Western sycamore (*Platanus racemosa*). These stands are most likely in direct competition with recruiting and established Western sycamore that prefer this location due to both the water runoff from the bluffs and the north-facing slopes that allow this area to retain soil moisture. The invasive red gum eucalyptus (*Eucalyptus camaldulensis*) can be found in an established stand on the floodplain of the Schneider Property. In the ponds (caused by gravel pit mining on the Schneider Property), river islands and along the river channel (Riverbottom Park), red Sesbania (*Sesbania punicea*) has established. Rattlebox has become a prolific invasive further upstream, crowding out native vegetation on the river's edge.
