**Meeting of the Central Valley Flood Protection Board  
December 19, 2014**

**Staff Report**

**Schneider Property Habitat Restoration Project  
(Madera County)**

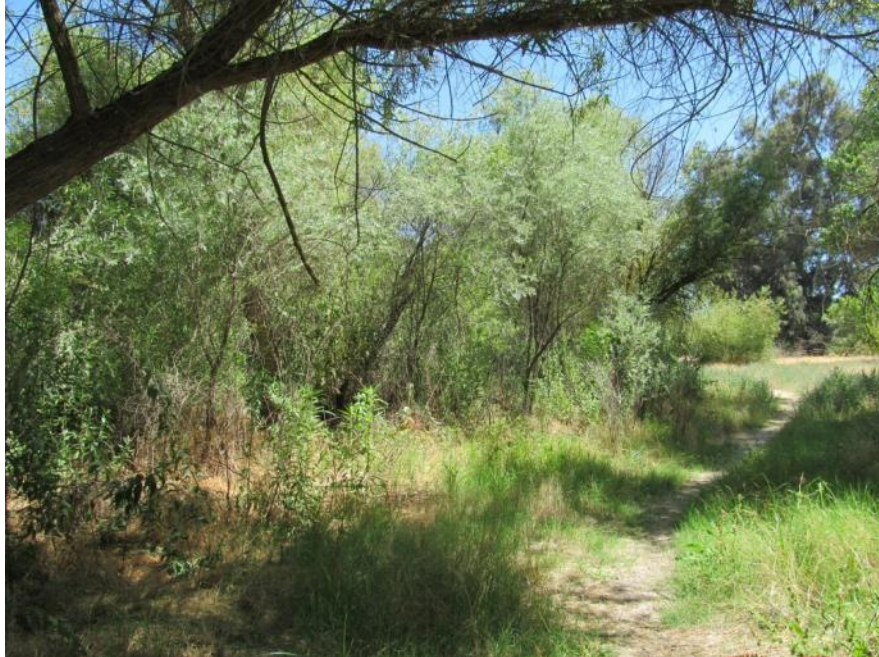
**Figure 20:** Native woody riparian vegetation along the San Joaquin River at on the San Joaquin River State Lands.

Remnant bands of native riparian vegetation cling to the edges of the river (and gravel pits on the Schneider Property) on both sites; these are dominated by black willow, sandbar willow, Oregon ash, box elder, Western sycamore, Fremont cottonwood, and buttonbush (Appendix III). Restoration plantings will connect these remnant bands of vegetation to create a network of habitat for riparian-obligate mammals and birds. Western sycamore (*Platanus racemosa*), elderberry (*Sambucus nigra*), California rose (*Rosa californica*), mulefat (*Baccharis salicifolia*), California buckwheat (*Eriogonum fasciculatum*), and bush lupine (*Lupinus albifrons*) are among the native woody species still found on the upper floodplain of Riverbottom Park, although their numbers are relatively low (Figure 22). The restoration design will incorporate existing native plants, where possible, to increase habitat connectivity.

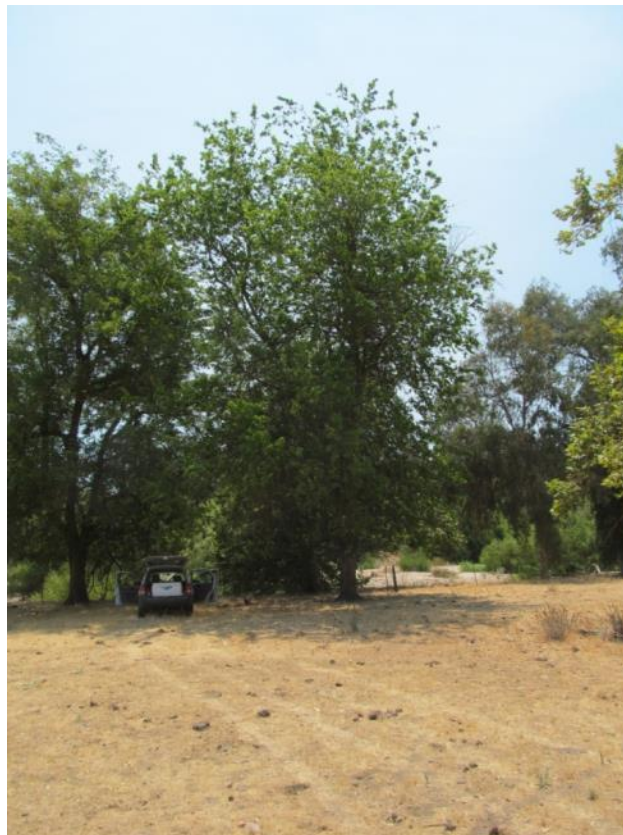
**Figure 21:** Schneider Property Restoration Site: Uplands dominated by invasive annual grasses with riparian vegetation on the lower floodplain along the River.

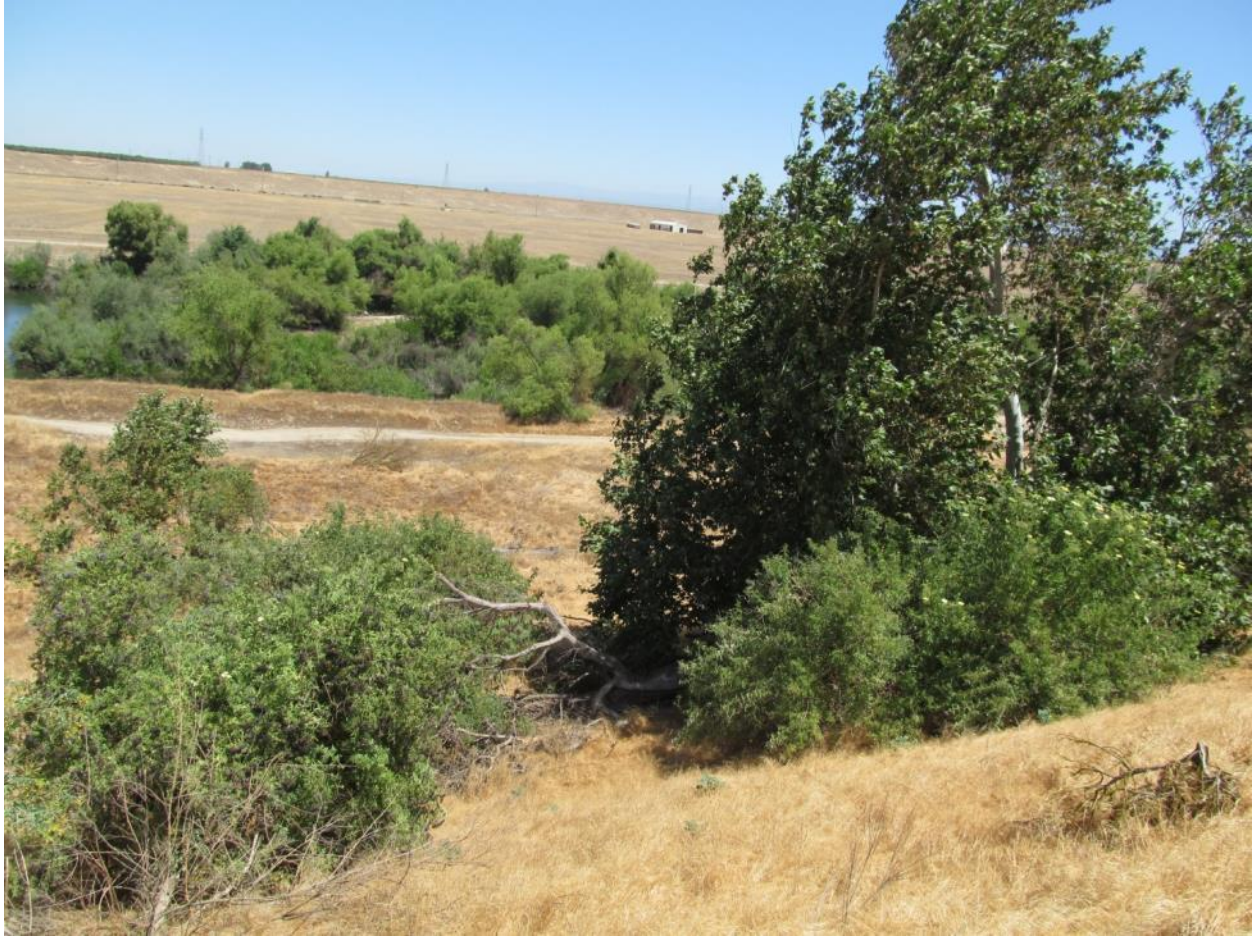
**Figure 22.** Remnant Western sycamore and blue elderberry along the north facing bluffs edge on the Riverbottom Project Site.

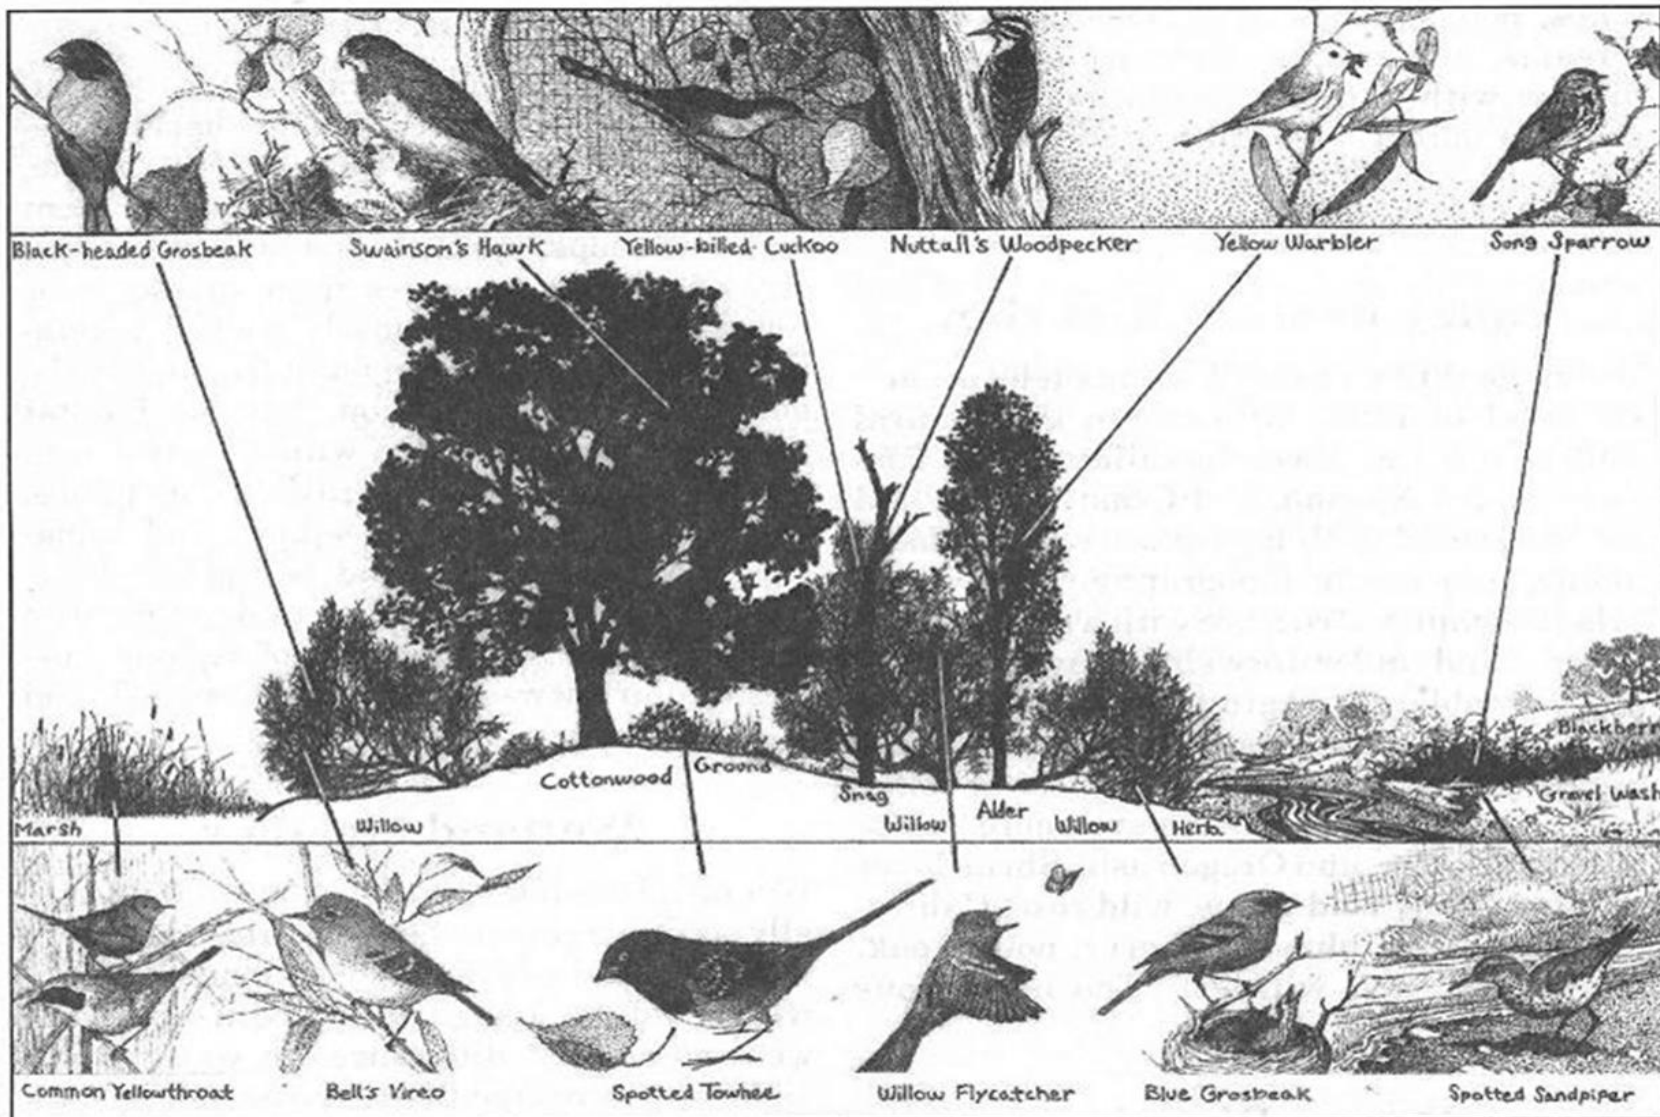
**Figure 23.** Avian riparian habitat usage and species requirements (RHJV 2000).

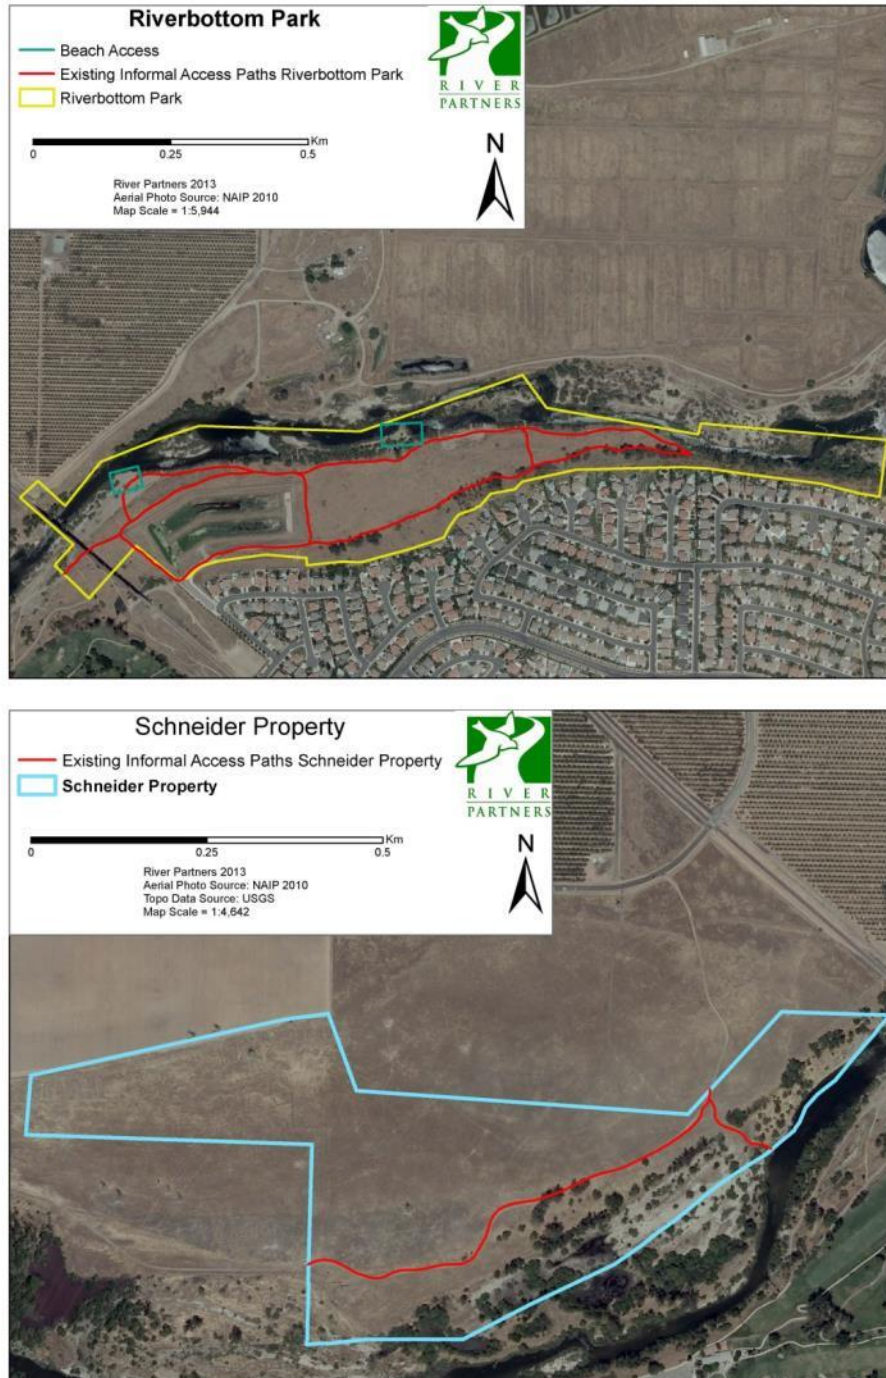
**Figure 24.** Proposed Access Considerations for Riverbottom Park (top) and the Schneider Property (bottom), Fresno and Madera Counties, California.

as well as for future recreation. The main access road will be left open, (drip lines may be buried beneath the road for the duration of the restoration) as well as an access path to the river itself. Existing informal access paths proposed for restoration Project use at the Schneider Property total 0.8 km.

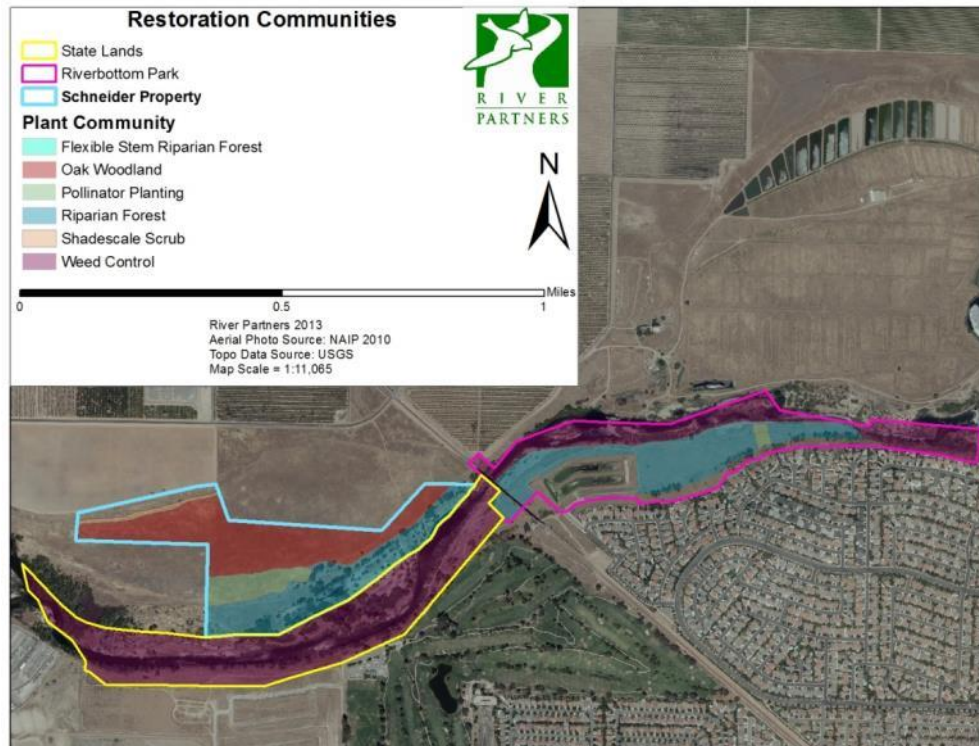
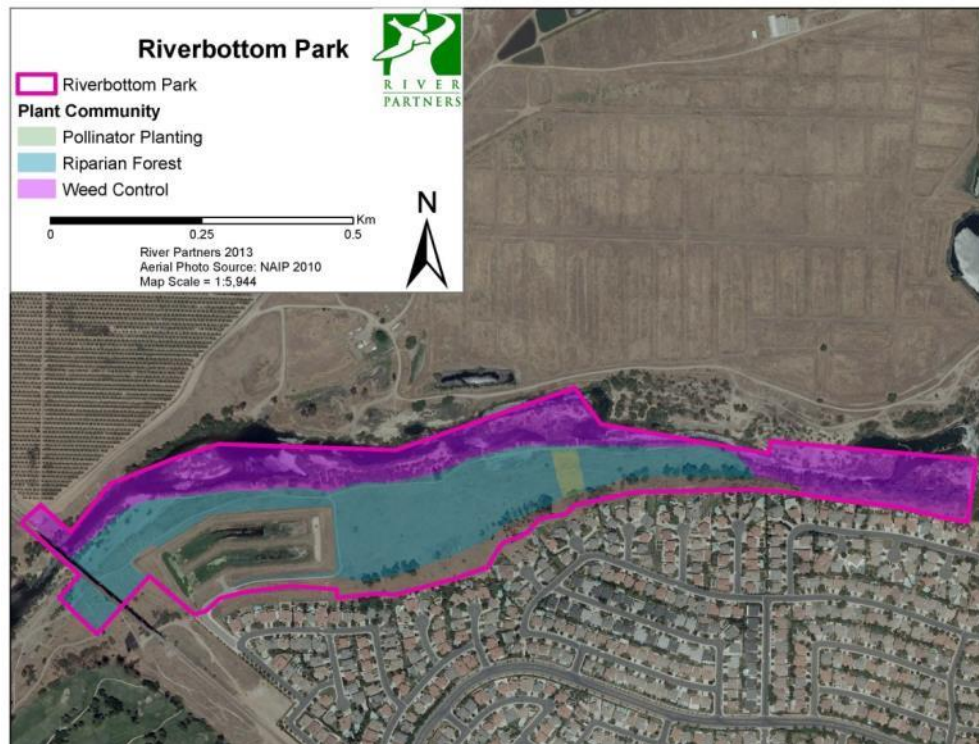
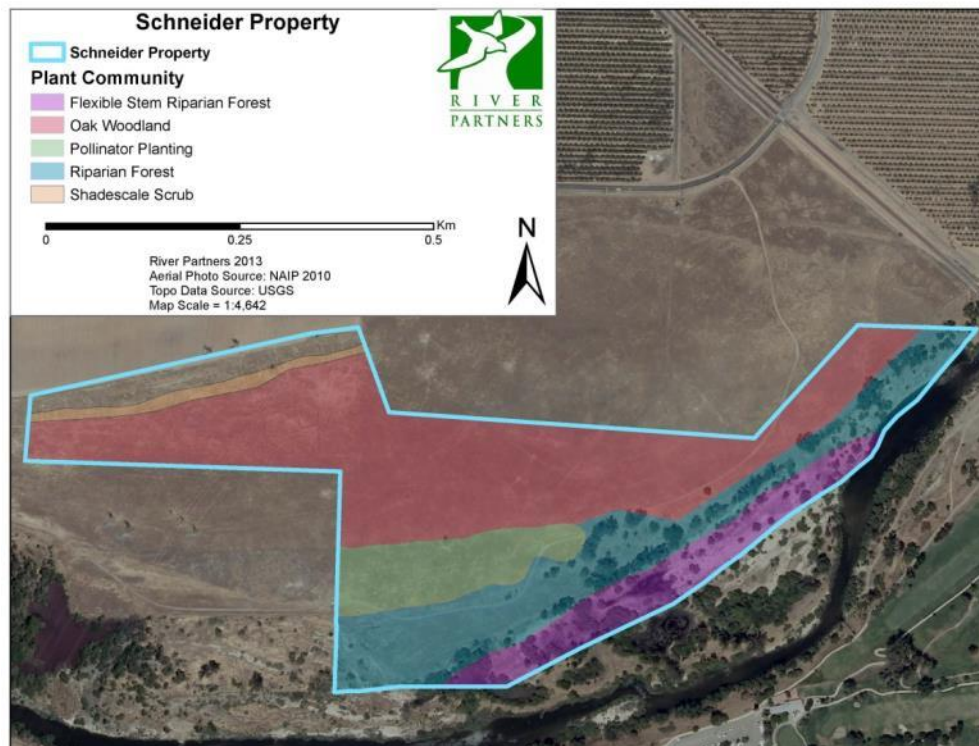
**Figure 26.** Plant Communities for Riverbottom Park and Schneider Property, Fresno and Madera Counties, California.

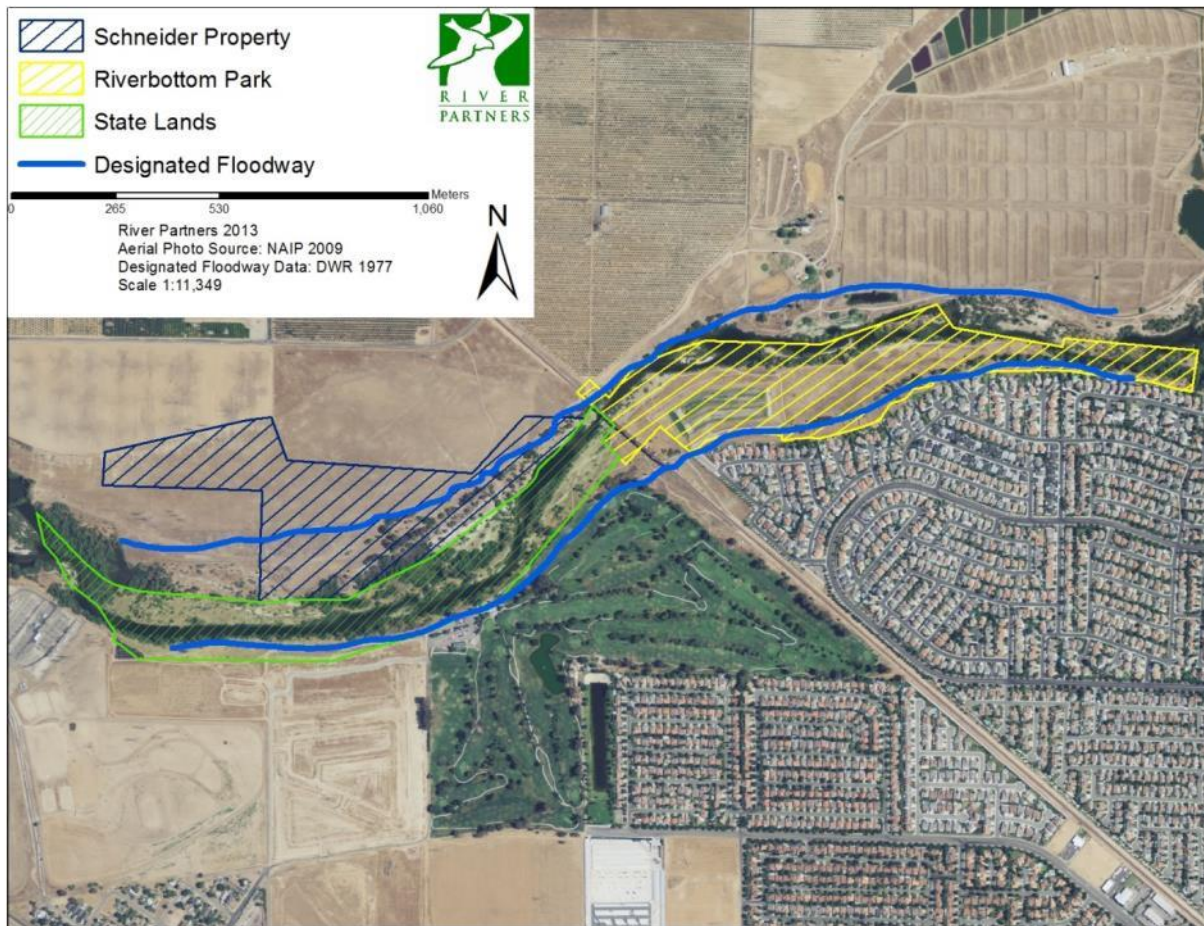
**Figure 27.** Project Area Geo-referenced with Designated Floodway.

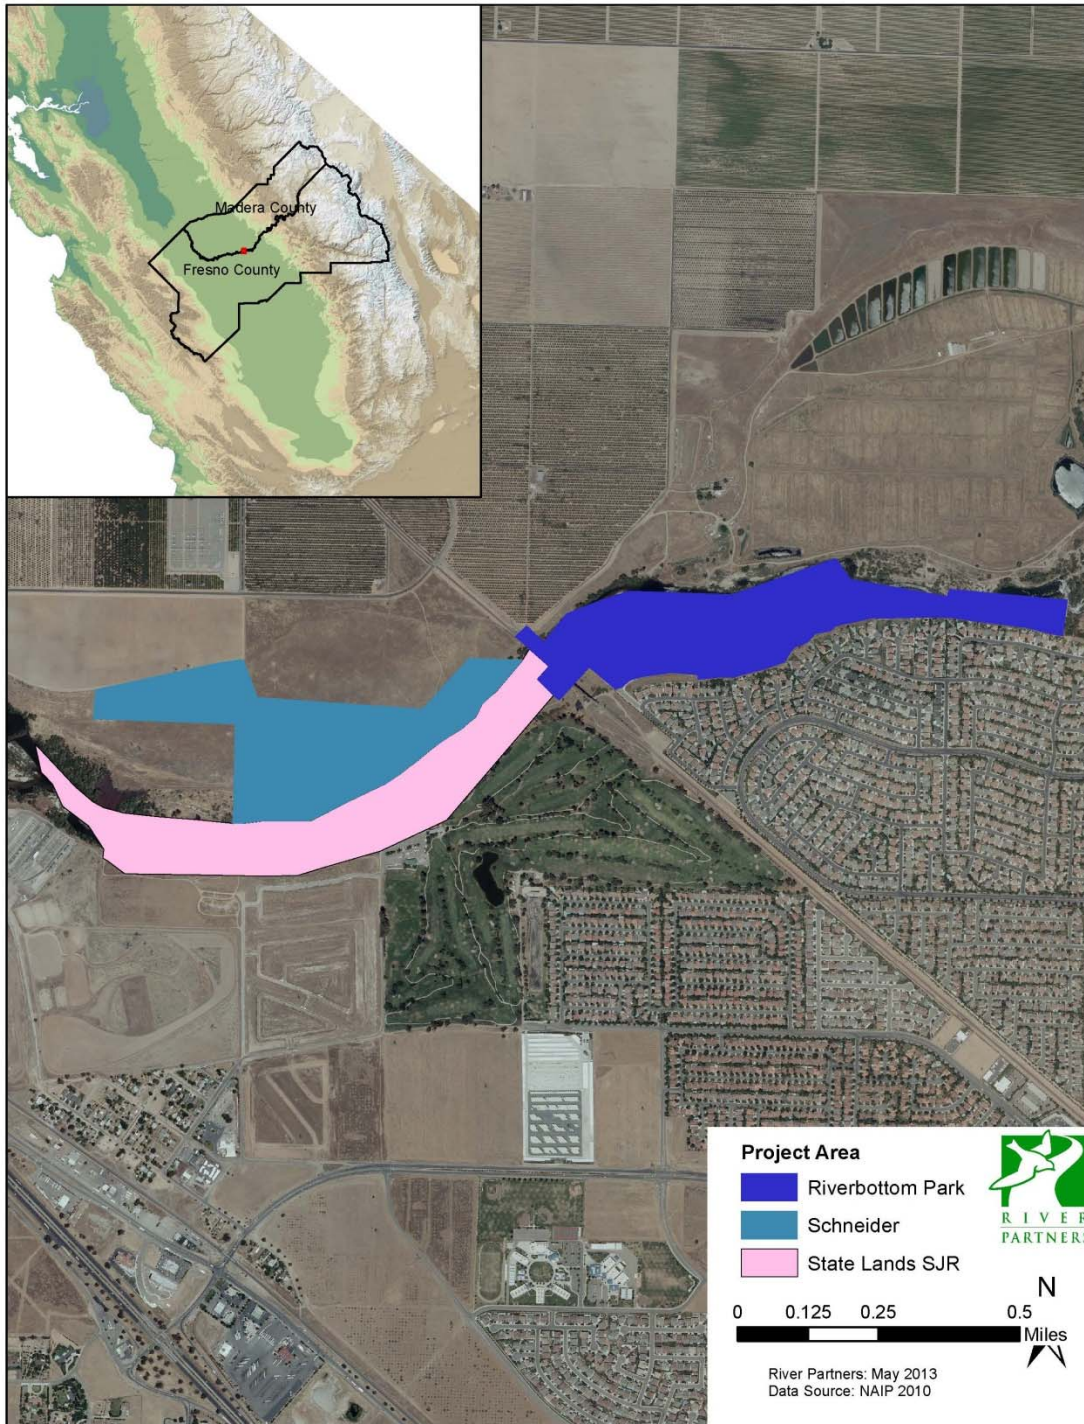
Figure 1

River Partners proposes to perform habitat restoration and enhancement along the San Joaquin River in Fresno and Madera County. The project is located along the river channel and upland area on the San Joaquin River at approximately USGS river mile 242 (Figure 1). The primary goal of the project is to increase and improve riparian, upland and wetland habitat to benefit multi-species. Plantings of native vegetation are proposed to achieve the goals. MBK Engineers has performed a hydraulic analysis of the proposed project in support of the California Central Valley Flood Protection Board (CVFPB) Encroachment Permit Application. This memorandum documents the hydraulic analysis performed.

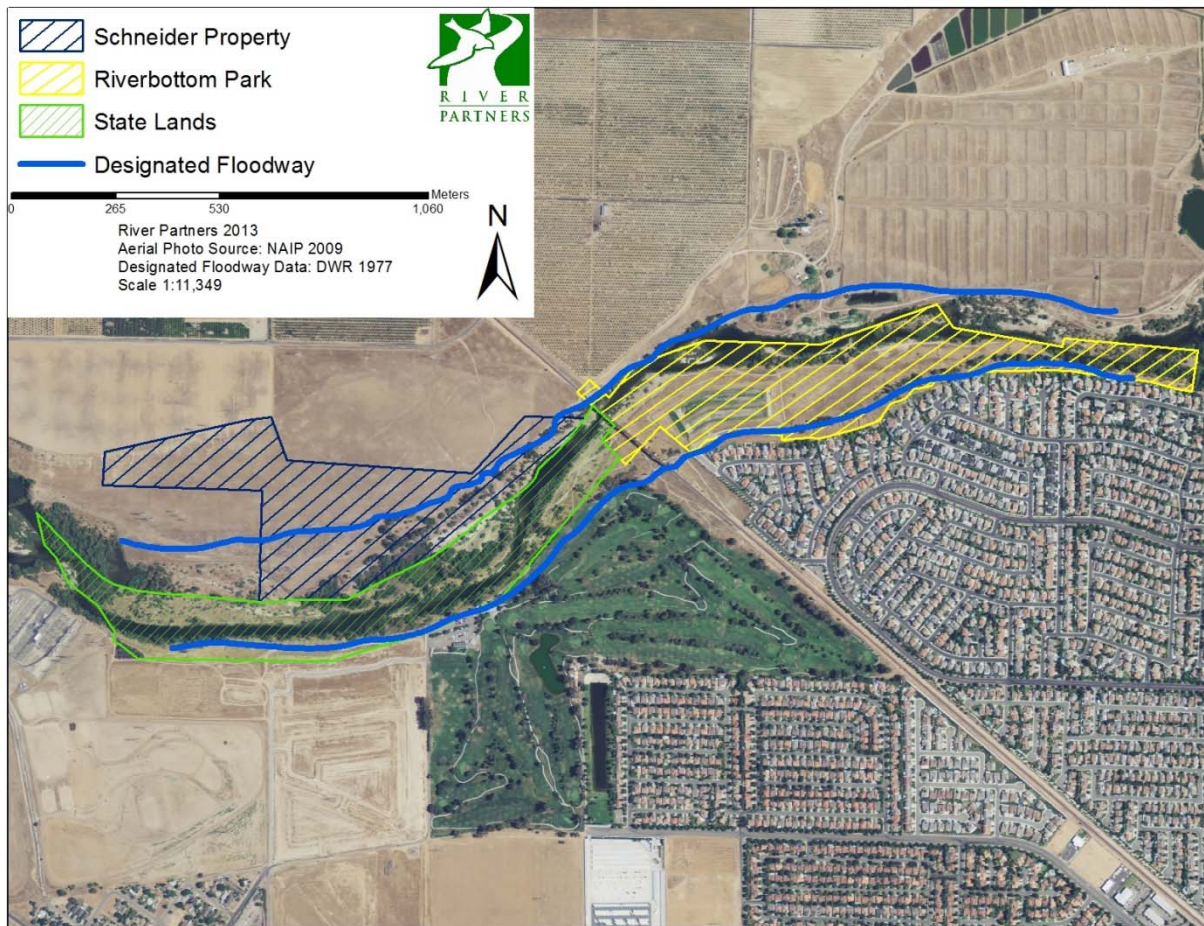
Figure 2

The project consists of enhancing approximately 147 acres of riparian and upland habitat on the San Joaquin River: Riverbottom Park (63 acres), Schneider Property (62 acres), and adjacent State lands (22 acres). The properties span approximately two miles of the San Joaquin River from river mile 242 to 244. The San Joaquin River runs between two bluffs through the project site with the federal project levees beginning approximately 22 miles downstream. Riverbottom Park is located within San Joaquin River floodplain and CVFPB Designated Floodway. About 50% of the Schneider Property is located within the Designated Floodway. (Figure 2)

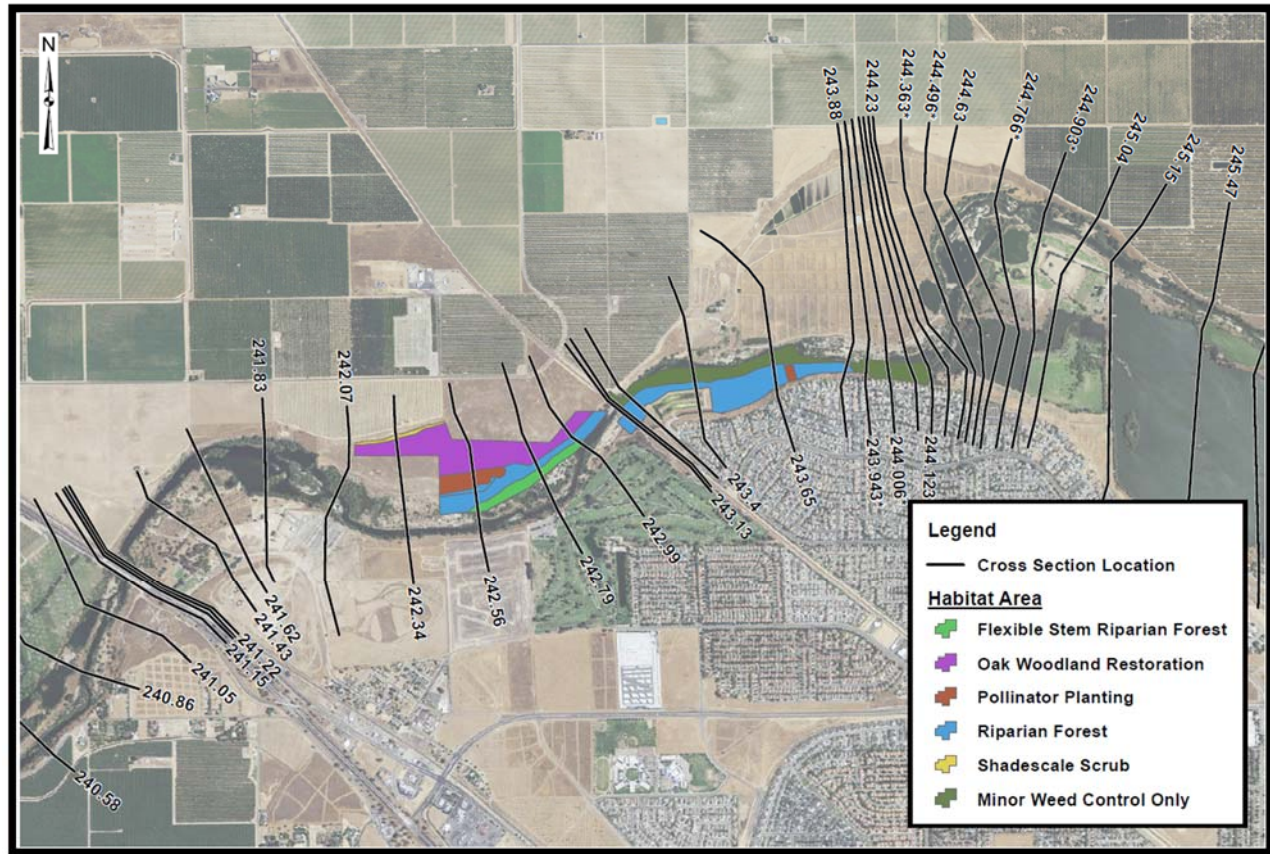
A 1-dimensional HEC-RAS model was used to simulate the existing and project conditions. The hydraulic model used was the California Department of Water Resources Central Valley Hydrology Study (CVHS) HEC-RAS model of the San Joaquin River Flood Control Project (SRFCP). The model development is documented in *“Interim Work product for the Central Valley Hydrology Study: Development of regulated CVHS Sacramento River and San Joaquin Basin HEC-RAS models”*, February 9, 2011, David Ford Consulting Engineers. The CVHS model was modified to only include the reach of the San Joaquin River between Comp Study river miles 227 and 264, extending 20 miles upstream and 15 miles downstream from the project site. To simulate the project condition, the HEC-RAS model geometry was modified to reflect the proposed project on at the Riverbottom and Schneider properties. To represent the proposed vegetation, the Manning’s roughness coefficients in the model were modified to reflect the long term vegetation at the two sites. Figure 3 shows the cross sections through the project site along with the proposed plant associations. For each of the plant associations the Manning’s roughness coefficient was adjusted in the respective cross sections. Appendix A shows each of the cross sections modified along with the existing and project condition Manning’s roughness coefficient. The Manning’s roughness coefficient used for each plant association is tabulated in Table 6.

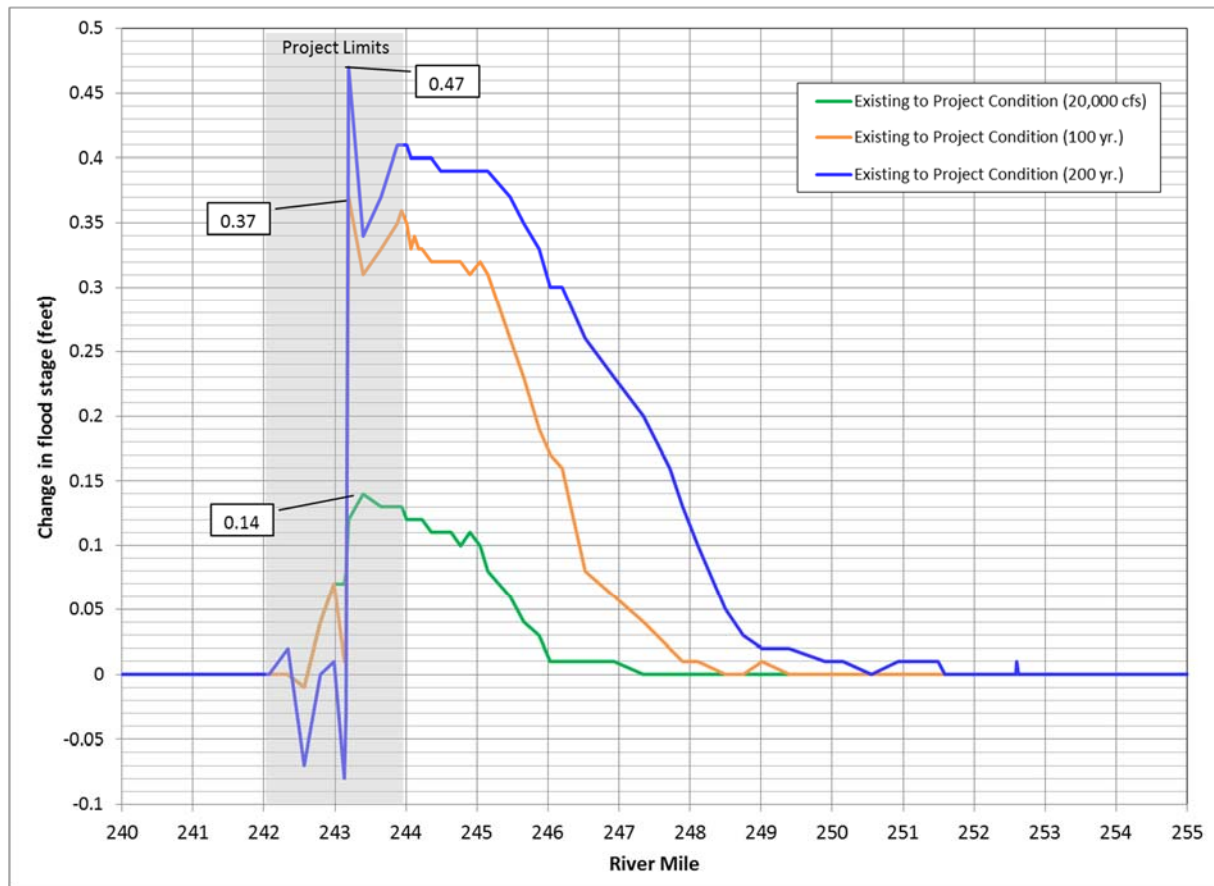
Figure 4

The computed water surface elevations and the differences in water surface elevations for the existing condition and project condition are tabulated in Table 8. Profile plots of the computed flood stage changes due to the Project Condition are provided in Figure 4.

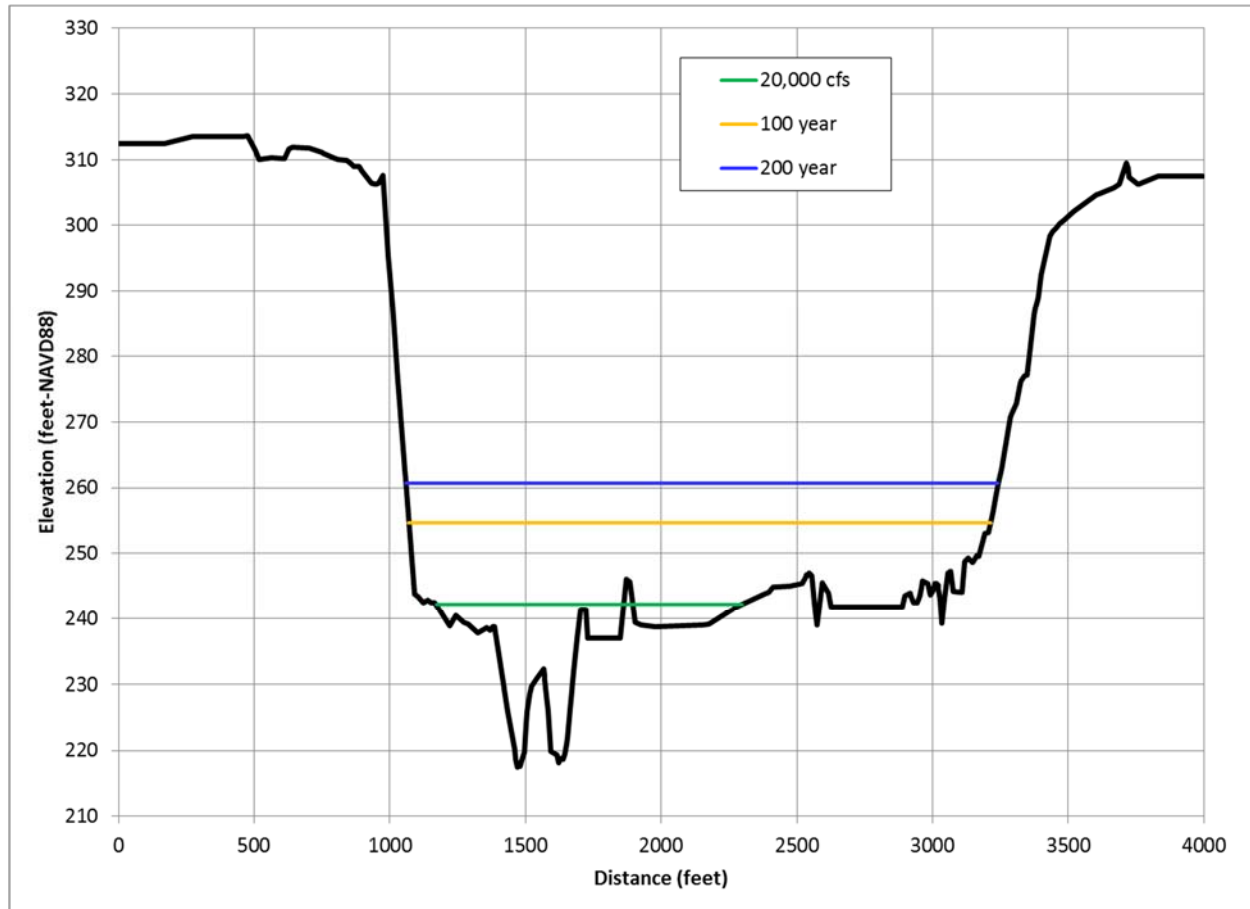
**Figure 5**

The proposed project is located along the San Joaquin River reach where the river runs between two bluffs. There is no Federal, State or local levees along this reach of the river until approximately river mile 220, 22 miles downstream of the project site. Under existing conditions, the water surface along the project reach is typically a minimum of 55 feet below the top of the bluff for the CVFPB design flow, 45 feet for the 100 year flood and is 40 feet for the 200 year event. Figure 5 shows a typical cross section.

The proposed project would increase water surface elevations by as much as 0.14, 0.37 and 0.47 feet for the CVFPB DF design flow, 100 year, and 200 year flood event, respectively. There would still remain a significant amount of freeboard to the top of the bluff for all flood events simulated. Based on the analysis results and review of the project plans and existing topography, the increase in water surface elevation would not significantly reduce the ability of the San Joaquin River through the project reach to pass the flood events simulated, nor would it increase flood risk.
